NATIONAL TRANSPORTATION SAFETY BOARD

SITE and ON-SCENE INFORMATION (Rev B)

**NTSB Accident: WPR18FA143
Accident Date: May 19, 2018**

Location: Near Avenal, California
Date: May 19, 2018
Aircraft: ICA-Brasov IS-29D Lark, N38ES, Serial # 38
NTSB IIC: Michael Huhn

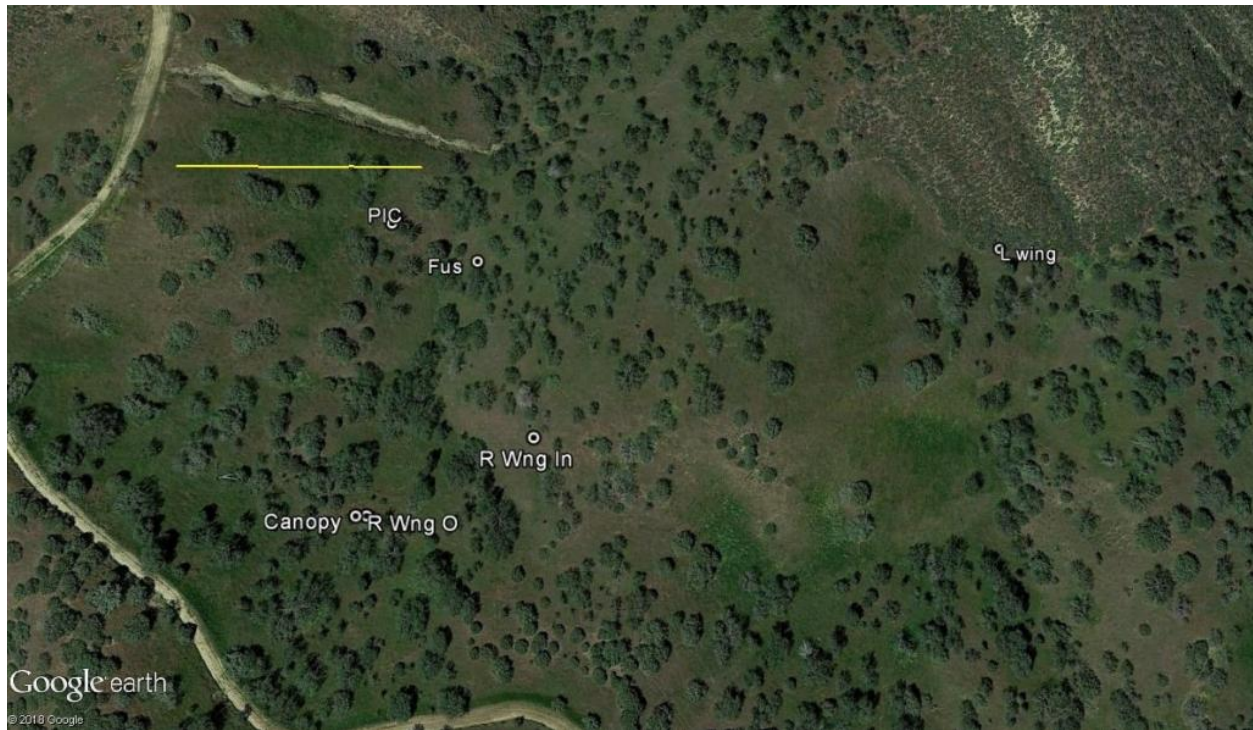
- The wreckage was situated in remote, rugged terrain
- The wreckage was determined to be in two primary locations
 - Most wreckage was loosely grouped in one location
 - The left wing was located about ¼ mile from the remainder of the wreckage
- The geographic coordinates of the major items were determined and recorded

Figure 1 - Wreckage Overlaid on Google Earth View

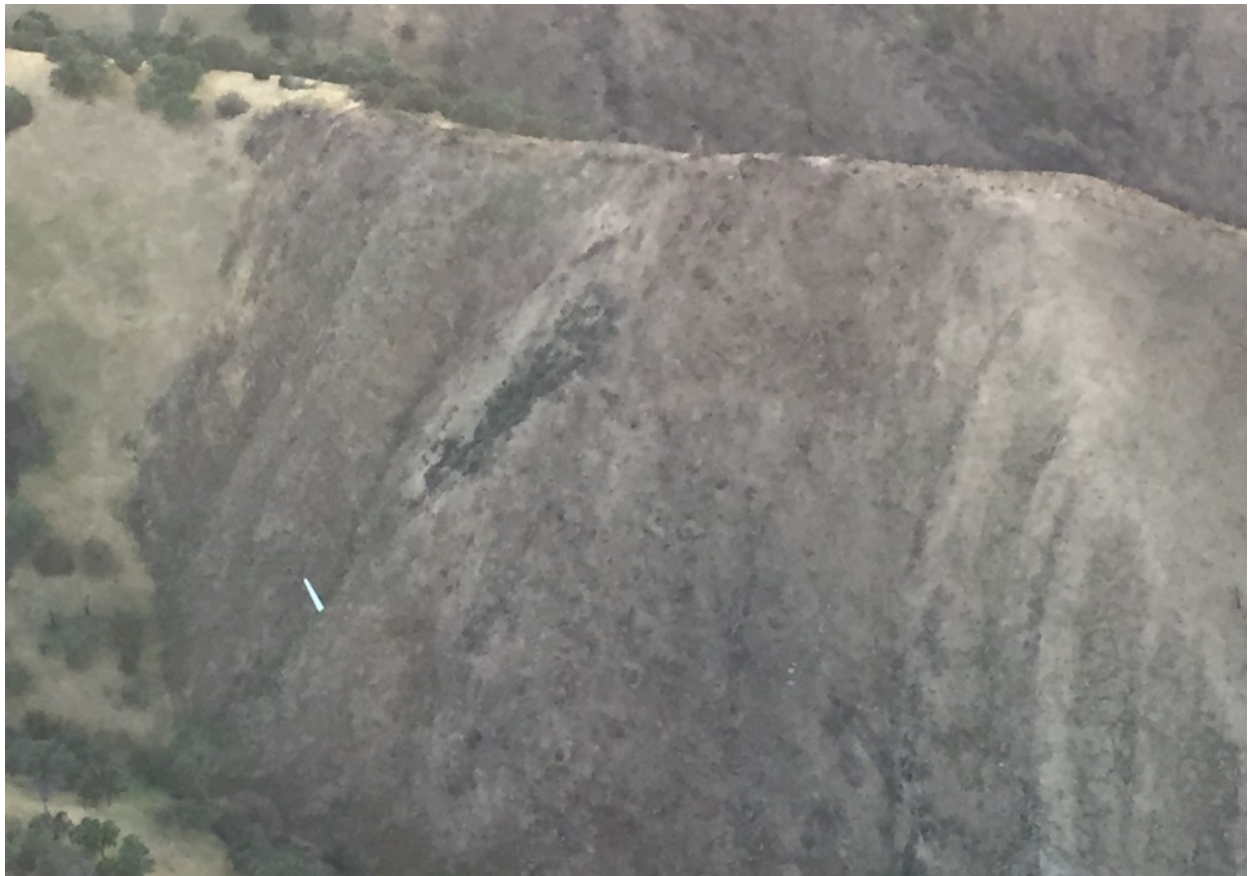
Figure 2 - Left Wing (Aerial View)

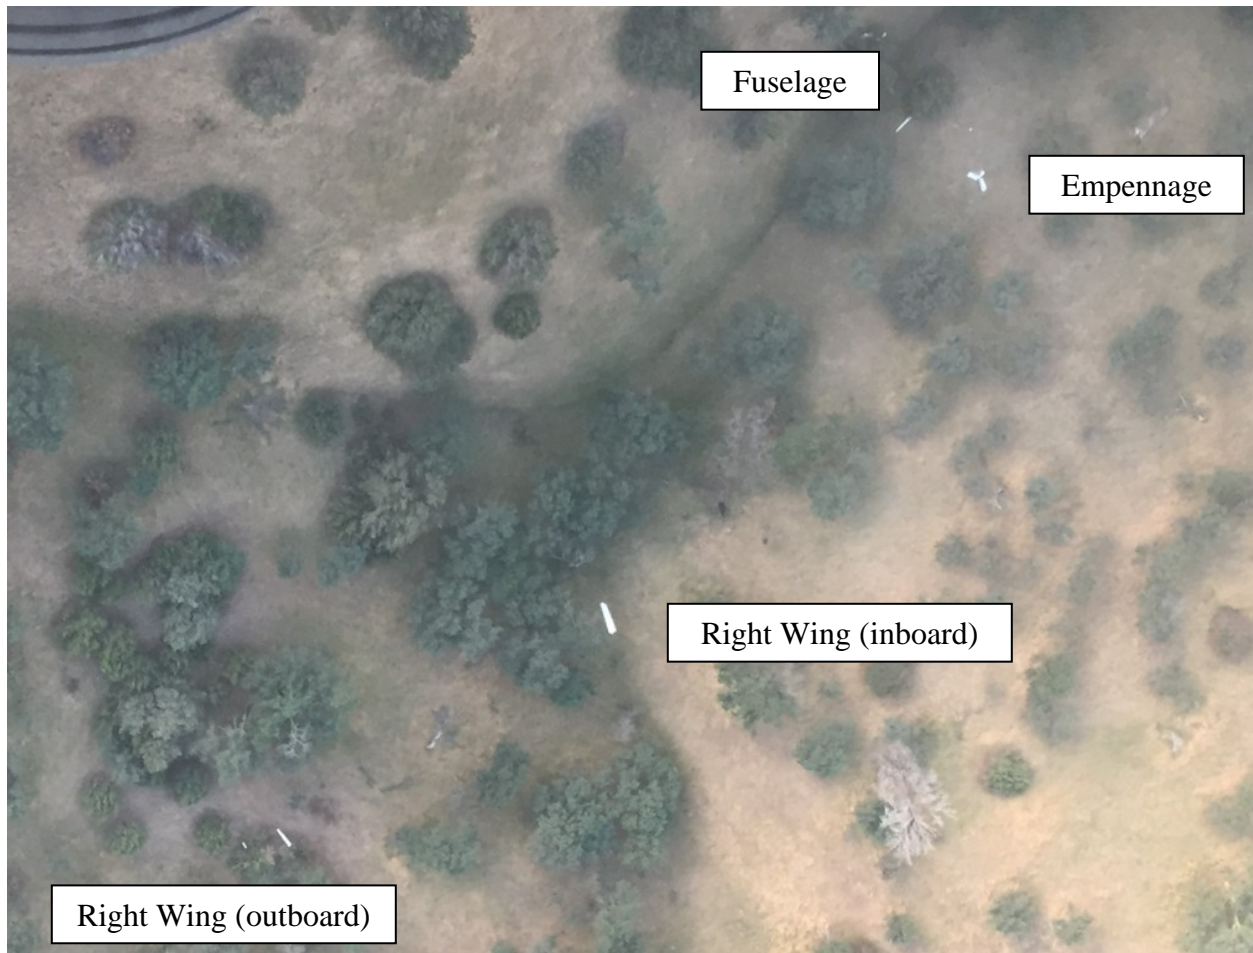
Figure 3 - Main Wreckage Group

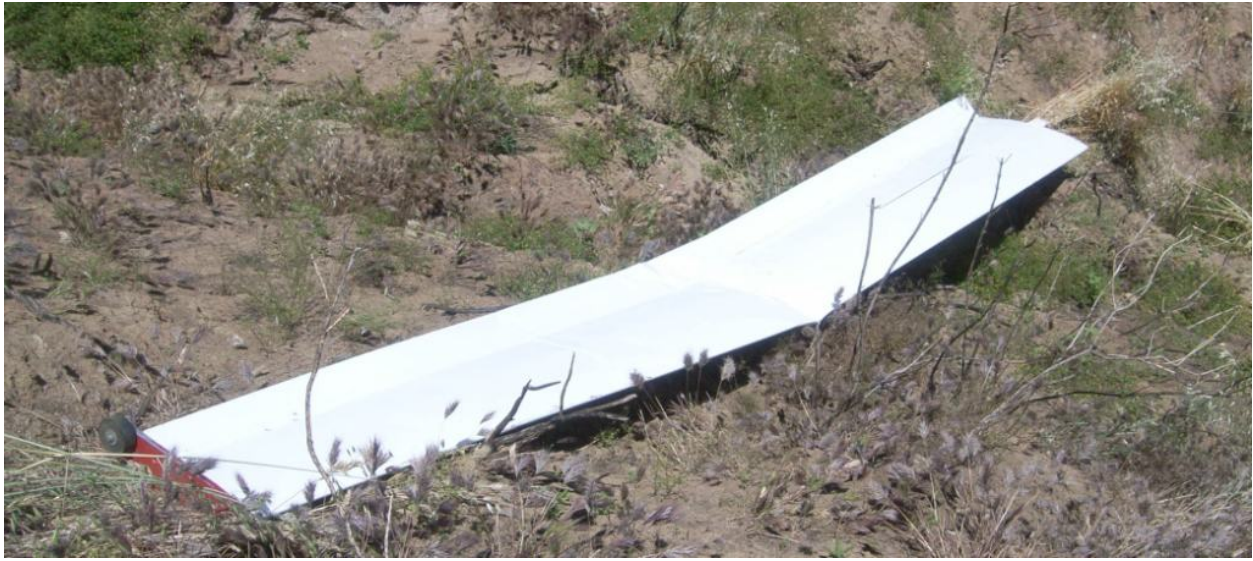
- The entire, all-aluminum wing was in 1 piece
- The wing was slightly buckled in the wingtip down direction near the 1/3 span point
 - This appeared consistent with ground impact damage

Figure 4 - Left Wing as Found

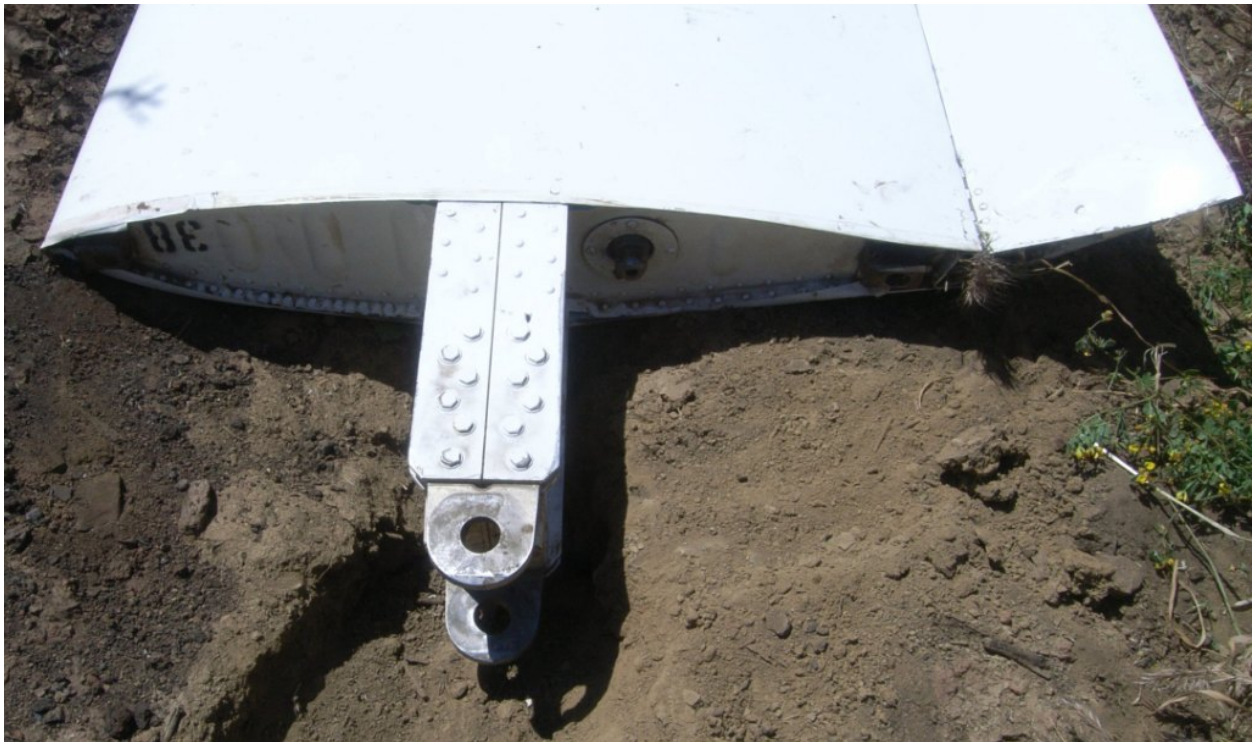
- The flap and aileron both remained fully attached to the wing, and appeared undamaged
- The 'air brakes' (1 panel each on the upper and lower wing surfaces) were intact and retracted
- The aileron, flap, and air brake control links appeared intact
- The 2 clevis tangs displayed minimal damage, primarily in the form of slight scoring, plus caked dirt from ground impact
- The machined holes in the tangs (to accept the cone nuts) were intact and essentially undamaged

Figure 5 - Left Wing Root

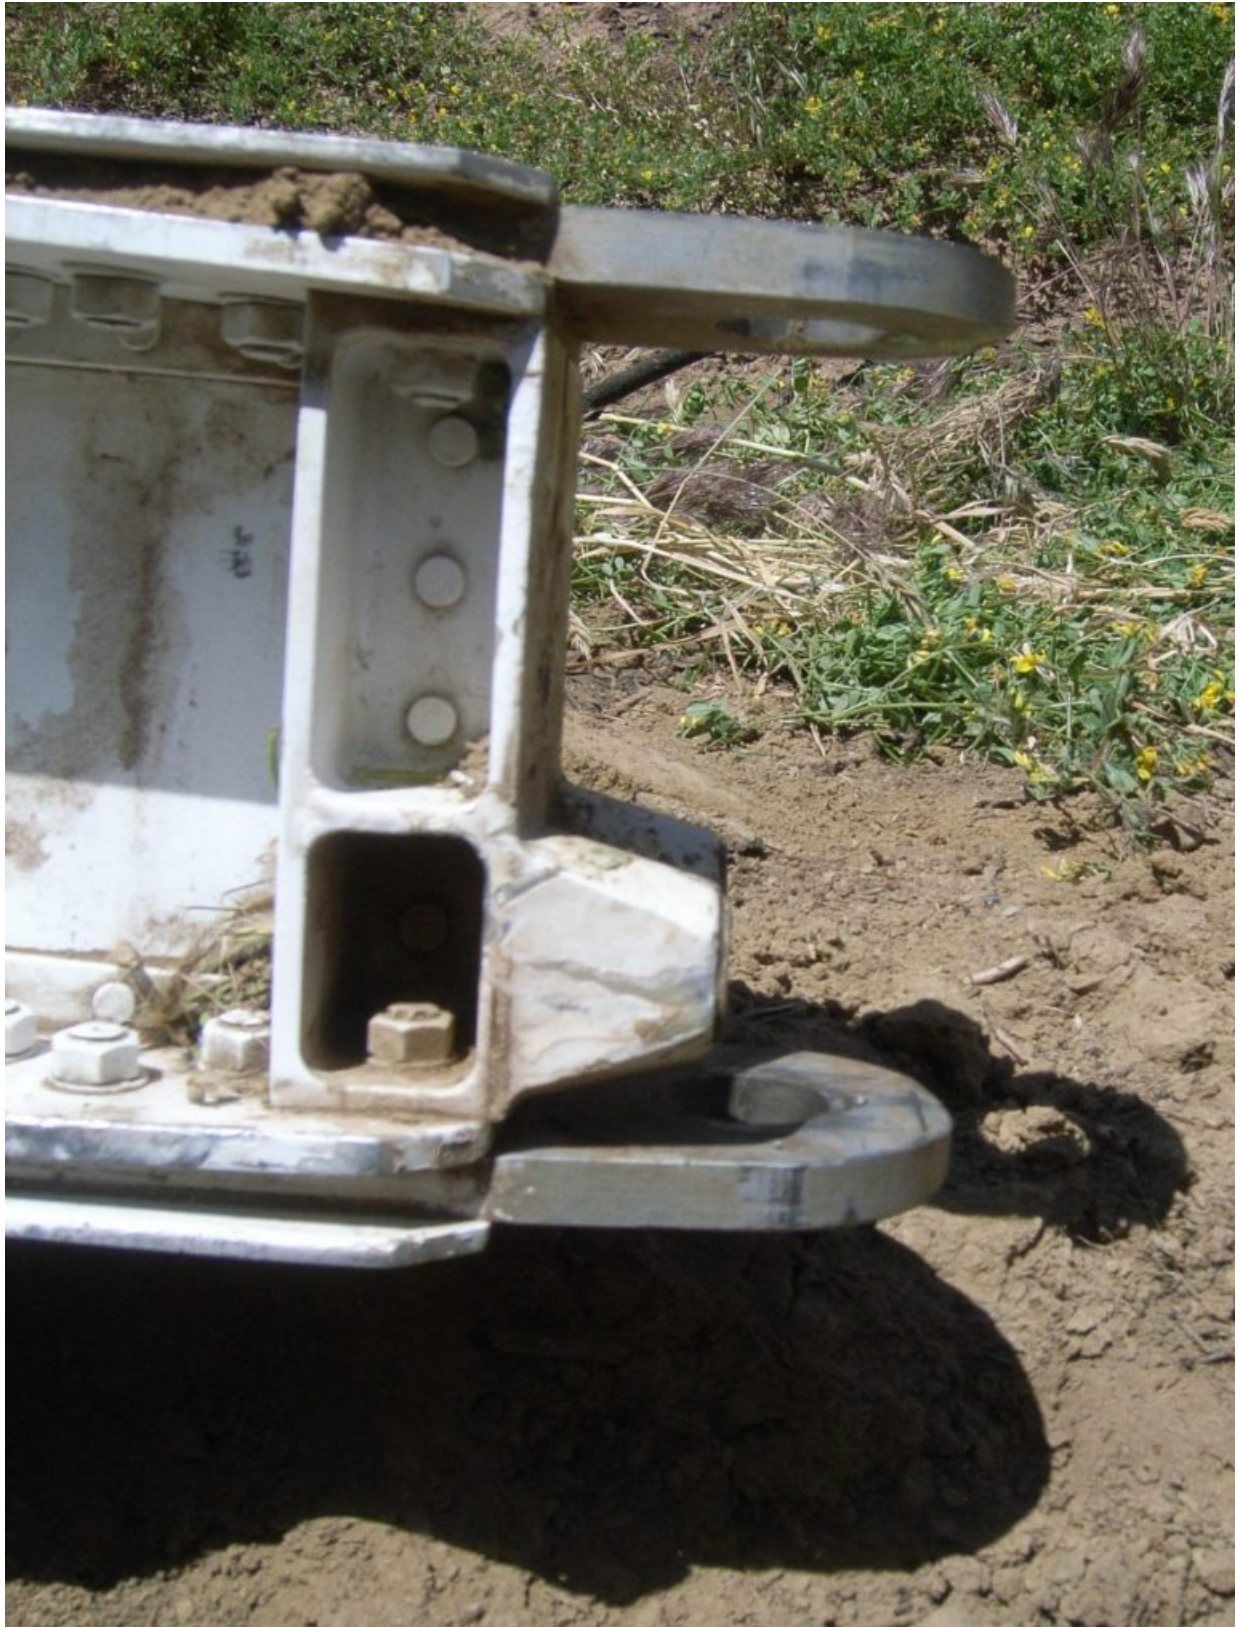
Figure 6 - Left Wing Clevis Tangs

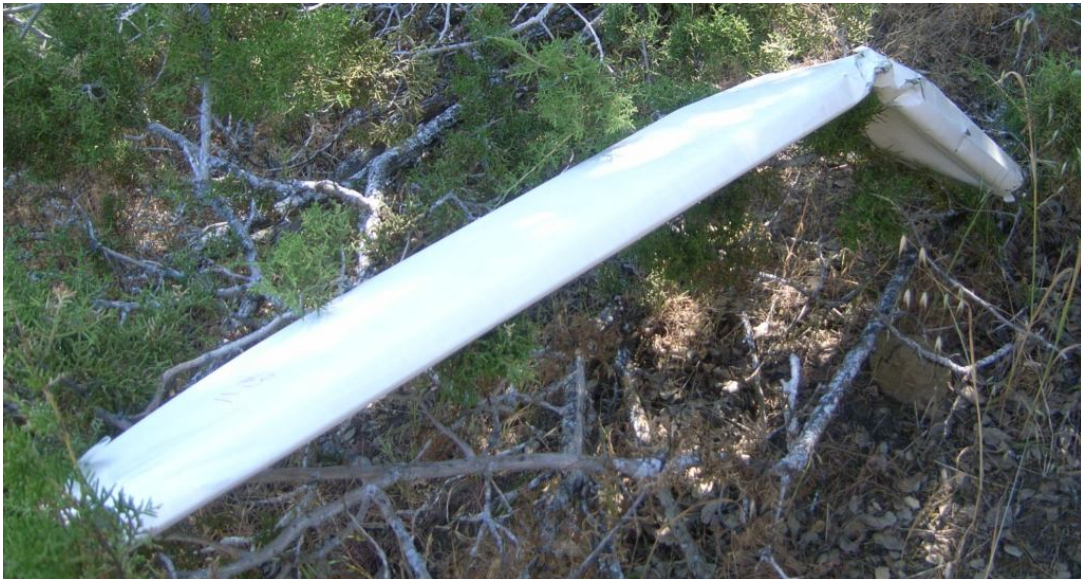
- Inboard aileron section (approx. 4 ft)
- These 3 components were loosely grouped, and formed part of the primary wreckage group
- The flap remained fully attached to the wing, and appeared only slightly damaged

Figure 7 - Right Aileron

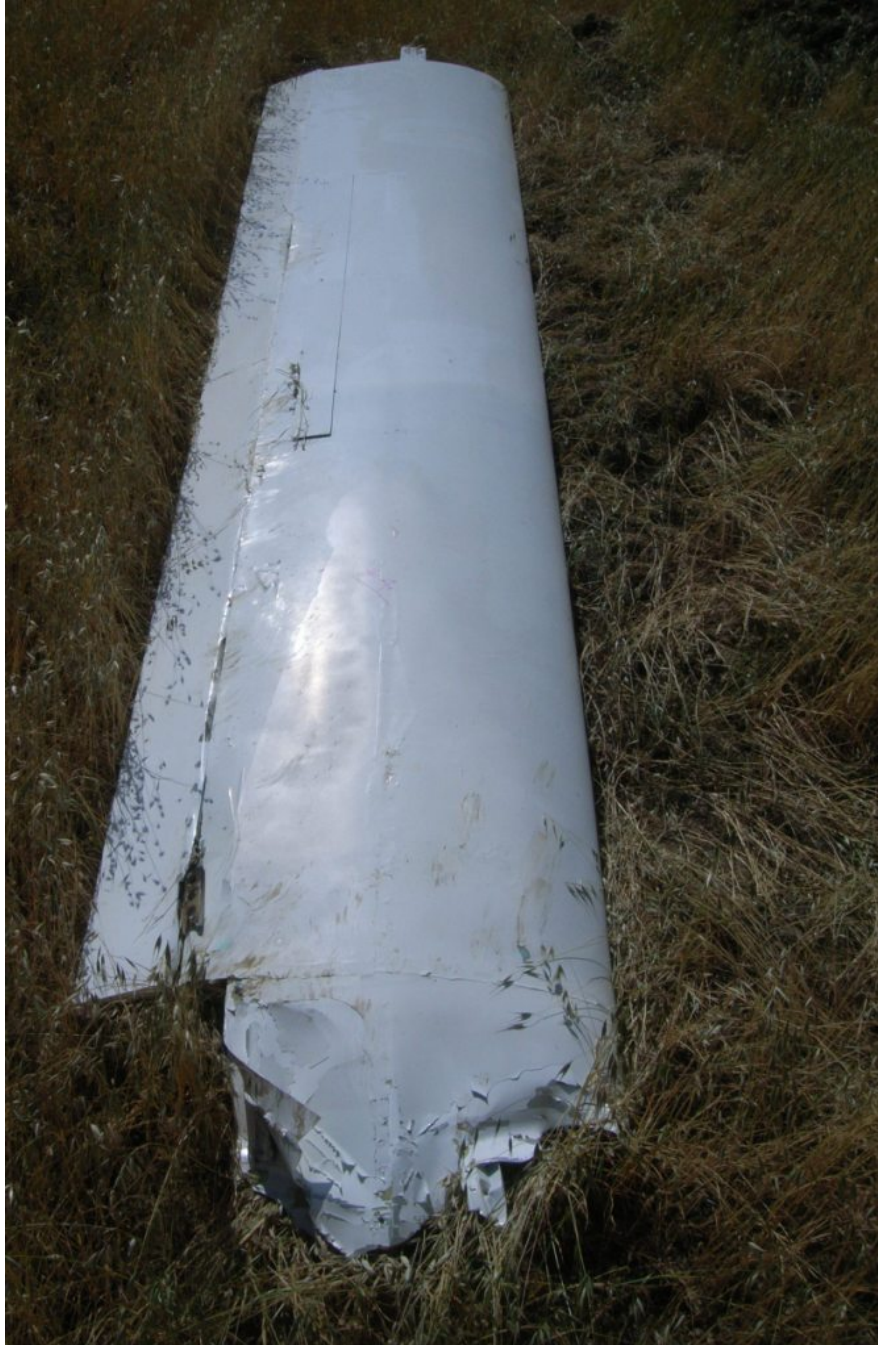
- The all-aluminum wing was fractured/torn into 3 primary sections
 - Inboard wing section (approx. 15 ft, near the aileron-flap junction)
 - Outboard wing section (approx. 7 ft)

Figure 8 - Right Wing Outboard Section

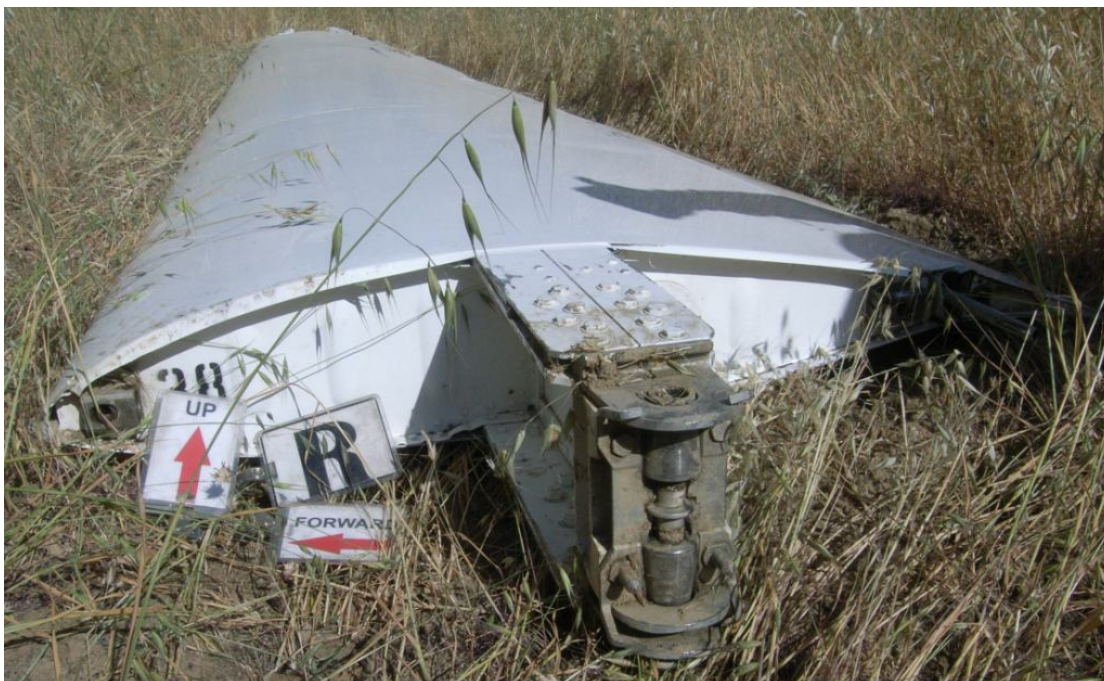
- The 'air brakes' (1 panel each on upper and lower wing surfaces) were intact and retracted
- The upper leg of the top clevis was fracture-separated, and not located

Figure 9 - Right Wing Root

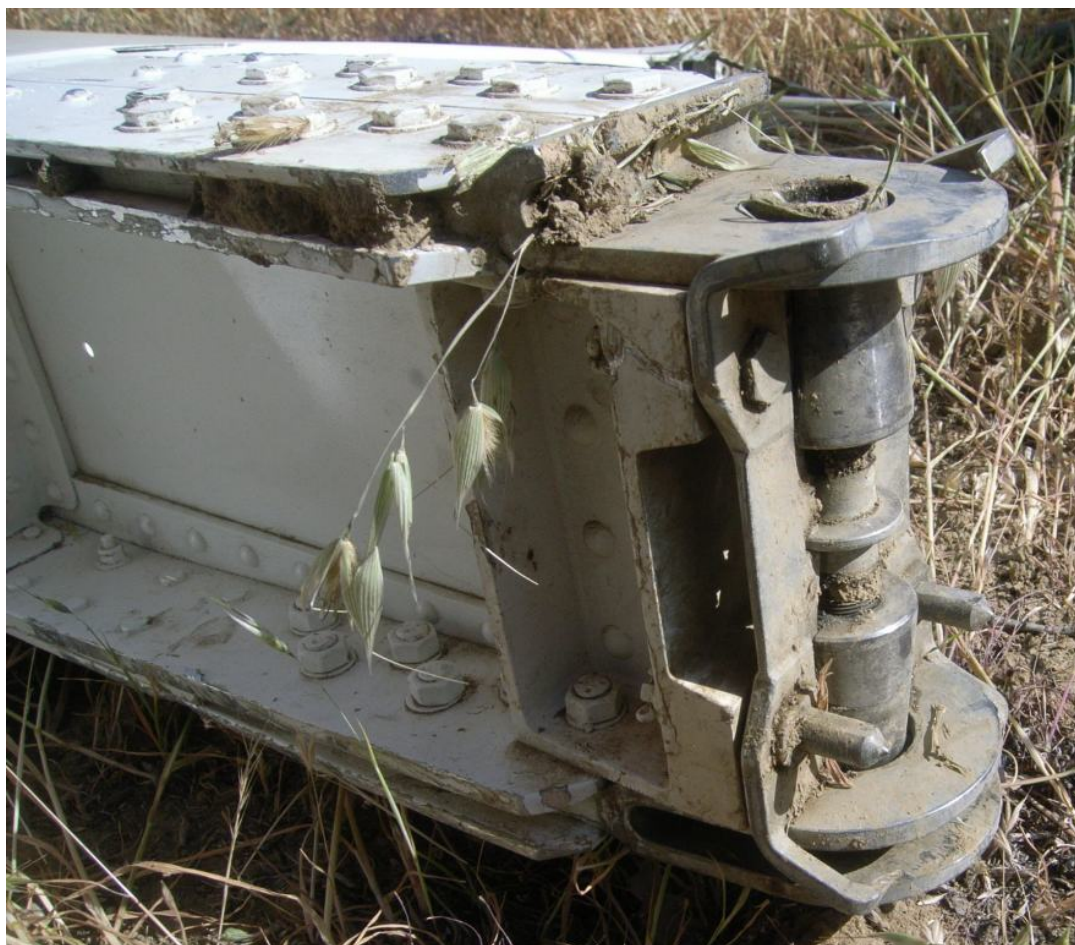
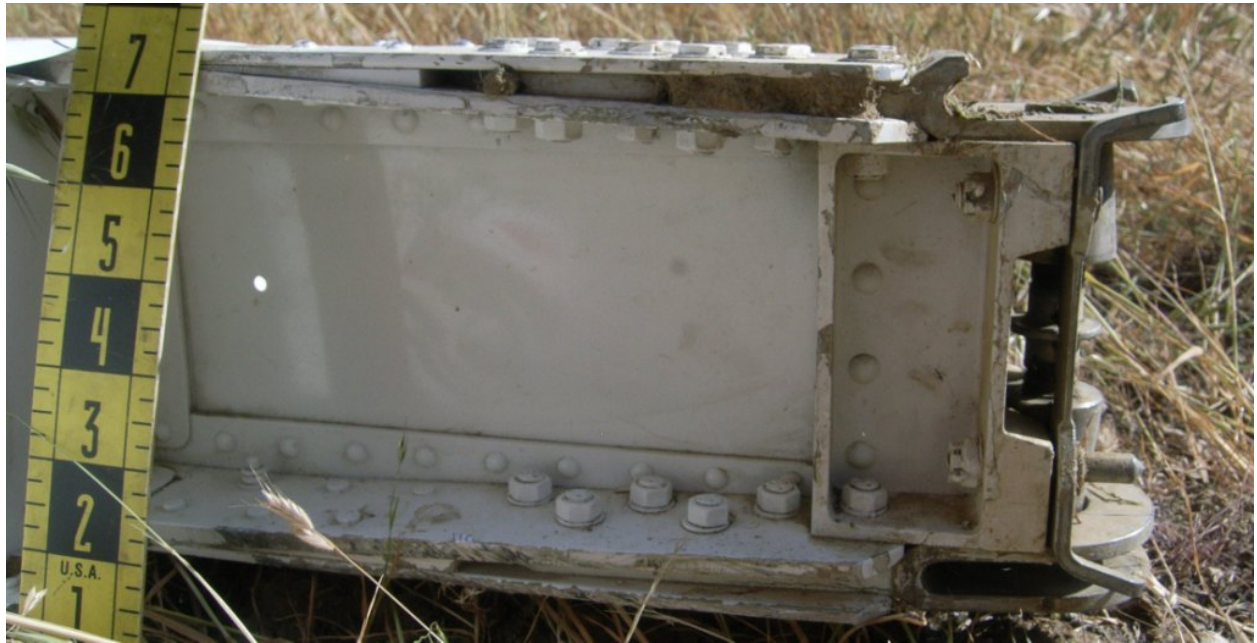
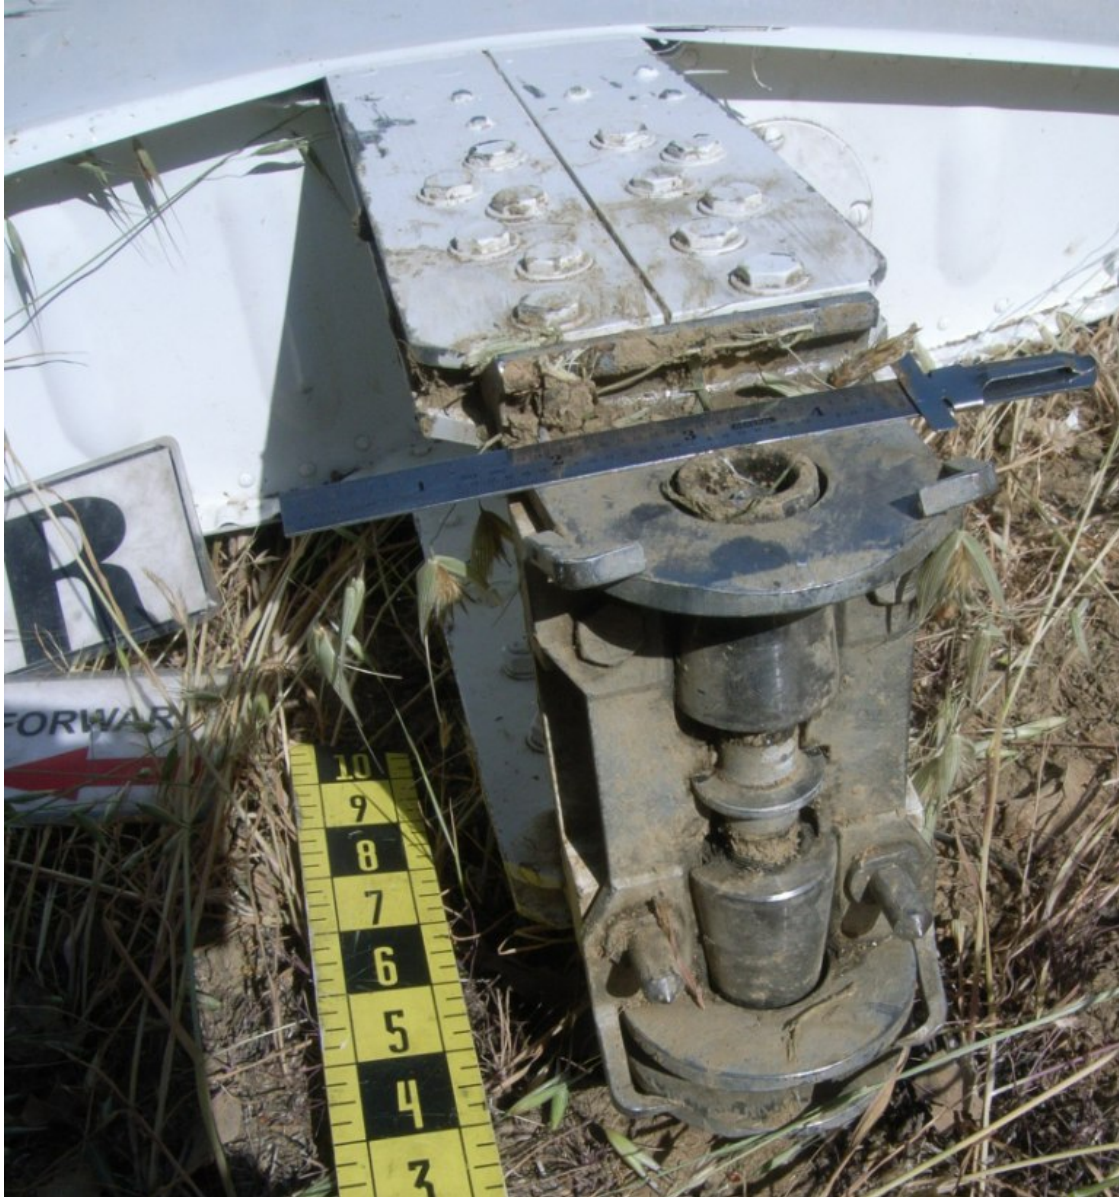
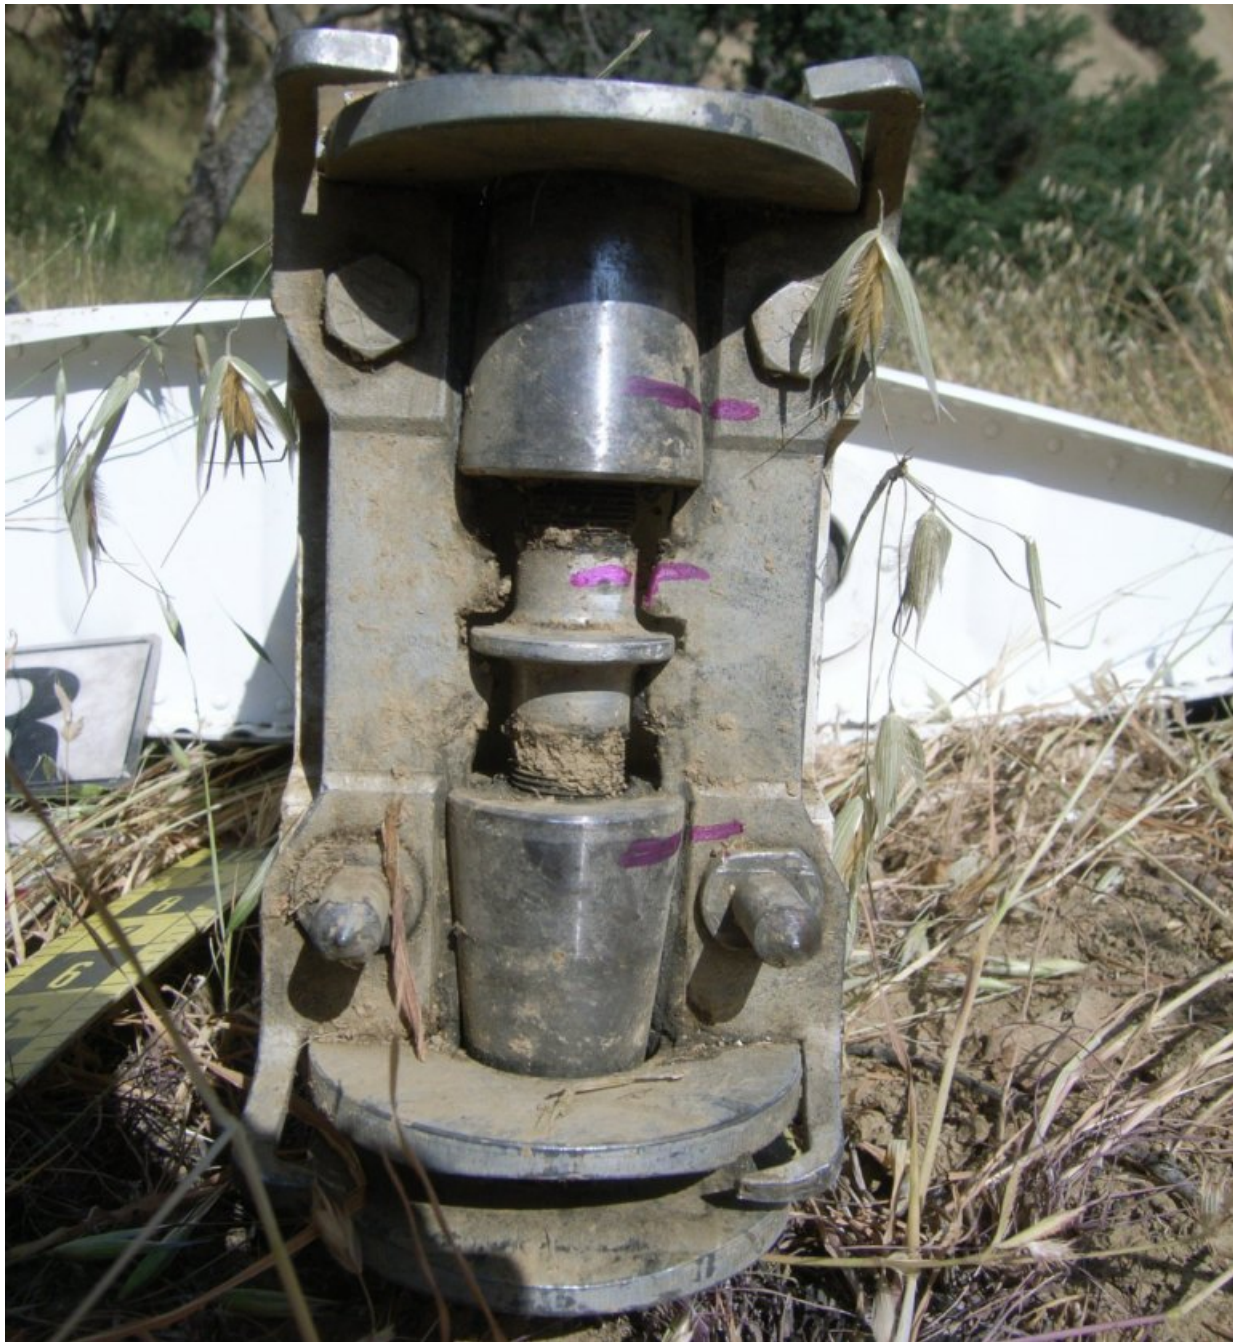
- The lower leg of the top clevis, and the 2 legs of the bottom clevis, were essentially undamaged
- The machined holes in the 3 remaining legs (to accept the cone nuts) were intact and essentially undamaged

- The 2 pin-capture/assembly guide plates were only slightly damaged
- The pin, with its 2 cone nuts were present and captive in the clevis assembly
 - The pin and cone nuts appeared undamaged

- The nuts were symmetrically positioned (up and down) along the pin
- The nuts were positioned so that their respective ends protruded only slightly (maximum ~1/8 inch) beyond the 'innermost' two (lower leg of top clevis, and upper leg of bottom clevis) clevis legs, so that they only minimally engaged the two tangs.

- They did not at all engage the other two (upper leg of top clevis, lower leg of bottom clevis) clevis legs
- The hex/allen key assembly tool was not present in the pin, and was not located at the accident site

Figure 10 - Right Wing Clevis and Pin Assembly

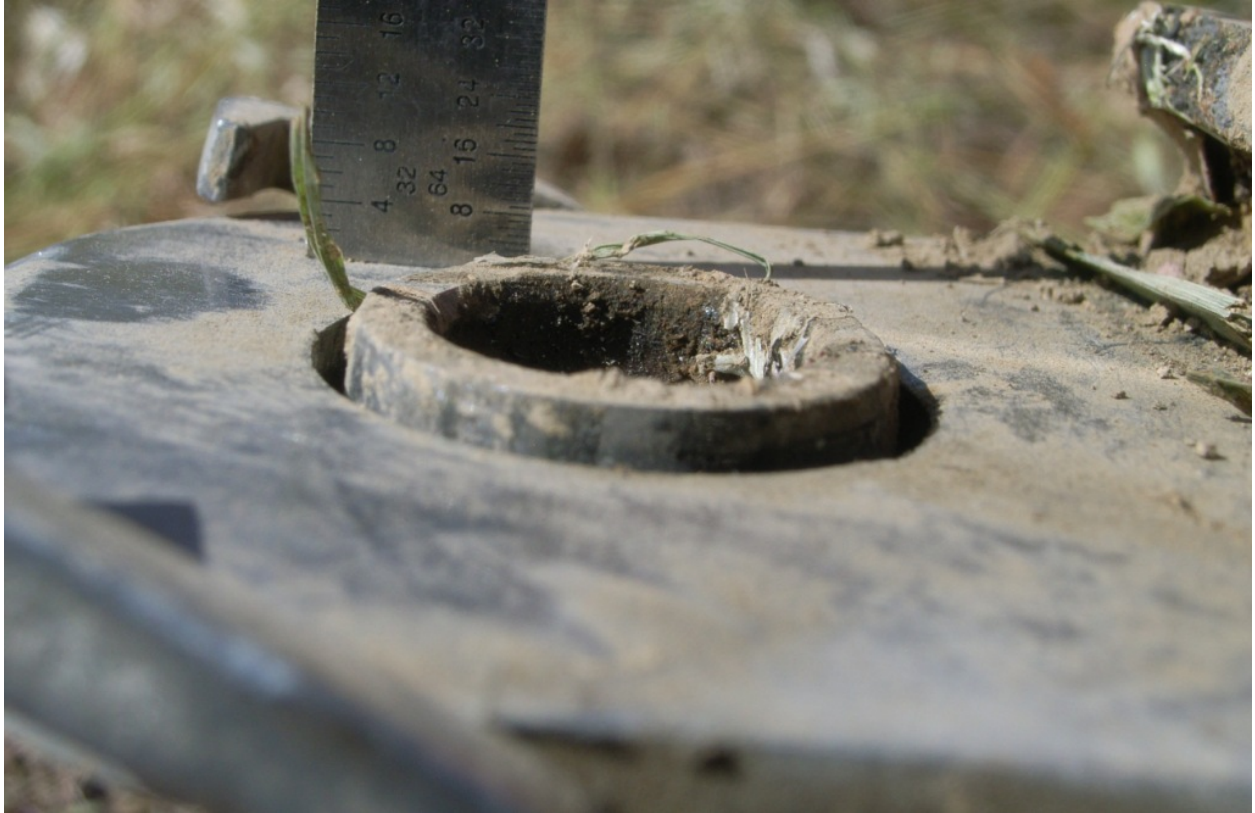
Figure 14 - Upper Cone Nut (at rest)

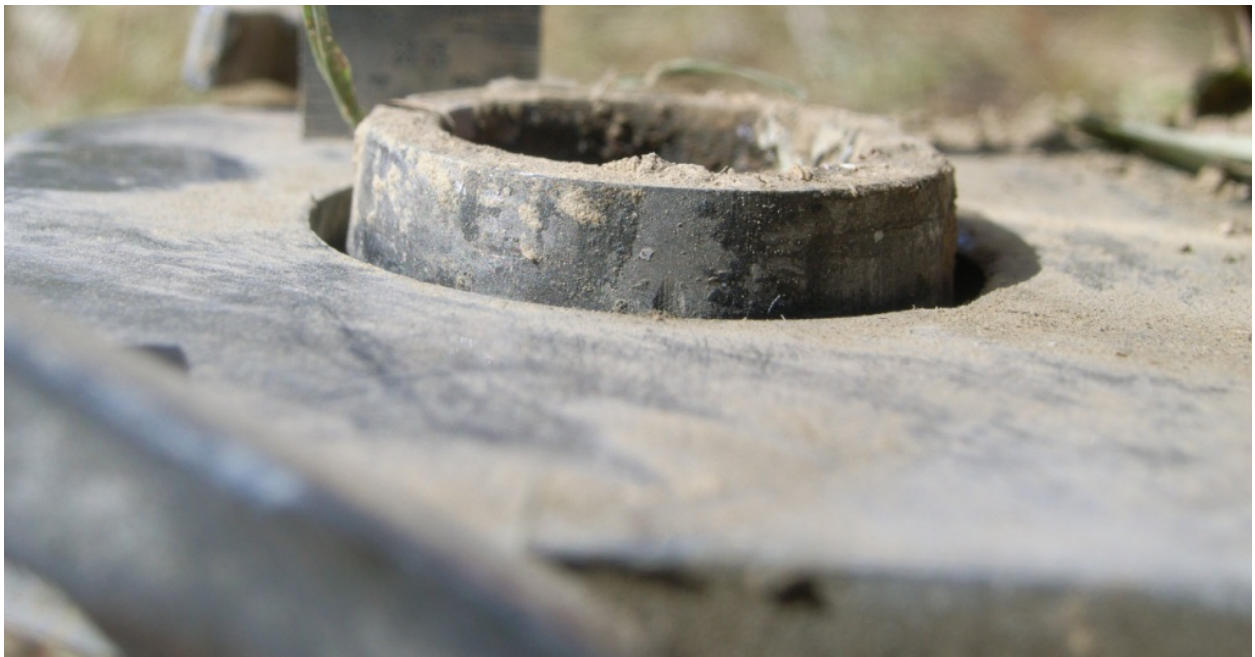
Figure 15 - Upper Cone Nut (pushed up from below)

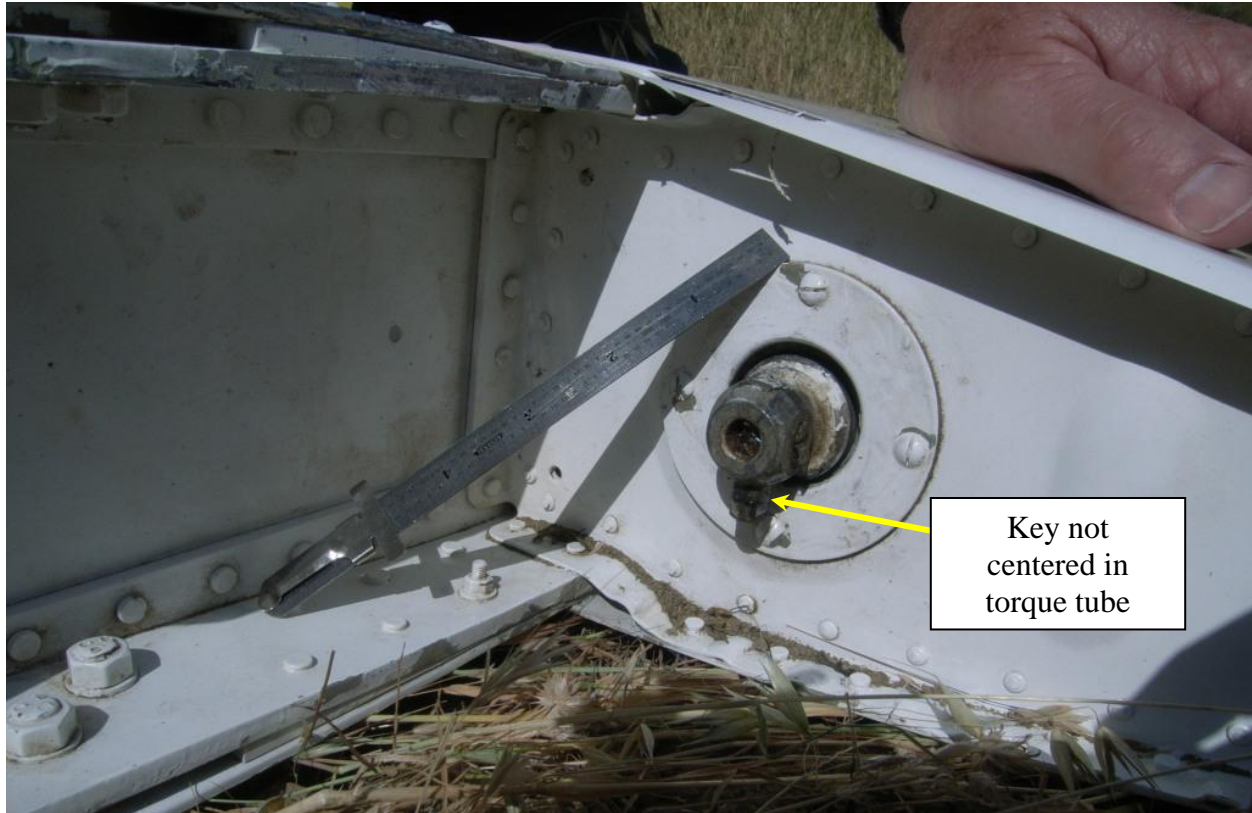
- An indexing/locking key for the air brake control linkage was partially displaced in the torque tube

Figure 16 - Displaced Air Brake Control Indexing Key

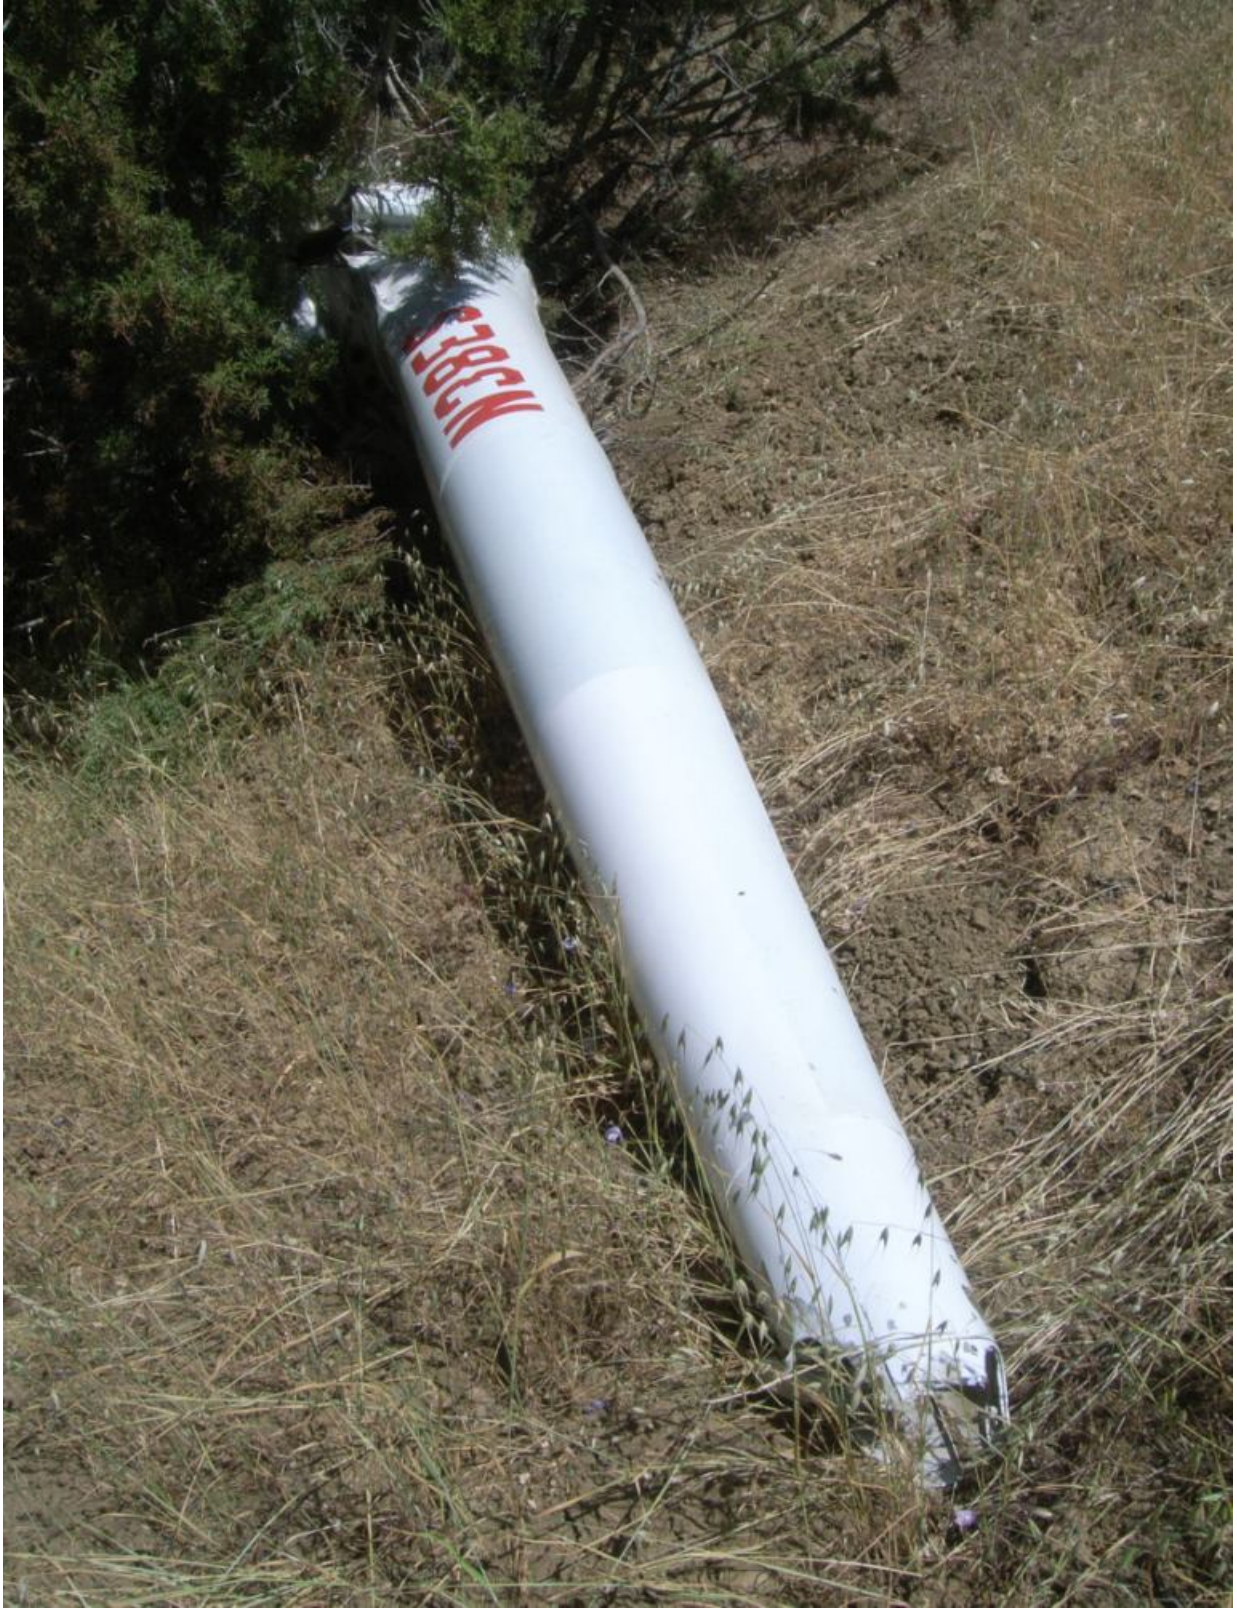
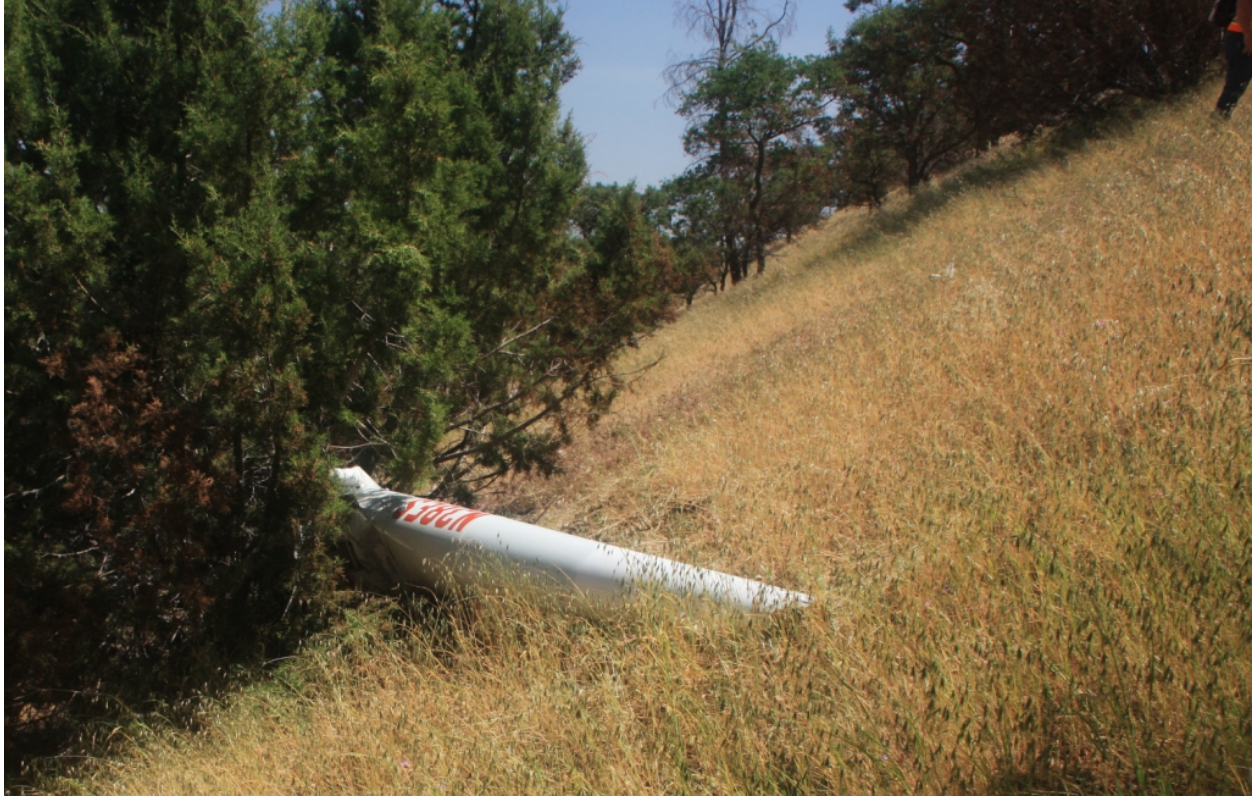
- The all-aluminum fuselage, minus the empennage and most of the canopy, was located in the primary wreckage group
- The fuselage ground impact created a small crater about 1 ft deep, 3 ft wide, and about 5 feet long

- The empennage and some canopy and cockpit fragments were located in and around the crater
- The circular-cross section fuselage was found about 100 feet downhill from its initial impact point

- The fuselage was severely crushed in the aft direction, consistent with a nose-first ground impact
- The fuselage-wing attach structure and surrounding skin panels were significantly crushed or deformed

Figure 18 - Fuselage as Found

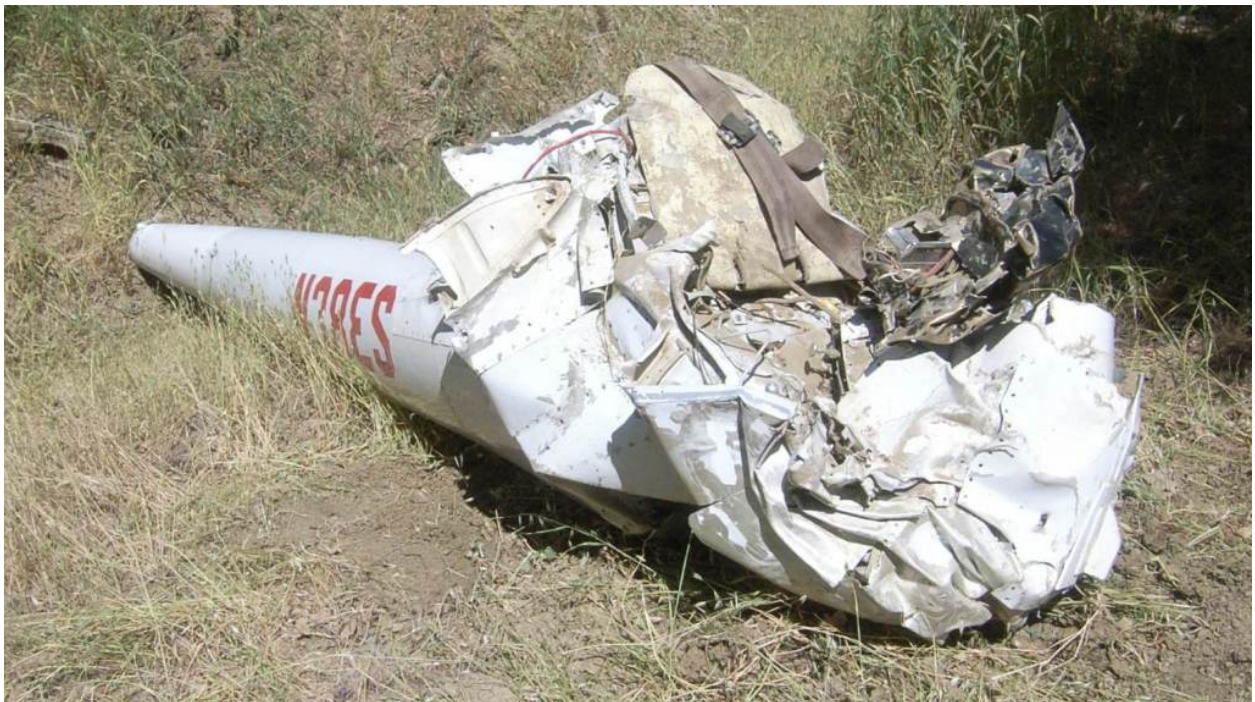
- The crush damage extended to approximately the location of the wing trailing edge
- The cockpit was severely compromised
- The instrument panel was severely disrupted; Some intact instruments and some portions of instruments remained

Figure 20 - Fuselage Crush (resituated for examination)

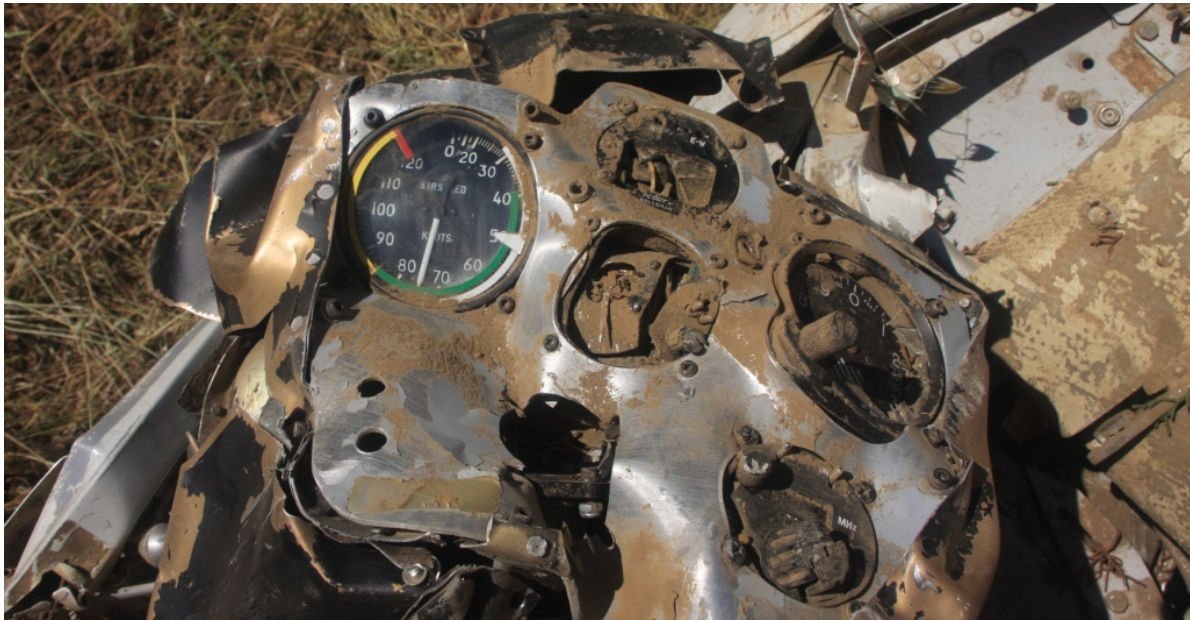
- Airspeed Indicator - intact, needle at 74 knots
 - Altimeter – hands missing
 - 'Whiskey' compass – destroyed

- Radio head – damaged, unreadable
- No other instruments identified
- A significant dent on right side of the fuselage was present just aft of the cockpit, and another one was present on the upper left side towards the aft end of the N-number
- The canopy was of the quick-release, jettisonable design
- The bulk of the canopy was found about 400 feet from the fuselage impact point, near the right wing fragments
- Portions of the canopy frame were found in or adjacent to the fuselage impact crater
- The pilot's cockpit restraint system was found unbuckled
- The pilot struck the ground about 200 ft from the fuselage
 - First responders reported that his parachute was partially deployed
- The pilot was reported to be wearing a memory-stick sized GPS position logging device
 - The device was recovered on scene and will be subjected to data download attempts

Figure 21 - Instrument Panel
