NATIONAL TRANSPORTATION SAFETY BOARD

SITE and ON-SCENE INFORMATION (Rev B)

**NTSB Accident: WPR18FA143
Accident Date: May 19, 2018**

Location: Near Avenal, California
Date: May 19, 2018
Aircraft: ICA-Brasov IS-29D Lark, N38ES, Serial # 38
NTSB IIC: Michael Huhn

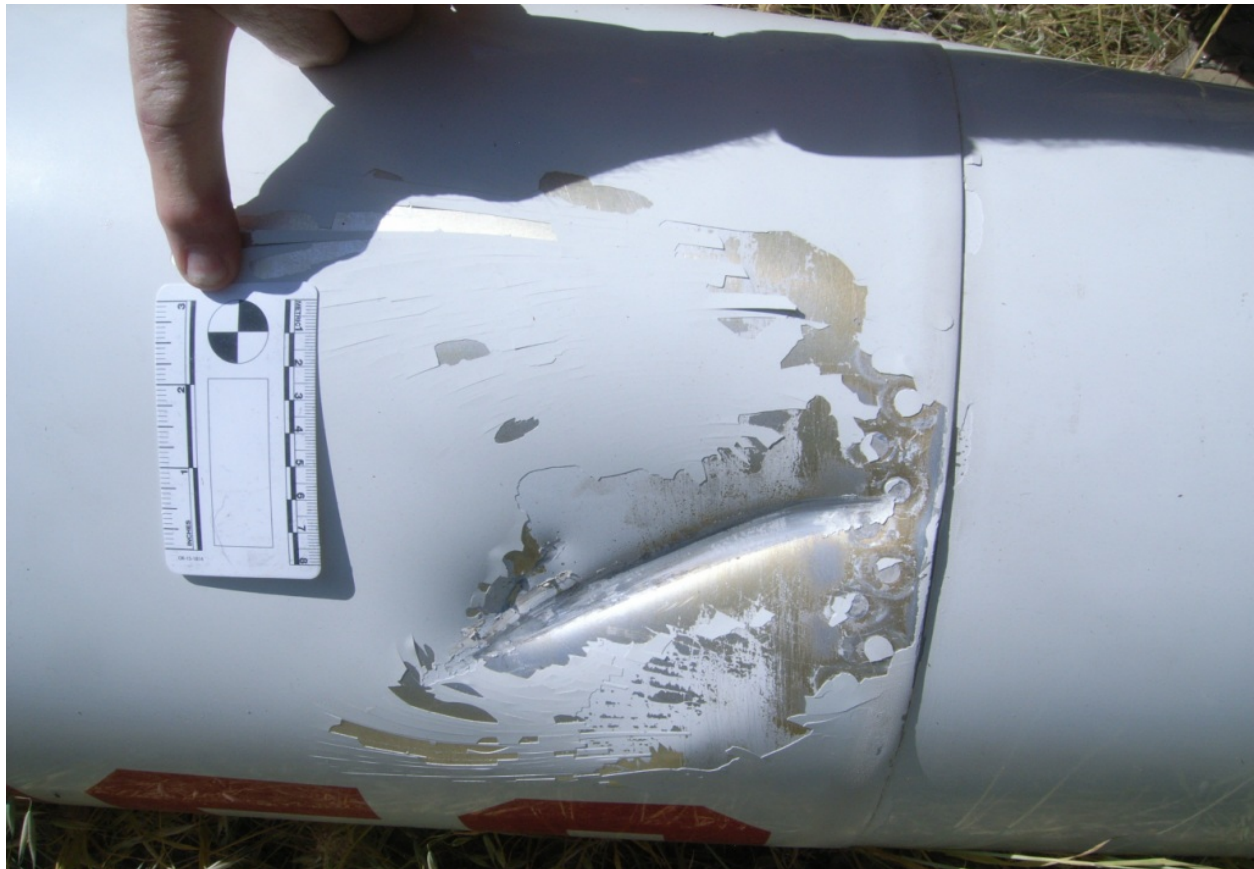
Figure 22 - Fuselage Dent

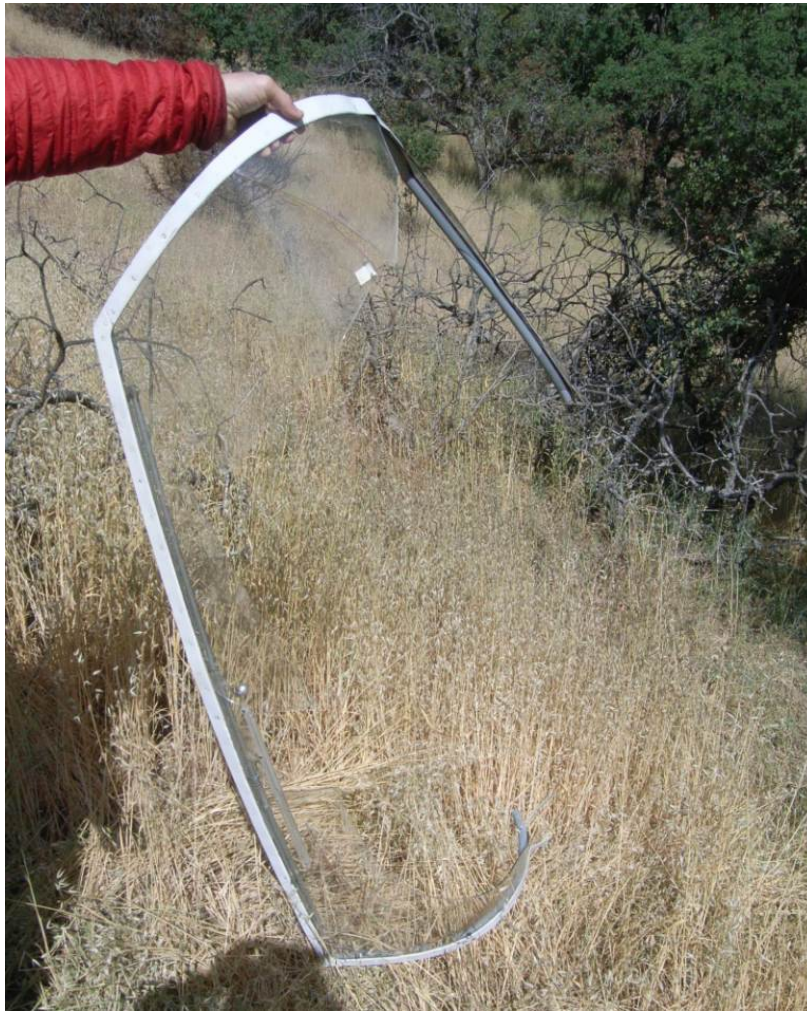
Figure 23 - Bulk of Canopy

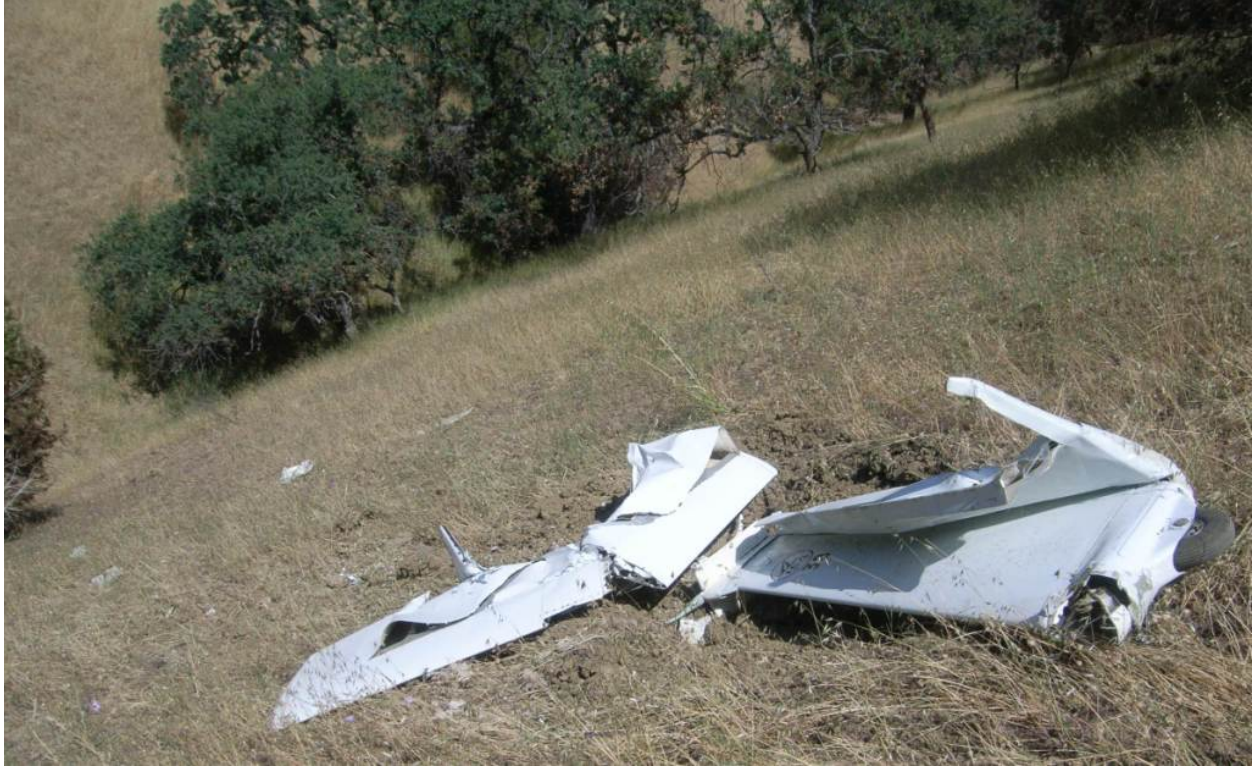
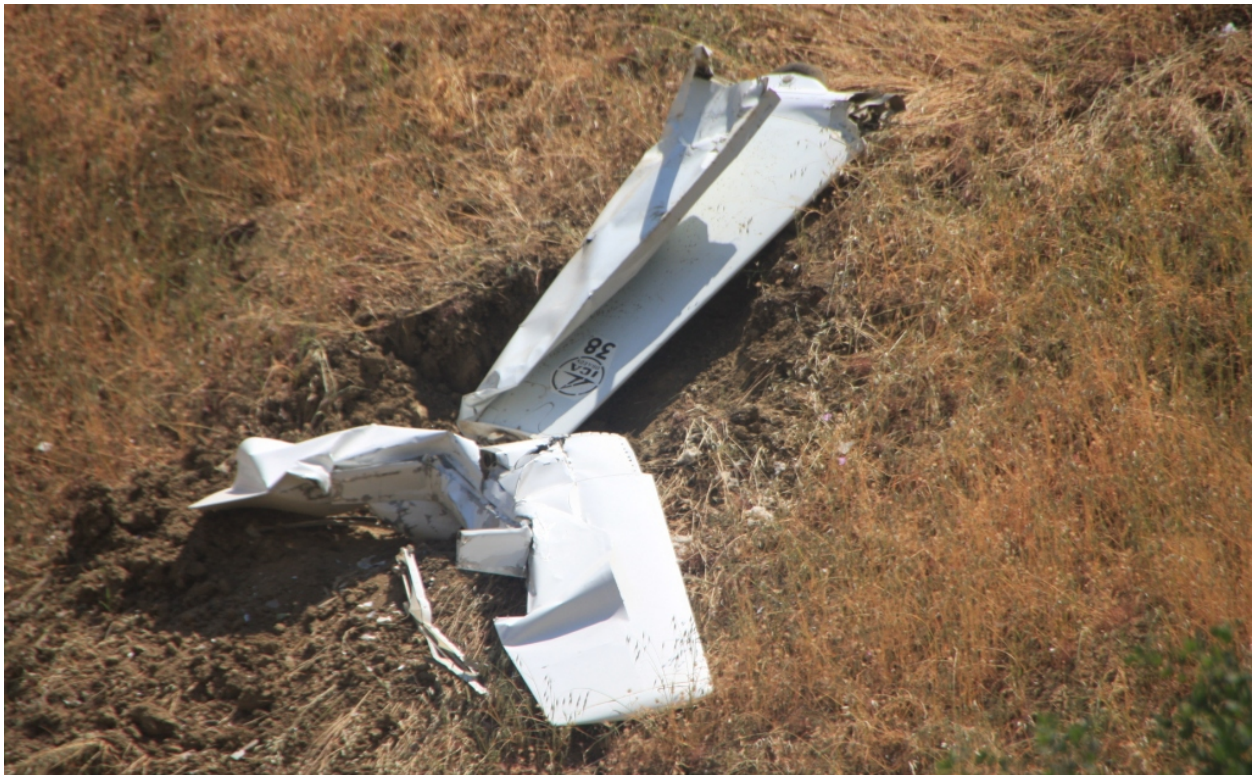
- The vertical stabilizer and T-tail horizontal stabilator were found adjacent to the fuselage impact crater
- The rudder remained attached to the vertical stabilizer
- The single-piece stabilator was fracture-separated from the vertical stabilizer
- The pitch tab (undetermined whether trim or servo) remained attached to the stabilizer
- The stabilator balance weight was found fracture-separated from its attach structure, but in the fuselage impact crater

Figure 24 - Empennage as Found

Figure 25 -Empennage as Found at Fuselage Crater

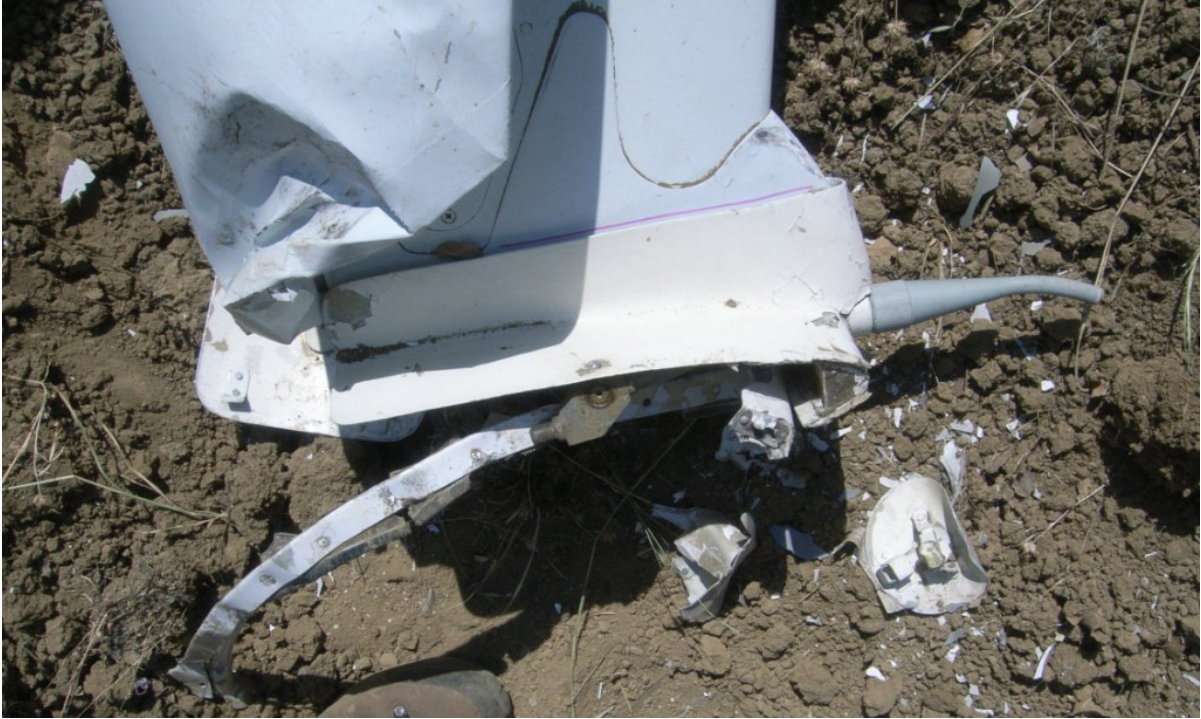
Figure 26 - Top of Vertical Stabilizer

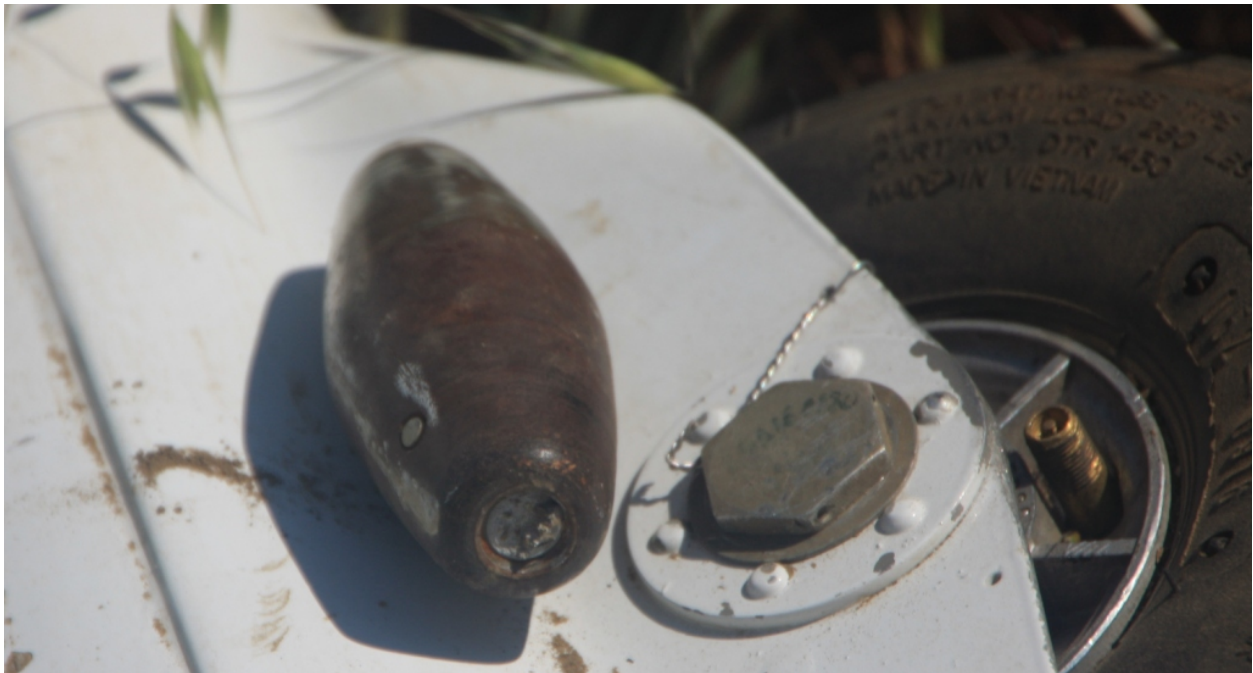
Figure 27 - Fracture-Separated Stabilator Balance Weight

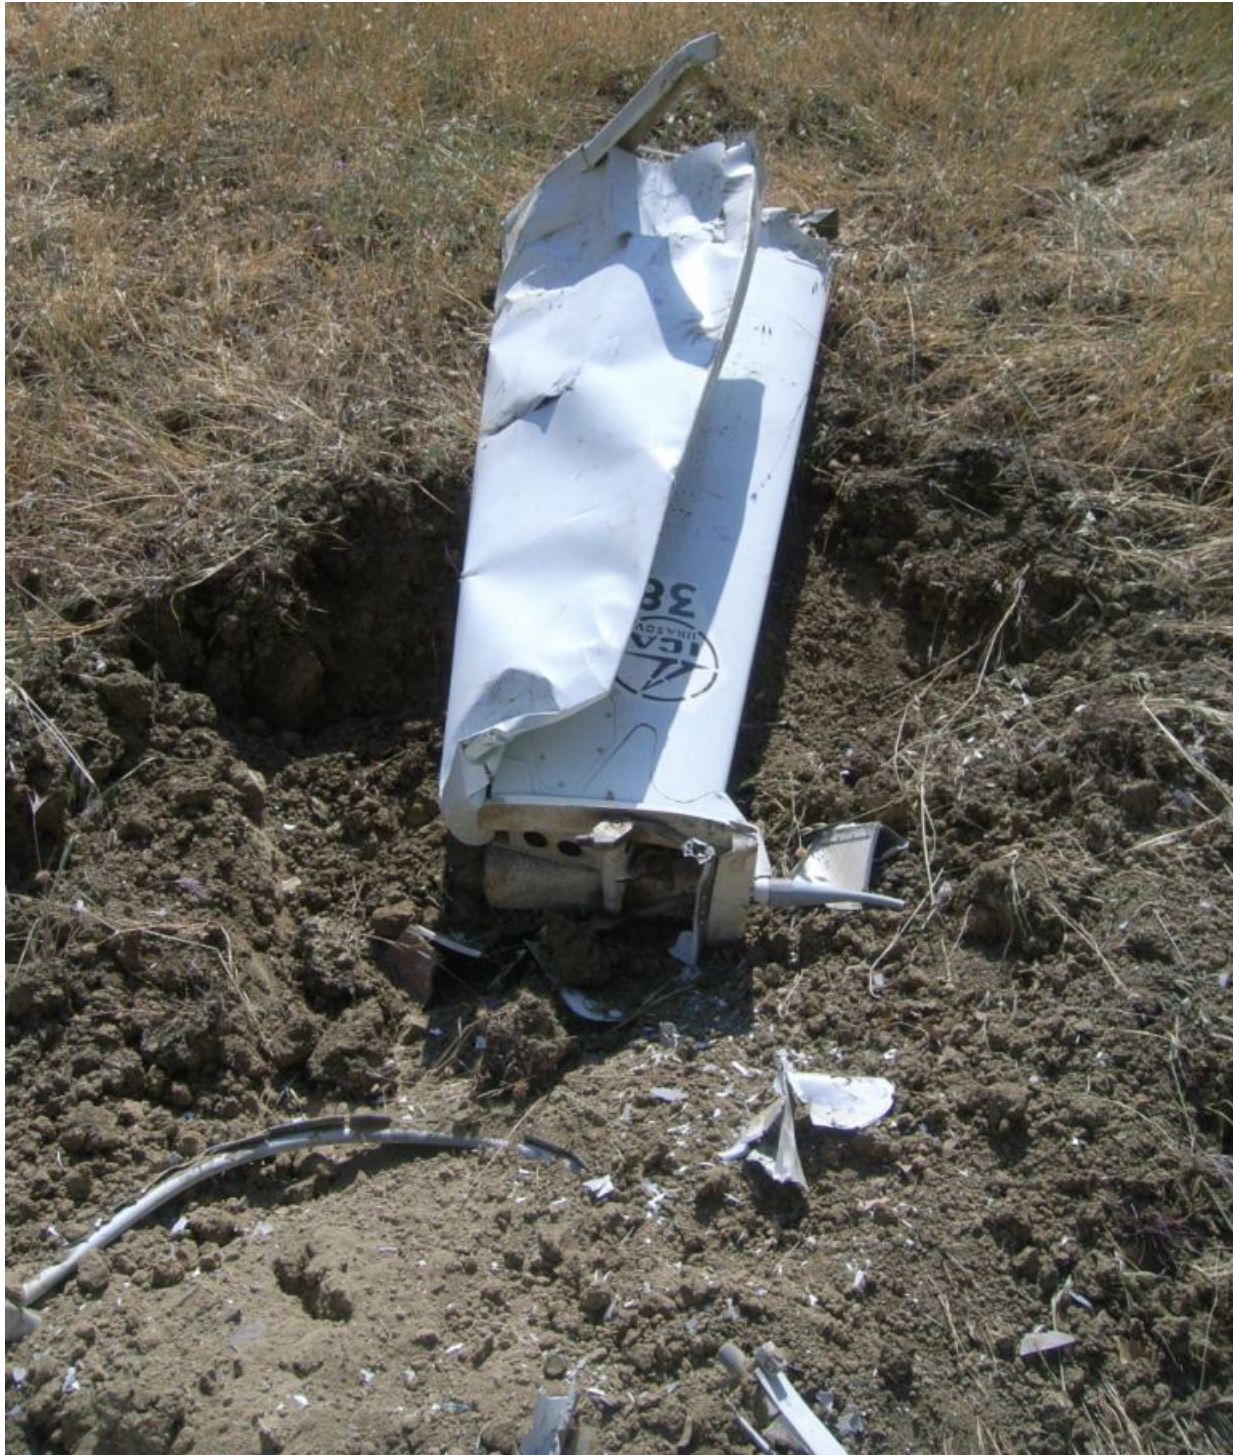
Figure 28 - Vertical Stabilizer and Rudder
