**NATIONAL TRANSPORTATION SAFETY BOARD  
Office of Research and Engineering  
Vehicle Recorder Division  
Washington, D.C. 20594**

**SPECIALIST'S FACTUAL REPORT OF INVESTIGATION  
SOUND SPECTRUM STUDY  
ERA14FA300**

Location: Huntsville, Alabama  
Date: June 18, 2014 1424 CDT  
Aircraft: Israel Aerospace Industries WestWind, Registration N793BG  
Operator: SynFuels Holdings Finance LLC  
NTSB Number: ERA14FA300

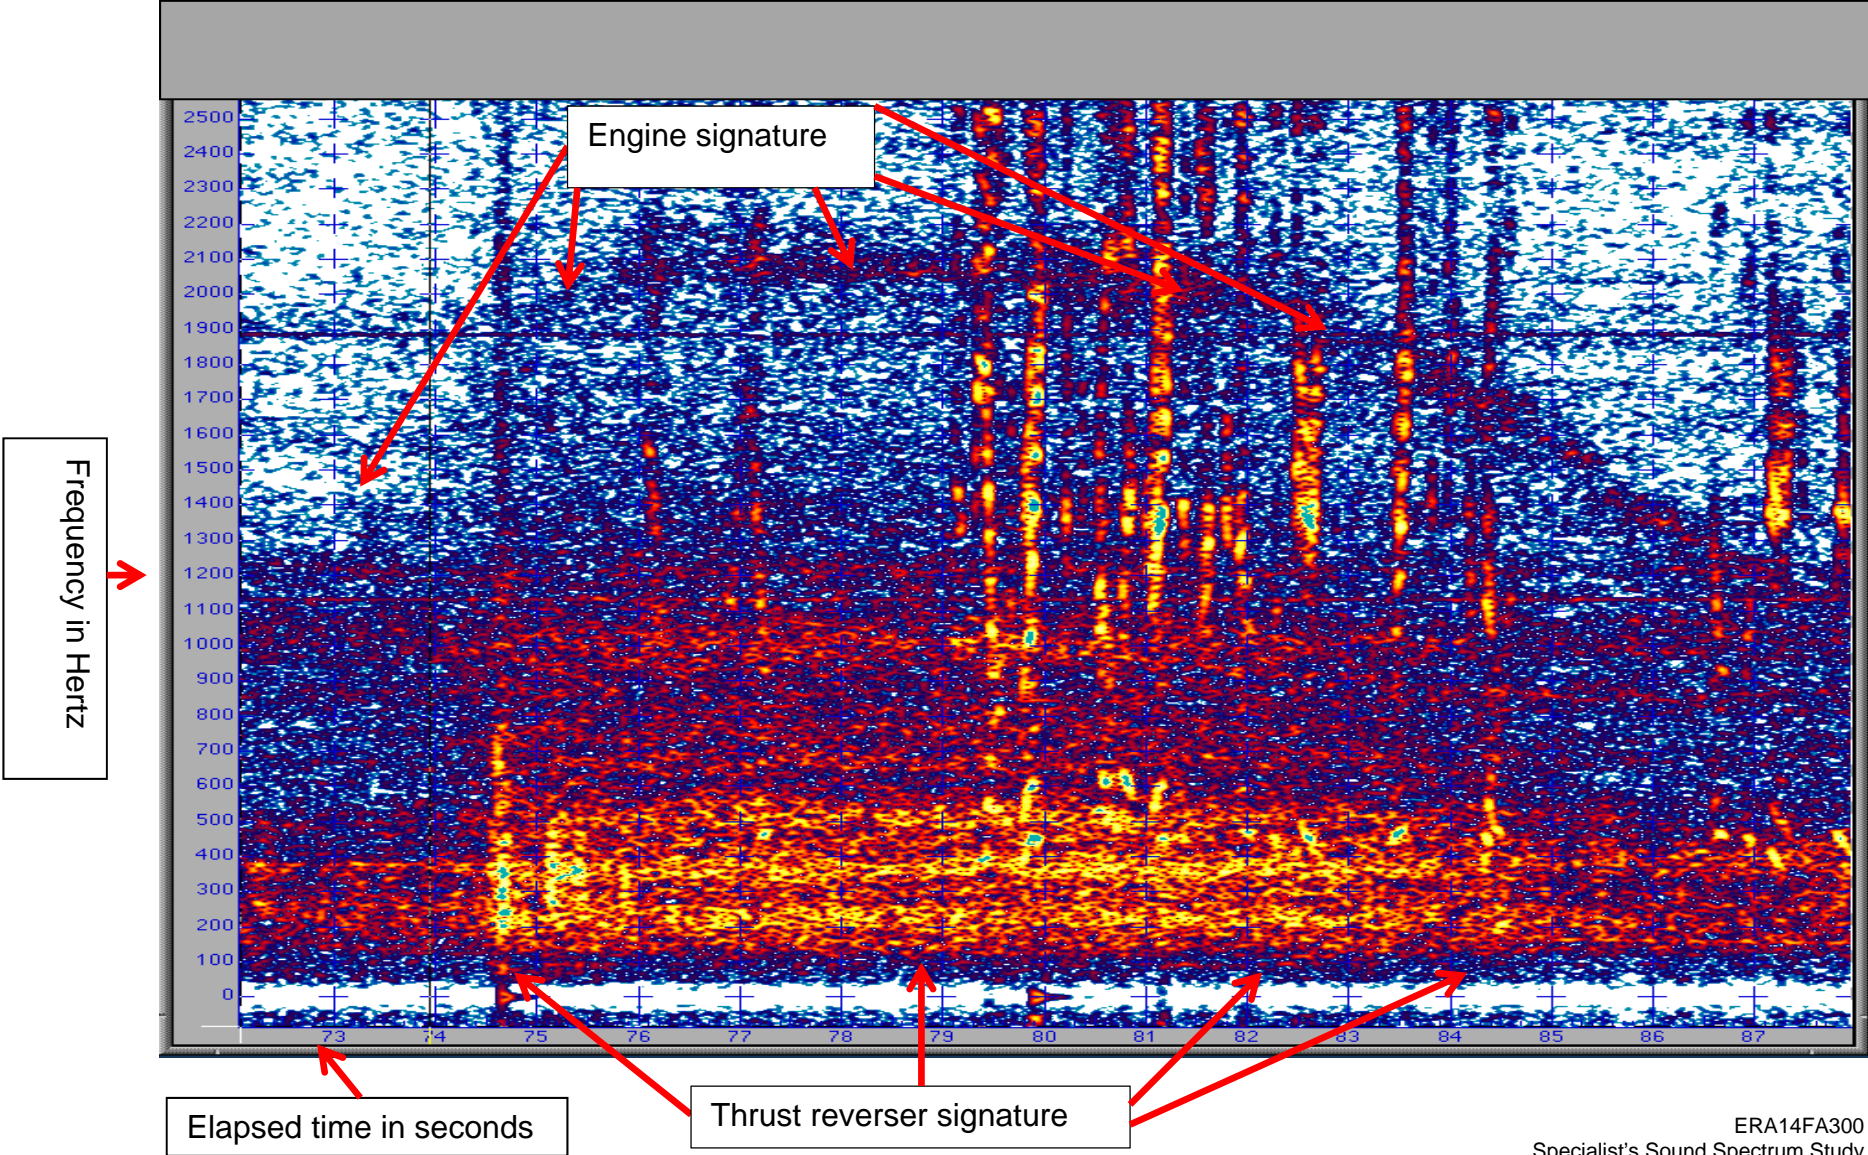
# PLOT- 1 Previous Full Stop Landing Spectrogram

The tape speed of the original recording was found to be not at the normal design speed of 1 7/8 inches per second (IPS). It was discovered that the tape speed was running slow, at about 94.4% of the normal design speed. A correction of 1.059 was made to all of the frequency and time data recovered from the spectrum charts (Plot-1 and Plot-3).

During the landing segment several frequency signatures could be seen. One signature was associated with the rotation speed of the engines. Specifically, the second harmonic of the sound produced by the rotation of the "HP-Spool" or N-2 of the engine. Even though, the aircraft has two engines, only one sound signature was visible. This is attributed to both engines rotating at approximately the same speed. This second harmonic of the N-2 trace was visible from just above idle speed throughout the reverser deployment of about 80% N-2, and back to about the idle setting.

The second signature that was identified was associated with the thrust reverser deployment during the landing roll. The signature appears as the engine is accelerating above approximately 55% N-2 in reverse thrust. The signature is visible until the engine decelerates below about 60% N-2 during the landing roll out.

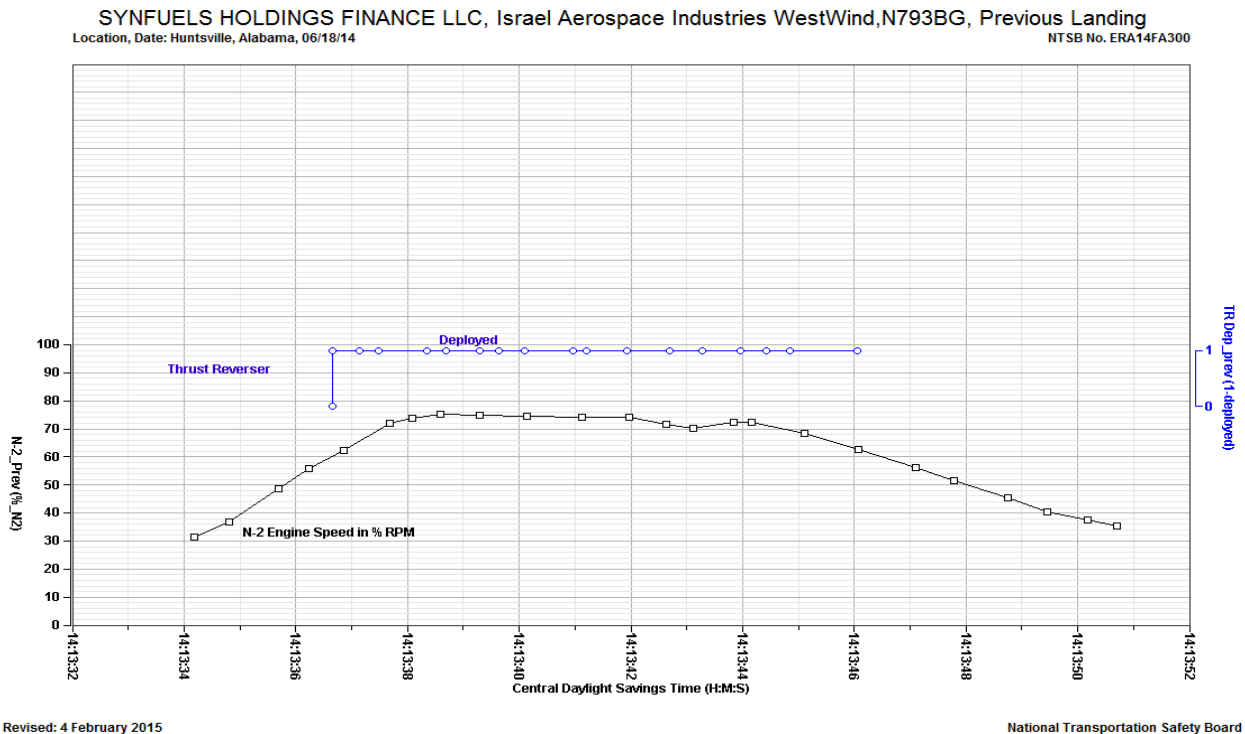
## PLOT-2 Previous Landing Data

To better illustrate the data recovered from the sound spectrum examination of the landing portion of the recording, Plot-2 was generated. This plot depicts the aircraft's N-2 engine speed and thrust reverser status during the landing rollout.

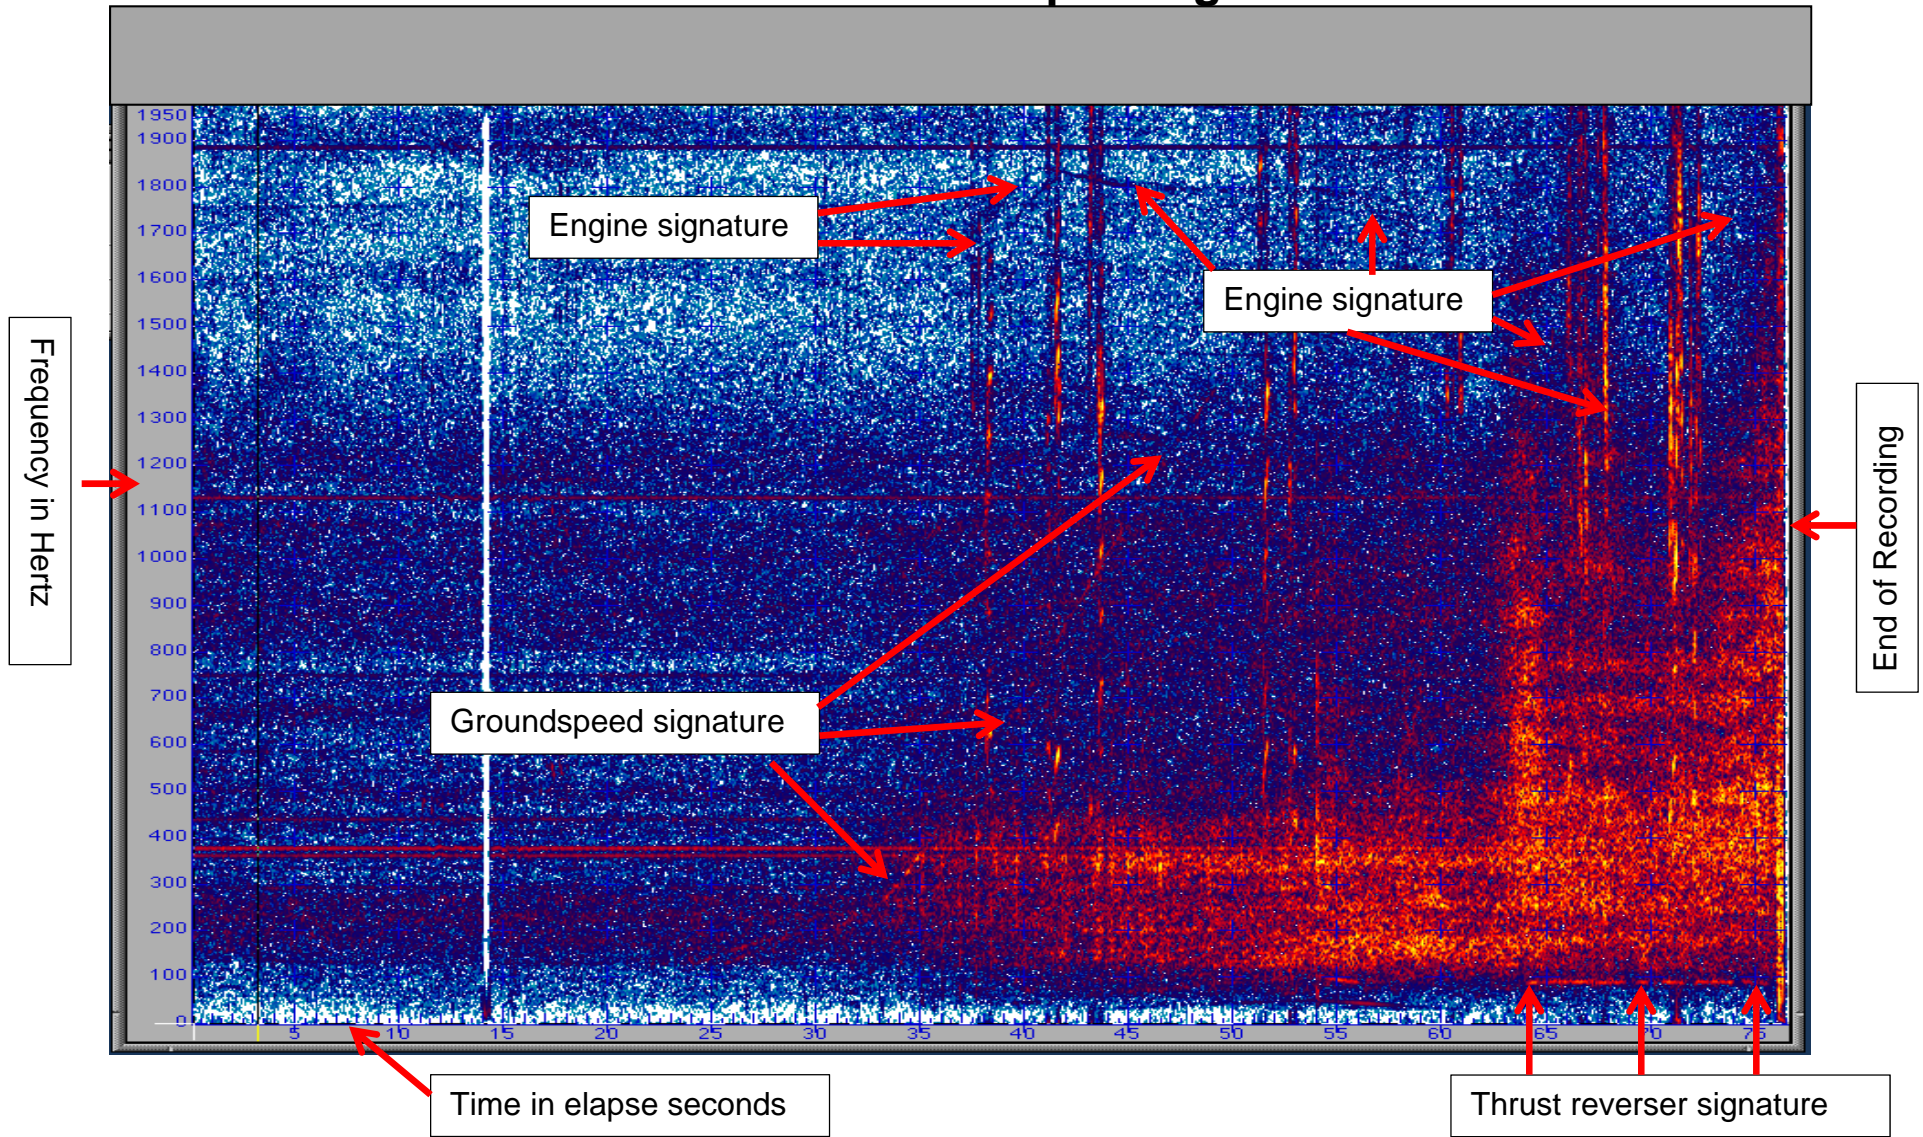
# PLOT 3 Accident Takeoff Spectrogram

Plot-3 depicts the last 75 seconds of the CAM channel of the CVR recording. As in the previous plot, elapsed time in seconds is depicted along the X or horizontal axis and frequency in Hertz is depicted along the Y or vertical axis. Intensity of the signals is shown by the various colors from blue to red indicating low to higher intensities.

It can be seen on Plot -3 that the beginning of the takeoff appeared normal. During the takeoff roll, two engine sound signatures are identifiable, one from the right engine and the other from the left engine. It should be noted that there is no way to associate which sound trace was being produced by which engine. It can be seen that both engines peak at about 98 to 99% N-2 and then drop down to a stabilized 96% N-2. Additionally the sound trace associated with the aircraft's groundspeed can be seen as a steadily increasing frequency trace consistent an accelerating wheel speed.

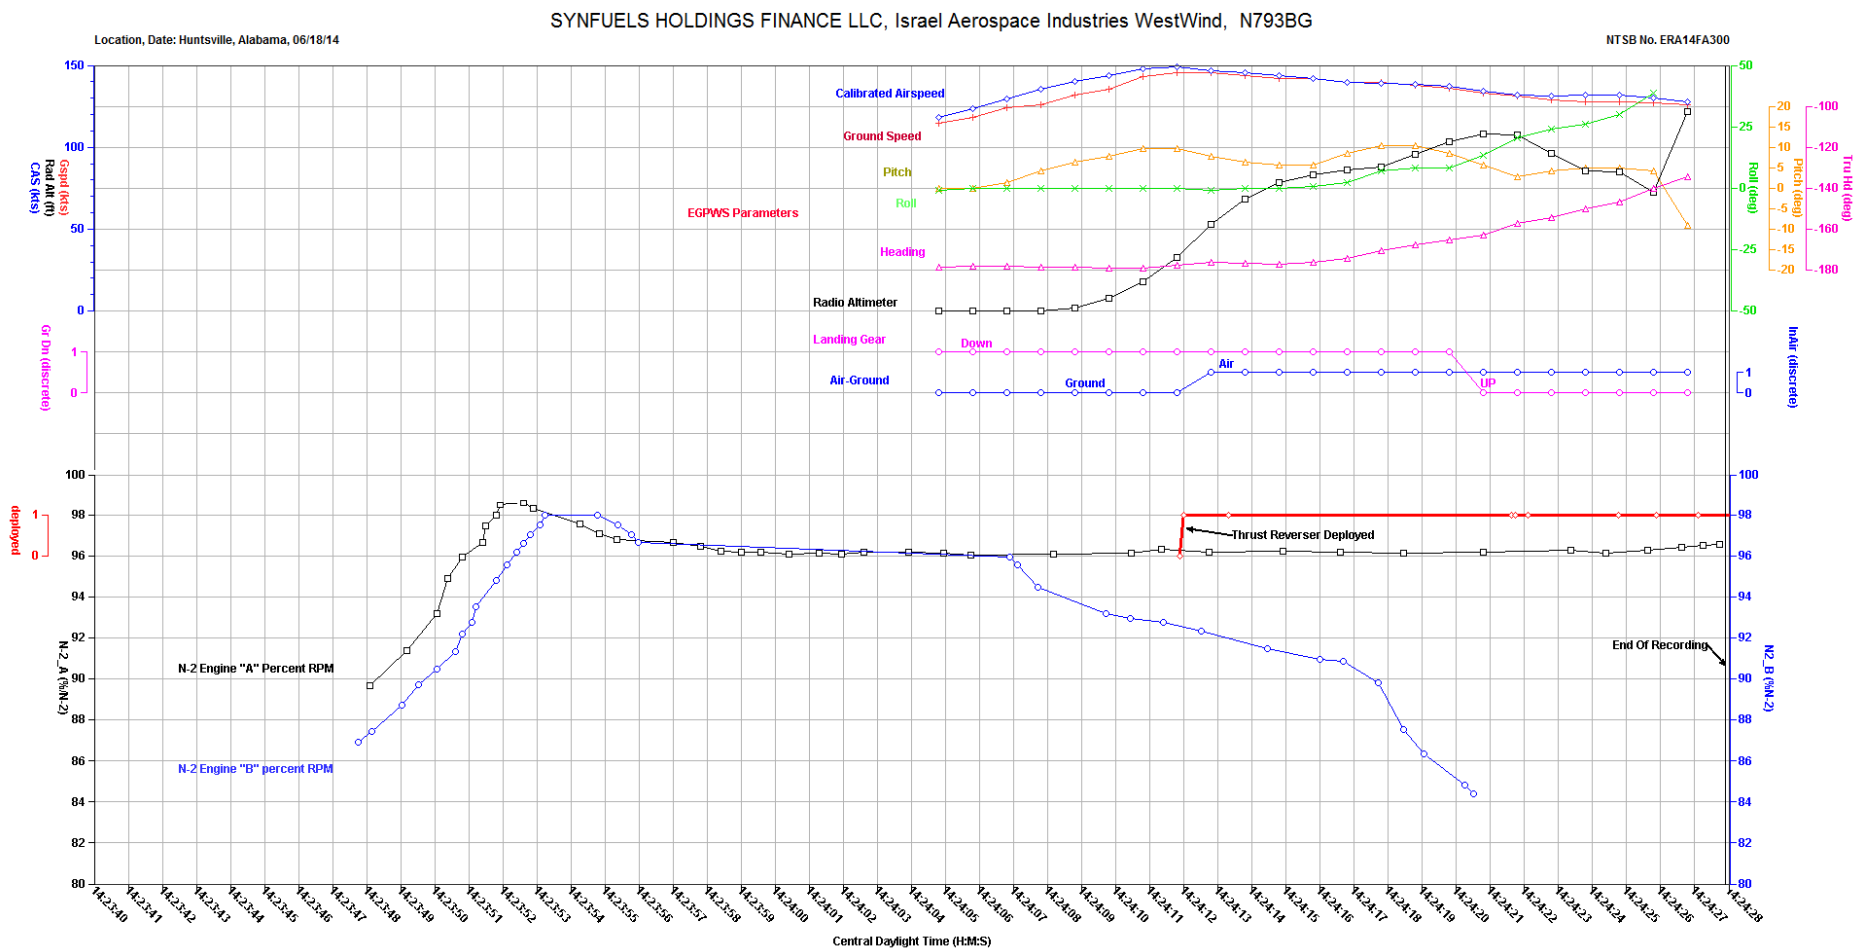
# PLOT-4 Accident Takeoff Data

To better illustrate the data shown on Plot-3 along with data recovered from the aircraft's Enhanced Ground Proximity Warning system (EGPWS), Plot-4 was generated<sup>1</sup>. Plot 4 depicts the sound spectrum derived data (engine "A" N-2 speed, engine "B" N-2 speed, and thrust reverser deployment signature) along with EGPWS data (radio altimeter, aircraft pitch, roll, groundspeed, calibrated airspeed, heading, landing gear up/down status, and aircraft air-ground status). In addition a second plot, Plot-5, was produces which contained the data found on Plot-4 overlaid with selected CVR background noises and crew comments.

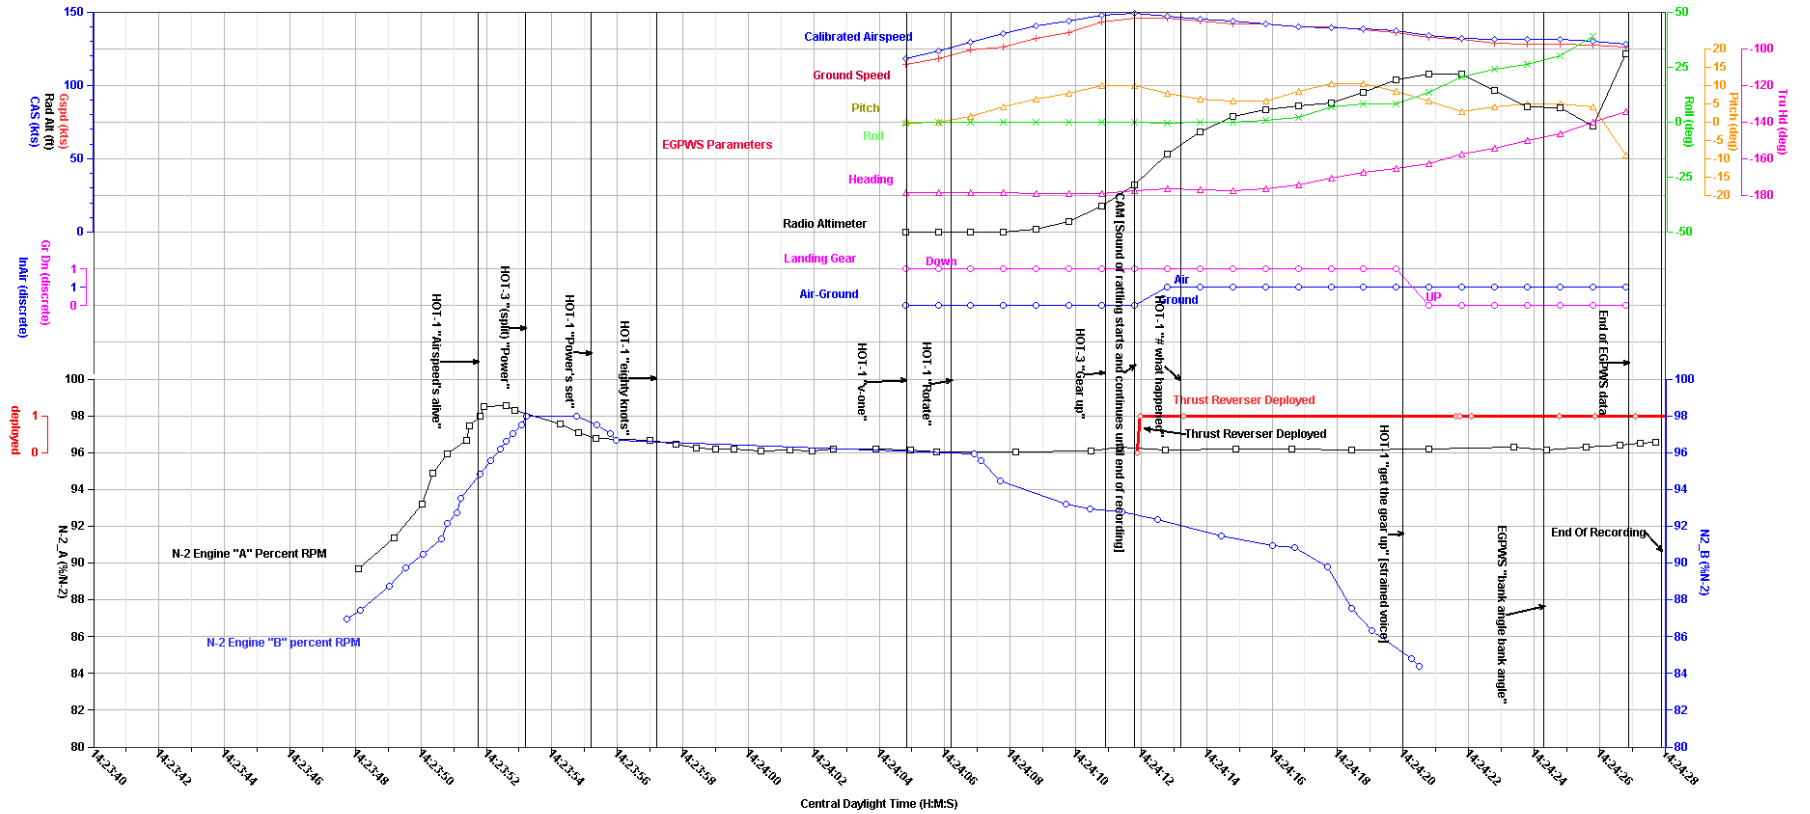
# PLOT-5

It can be seen on Plots 3-5 that as the engines were advanced for takeoff, two engine traces could be seen. After peaking at about 98-99% N-2 RPM both engines settled at about 96% N-2. At about 1424:07 CDT it is observed that one of the two engine traces start to decrease from the steady 96% N-2 speed. This decrease happens just after the “rotate” call from the pilot. The engine continues to decrease in RPM until the trace was no longer visible at about 84% N-2. The other engine trace remains steady at about 96% N-2 until the end of the recording at 1424:28 CDT.

The sound signature that was associated with the thrust reverser deployment during the previous landing (Plot-1 and Plot-2) could again be identified during the accident takeoff. The signature starts at 1424:12 CDT, just after the sound of rattling is heard on the CVR recording. The thrust reverser signature remains visible until the end of the recording at 1424:28 CDT.
