NATIONAL TRANSPORTATION SAFETY BOARD

ADDENDUM – Sound Spectrum Study

Specialist's Factual Report

Location: Zaleski, Ohio
Date: January 29, 2019
Helicopter: Bell 407
Registration: N191SF
Operator: Viking Aviation, LLC.
NTSB Number: CEN19FA072

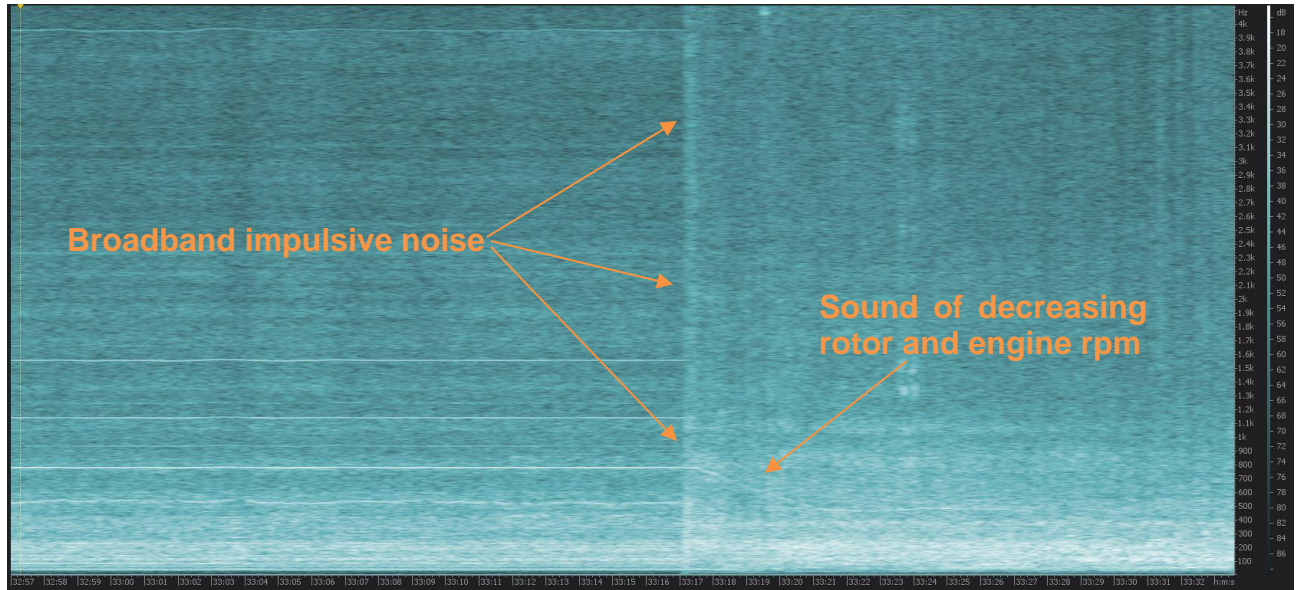
Figure 1. The spectrograph of the audio recording from CEN09MA117 at the time of “[sound of bang and loud air noise].”

The spectrograph in figure 1 shows an impulsive broadband signal throughout the plotted frequency range that appears at the time of “[sound of bang and loud air noise.]”

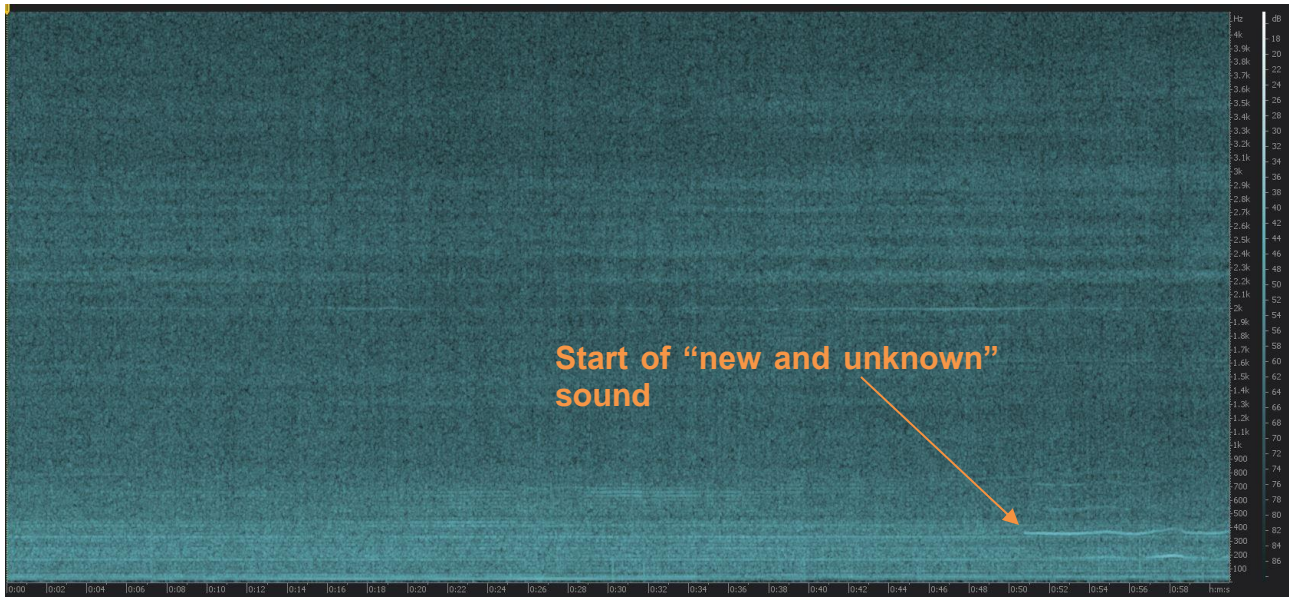
Figure 2 is a spectrograph using the same display settings of the accident case, CEN19FA072. The Flight Data Monitor (FDM) – Audio Report describes the sound as the following: “[Whining sound, potentially aerodynamic in nature. Lasts until the end of the recording.]”

Figure 2. The spectrograph of the audio recording from CEN19FA072 showing the final portion of the accident audio recording.

The sound spectrum study for CEN19FA072 shows the value of this “new and unknown sound” was measured at approximately 180 Hz, with a strong harmonic at 356 Hz. The sound spectrum group continued to describe audio descriptions of this portion of the recording. The transcription group noted the following possibilities:

- Air being rammed into a plenum
- A horn sound, such as air across the top of a bottle. A “blue note.”
- Possibility of air blowing into a window opening
