NATIONAL TRANSPORTATION SAFETY BOARD
Vehicle Recorder Division
Washington, DC 20594

Sound Spectrum Study

Specialist's Study Report
By Christopher Babcock

Location: South Bend, Indiana
Date: March 17, 2013, 1623 Eastern Daylight Time (EDT)
Aircraft: Hawker Beechcraft 390
Operator: Private
Registration: N26DK
NTSB Number: CEN13FA196

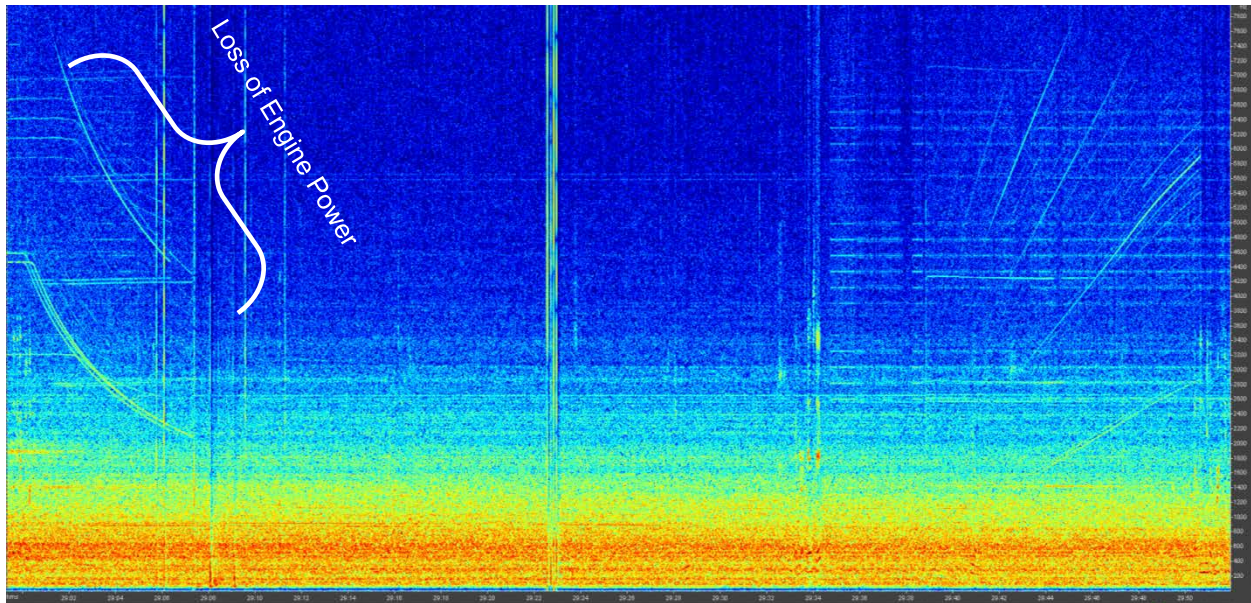
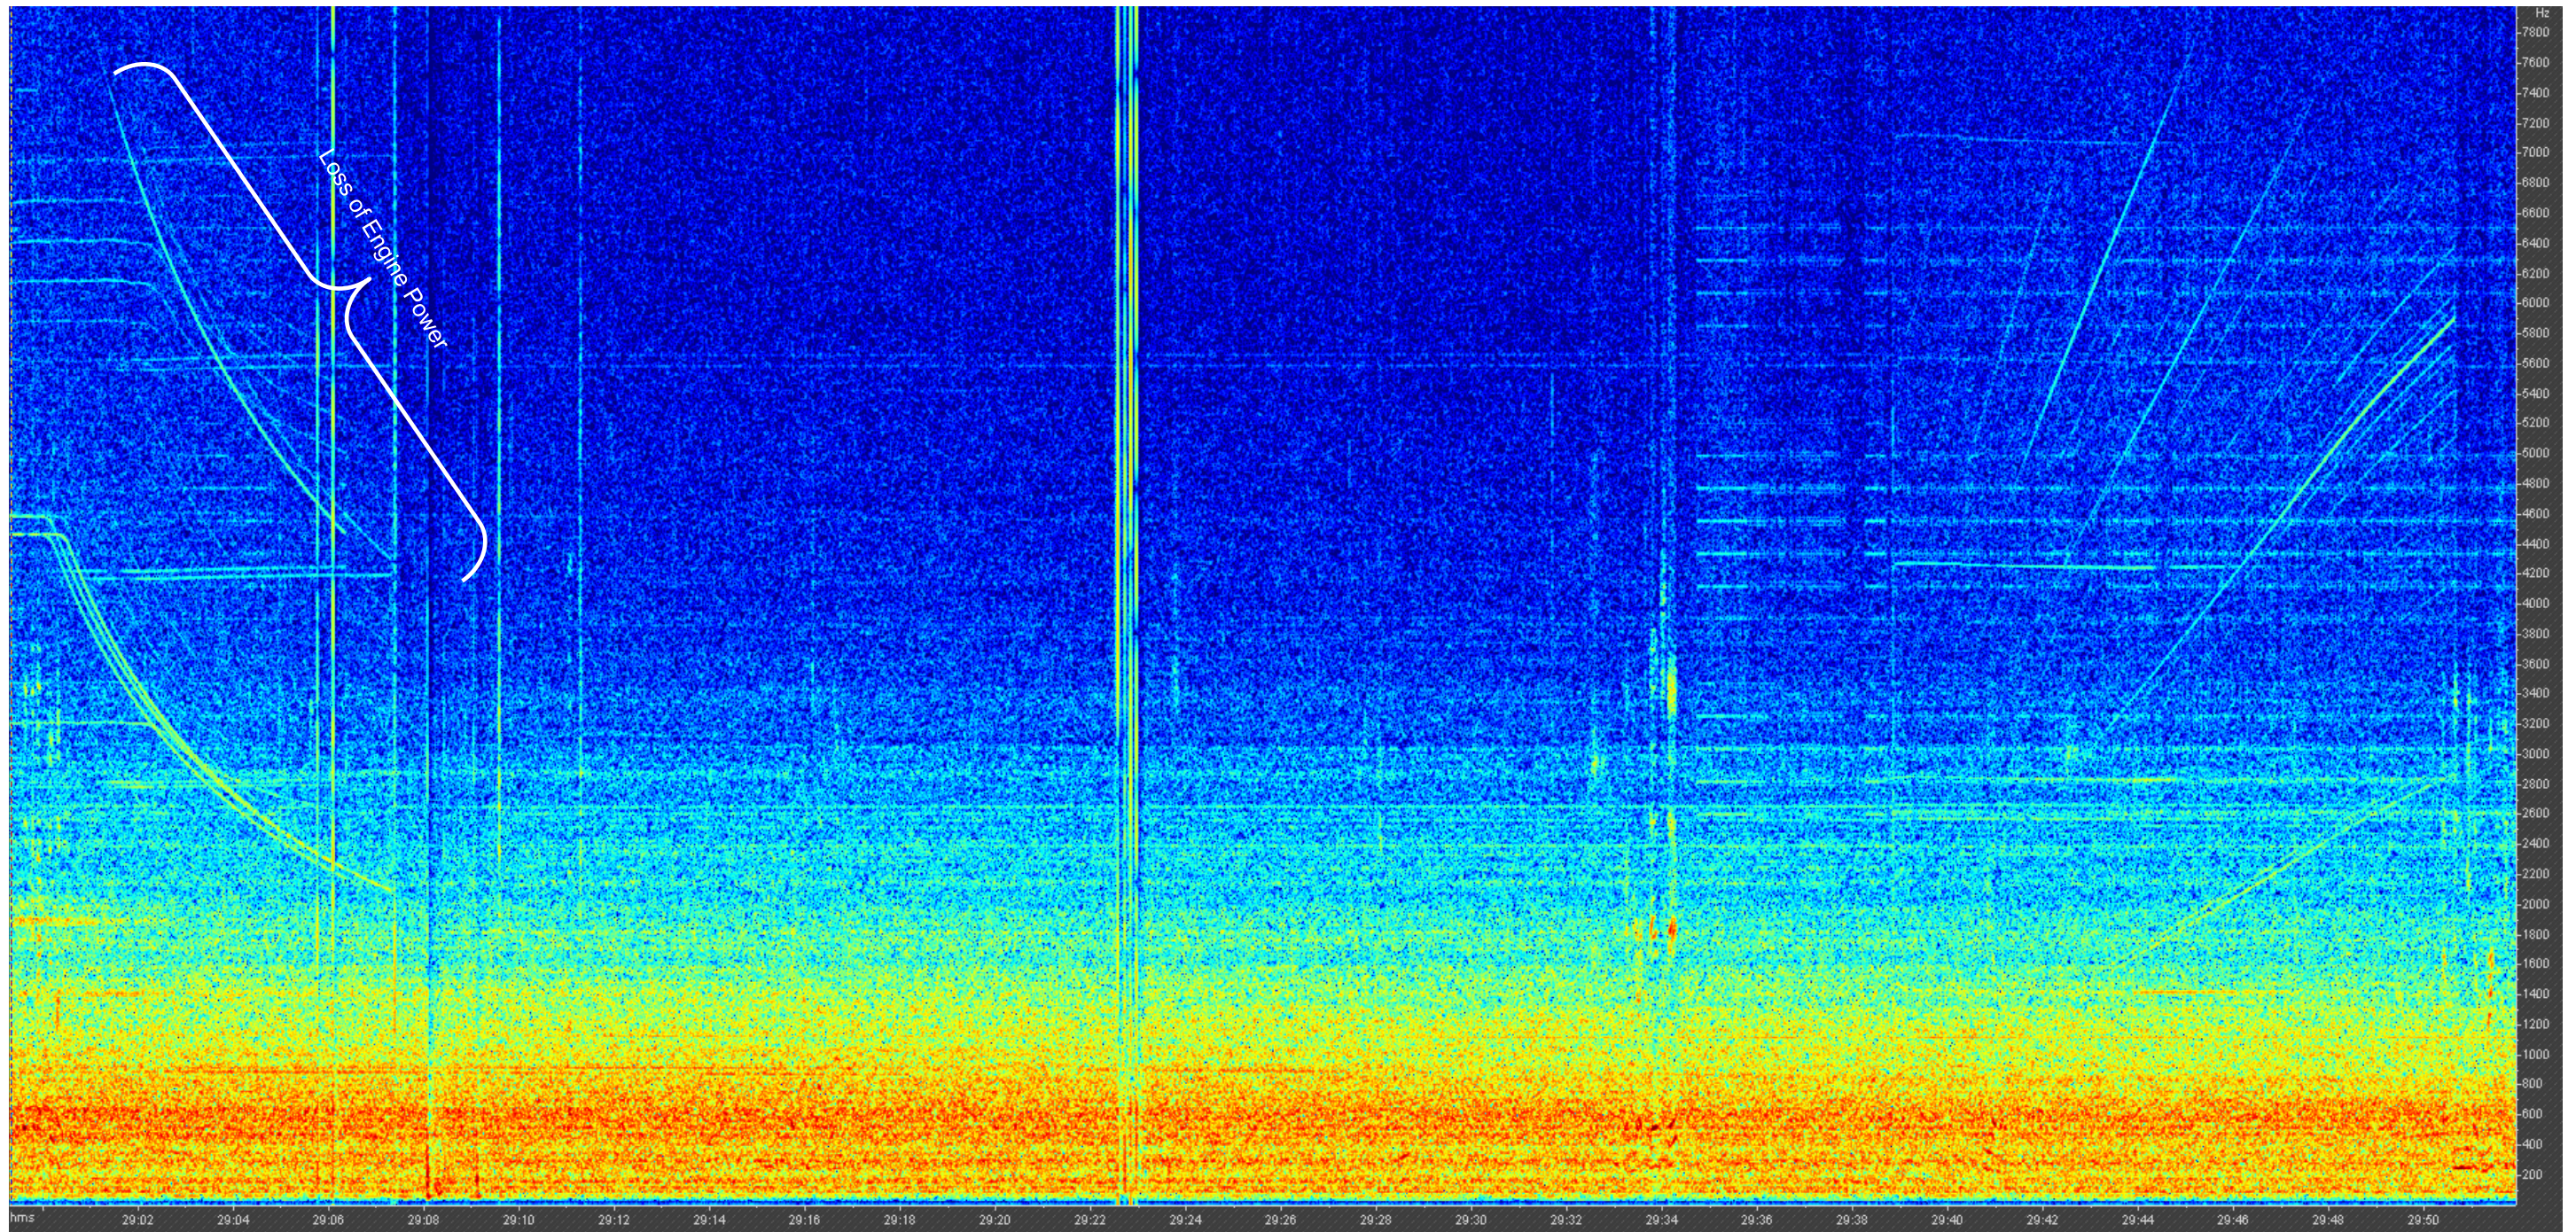
Figure 1 shows a spectrogram of the audio recorded after the loss of engine power prior to the accident.² A spectrogram is a plot showing frequency content of audio over time with time on the x-axis, frequency on the y-axis, and intensity displayed as color. Timing on all spectrograms is displayed in elapsed times from the start of the recording. Crew discussion around the time of the power loss indicated the aircraft was descending to 3000 feet and slowing to 200 knots. According the airplane flight manual, either an air start or a starter assisted engine start is possible following a loss of engine power at this flight condition. A windmill start uses residual engine speed and engine igniters to relight the engine and regain power. A starter assisted start uses electrical power to increase the N2 shaft to a point where the igniters can restart the engine.

Figure 1. Spectrogram of loss of power on accident flight.

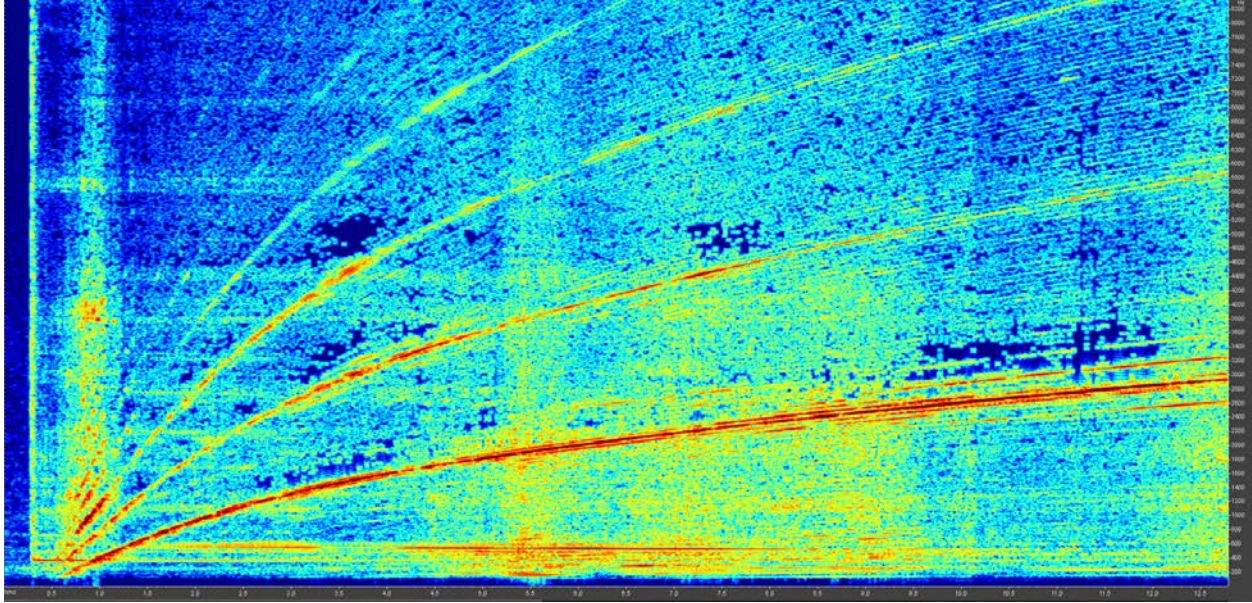
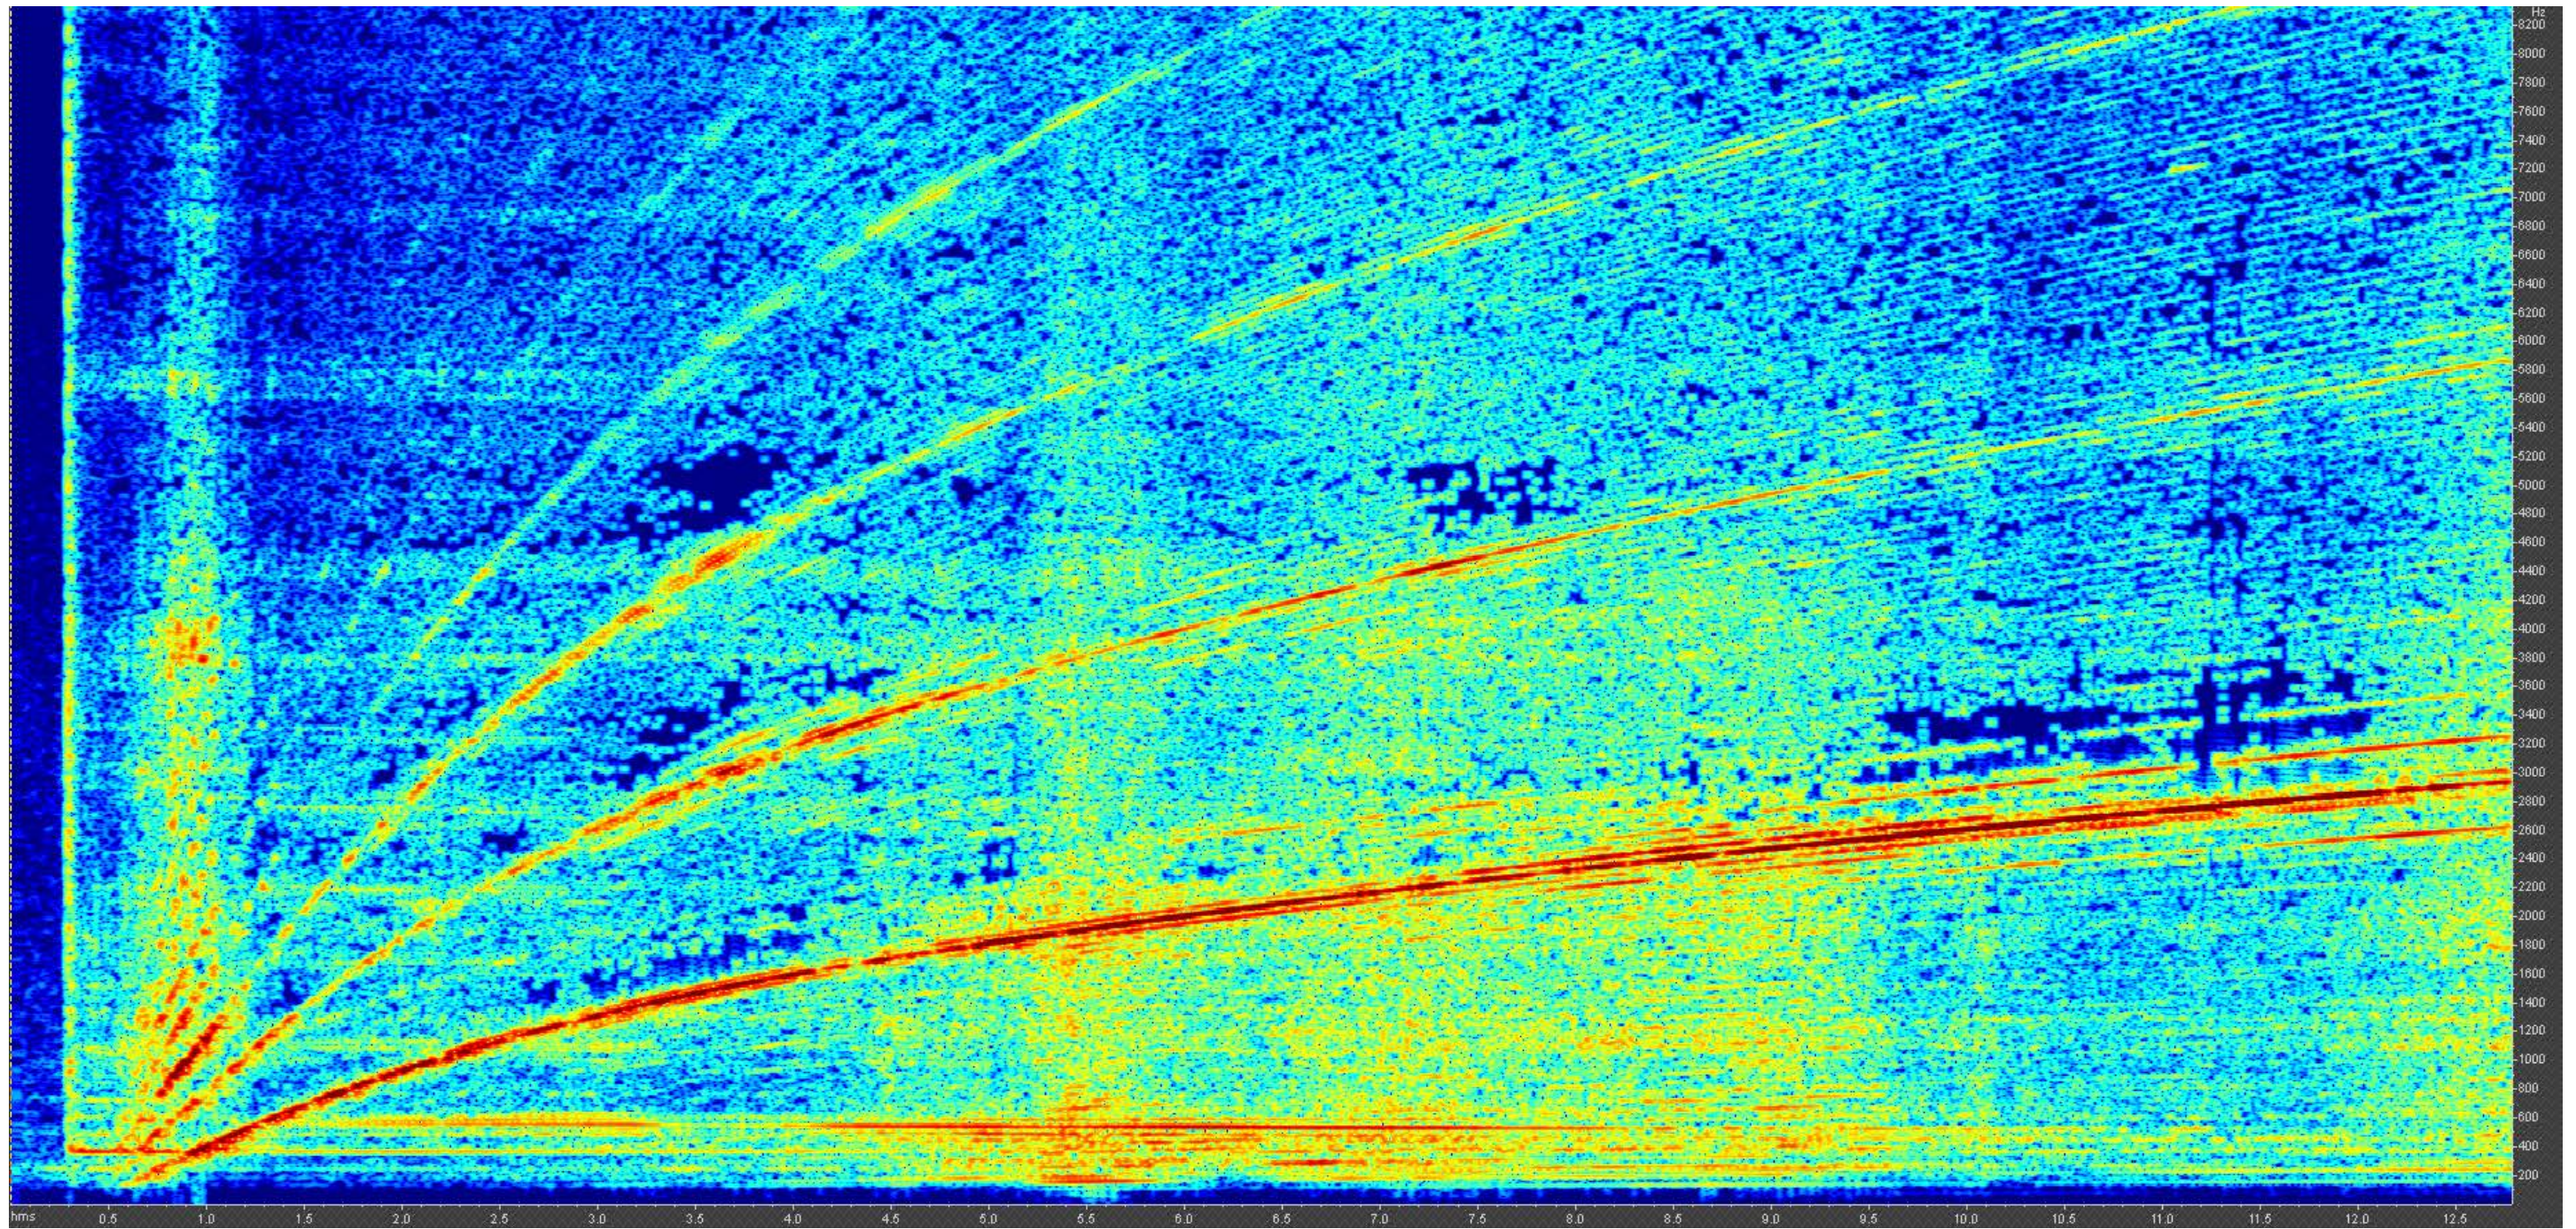
Figure 2 shows a spectrogram of audio recorded during a functional test of the accident aircraft's starter/generator at a test facility. The plot has been cropped to show the same bandwidth of the audio recorded on CAM channel of the CVR (8 kHz). The starter/generator was tested by itself with no other accessories present.

Figure 2. Spectrogram of functional test on the accident aircraft's starter/generator (SN 461AB).

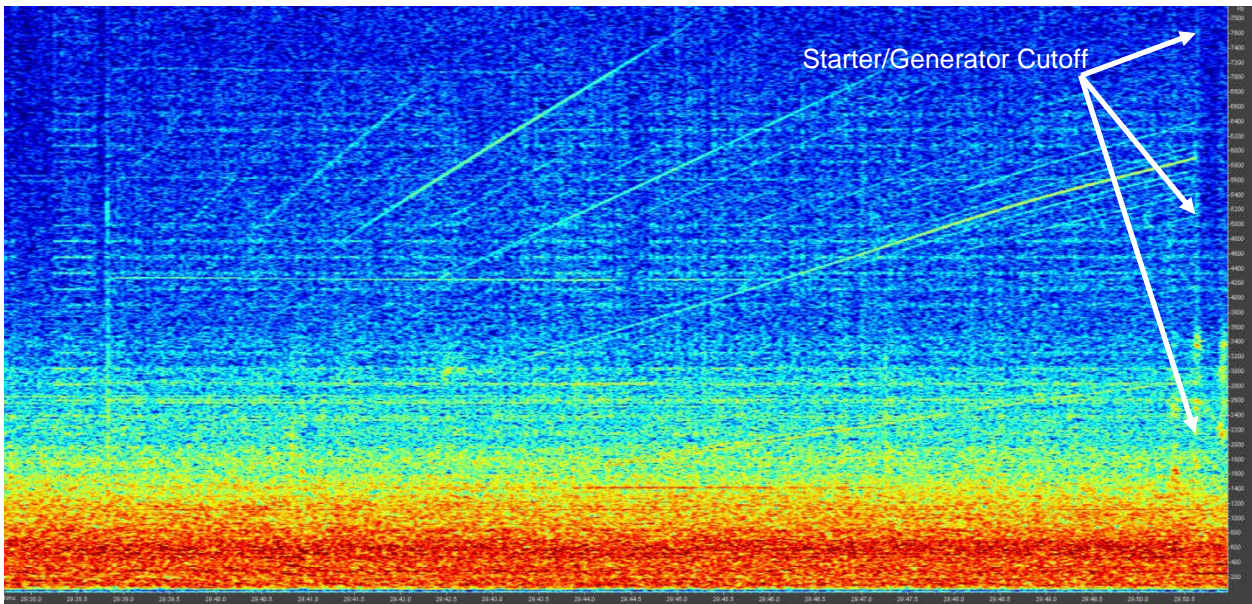
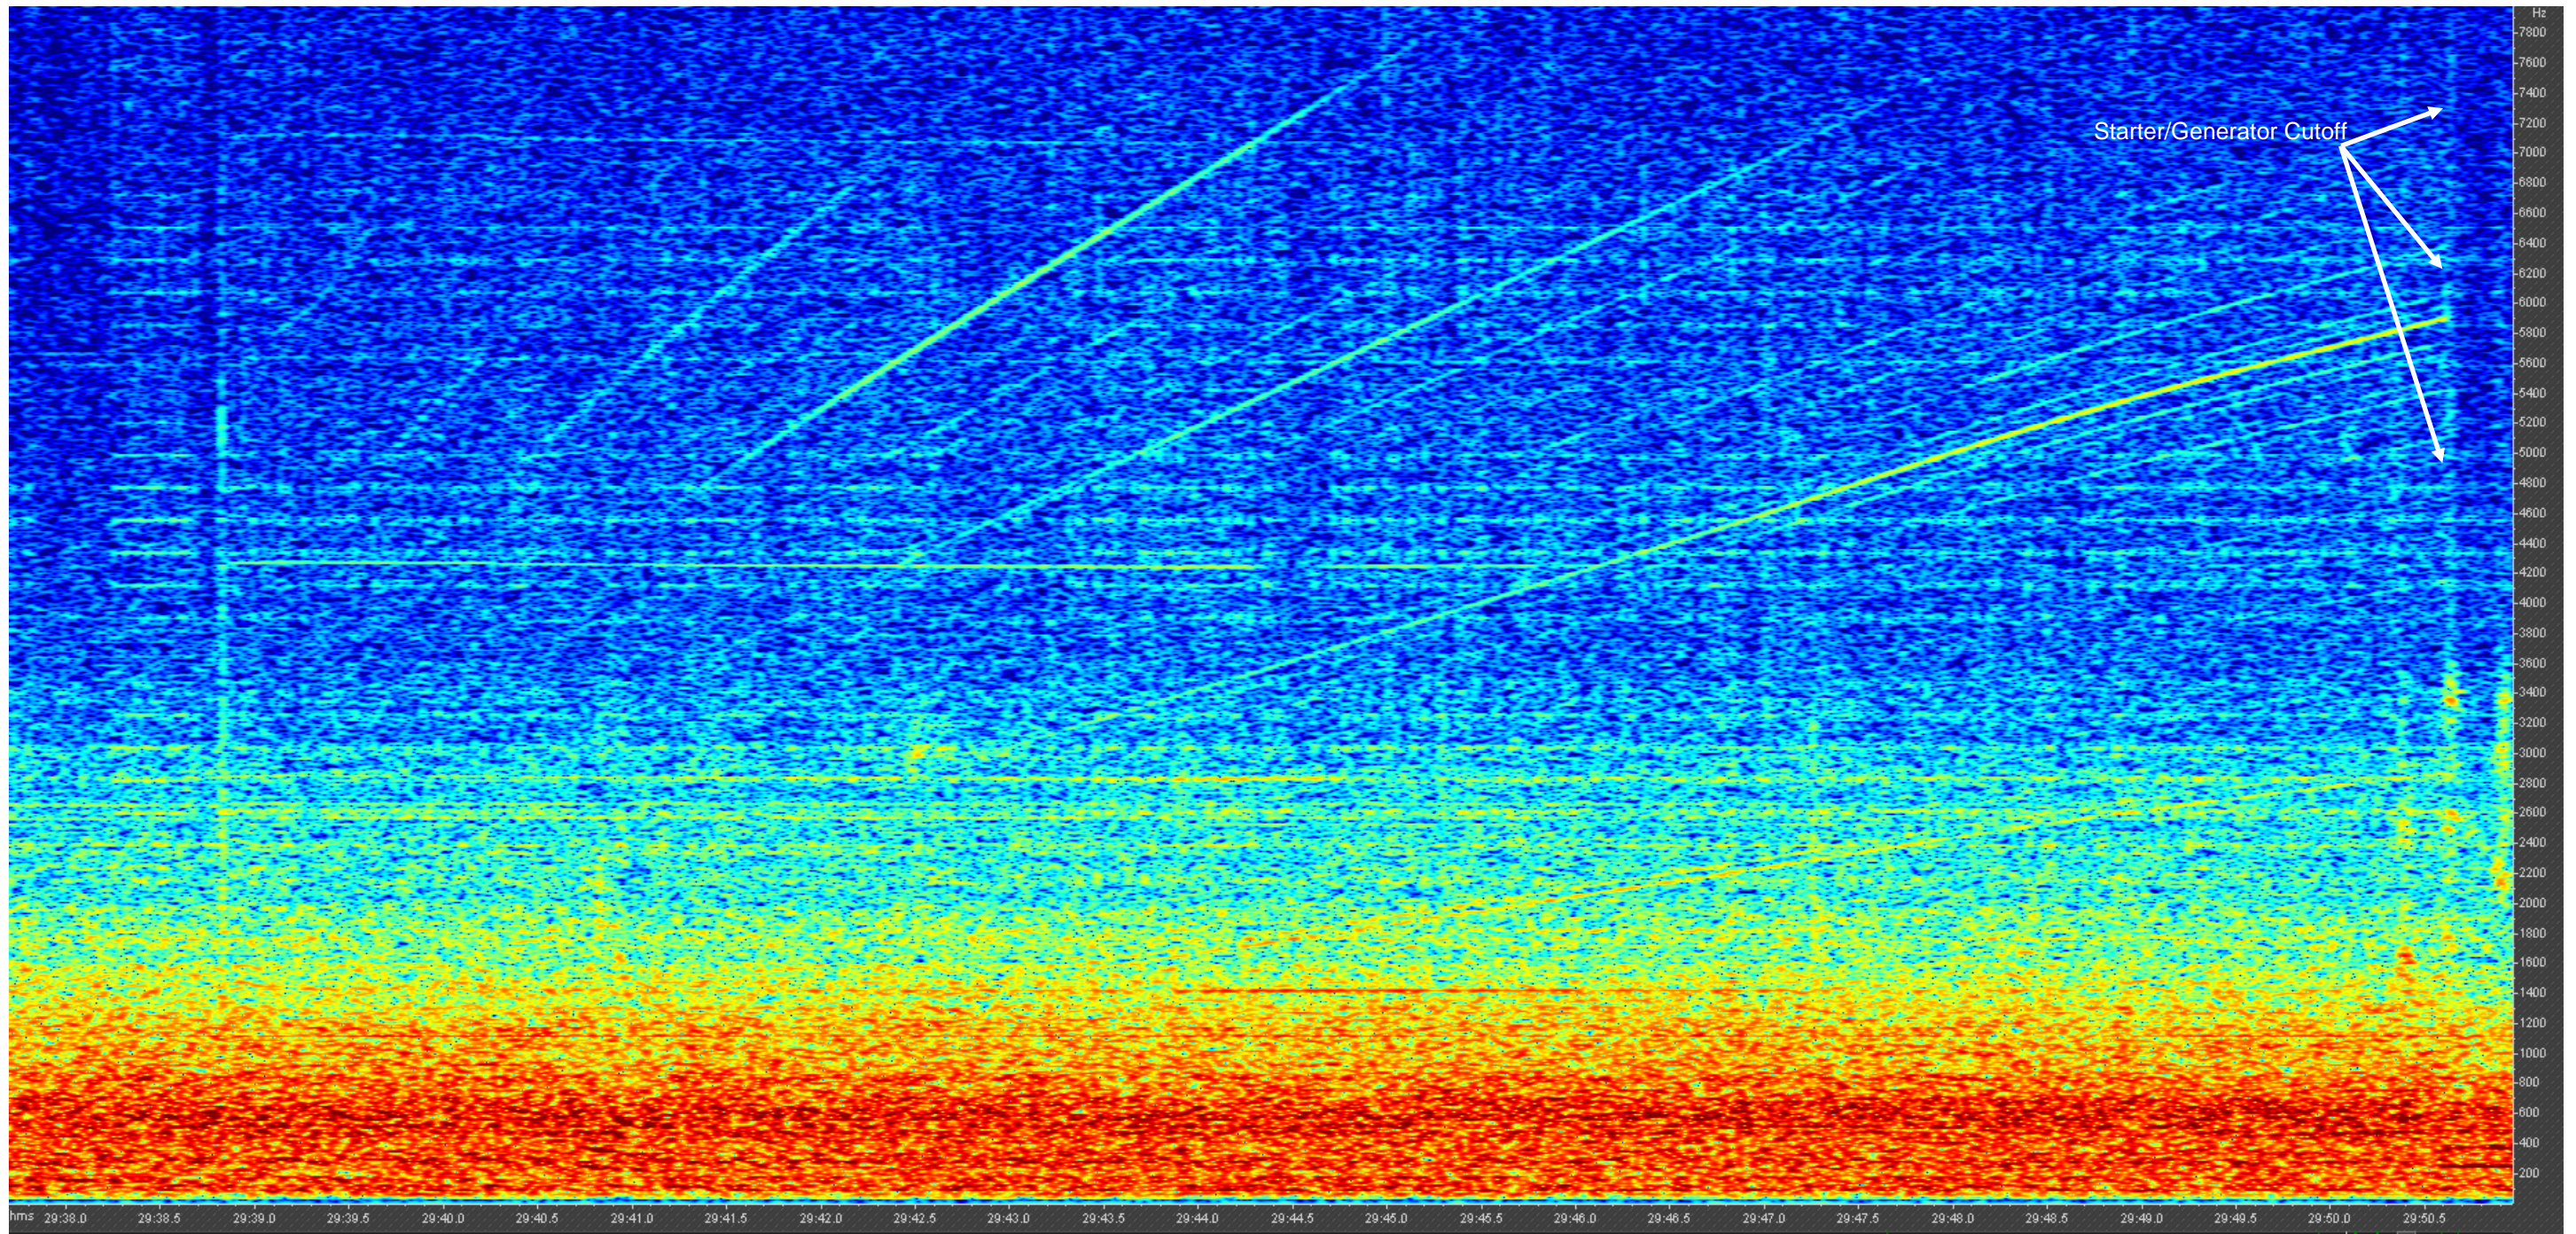
A comparison between the spectrogram in Figure 2 and a similar spectrogram recorded after the loss of engine power on the accident flight (Figure 3) indicate that the crew attempted a starter assisted start in an attempt to restart the engine. Both spectra show similar frequency content, harmonics, and duration.

Figure 3. Spectrogram of restart attempt on accident flight.

Figure 3 shows that the electrical noise from the engine igniters is not present during the accident flight. In contrast to the normal ground start procedure, the air start procedure from the flight manual requires that the igniter switches be switched to the “ON” position prior to an inflight start attempt.

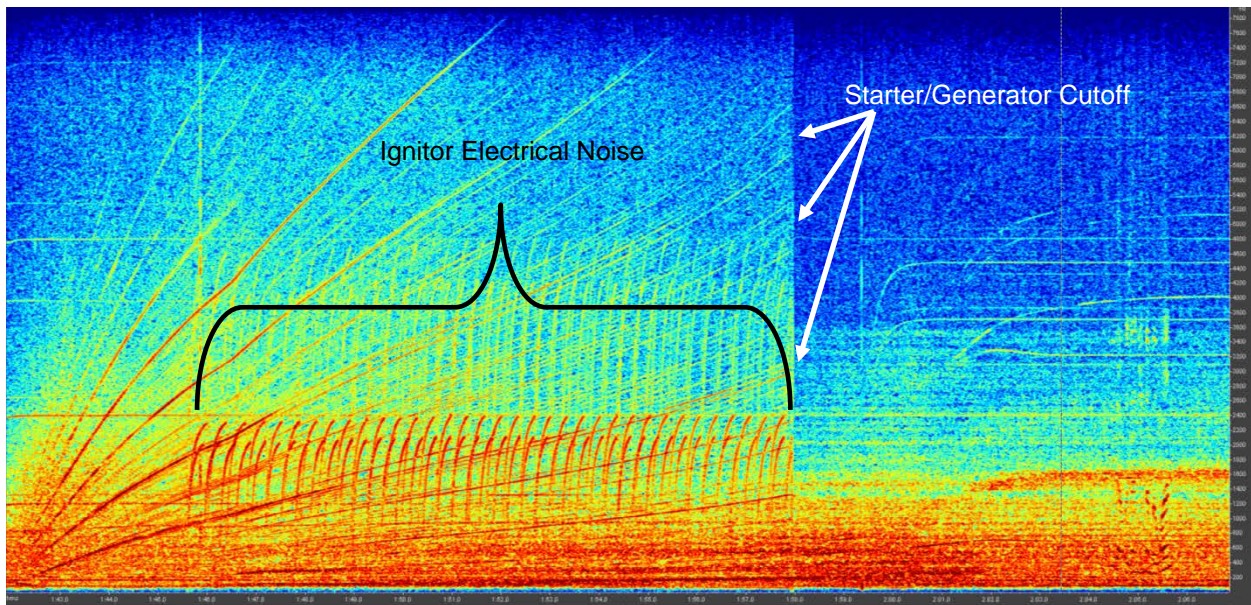
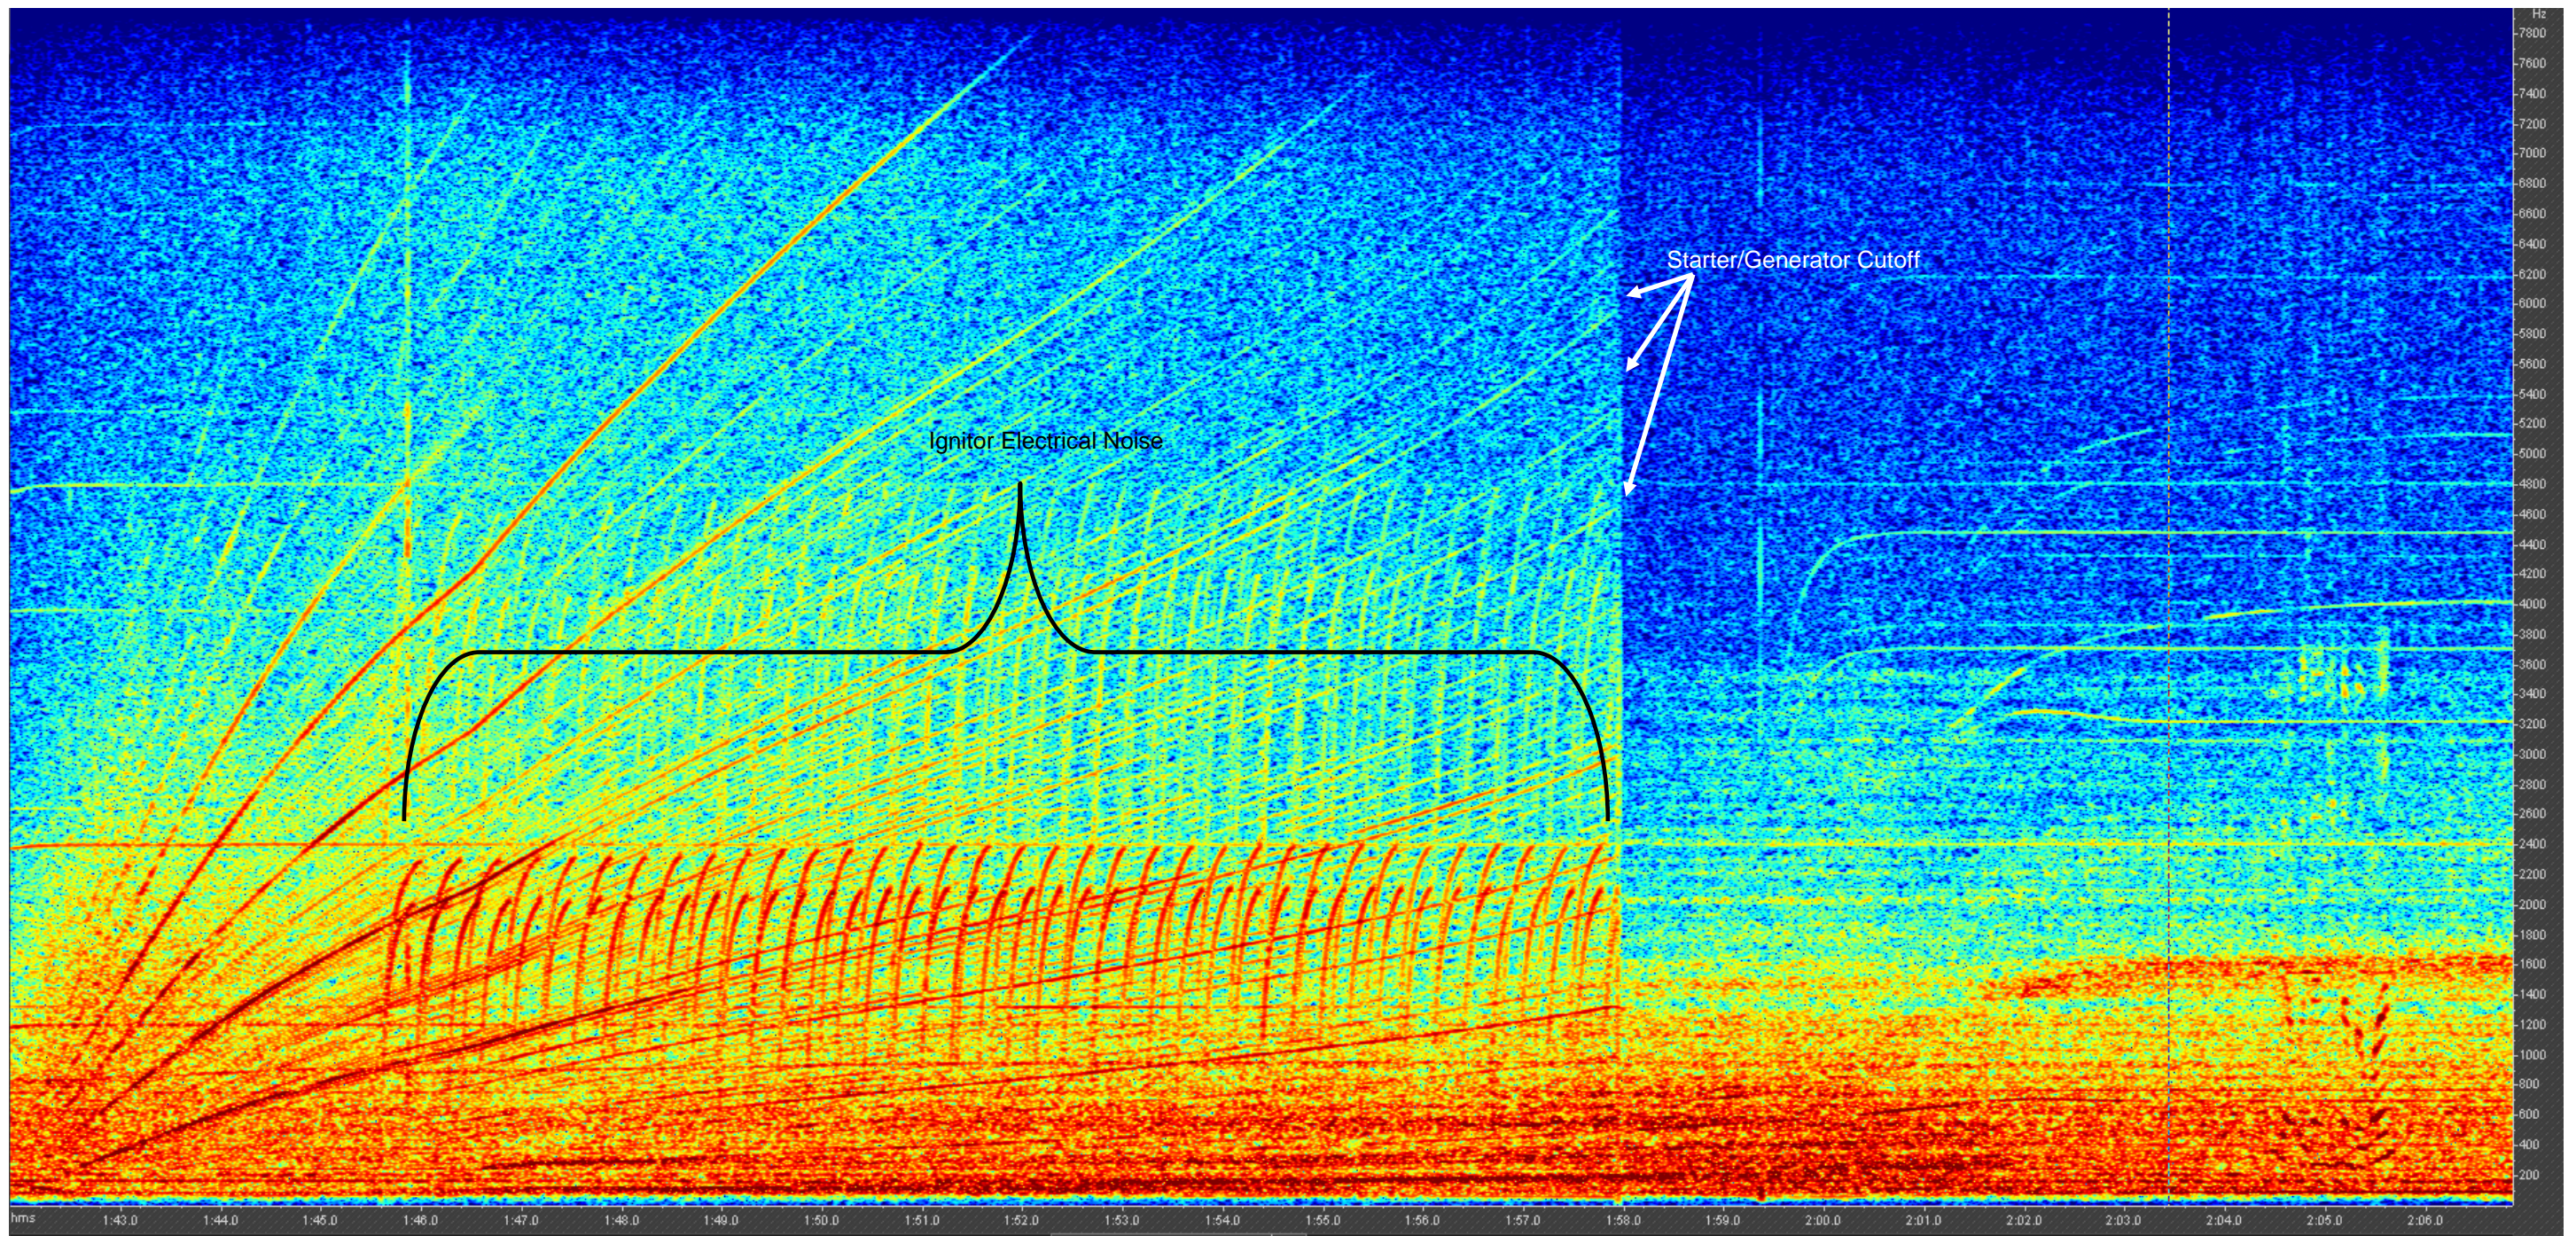
During the ground testing, an exemplar engine start was recorded with the aircraft's installed CVR as well as a handheld audio recorder. Figure 4 shows the spectrogram for this engine start. The electrical interference sound of the igniters is clearly present. These sounds are not normally audible to the ear, but are commonly present as electrical interference on Beechcraft 390 CVR channels.

The traces of the engine shafts spooling up to ground idle is also clearly seen after the starter/generator cuts out at approximately 40-45% N2, according to the manufacturer. While CVR systems normally employ a high pass filter with a cutoff frequency of approximately 150 Hz, some audio characteristics may be visible below 150 Hz if the signal is high enough. Figure 5 shows the N1 shaft spooling up to 85 Hz, equivalent to a ground idle speed of 29.5% N1. Figure 6 shows the same engine start as Figure 5, but at a higher frequency window on the y-axis. While faint, the blade passage trace for the N1 shaft with 16 compressor blades, corresponding to the N1 shaft spool up, can be seen increasing to approximately 1,360 Hz.

Figure 4. Spectrogram of left engine start during ground test.

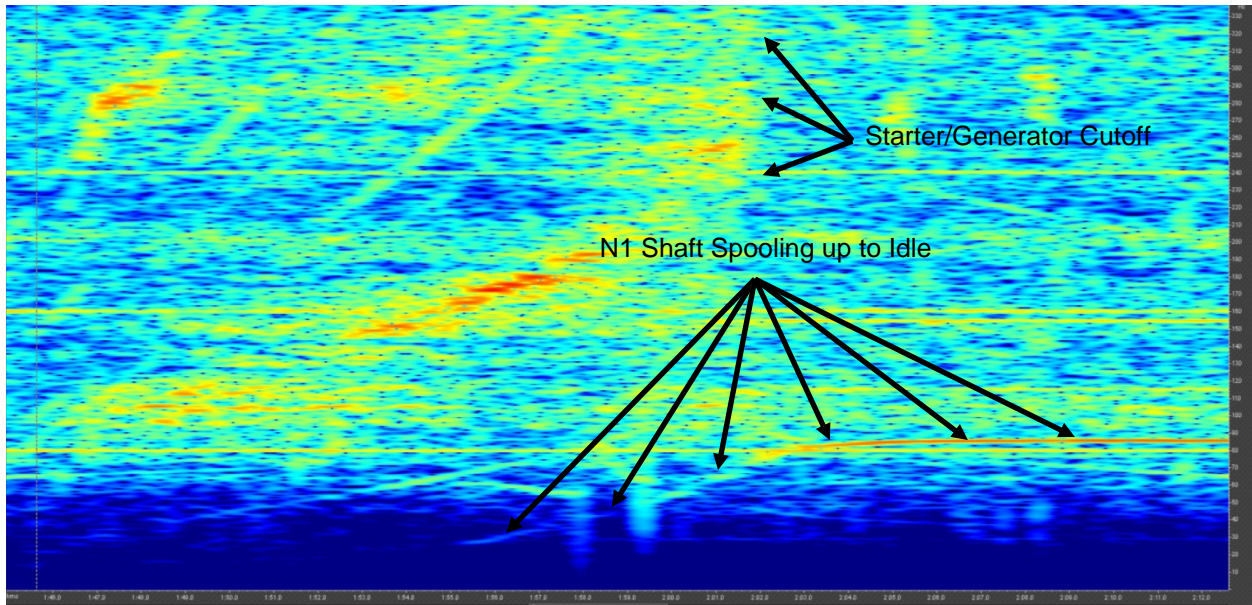
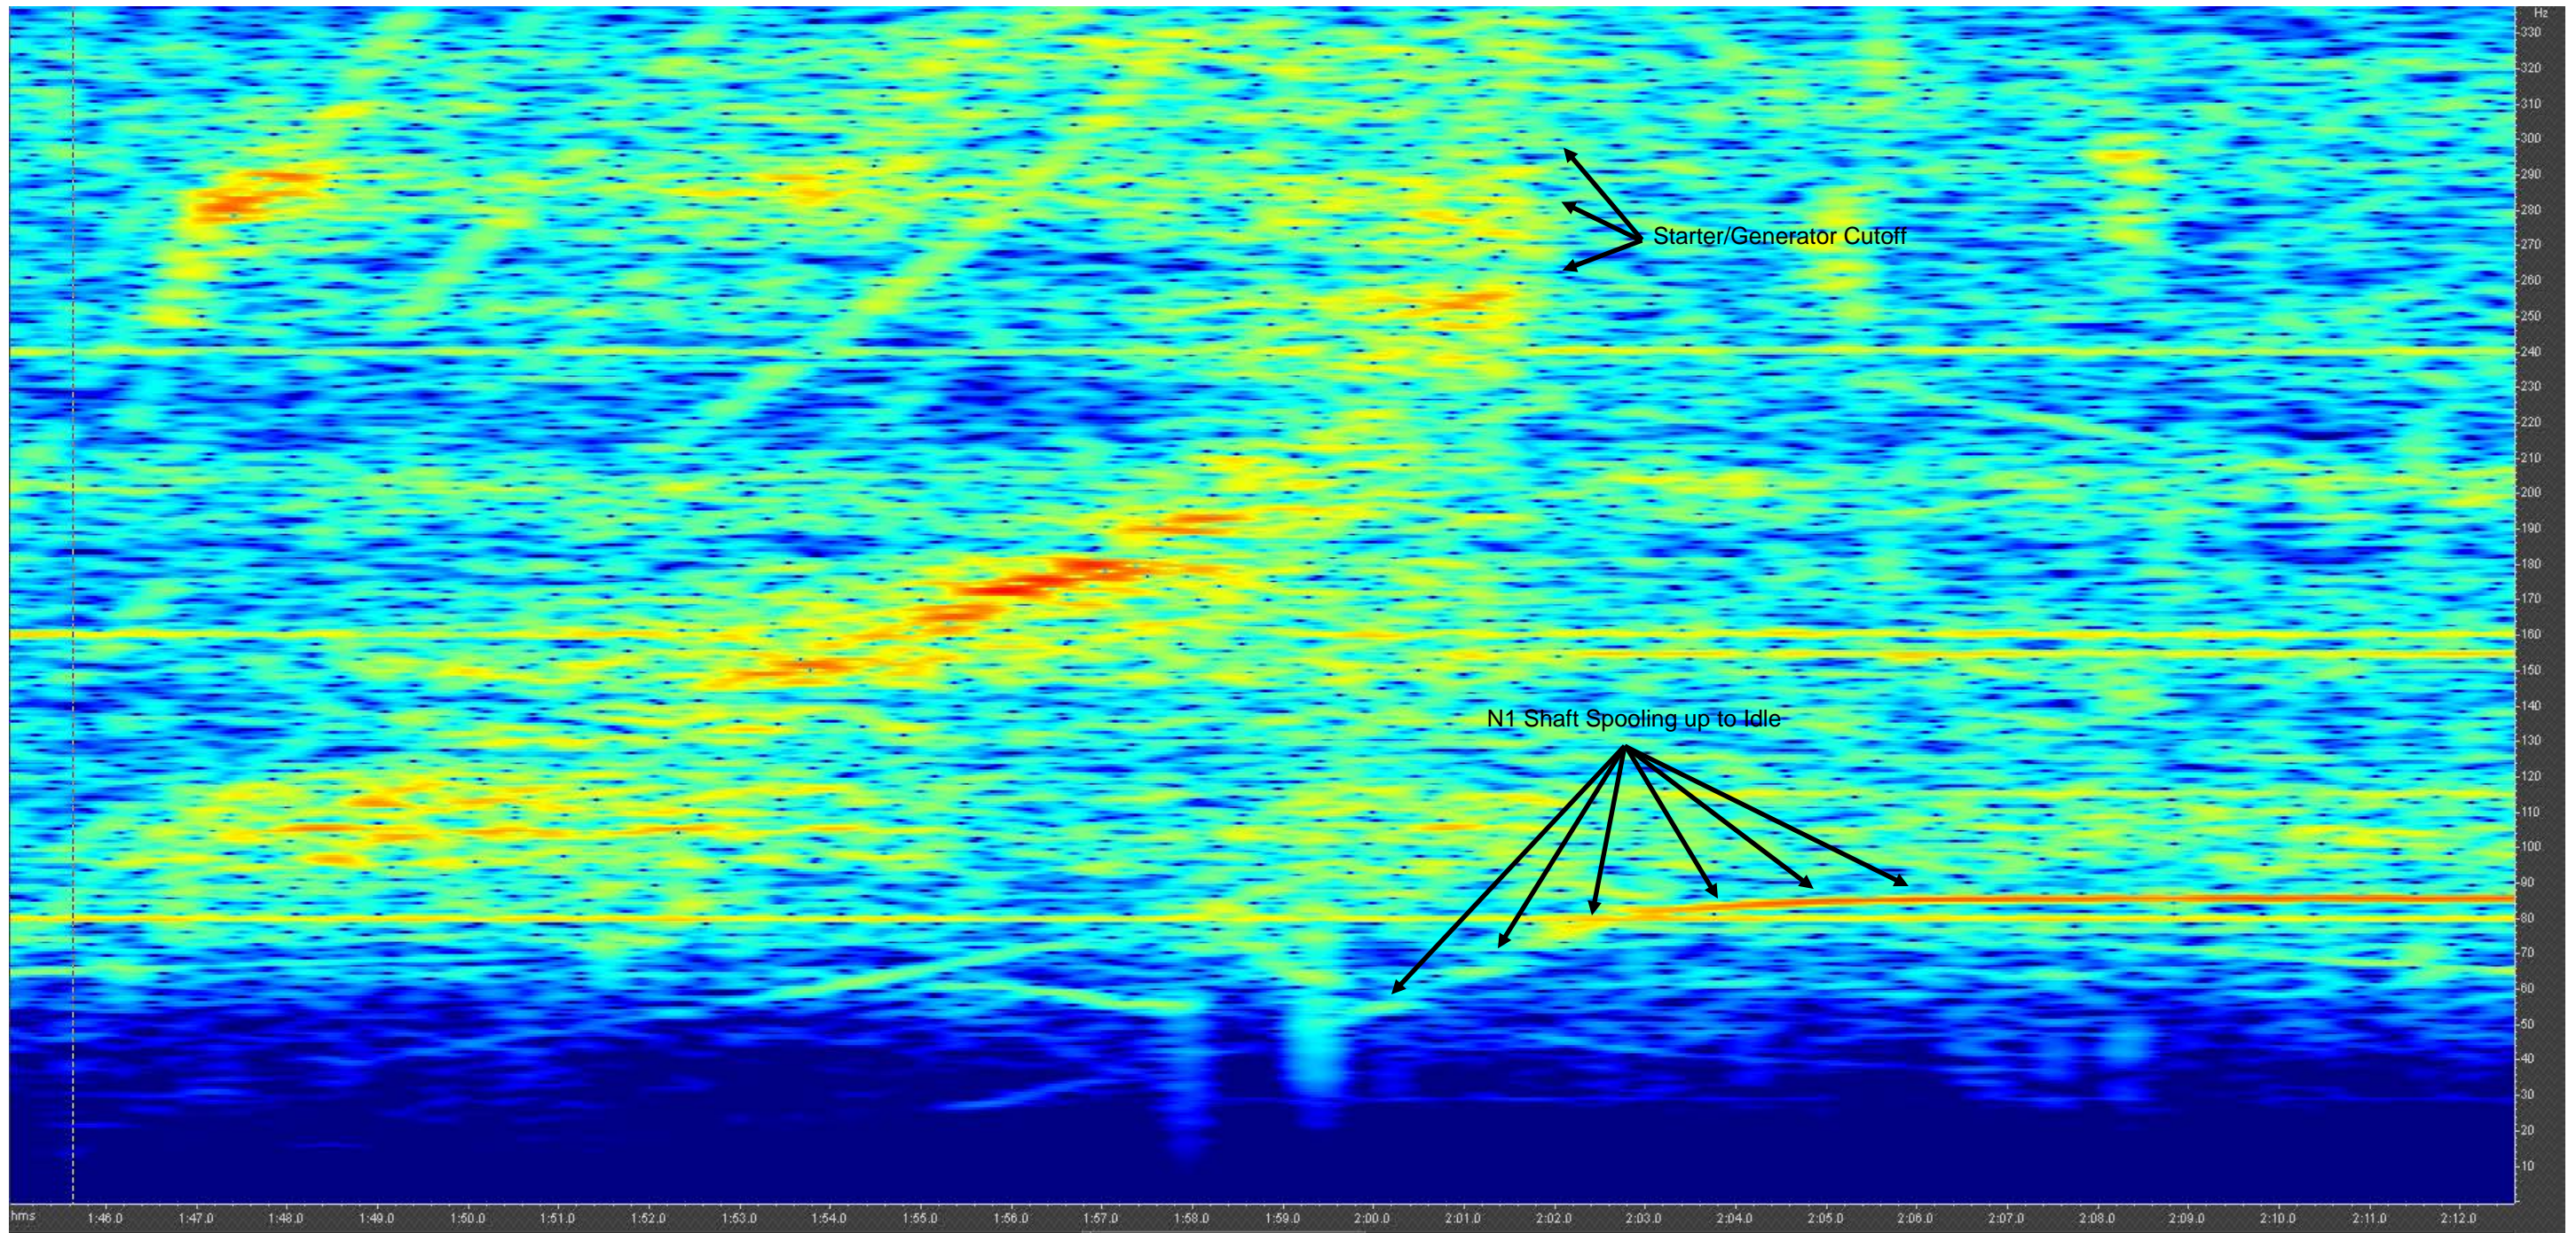
Figure 5. Spectrogram showing N1 shaft spool up during ground test.
