NATIONAL TRANSPORTATION SAFETY BOARD
Vehicle Recorder Division
Washington, DC 20594

Sound Spectrum Study

Specialist's Study Report
By Christopher Babcock

Location: South Bend, Indiana
Date: March 17, 2013, 1623 Eastern Daylight Time (EDT)
Aircraft: Hawker Beechcraft 390
Operator: Private
Registration: N26DK
NTSB Number: CEN13FA196

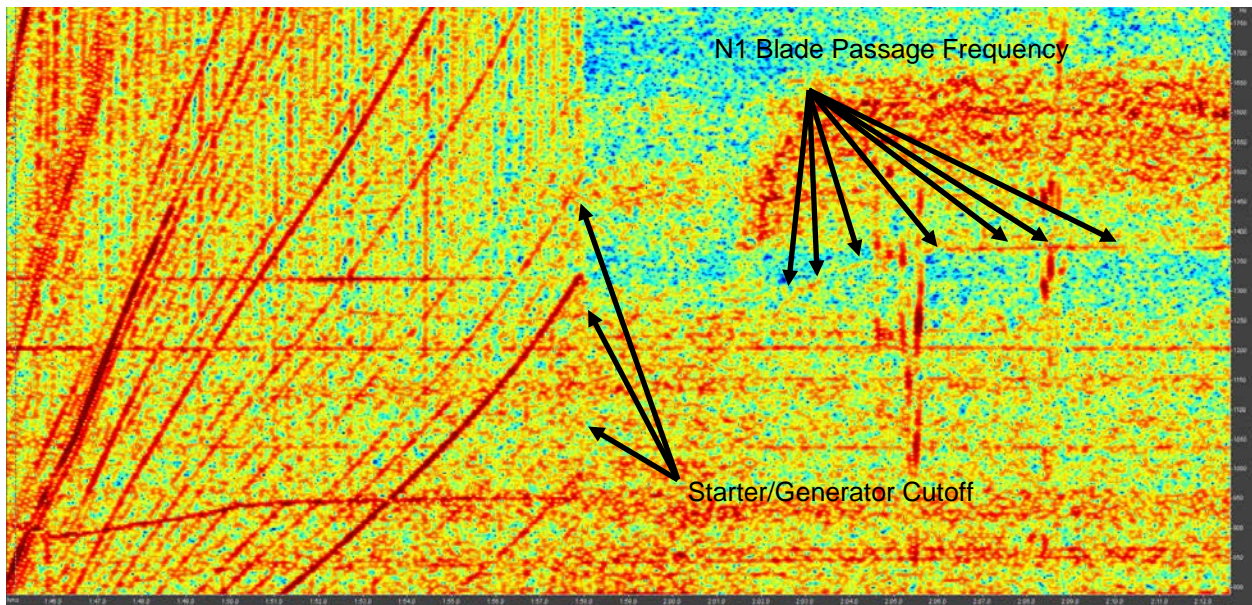
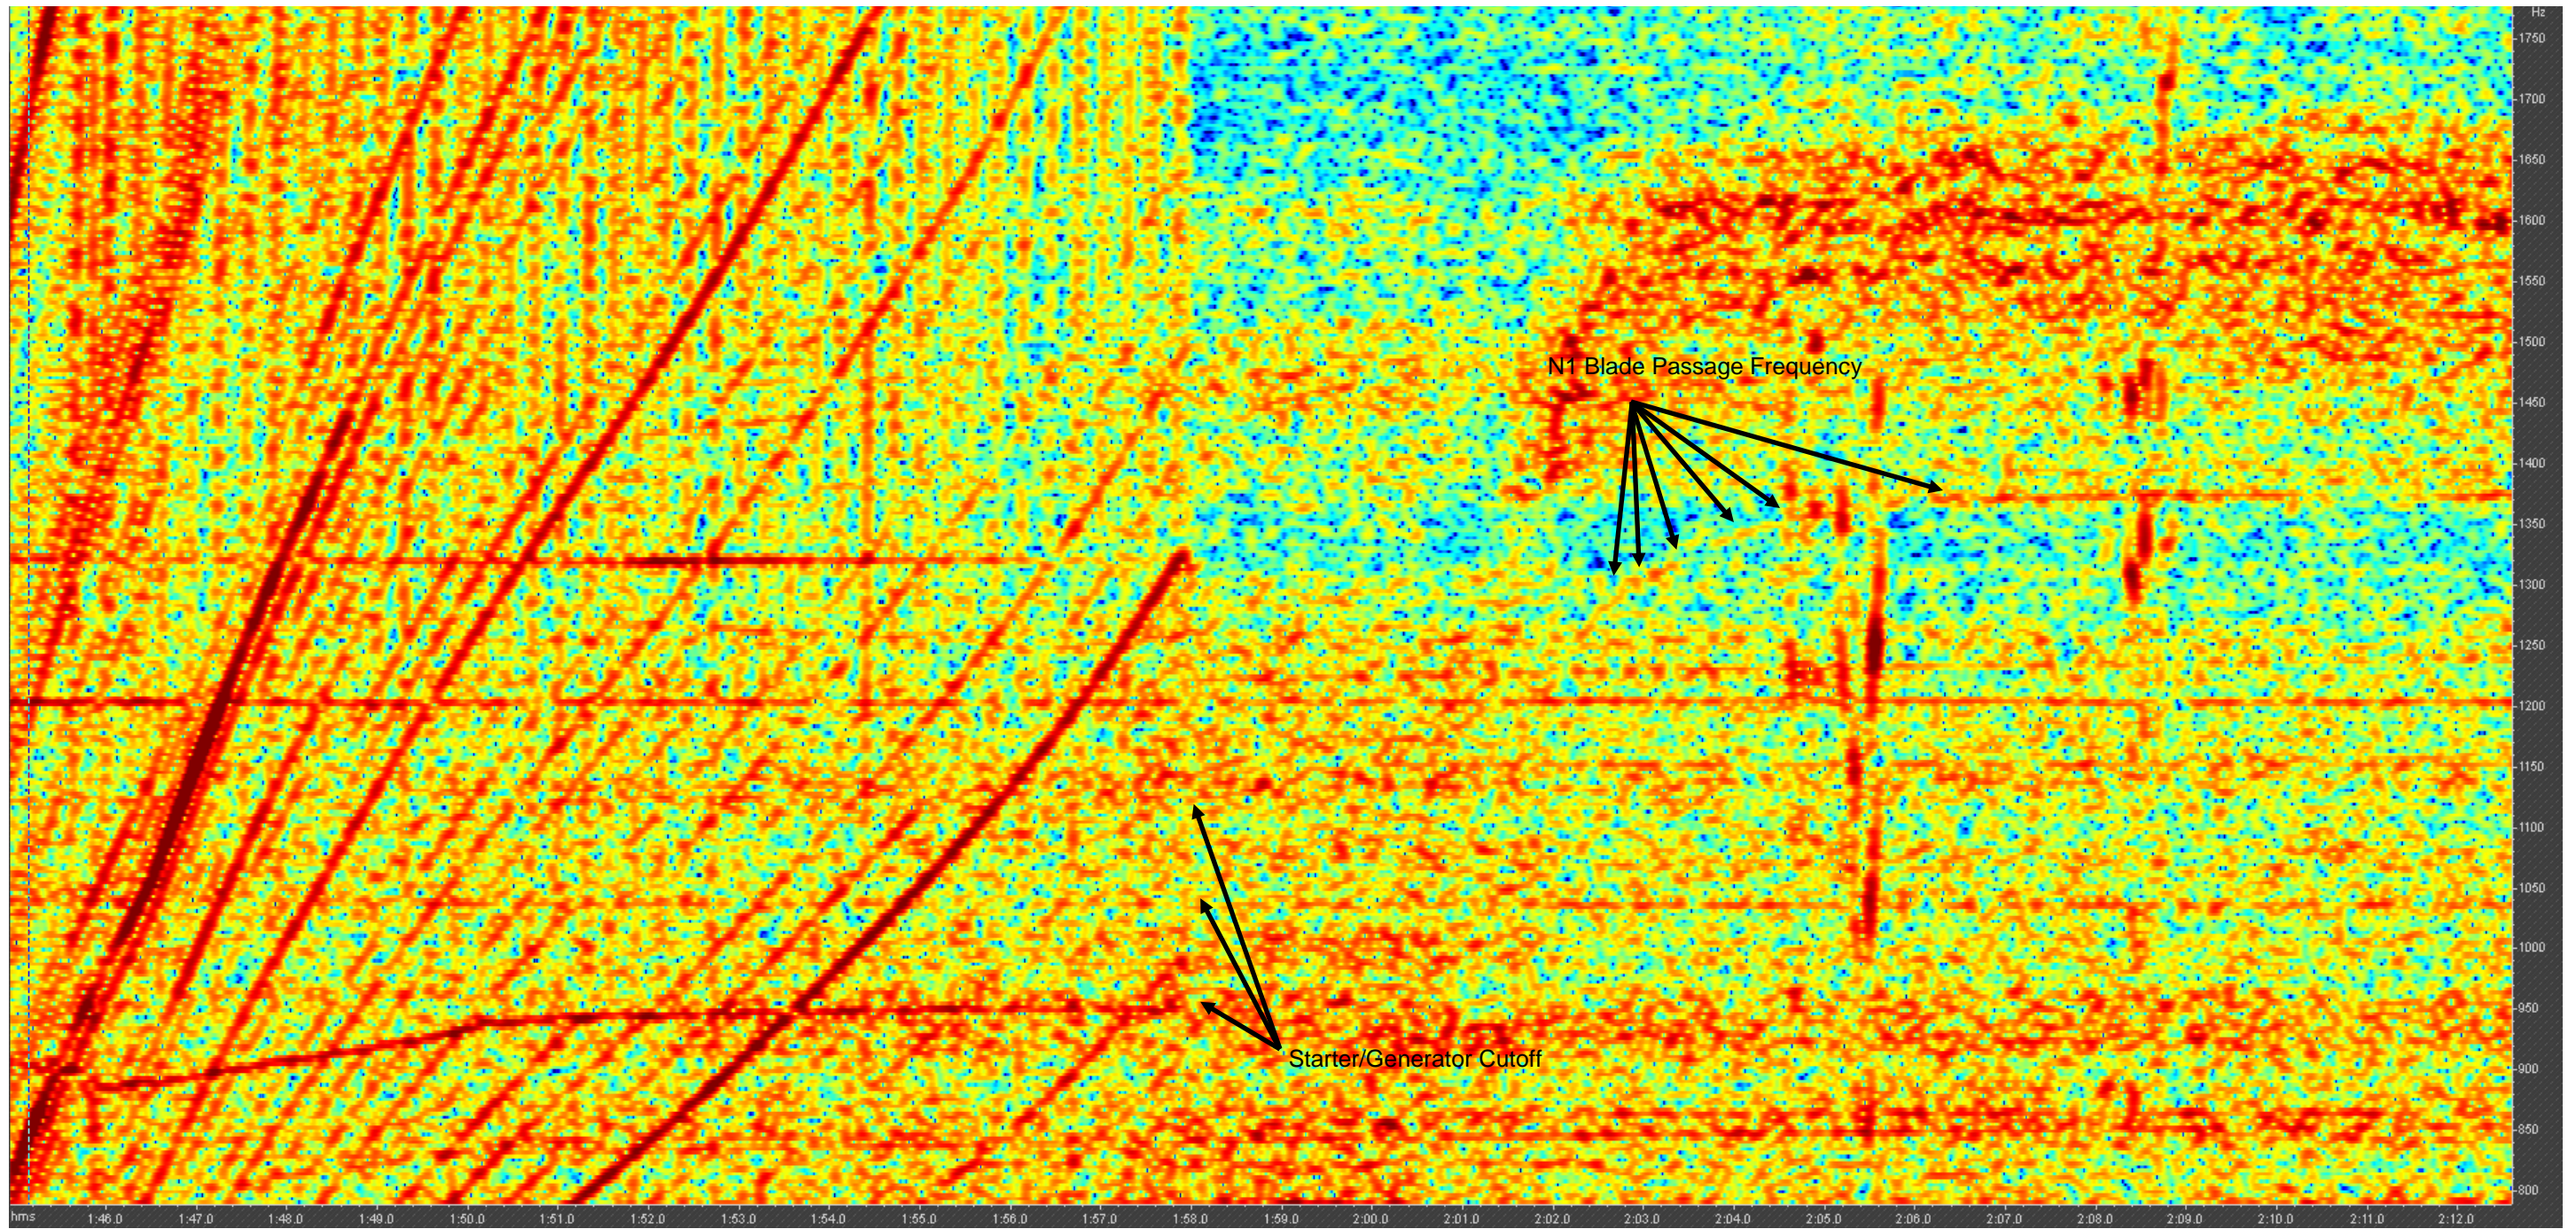
Figure 6. Spectrogram showing N1 blade passage frequency during engine start ground test.

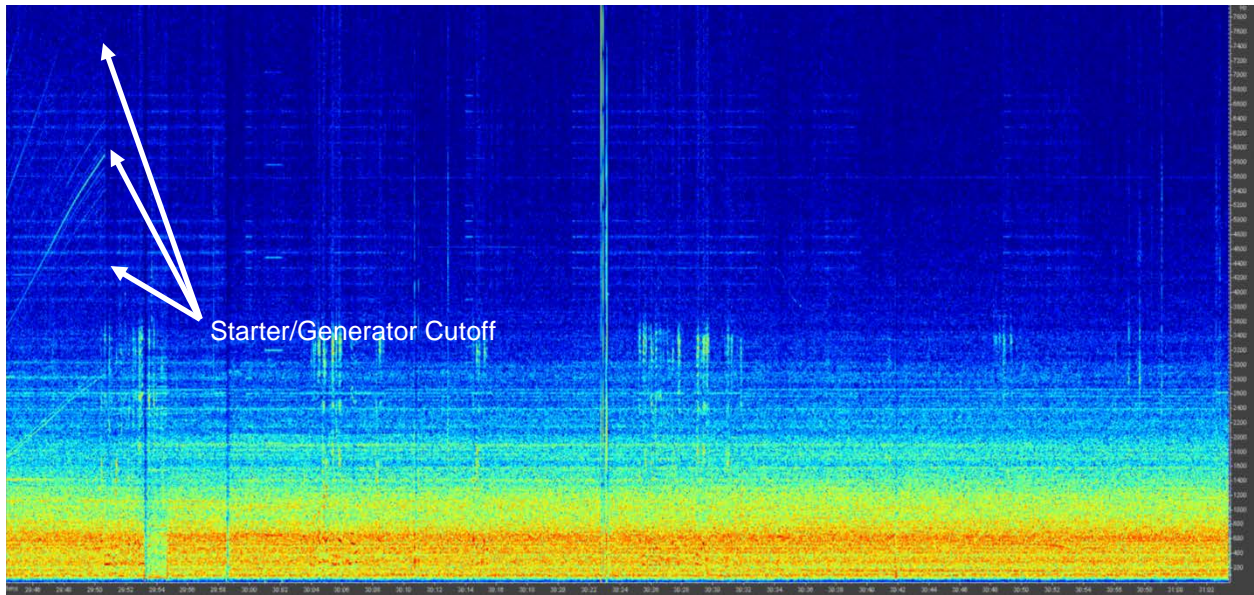
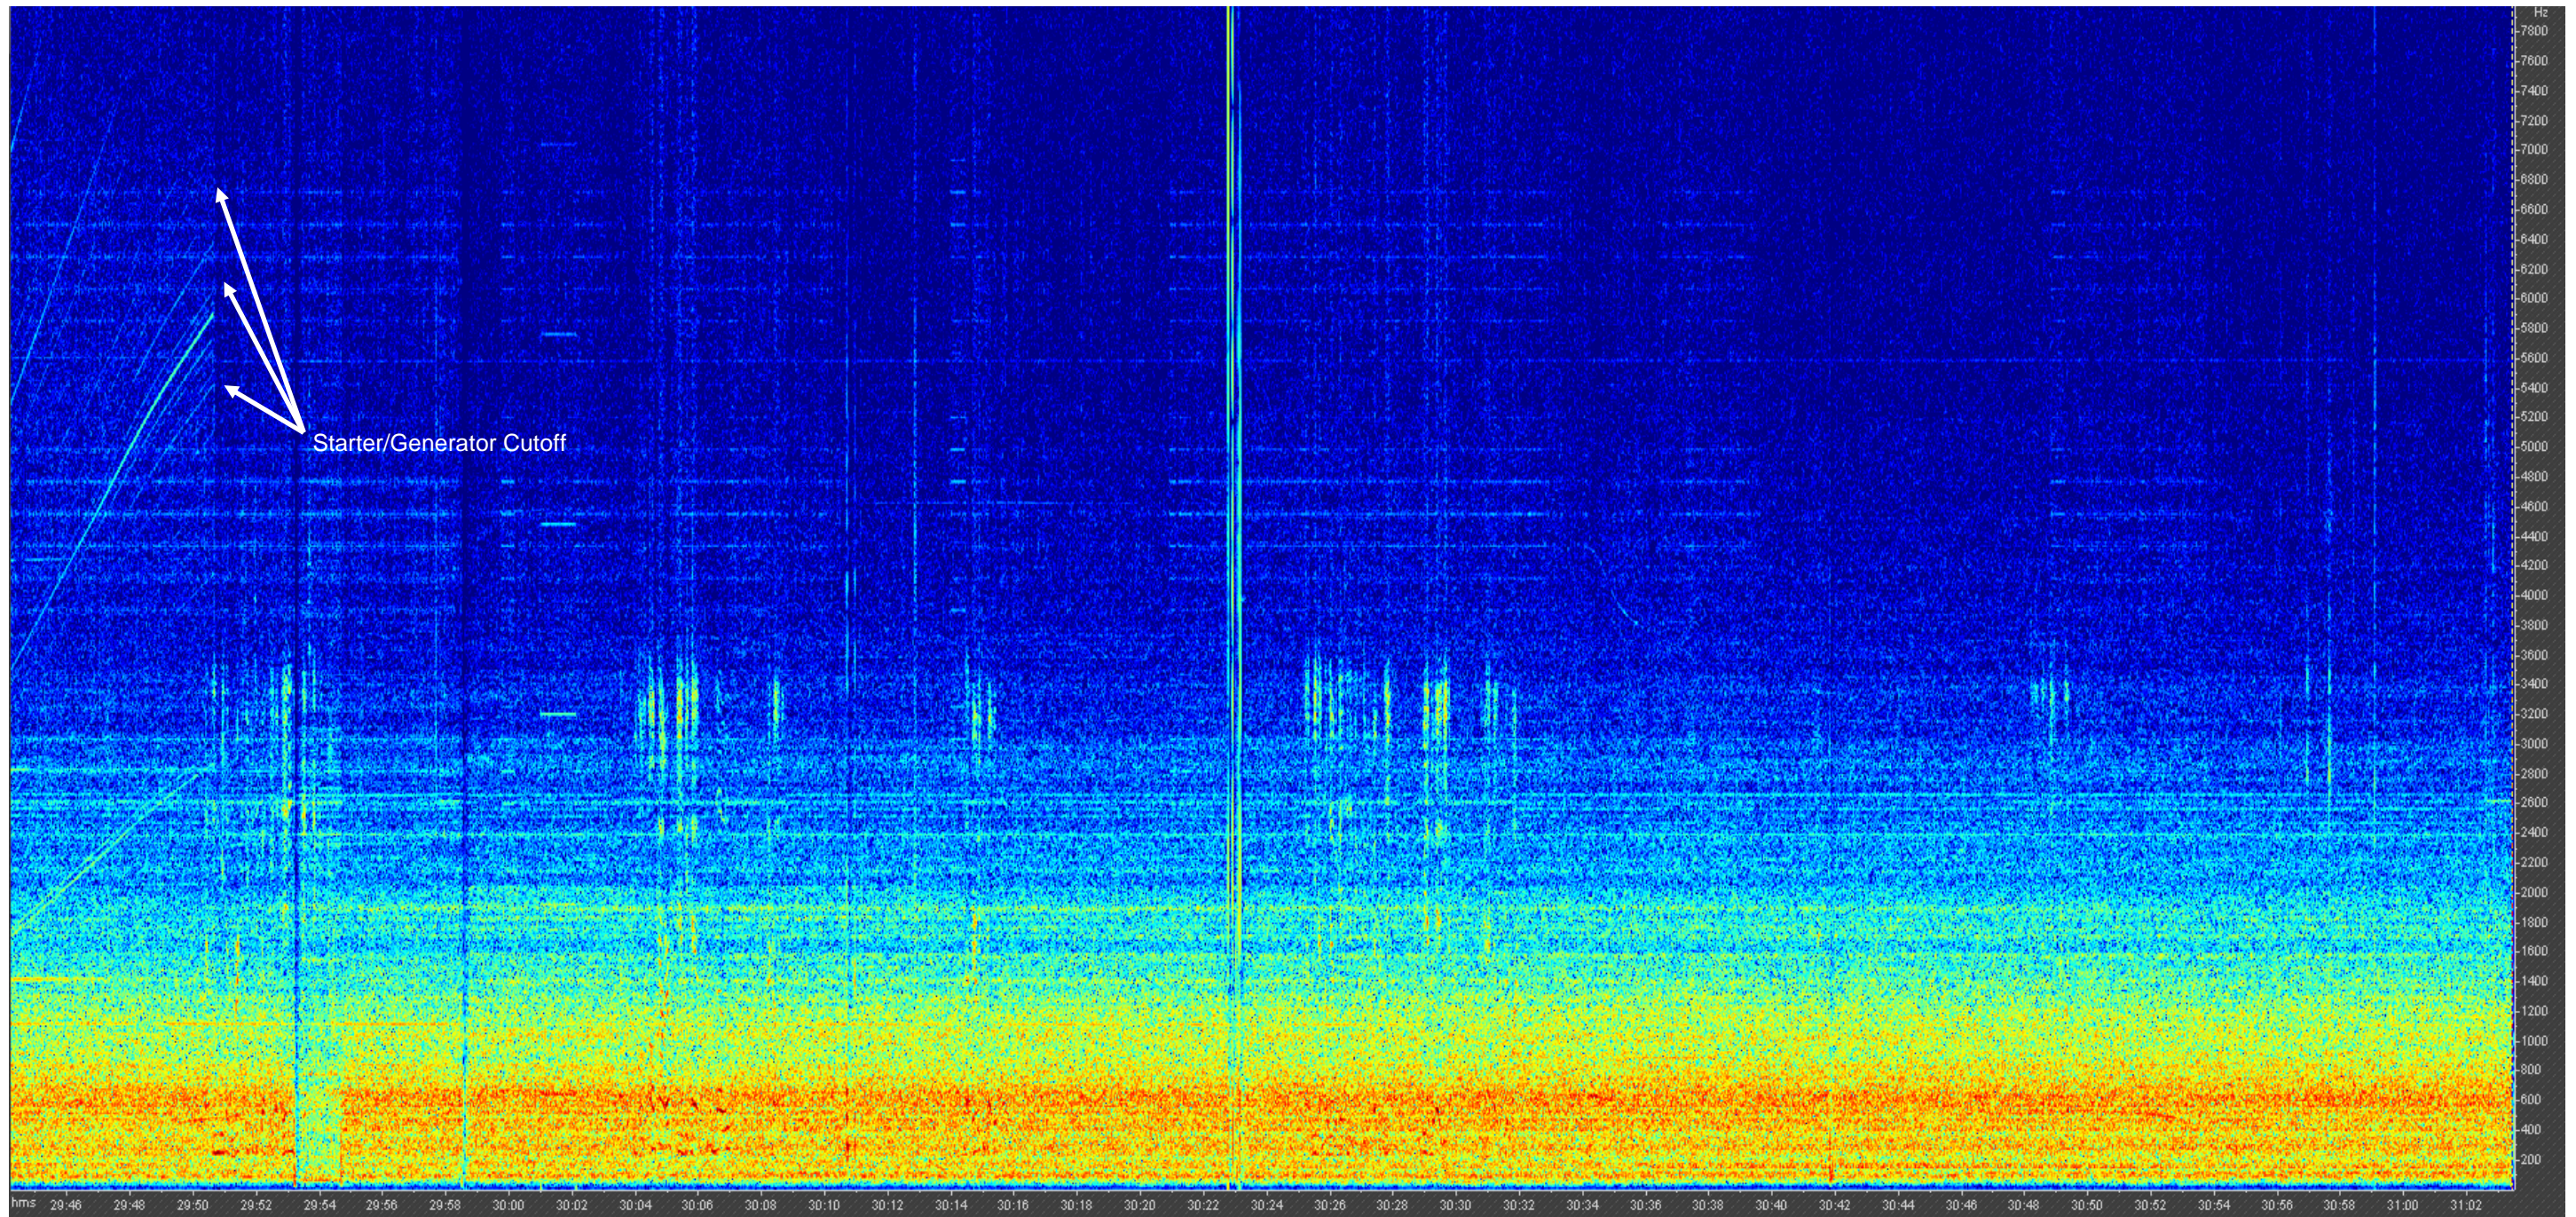
While several frequency traces of engine shafts and accessories spooling up are present in the exemplar ground start, none are visible for the period after the start attempt through the end of the CVR recording 64 seconds later (Figures 7 and 8) during the accident flight.

Figure 7. Spectrogram of period after start attempt until the end of recording (full bandwidth).

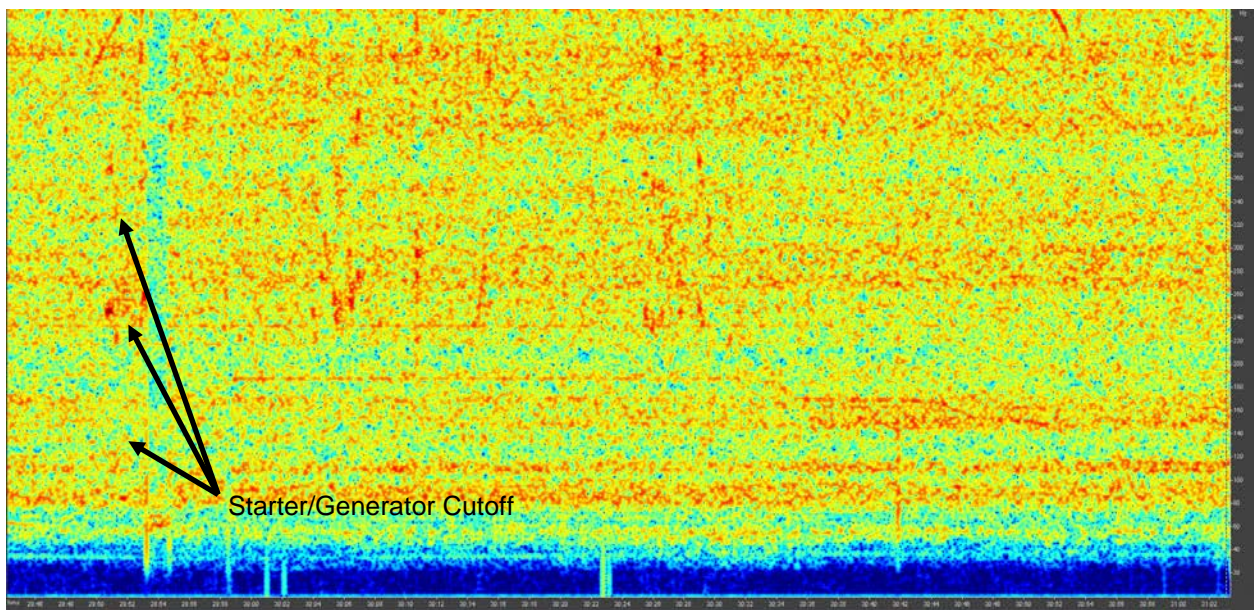
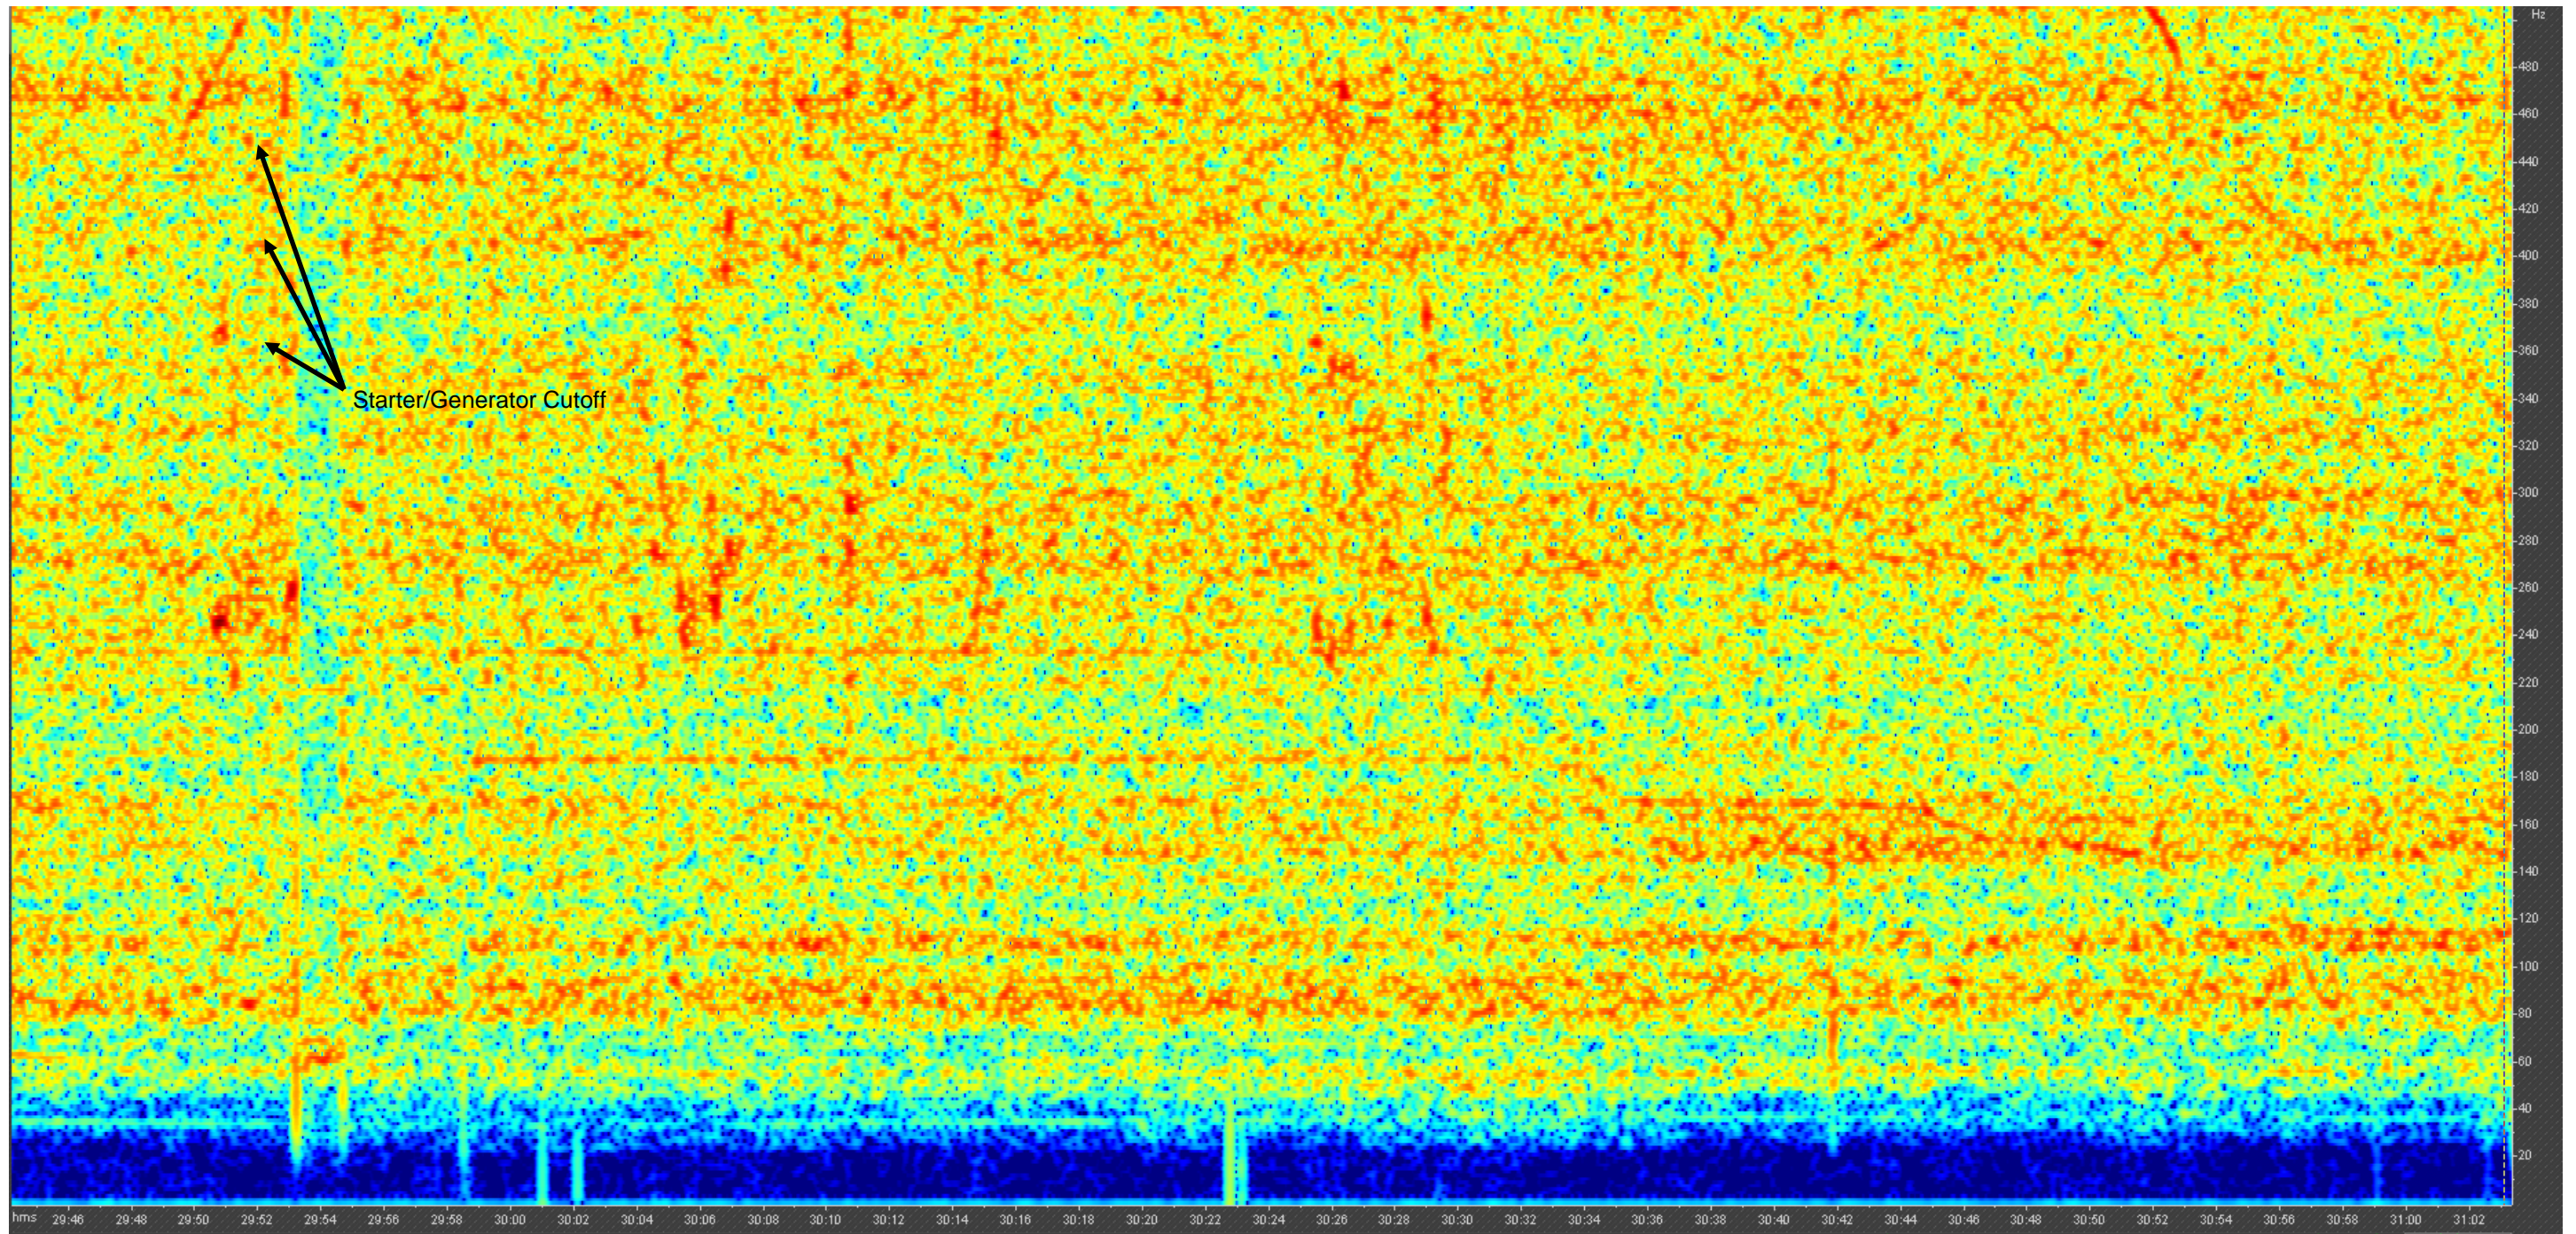
Figure 8. Spectrogram of period after start attempt until the end of recording (0-500 Hz).
