**NATIONAL TRANSPORTATION SAFETY BOARD**  
Vehicle Recorder Division

## **Sound Spectrum Study**

**Group Chairman's Study Report**  
**By Christopher Babcock**

Location: Palm Bay, Florida  
Date: September 6, 2016  
Aircraft: Sikorsky S-61N, Registration N805AR  
Operator: AAR Airlift Group  
NTSB Number: ERA16FA311

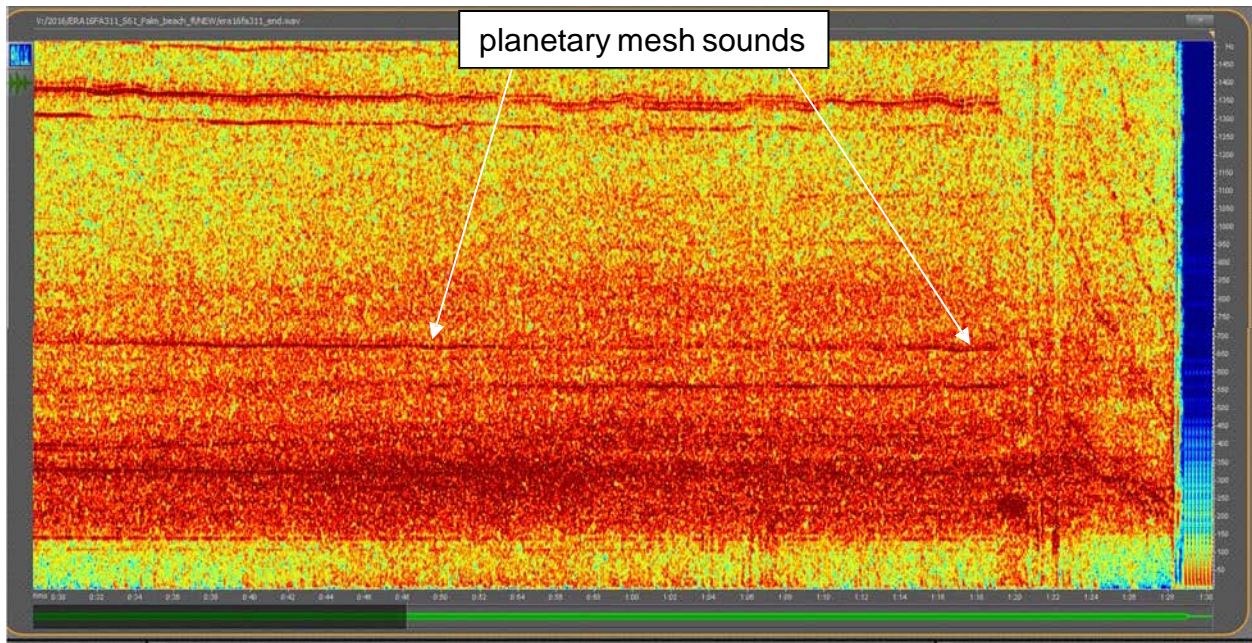
The speed of the main rotor system was measured by identifying the planetary gear mesh sound signature. This meshing of the gears produces an actual sound signature of 663.1 Hz at 100% Nr; however, according to Sikorsky, phase and measurement effects will show an apparent planetary mesh frequency of 659.8 Hz at 100% Nr. The planetary gear sound signature is very loud and quite pronounced on the spectrogram of the CAM channel of the CVR (see Figure 1).

**Figure 1.** Apparent planetary mesh frequency for the last minute of flight.

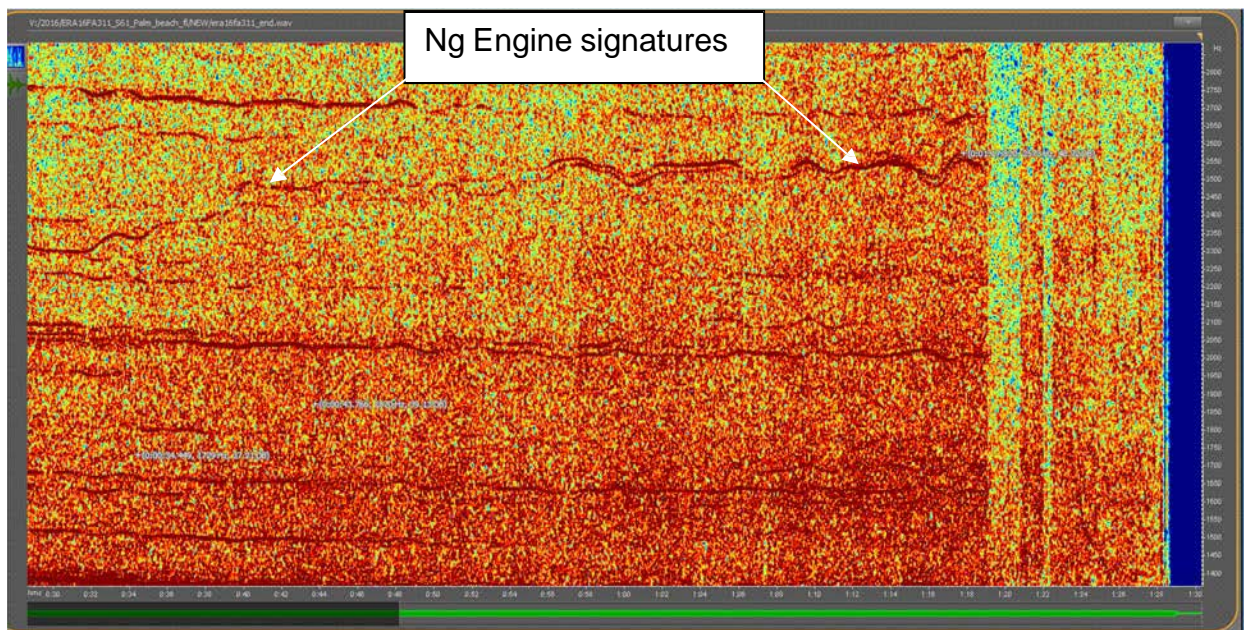
Similar techniques were used to identify and measure sounds associated with the rotational frequencies of the gas generators of each engine. The rotating gas generator of the engine produces noise at the fundamental (primary) frequency and at integer multiples or harmonics of that frequency. The sixth harmonic of the gas generators produced the most identifiable sound signature during operation (see Figure 2).

**Figure 2.** Sixth harmonic of Ng fundamental frequency for the last minute of flight.

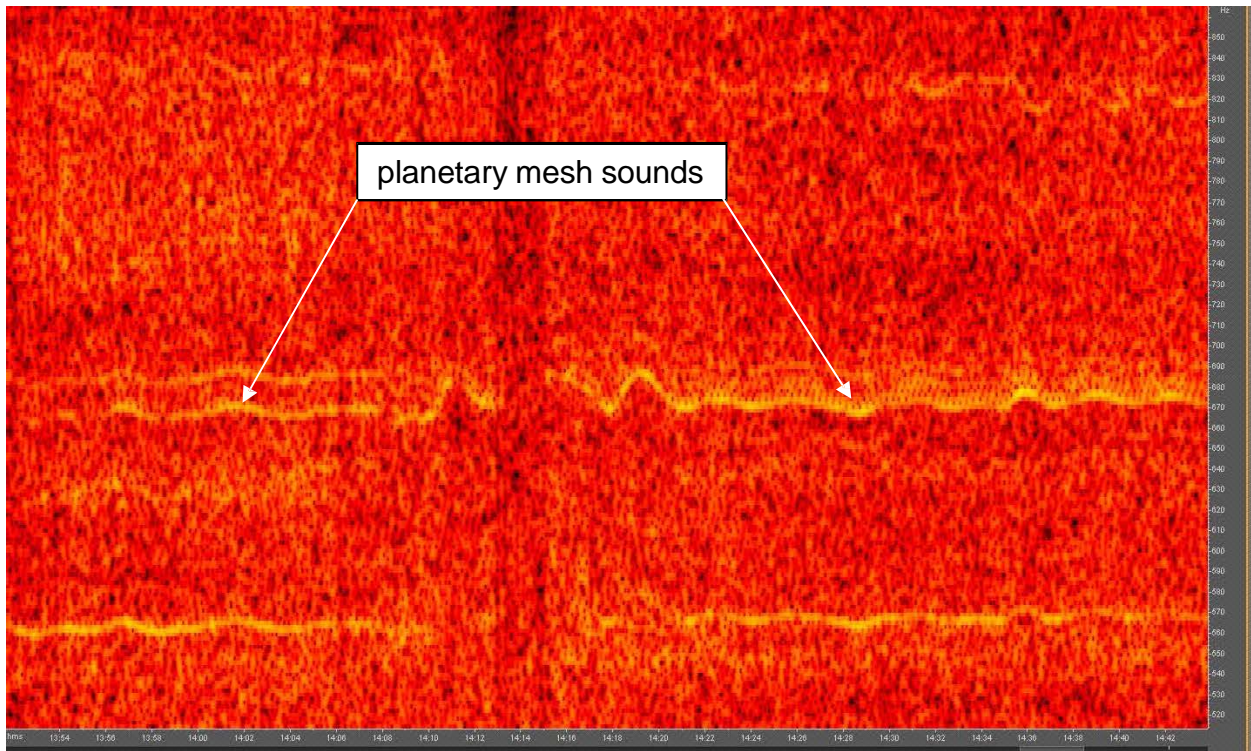
**Figure 3.** Apparent planetary mesh frequency for the first rearward flight maneuver.

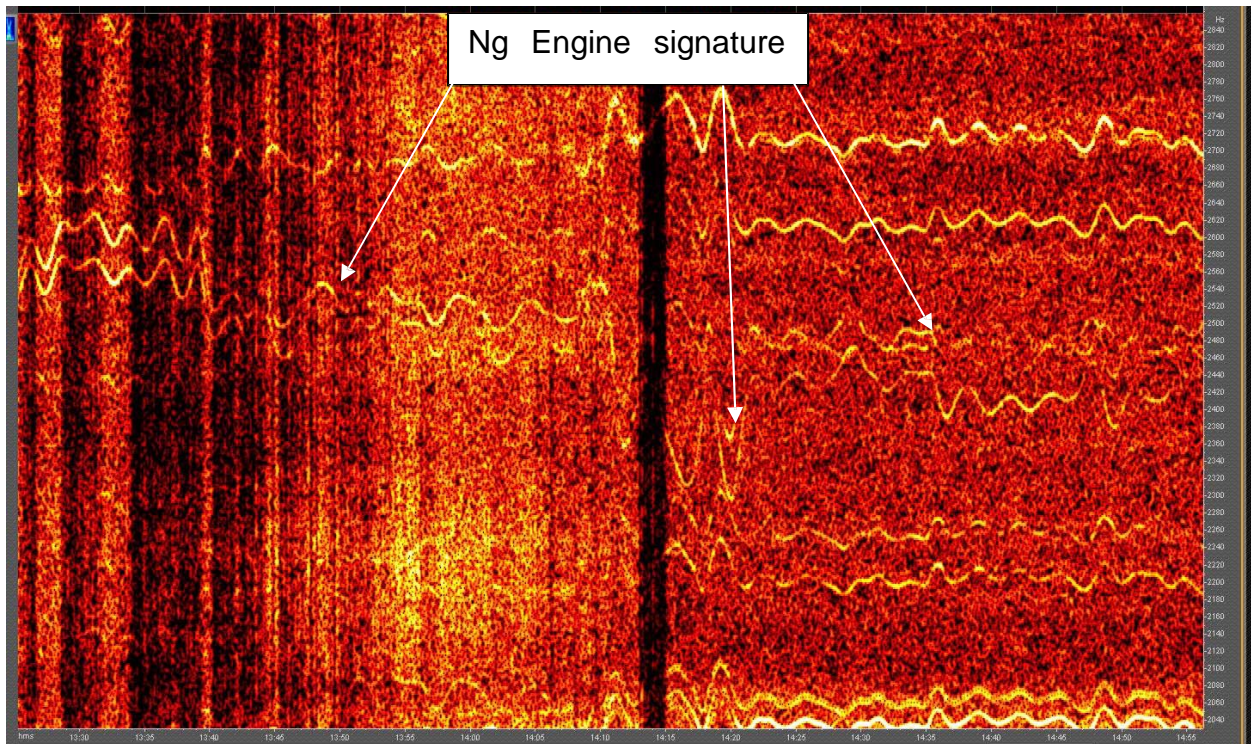
**Figure 4.** Sixth harmonic of Ng fundamental frequency during first rearward flight maneuver.

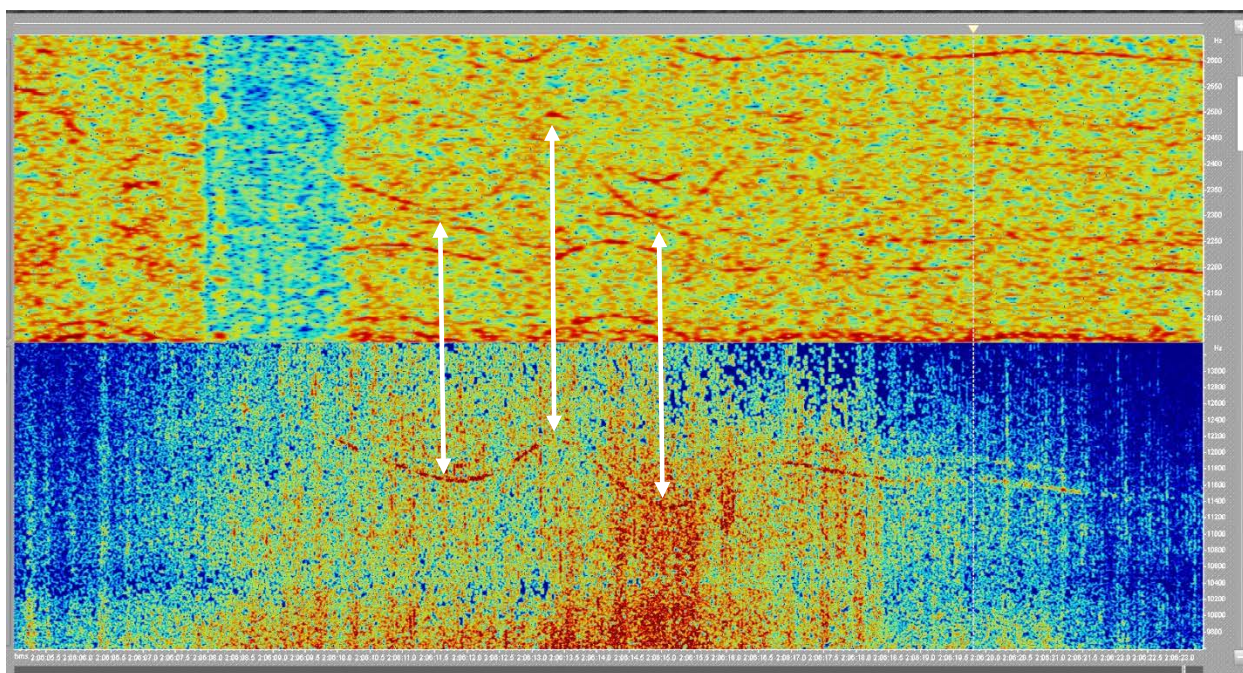
Examination of the video showed spectral content in the range of 11200-12500 Hz. This frequency range is similar to the frequency range of the blade passage frequency of the first stage compressor on the engine where 100% Ng is 13150 Hz blade passage frequency. Because this frequency is too high to be seen on the CVR, the shape of this trace was fit to the 6<sup>th</sup> harmonic of the Ng core trace on the CAM channel of the CVR to determine a time offset to match the video (Figure 5). Using the timing determined in the *CVR Group Chairman Factual Report*, the start of the video occurred at 1336:55.2 EDT.<sup>1</sup>

**Figure 5.** Matched spectrum of the CVR CAM channel (upper) and the witness video (lower).

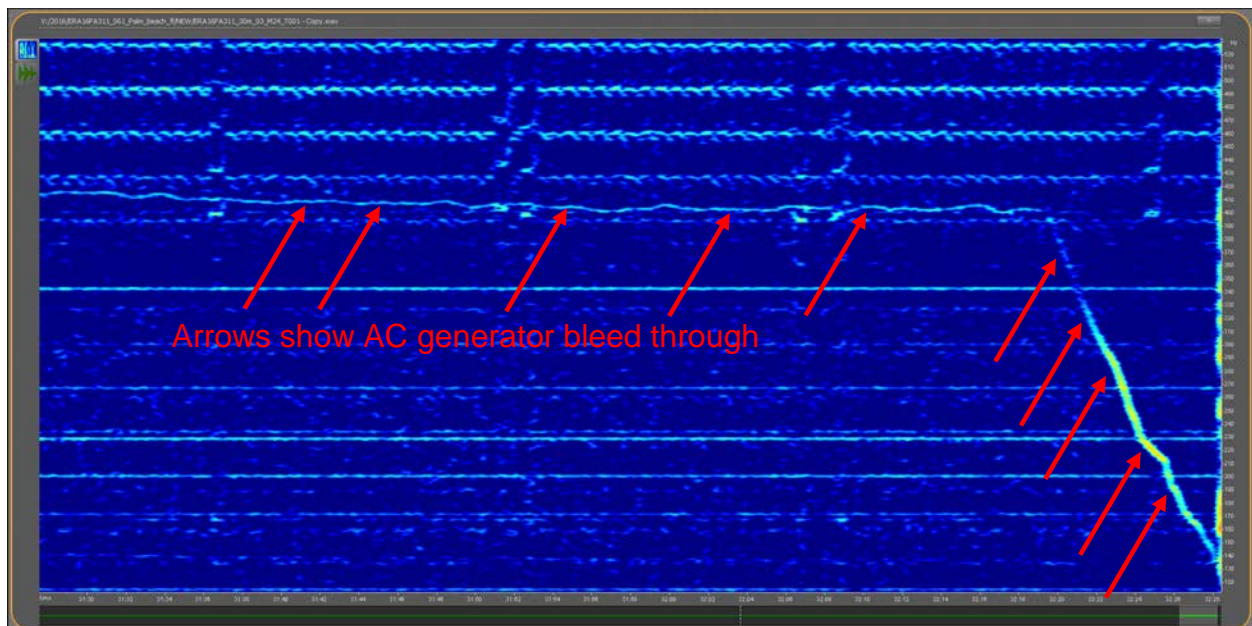
An alternate means to determine the rotor trace over the entirety of the two events was proposed. Analysis of one of the unused crew channels contained very low levels of electrical bleed through AC generators. As the generators are directly linked to the aircraft drivetrain, a continuous determination of rotor speed through the entirety of the two events could be determined because this channel did not suffer from the overdriven audio problem present on the CAM channel and was subject to less noise than what was found on the CAM channel. At 100% Nr, the frequency of the generator bleed through on the crew channel of the CVR is 400.5 Hz, according to Sikorsky. Figure 6 shows a spectrogram of the electrical bleed through on the crew channel during the accident sequence and Figure 7 shows a spectrogram of the electrical bleed through during the first rearward flight maneuver.

**Figure 6.** Spectrogram of AC generator bleed through during last minute of the accident flight.

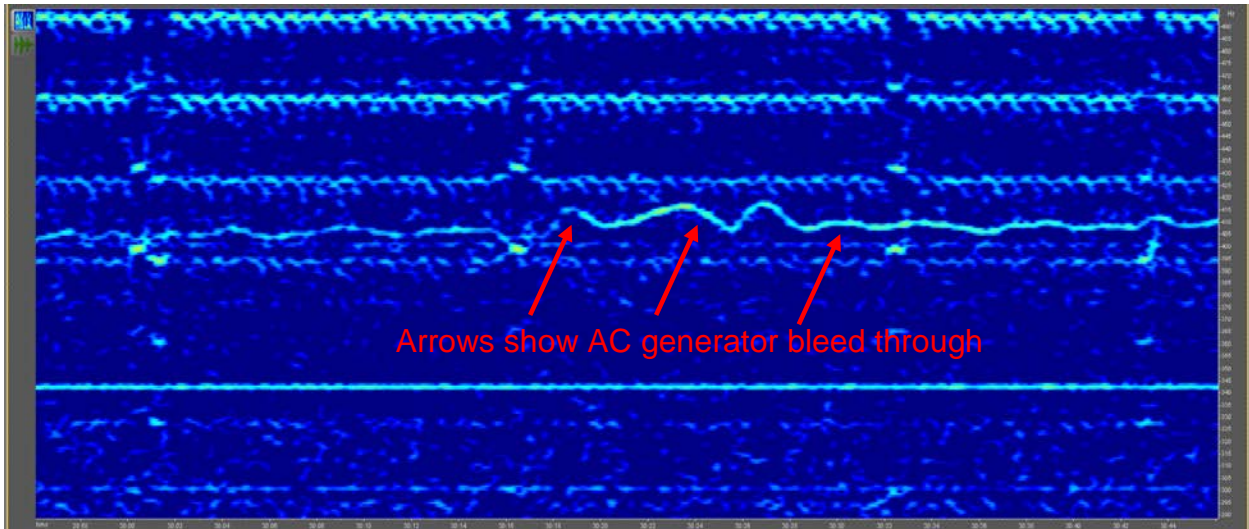
**Figure 7.** Spectrogram of AC generator bleed through during first rearward flight maneuver.

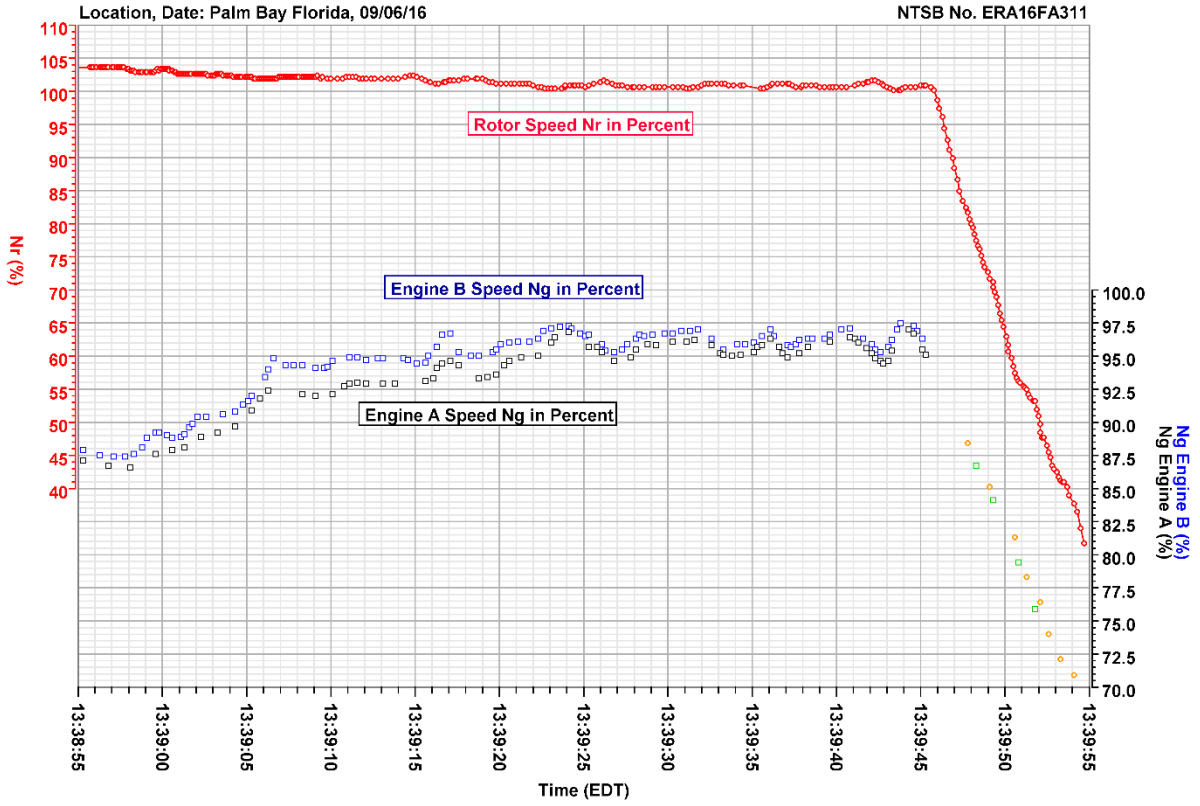
Figure 8 shows a plot of the conversion of the rotational frequencies into engineering units for the last minute of flight. It is not possible to determine which engine produced which Ng sound so they are labeled as Engine A and Engine B on the plot. Because the audio on the CAM channel was overdriven between 13:39:45.5 and 13:39:47.8, it was not possible to determine which trace corresponded with Engine A or Engine B for the points identified after the gap so the traces corresponding to Ng speeds are depicted in different colors. Figure 9 shows a similar plot for the first rearward flight maneuver. It is not possible to determine which engine produced which Ng sound so they are labeled as Engine A and Engine B on the plot. A comma separated value file (csv) containing the data used to generate the plots can be found in the public docket for this accident as Attachment 2 to the Group Chairman's Sound Spectrum Study.

Figure 8. Derived Ng and Nr speeds for last minute of flight. National Transportation Safety Board

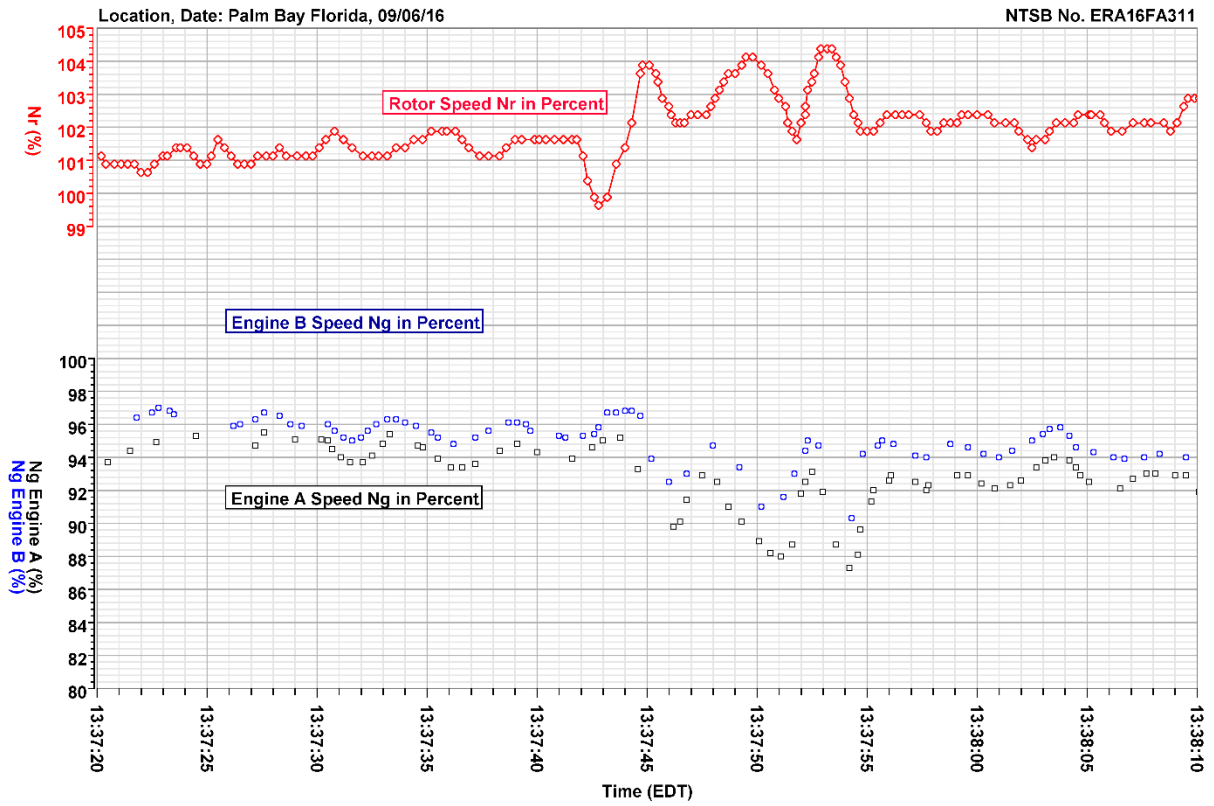
**Figure 9.** Derived Ng and Nr speeds for first rearward flight maneuver.
