NATIONAL TRANSPORTATION SAFETY BOARD

Sound Study

Addendum 1

| NTSB Number: | DCA15MR006 |

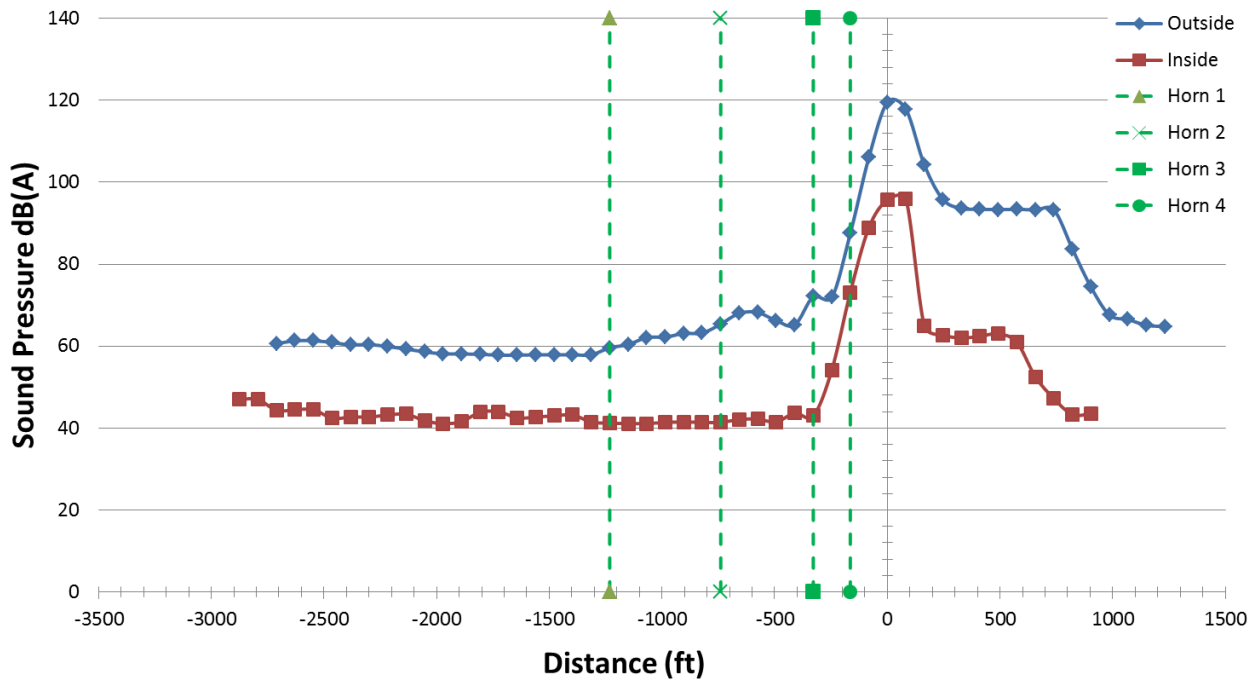
Figure 3. Summary of sound meter results from Test Point 1.

Figures 3 through 5 show the inside vehicle vs outside sound level meter readings during each test point taken on the west side of the track. Dashed lines denote where the horn was heard with respect to the recorded video. The x-axis shows time in eastern daylight time, while the y-axis shows weighted sound pressure in dB(A).

When looking solely at the inside vehicle sound level meter data, a consistent trend was noticed between all three test points. The data showed engine-idle ambient readings until the train was about 350 feet from the crossing, where the dB(A) increased rapidly to its maximum recorded dB(A). For test point 1 and 3, this was at the 3rd horn activation. Because test point 2 had a much later start to its horn cadence, this was around the 2nd horn activation, although comparatively, the rise began around the same distance.

When looking solely at the outside vehicle sound level meter data, all three test points showed a progressive rise in dB(A) after the first horn activation.

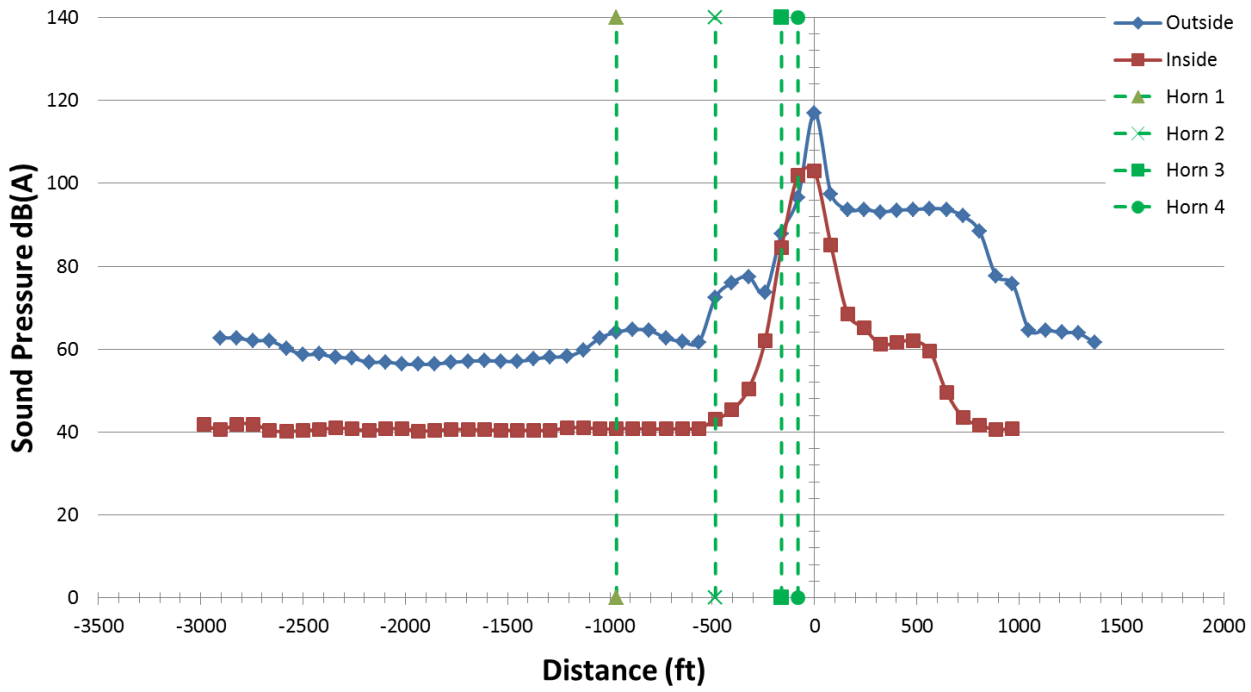
Figure 4. Summary of sound meter results from Test Point 2.

The horn was consistently applied at nearly the same distances for all three test points except for test point 2. Each horn activation of test point 2 occurred closer to the crossing when compared to the other test points.

Use of the horn was at the discretion of the train operator, a significantly shorter cadence was noticed in test point 2.

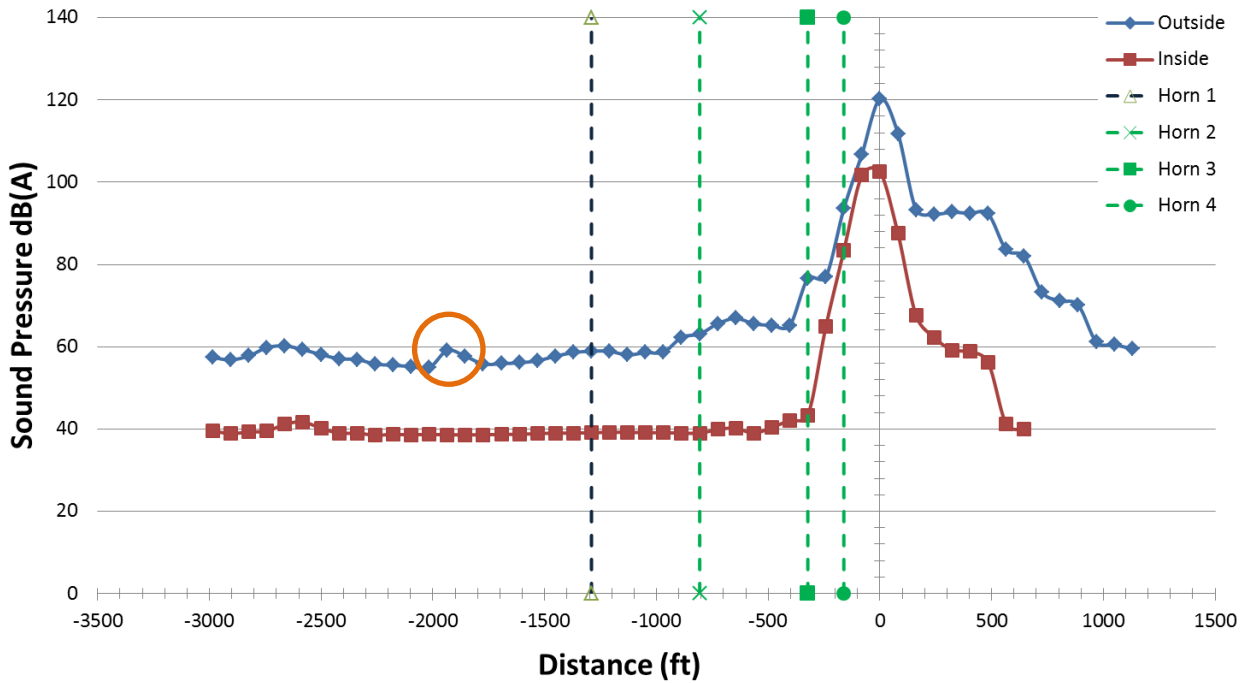
Figure 5. Summary of sound meter results from Test Point 3.

An orange circle denotes an increase in the ambient noise from passing vehicles during the test point.

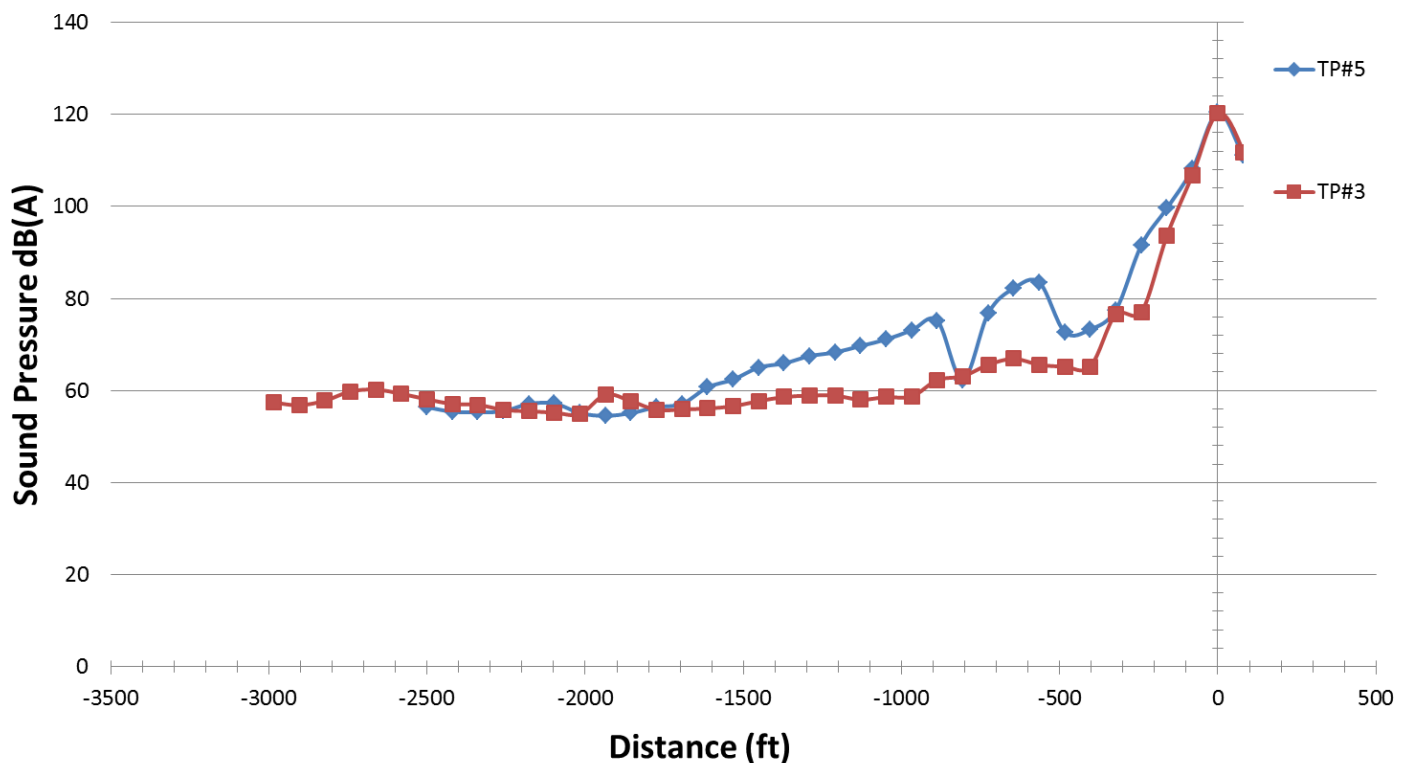
Figure 6. Test Point 3 vs Test Point 5.

Figure 6 compares the sound profile readings from test point 3 and test point 5 from the outside sound level meter. Test point 5 experienced a max dB(A) reading of 120.4. Both test points had a similar horn cadence that began about 1291 feet prior to the train passing the crossing.

Data from test point 5 plotted against test point 3 showed an earlier and more pronounced rise in dB(A) from the east side when compared to the west side. In order for a train horn to be effective, it must be 10 dB above ambient noise to attract attention. Therefore, it can be concluded that a train would have been audible earlier from the east side of the track vs the west side of the track with the substation. At 400 feet from the crossing, the plots merged to their respective max recorded dB(A) reading indicating no difference in audibility.⁴
