**NATIONAL TRANSPORTATION SAFETY BOARD**  
Vehicle Recorders Division  
Washington, D.C. 20594

**Video Study - ADDENDUM**

NTSB Accident Number:  
**DCA02MA001**

Location: Belle Harbor, NY  
Date: November 12, 2001  
Time: 9:16 a.m. Eastern Standard Time  
Aircraft: Airbus A300-600, N14053  
Operator: American Airlines

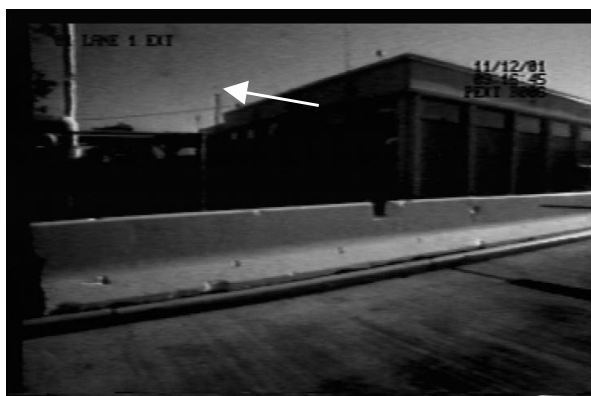
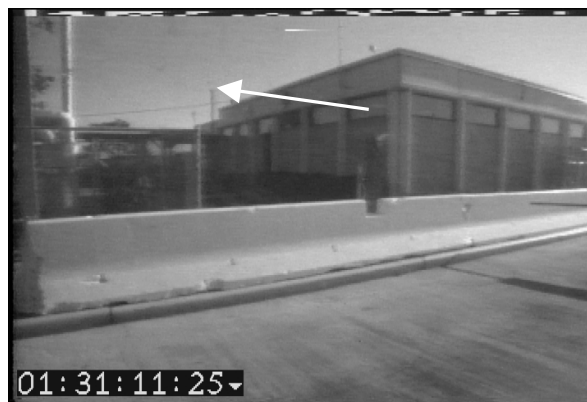
**Figure 1 – Comparison of images from Lane 1 Camera**

The original tapes were processed and reviewed in the NTSB Vehicle Recorder laboratory in Washington D.C. The original tapes provided higher quality images than those on the initially received copy tape, which were examined and used in the Video Study Report, dated April 2, 2002. The most apparent difference was in the brightness/contrast levels of the images. See Figures 1 and 2 below.

Figures 1 and 2 are provided as a comparison between the images that were extracted from the initially received copy tape and those extracted from the original tape, from two different camera views.

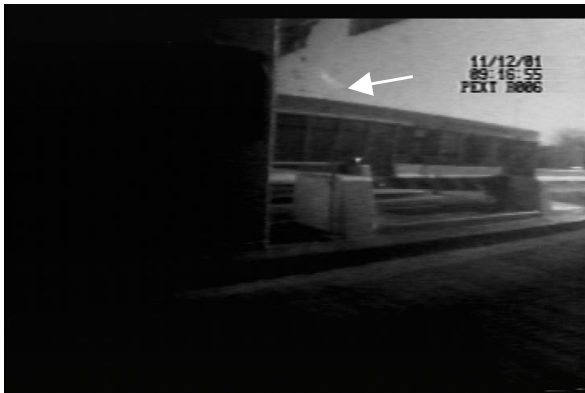
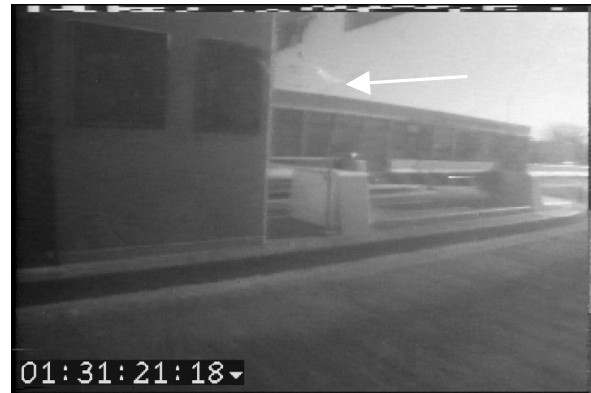
**Figure 2 – Comparison of Images from Lane 5 Camera**

The location of the airplane is indicated with a white arrow. The timecode in the lower left corner of the images from the original tape was added to each image after it was digitized in the computer. The format is in (hours):(minutes):(seconds):(frames):(field indicator). This timecode is an arbitrary elapsed time indicator used to mark each video field and does not reflect the time of day.

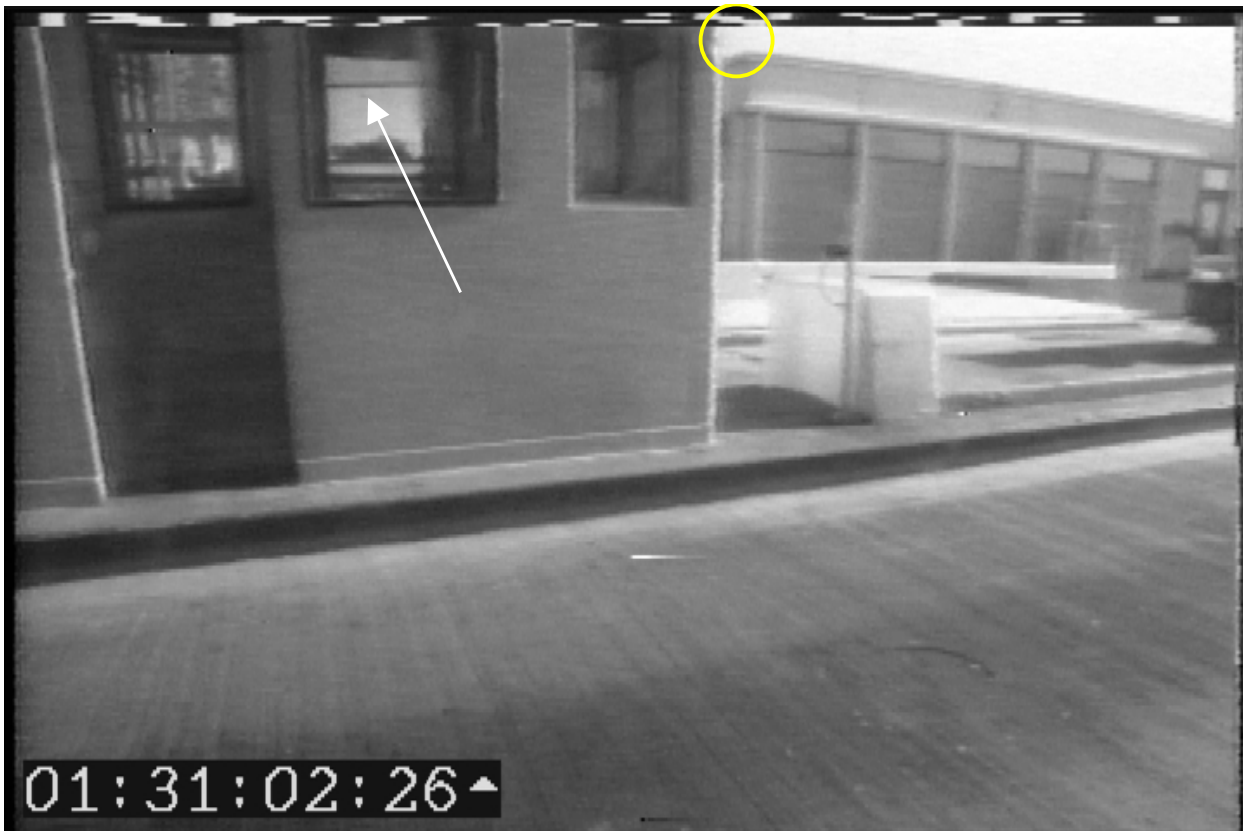
**Figure 3 – image extracted from additional camera view (Lane 3)**

Figure 3 is an image extracted from the original tape labeled “Multi B”, from a camera that was not included on the initially received copy tape. In this image, the airplane is visible through the window in the tollbooth, and is denoted by the white arrow. In the entire sequence of images from this camera, the airplane can be seen traveling from left to right at a slight upward angle as it traverses the width of the window frame, before it becomes obscured by the tollbooth. Later, the airplane can be seen for two to three successive images in the area denoted by the yellow circle, before it descends behind the building. Shortly thereafter, a small portion of the “streak”<sup>2</sup> can be seen along the roofline of the building. The camera is located in lane 3 of the toll plaza<sup>3</sup>.

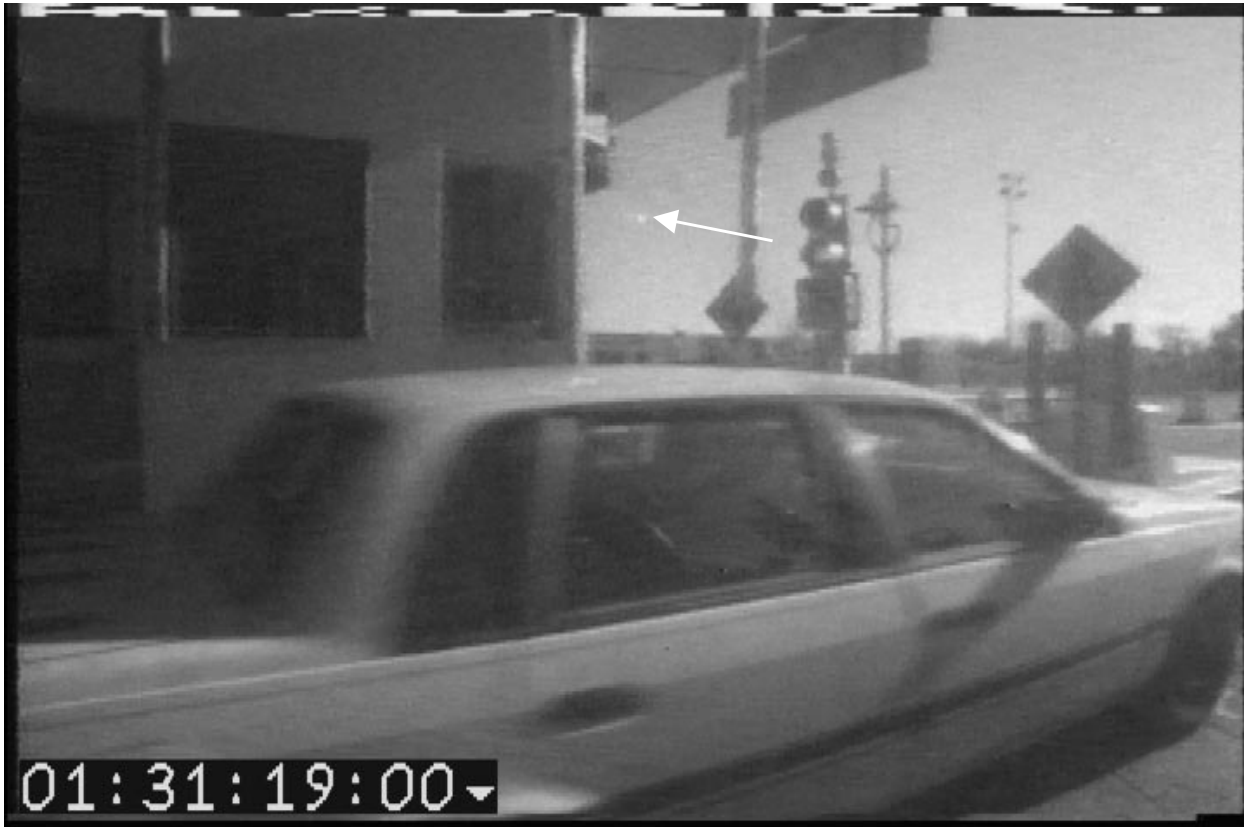
**Figure 4 - image extracted from additional camera view (Lane 13) at the start of the “streak”.**

Figure 4 is a still image extracted from the original tape labeled “Multi D”, from another camera located in Lane 14 of the toll plaza, that was not included on the initially received copy tape. The view from this camera is similar to the one from Lane 5. In this camera view, the airplane travels from left to right and is descending. Like the view from Lane 5, the streak can be seen trailing behind the airplane as it descends. This camera is located in lane 13 of the toll plaza.

Review of the original recording revealed a newly discovered camera view from Lane 13 (Figure 4 above). In the initial copy tape, the airplane was last seen as it descended behind a building in the Lane 5 camera view. In newly discovered Lane 13 view, the airplane is visible for about 1 ½ to 2 additional seconds before it is obscured by a traffic light in the foreground. See Figure 8 below.

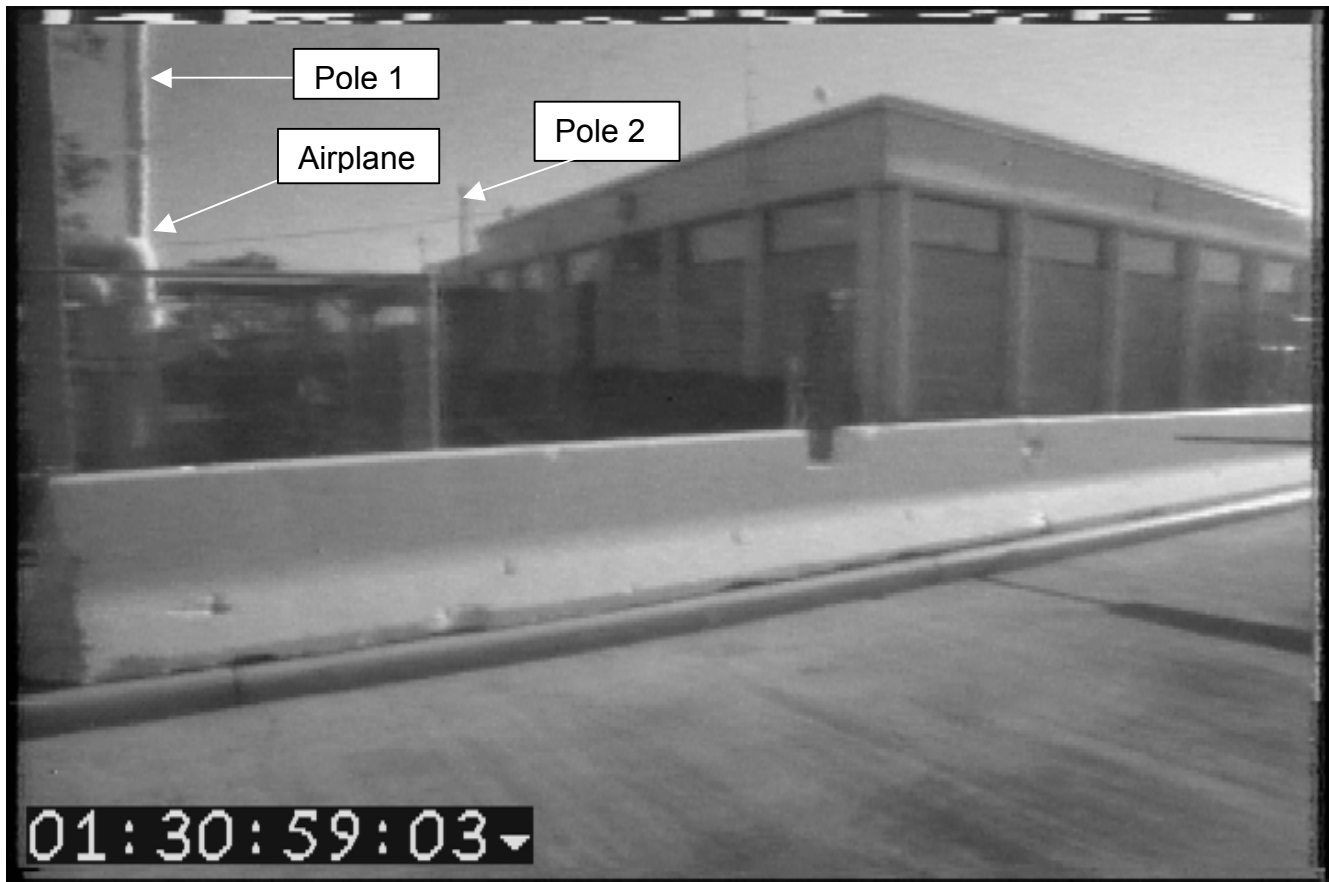
**Figure 5 – First time the airplane is in view in the *original recording* (view from Lane 1)**

Figure 5 is the first image in which the airplane is visible on the *original recording*. It is just emerging from behind Pole 1 in the view from Lane 1 at this time. In comparison, Figure 5a below is the first image in which the airplane is in view on the *initially received copy tape*.

Figure 7 is the first image available on the initially received copy tape after the period of noise/distortion ends. Comparing Figure 7 to Figure 5, the airplane can first be seen about 9 ½ seconds earlier on the original recording (in Figure 5), as it emerges from behind Pole 1. (see the Video Study Report, Page 8, figure 3 for landmark references).

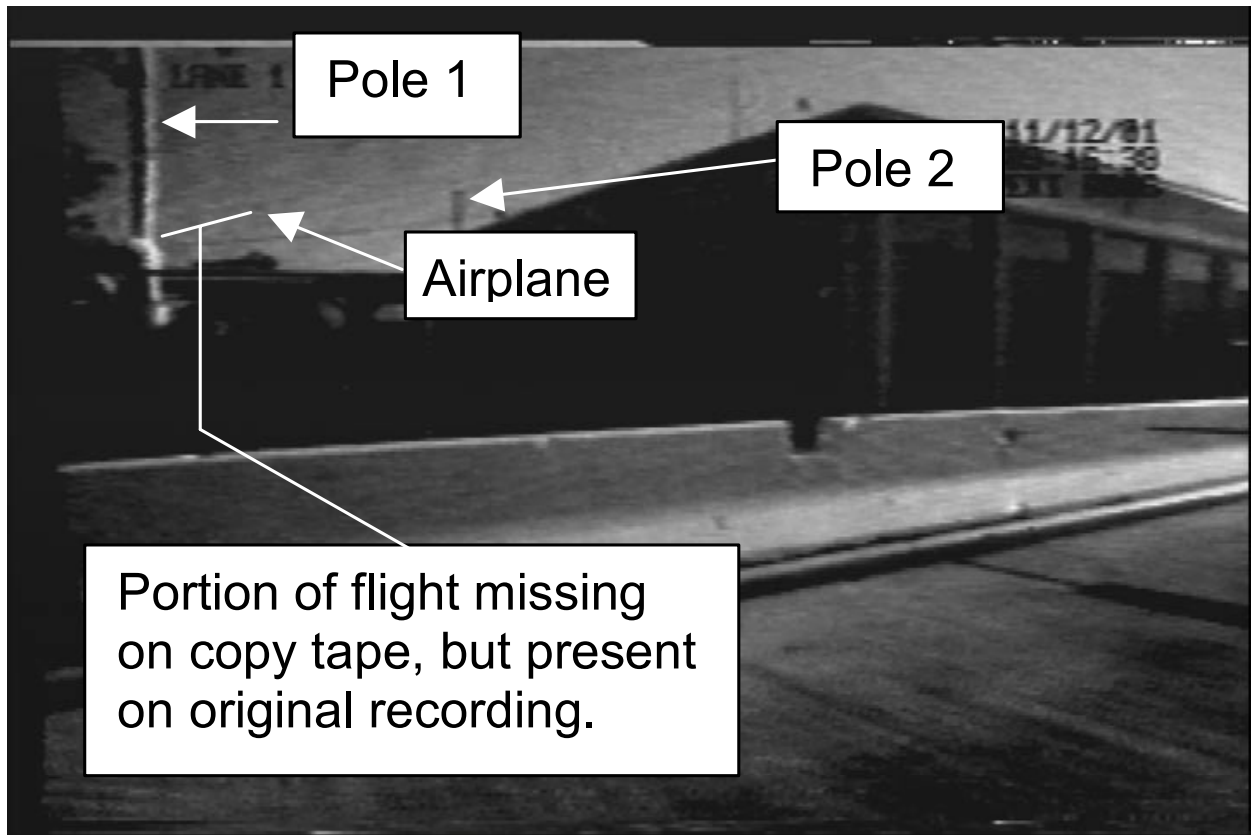
**Figure 5a – First image recovered from *initially received copy tape* (view from Lane 1)**

Figure 5a is the first image present on the initially received copy tape. The airplane is traveling from left to right in the view, and is already about 1/3 of the way between Pole 1 and Pole 2.

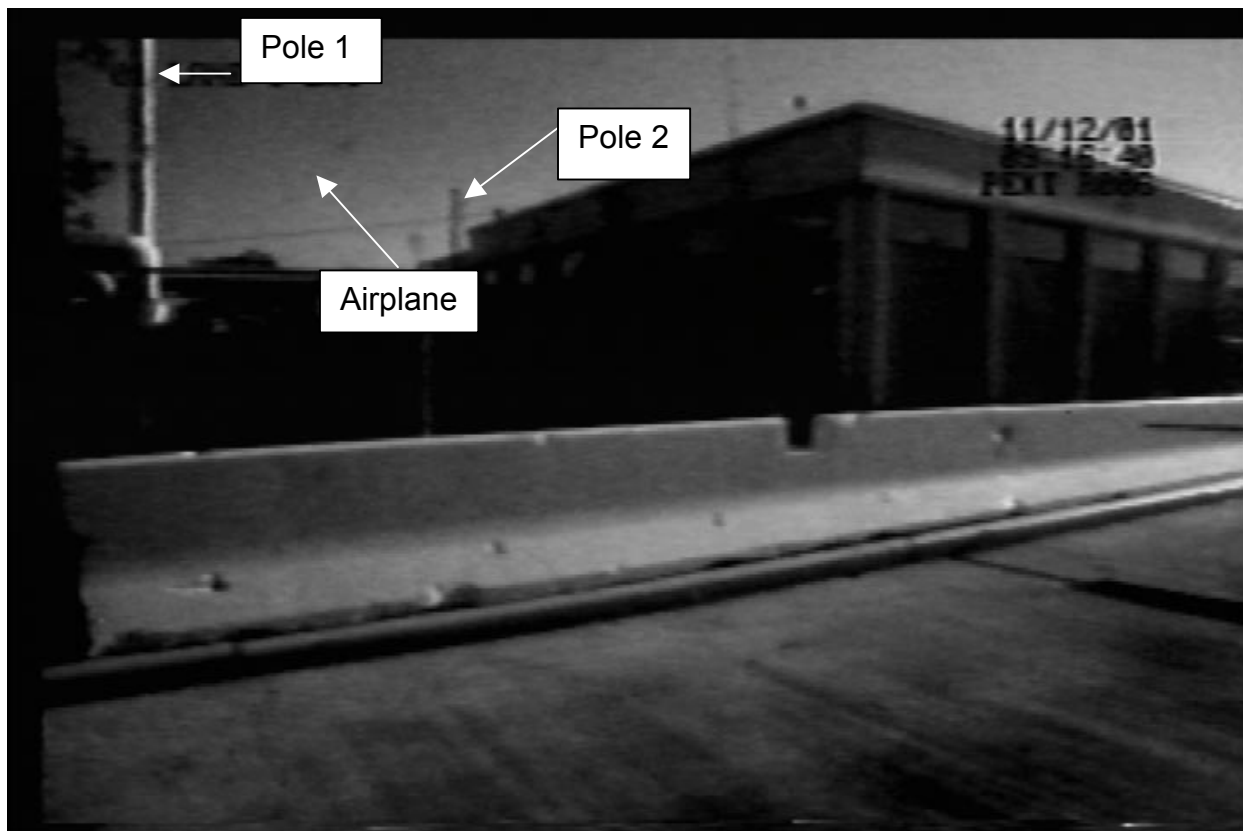
**Figure 7 – First image after the noise/distortion ceases on the initially received copy tape (view from Lane 1)**

After the 2 seconds of distortion, the airplane then becomes visible again, and is about  $\frac{1}{2}$  of the way between Pole 1 and Pole 2. See Figure 7 below.

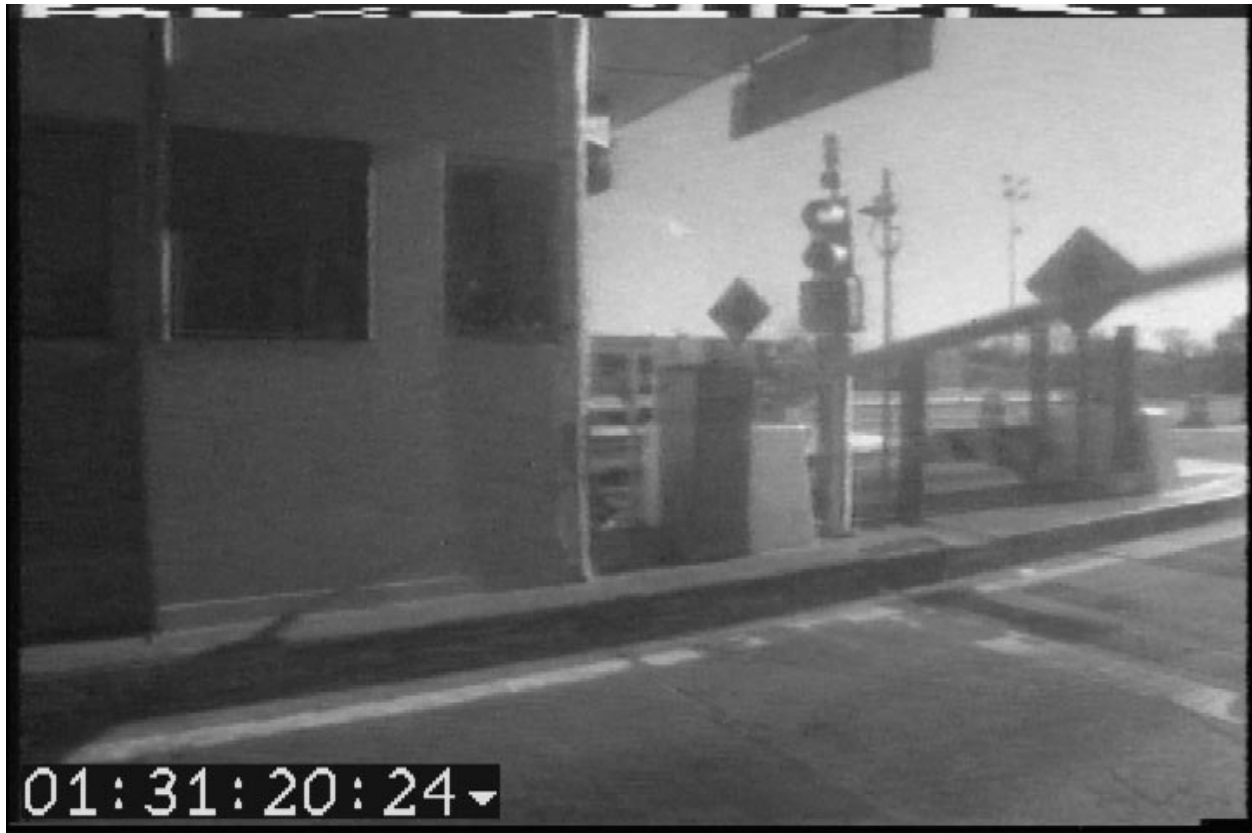
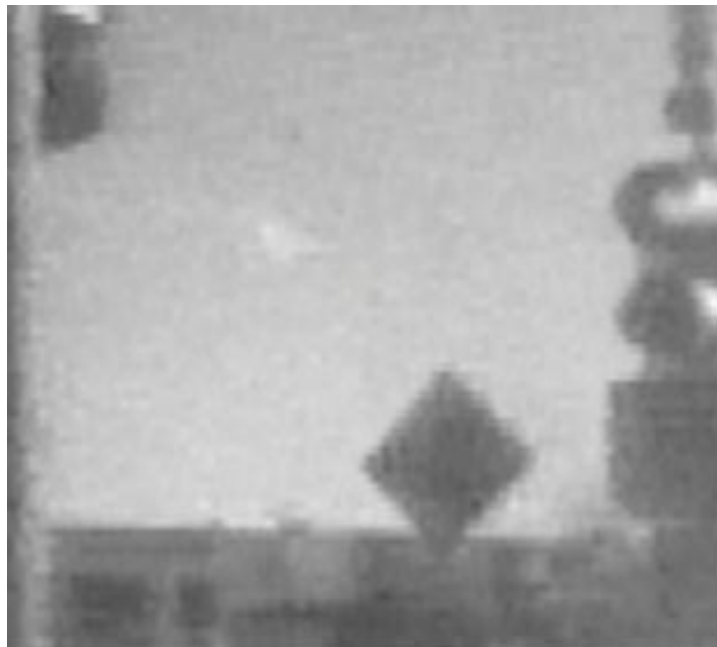
**Figure 9 - image extracted from additional camera view (Lane 13)**

The review of the original tapes, including the additional camera views and the increased duration of time during which the airplane was visible, did not reveal any new information that would affect the results previously set forth in the Video Study. One of the newly discovered camera views (Lane 13 view) provides a somewhat 'better' view of the streak than did the Lane 5 view from the initially received copy tape. The start of the streak is more defined in terms of the contrast difference between the streak and the background of the sky (as seen in Figure 4). Further, as the streak initially develops, it briefly appears as if it may be forming a bifurcation (see figures 9, 9a, and 9b below).

**Figure 9a – 200% zoom /crop of image in Figure 9**

**Figure 9b – same image as figure 9a, with streak shape outlined in yellow**
