Subj: POST SINKING INVESTIGATIVE STABILITY ANALYSIS OF THE F/V  
DESTINATION, O.N. 632374

**USCG MARINE SAFETY CENTER POST SINKING  
STABILITY ANALYSIS OF F/V DESTINATION**

**February 9, 2018**

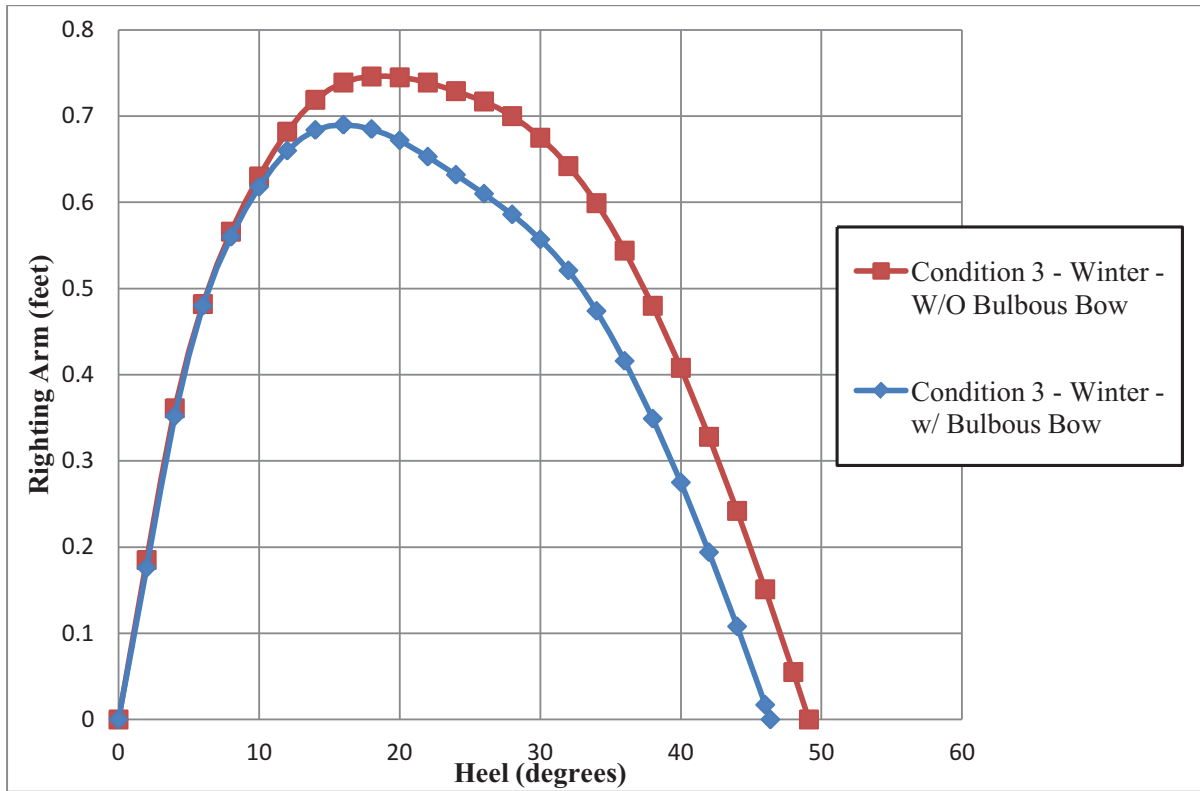
**Figure (4): Comparison of Righting Arm Curves and Stability Criteria for Bulbous Bow Addition**

In general, our results showed the bulbous bow reduced the righting arm values and provided no additional benefit to the vessel's stability as all stability criteria results further decreased. Figure 4 below compares the righting arm curves of the winter loading condition 3 from reference (b) with and without the bulbous bow appendage.

Limits from 170.173 (c)	Required	Attained Condition 3 w/o Bulbous Bow	Attained Condition 3 w/ Bulbous Bow
Initial Metacentric Height (GM)	> 0.49 ft	5.29	5.02
Angle of Maximum Righting Arm	> 15°	18.00	16.00
Area up to 40° or Downflood Angle	> 16.9 ft-deg	23.79	21.05
Area between 30° and 40°	> 5.6 ft-deg	5.62	4.35
Area at Max Righting Arm	> 12.54 ft-deg	9.49	7.76

While reference (c) states that stability is negligibly reduced and that the owner “should be totally safe to operate the vessel in accordance with the current booklet,” our analysis shows eight out of the ten loading conditions do not meet the intact stability criteria. Most typically, the vessel fails to meet the righting energy requirement of 46 CFR 28.570(a)(7) and 46 CFR 170.173(c)(5).

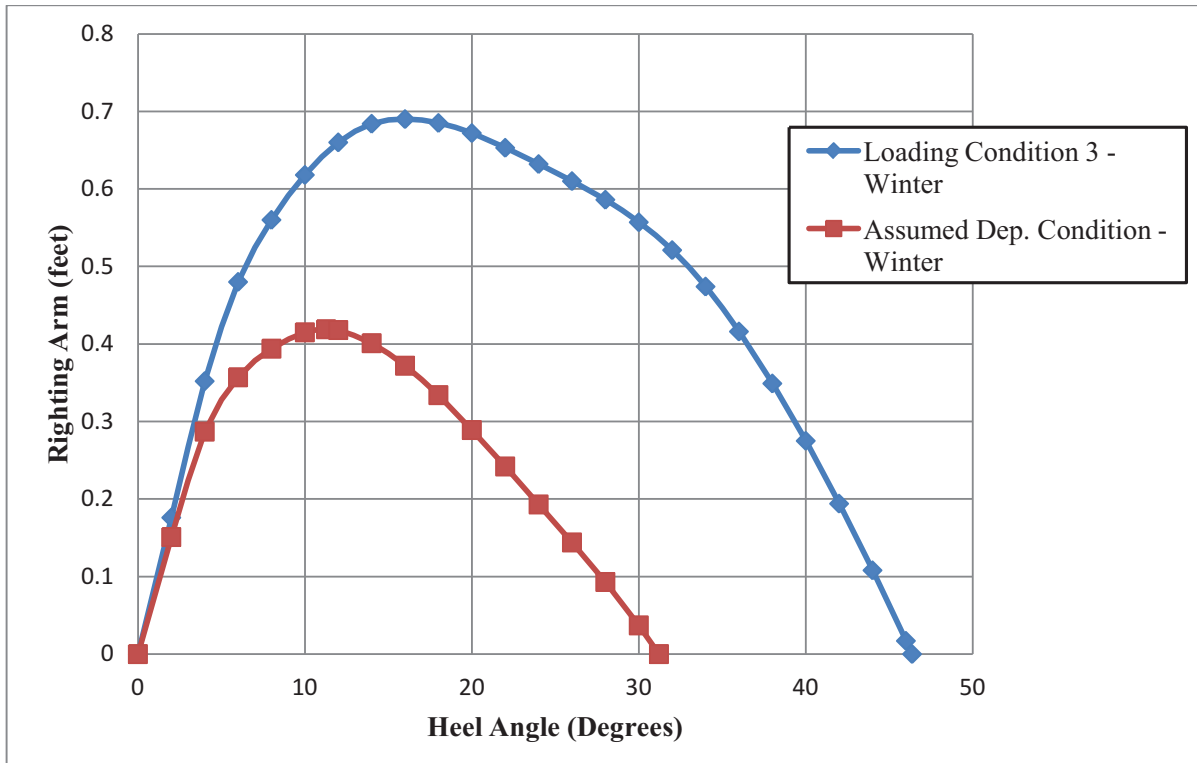
**Figure (5): Righting Arm Curves and Stability Criteria for Assumed Departure Loading Condition - Winter**

As previously presented, our analysis indicates that the winter loading condition number 3 failed to meet the stability requirements in 46 CFR 28.570 with the exception of the initial metacentric height (GM) criteria. Therefore, as we anticipated, our analysis of this modified loading condition shows that the DESTINATION failed to meet any of the intact stability requirements in 46 CFR 28.570 with the exception of the initial metacentric height (GM) criteria. Figure (5) below compares the righting arm curves for the assumed departure condition versus the loading condition 3 winter from reference (b) using our hull model.

Limit	Required	Attained Condition 3 - Winter	Attained Assumed Dep. Condition
Initial Metacentric Height (GM)	> 0.49 ft	5.02	4.32
Angle of Maximum Righting Arm	> 15°	16.00	11.27
Area up to 40° or Downflood Angle	> 16.9 ft-deg	21.05	8.27
Area between 30° and 40°	> 5.6 ft-deg	4.35	0.02
Area at Max Righting Arm	> 12.92 ft-deg	7.76	3.34

As noted above, the assumed loading condition of reference (e) does not correspond directly to an examined loading condition in reference (b). Both of these curves account for 1.3 inches on all horizontal surfaces and 0.65 inches on all vertical surfaces. In accordance with 46 CFR 28.530(b), each vessel must be provided with loading constraints and operating restrictions which maintain the vessel in a condition meeting all applicable stability requirements, as developed by a qualified individual. If the operators failed to load the vessel in accordance with the stability instructions, it is the responsibility of the owner/operator to contact the qualified individual to receive additional guidance.

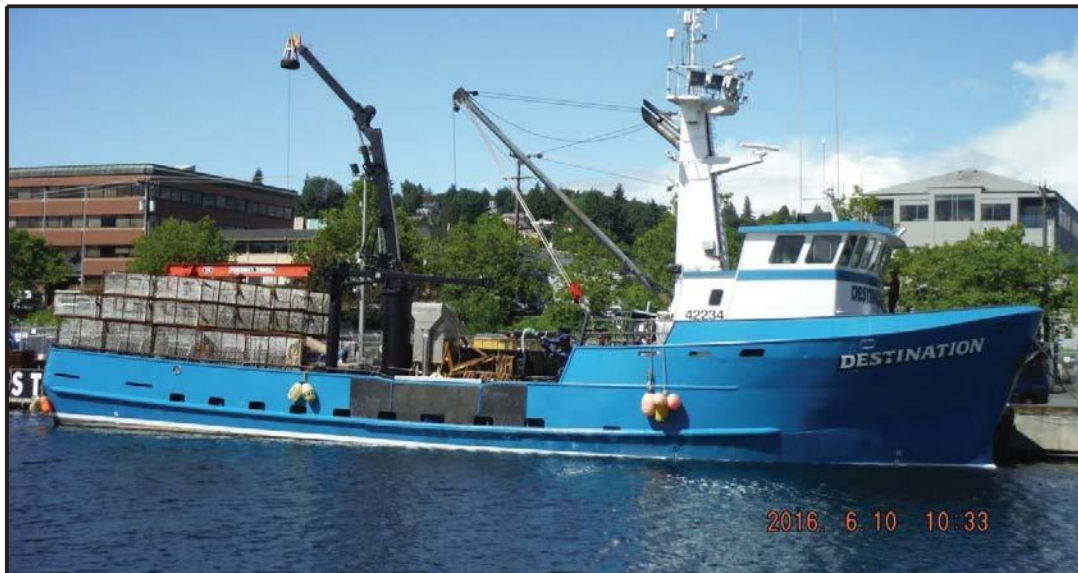
**Figure (6): Starboard Profile Showing 9 Freeing Ports**

As shown in figure (6) below, the vessel had nine freeing ports on each side. Reference (a) indicates that each had an estimated area of 120 in<sup>2</sup> resulting in a total freeing port area on either side of the vessel of 1,080 in<sup>2</sup>. For a vessel with a bulwark length of 72 feet, in accordance with 46 CFR 28.555(d), the required freeing port area per side is 2,390 in<sup>2</sup> (16.6 ft<sup>2</sup>). The required freeing port area far exceeds the actual freeing port area (1,080 in<sup>2</sup>). Additionally, the port side of the DESTINATION had a raised shelter bulwark from the deckhouse to the midship crane. Per 46 CFR 28.555(e), this would increase the required freeing port area on the port side by an additional 550 in<sup>2</sup>.

Figure (6) shows the starboard profile with the nine freeing ports. A vessel with insufficient freeing port area would likely result in more seawater becoming trapped on the main deck in foul weather. This water would add additional weight to the vessel, raise the vessel's overall vertical center of gravity (VCG), and increase the free surface moment acting on the vessel as the water flows side to side. These factors would negatively impact the vessel's intact stability.

MSC analyzed the required freeing ports on the vessel, and, assuming that the nine freeing ports on each side of the vessel each had an area of 120 in<sup>2</sup>, the vessel failed to meeting the minimum freeing port area required by 46 CFR 28.555.

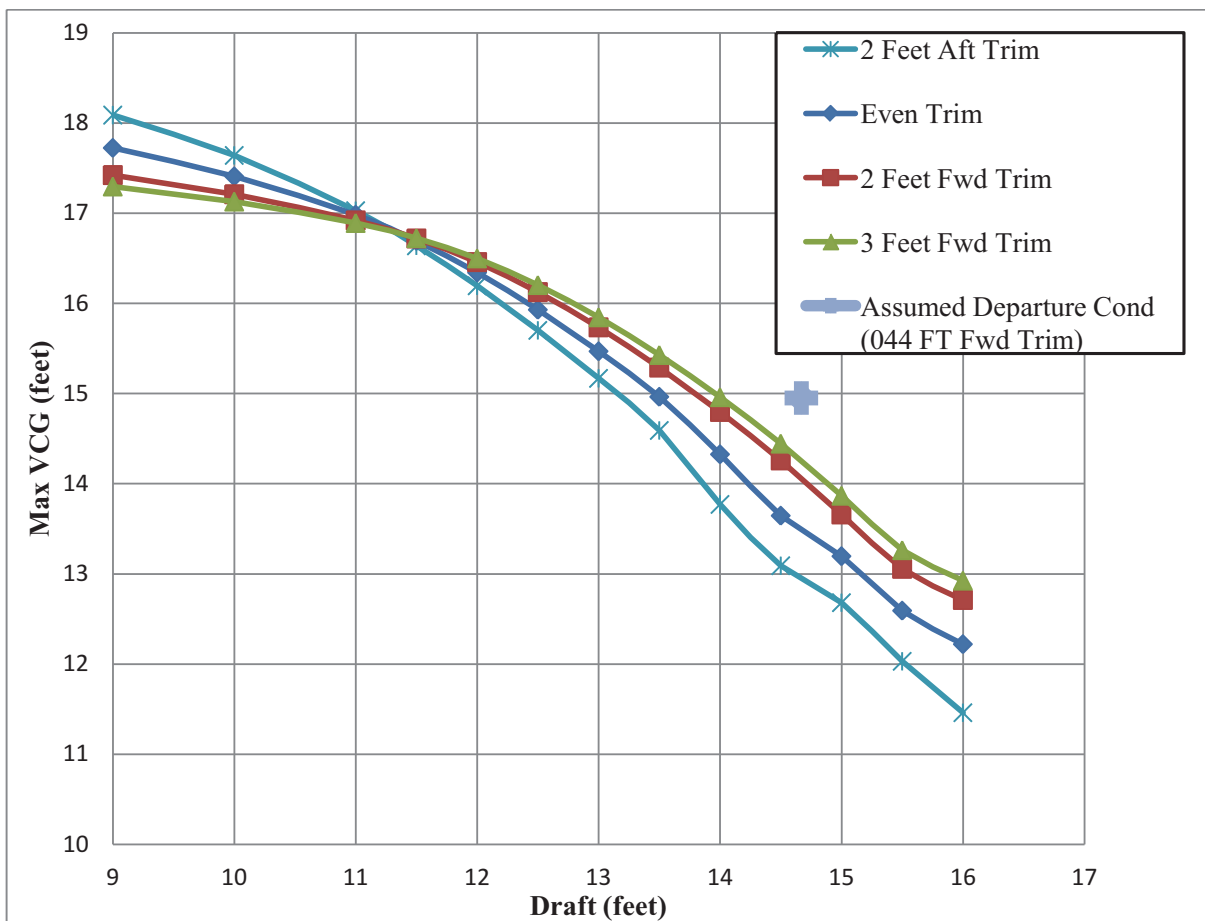
Figure (7): Maximum VCG Curves for Various Trims (46 CFR 170.173 Criteria)

Using GHS, we analyzed the maximum VCG curves at varying drafts and trims. The results are displayed below for the 46 CFR 170.173(c) stability criteria. As the drafts and displacements increase, the maximum VCG for which the vessel passes the applicable stability criteria decreases. A point representing the assumed departure condition from reference (e) is plotted on Figure 7. The assumed departure condition point clearly falls outside the maximum VCG curves. Our calculations indicate that a trim of 6 feet forward or greater would be required to allow the vessel to pass the stability criteria given the assumed loading condition VCG and draft. This draft is well outside the normal operating trims in which the vessel would have been operating.

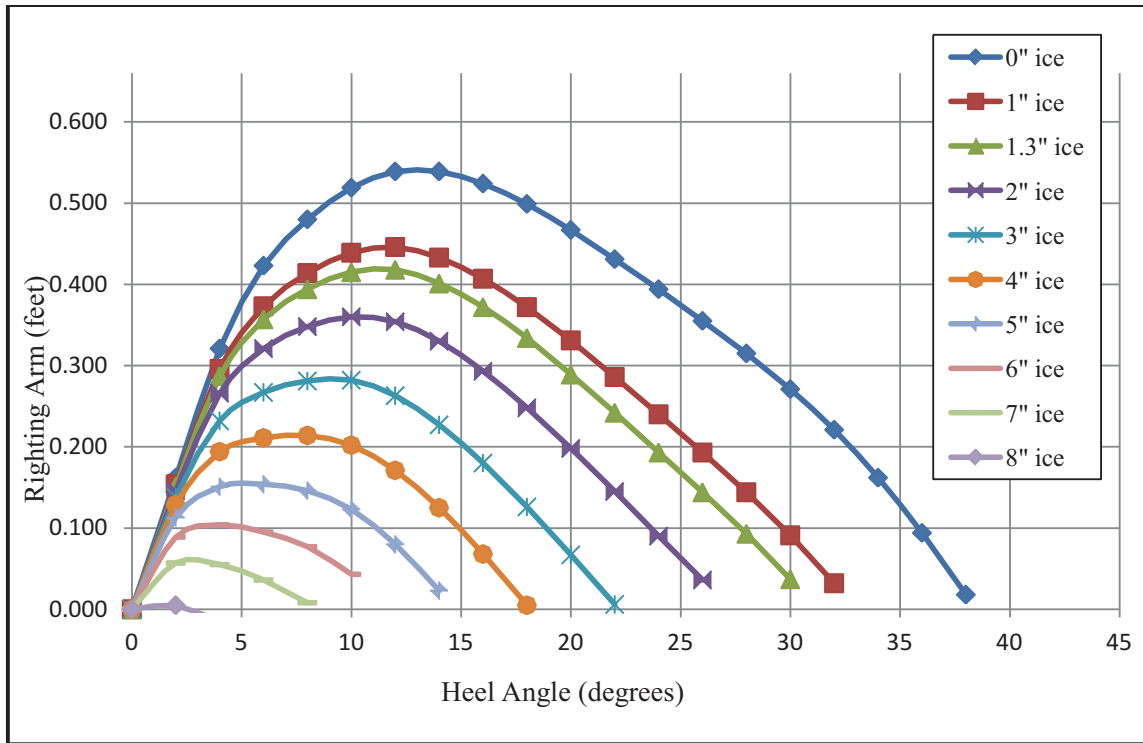
**Figure (8): Righting Arm Curves for Incremental Ice Loads**

We analyzed the assumed departure loading condition provided in reference (e) with increments of icing ranging from 1 - 12 inches. The respective righting arm curves are

shown below in Figure (8) for icing loads ranging from 0 – 8 inches. Ice loads greater than 9 inches are not shown, as they resulted in negative initial metacentric heights.

In general, and as demonstrated above, icing weight would impair stability as icing equates to weight addition up high on the vessel. Our analysis showed no icing load conditions passed the intact stability criteria with the exception of the required initial GM. In our analysis, we used the center of gravities provided in reference (b) for all increments.

MSC analyzed the DESTINATION applying incremental icing loads up to 8 inches. Our analysis showed that none of the icing load conditions passed the intact stability criteria, with the exception of the initial GM criteria. Ice loads greater than eight inches resulted in negative initial GM. In general, icing weight would impair stability as icing equates to weight addition up high on the vessel.

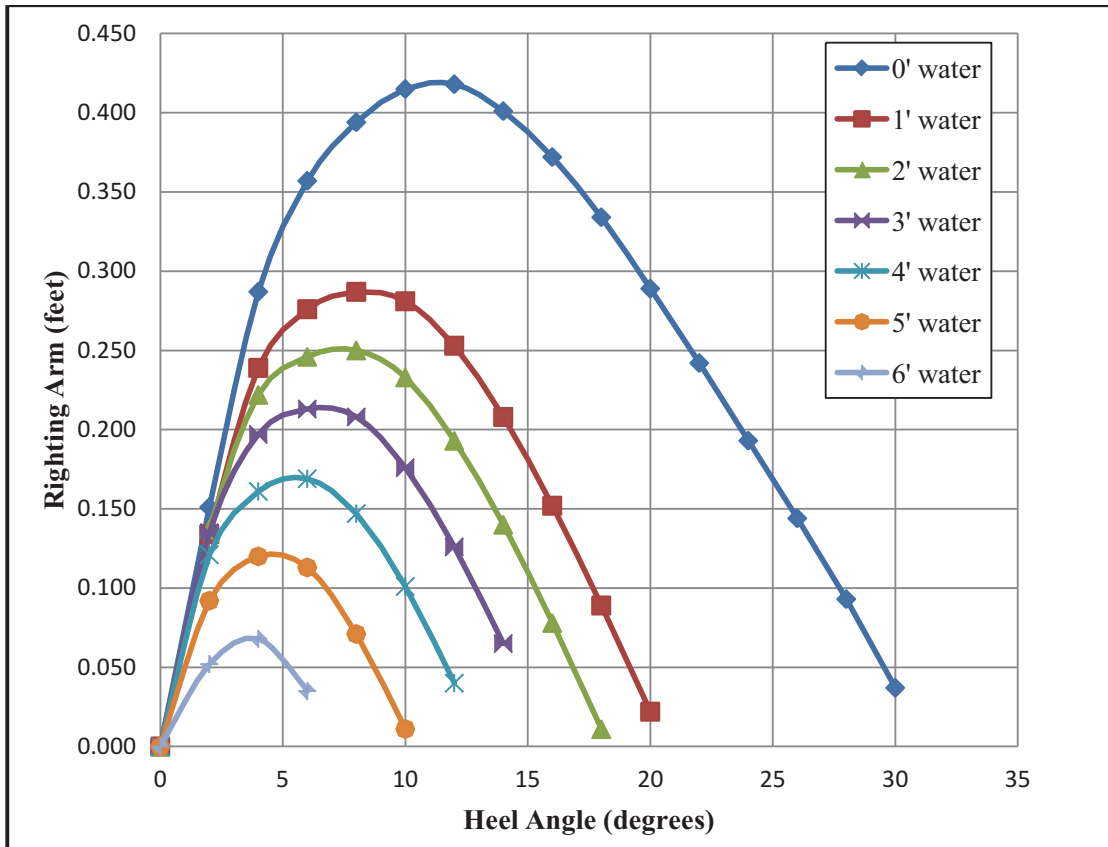
**Figure (9): Righting Arm Curves for Incremental Filling of No. 3 RSW Hold**

It was reported that the vessel would operate with the #3 RSW Hold deck hatch left open, prompting the request for the analysis of water in the hold. We analyzed the assumed departure loading condition provided in reference (e) with incremental levels of salt water in the No. 3 hold ranging from 0 – 6 feet. The respective righting arm curves are shown below in Figure (9).

Hold #3 levels greater than 6 feet resulted in negative initial metacentric heights. The maximum sounding of Hold No. 3 per reference (b) is 9.75 feet. Again, our analysis of these incremental levels of salt water in Hold No. 3 using the assumed departure condition as a baseline, shows that the DESTINATION failed to meet any of the intact stability requirements in 46 CFR 28.570 with the exception of the required initial GM. In general, allowing the #3 Hold to be partially filled would impair stability by increasing the free surface effect and increasing the vessel’s aft draft.

We analyzed the DESTINATION applying incremental levels of salt water in the No. 3 RSW Hold up to 6 feet. Again, our analysis of these incremental levels of salt water in the

Hold No. 3 using the assumed departure condition as a baseline, shows that the DESTINATION failing to meet any of the intact stability requirements in 46 CFR 28.570, with the exception of the initial GM criteria.
