NATIONAL TRANSPORTATION SAFETY BOARD
Office of Aviation Safety
Washington, D.C. 20594
January 14, 2016

Group Chairman's Factual Report

STRUCTURES

CEN16FA036

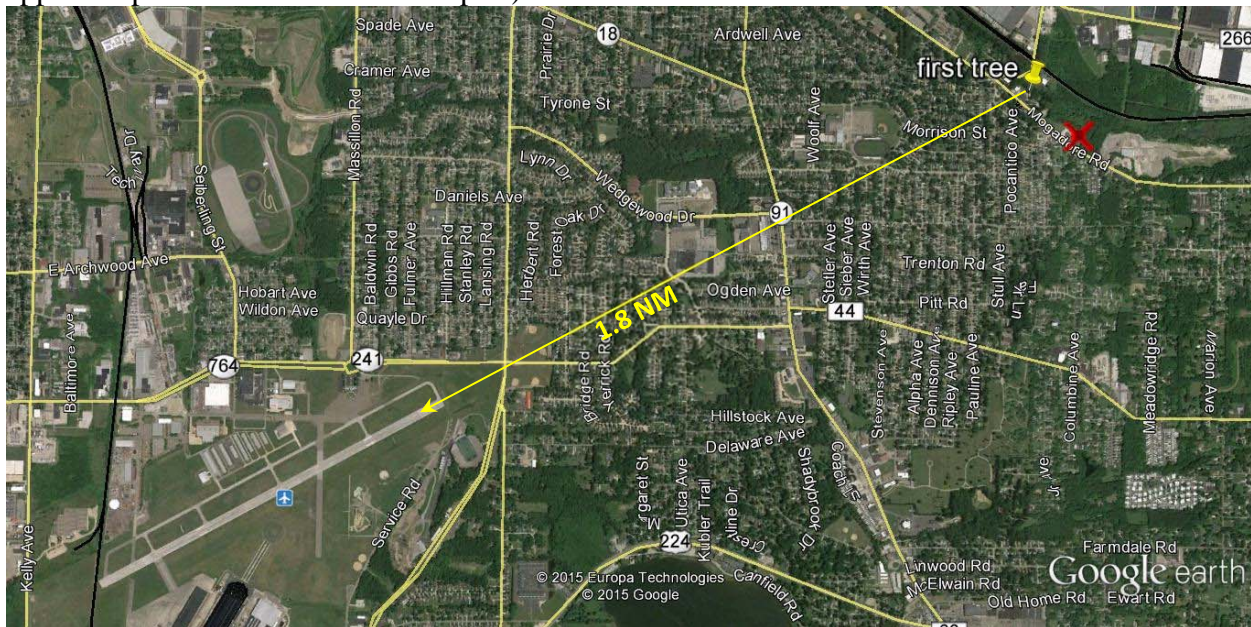
Survey of the wreckage site revealed that the airplane first impacted tree branches approximately 55 feet up on a tree located about 1.8 nautical miles (NM) from the runway 25 threshold at Akron Fulton International airport (as shown in Figure 1). The tree was (laterally) very close to the extended runway centerline as shown with the approach overlay in Figure 2. The tree and the wreckage were located approximately halfway between the airport and the locator outer marker (LOM) and final approach fix (i.e., “AK” and the Maltese cross on the approach plate 3.7 NM from the airport)

Figure 1 - Location of Initial Tree Strike Relative to Akron Fulton International Airport

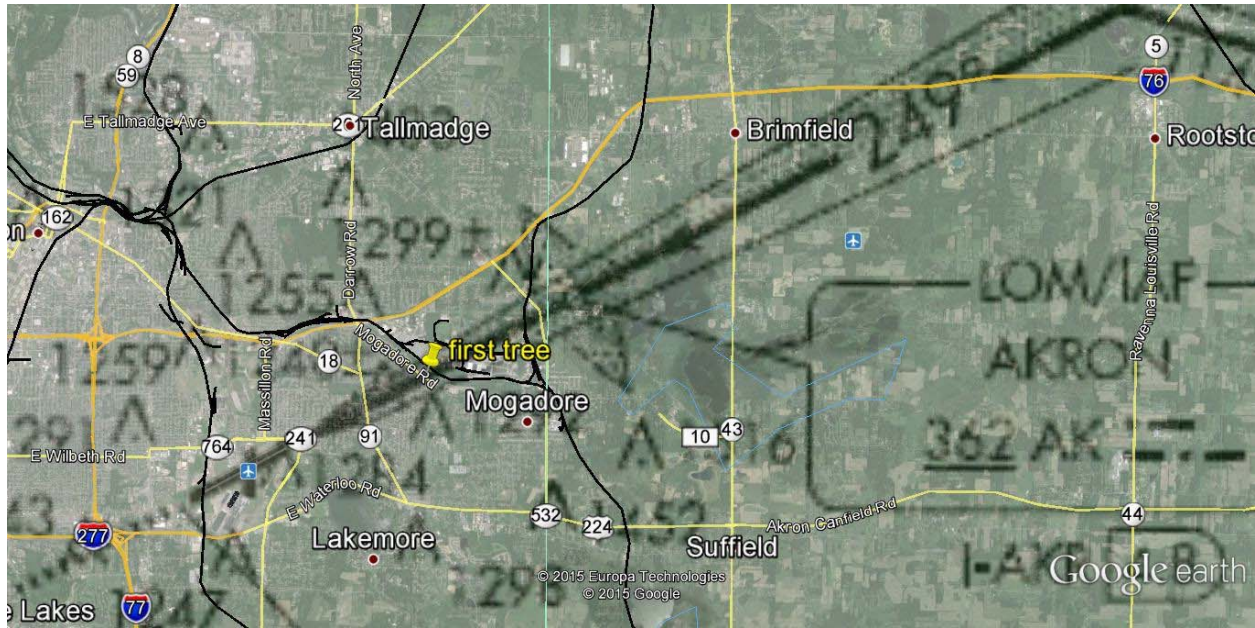
Figure 2 - Location of Initial Tree Strike with AKR LOC Runway 25 Overlay: Halfway Between the Runway and the Final Approach Fix

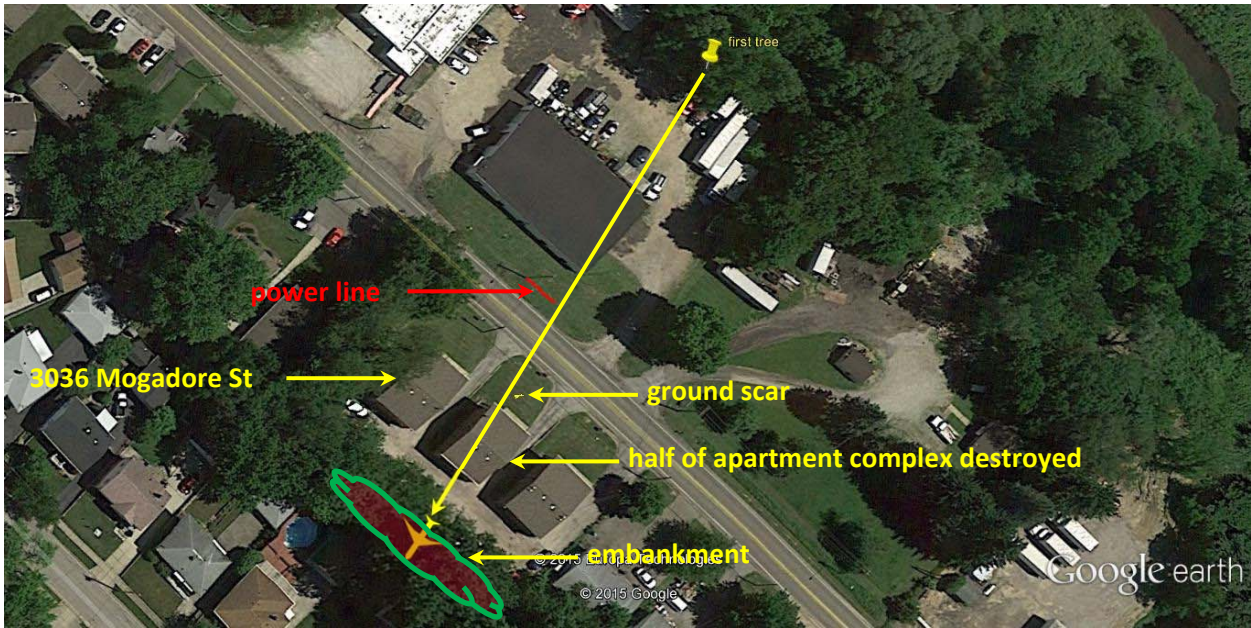
Figure 3 shows a more detailed overview of the accident site with select landmarks and features. After striking the tree branches, the airplane hit power lines adjacent Mogadore Street before banking sharply left and traveling through the middle of three apartment “duplex” buildings. Several ground scars were identified in the front yard of the residence that was struck by the airplane (Figure 4). The left aileron mass balance weight, two sections of the left aileron and an outboard portion of the left wing including the mating outboard wing to aileron hinge fitting were located in the front yard in the area of the ground scarring (Figure 5). After traveling through the right hand side of the duplex the airplane came to rest on an embankment located behind the apartments. While most of the wreckage was consumed by fire, all “four corners” of the airplane were located between the front yard and the airplane’s final location on the embankment. No airplane structure was located along the flight path prior to the first pieces of structure identified in the front yard.

Figure 3 - Overview of Accident Site with Select Features

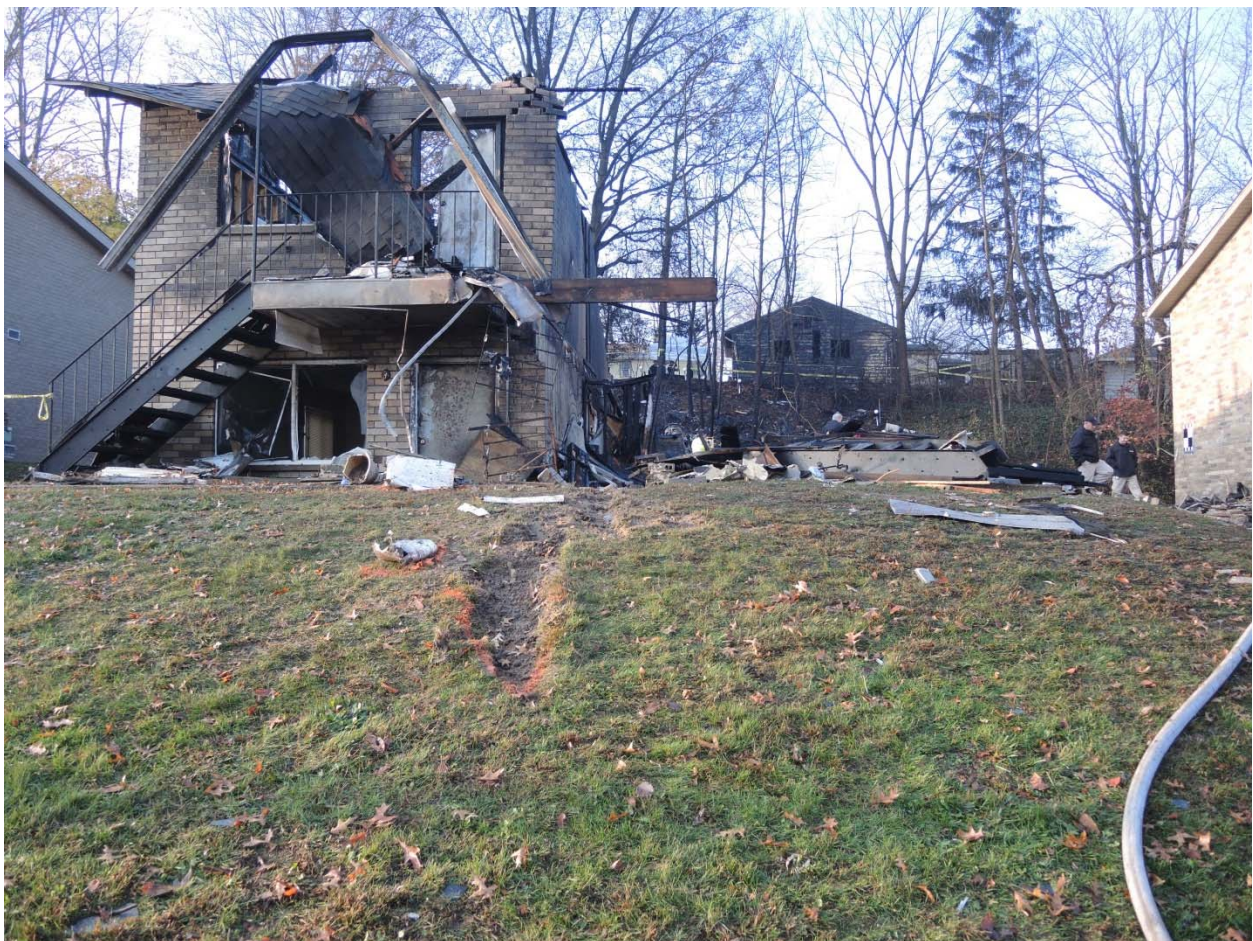
Figure 4 – Front yard ground scars

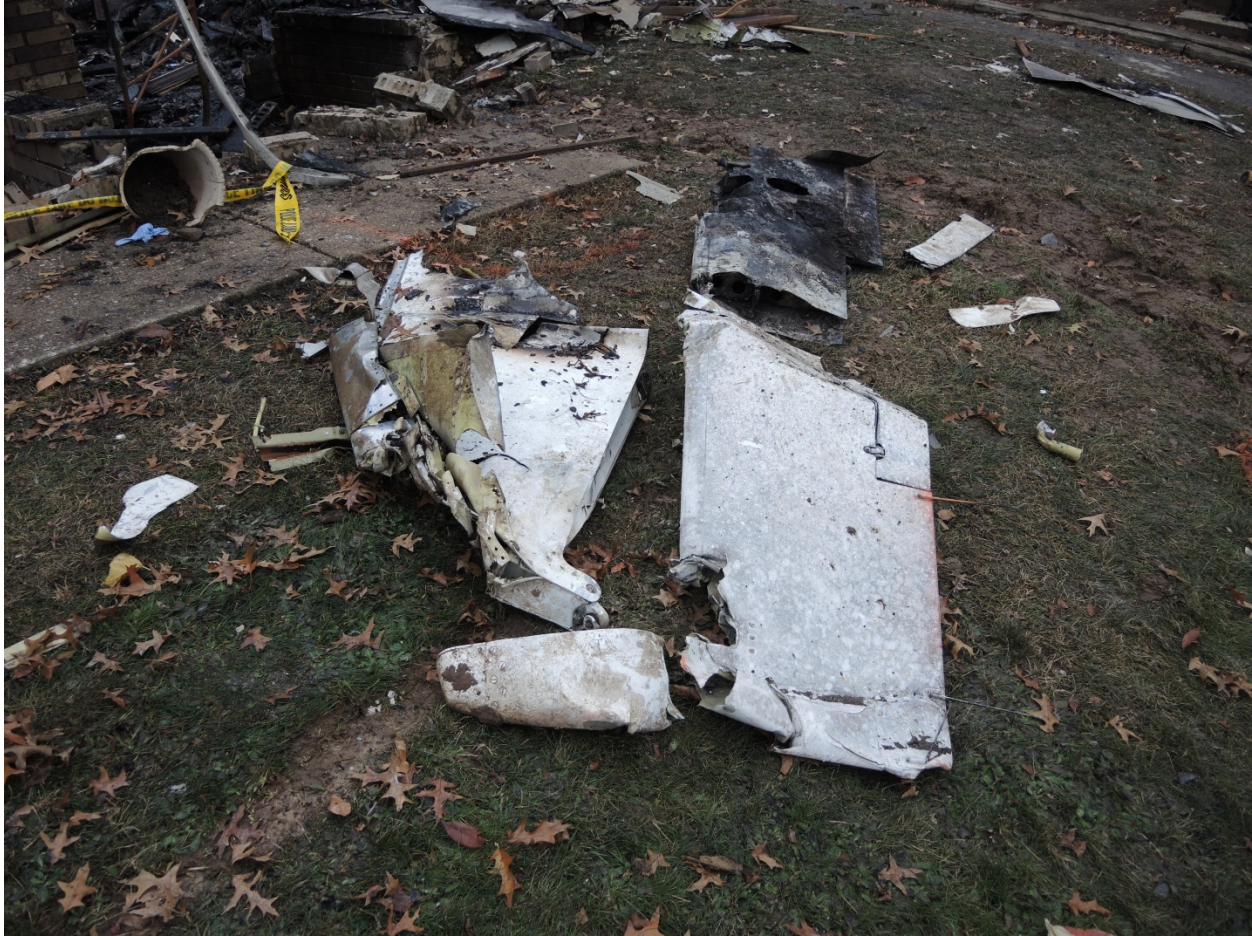
Figure 6 – Left aileron, aileron mass balance weight and outboard left wing

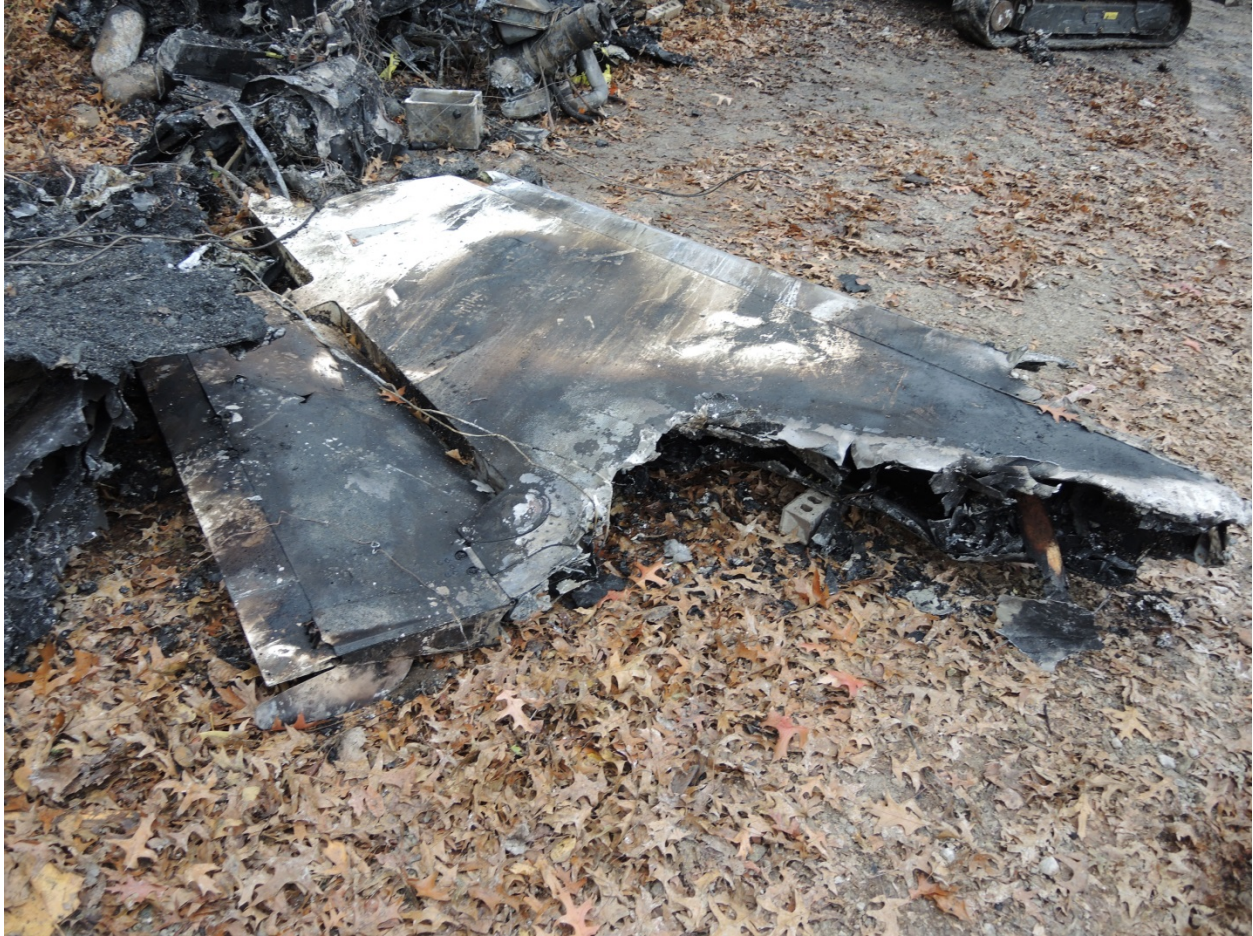
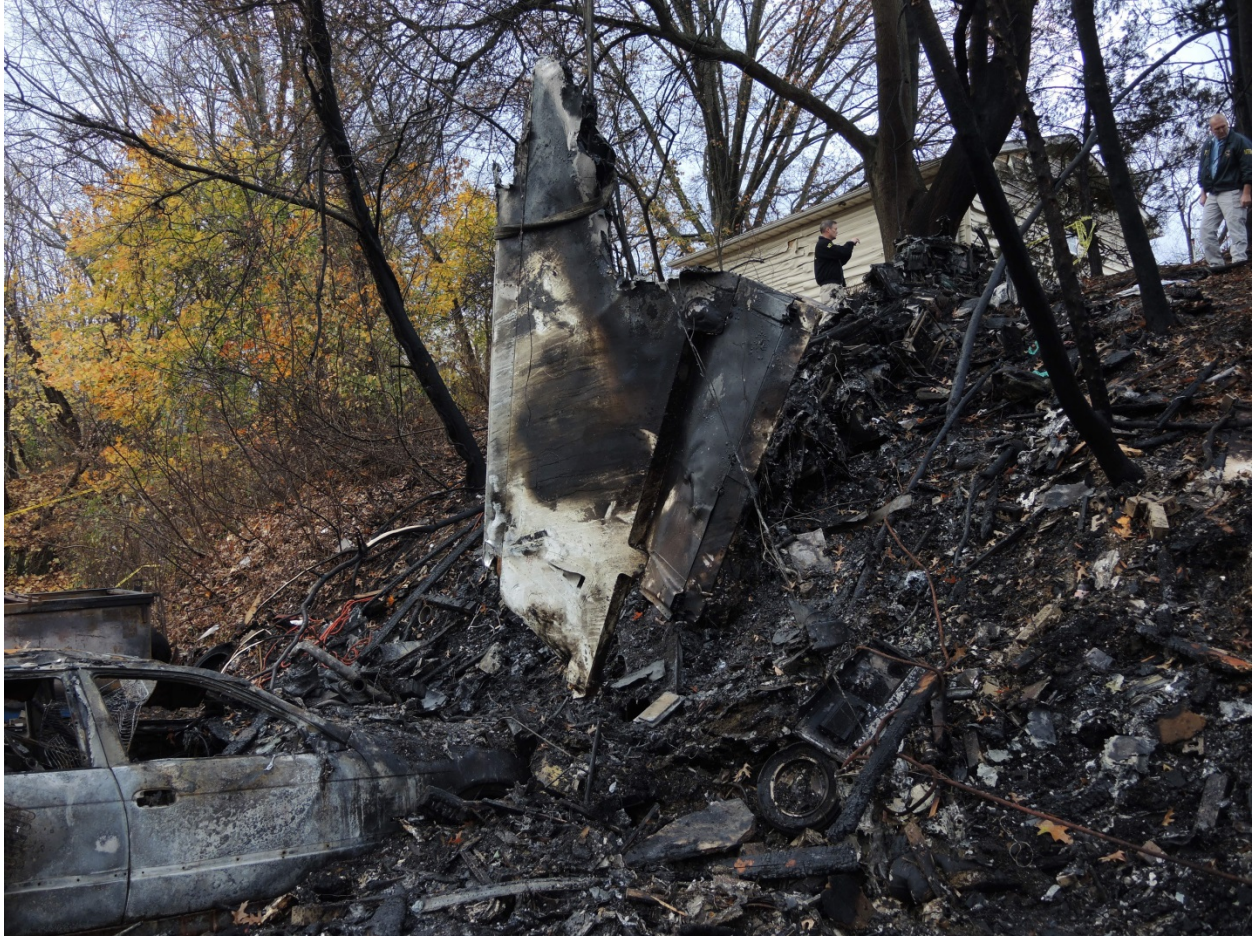
Figure 7 – Outboard right wing and aileron

Figure 8 – Outboard right wing and aileron

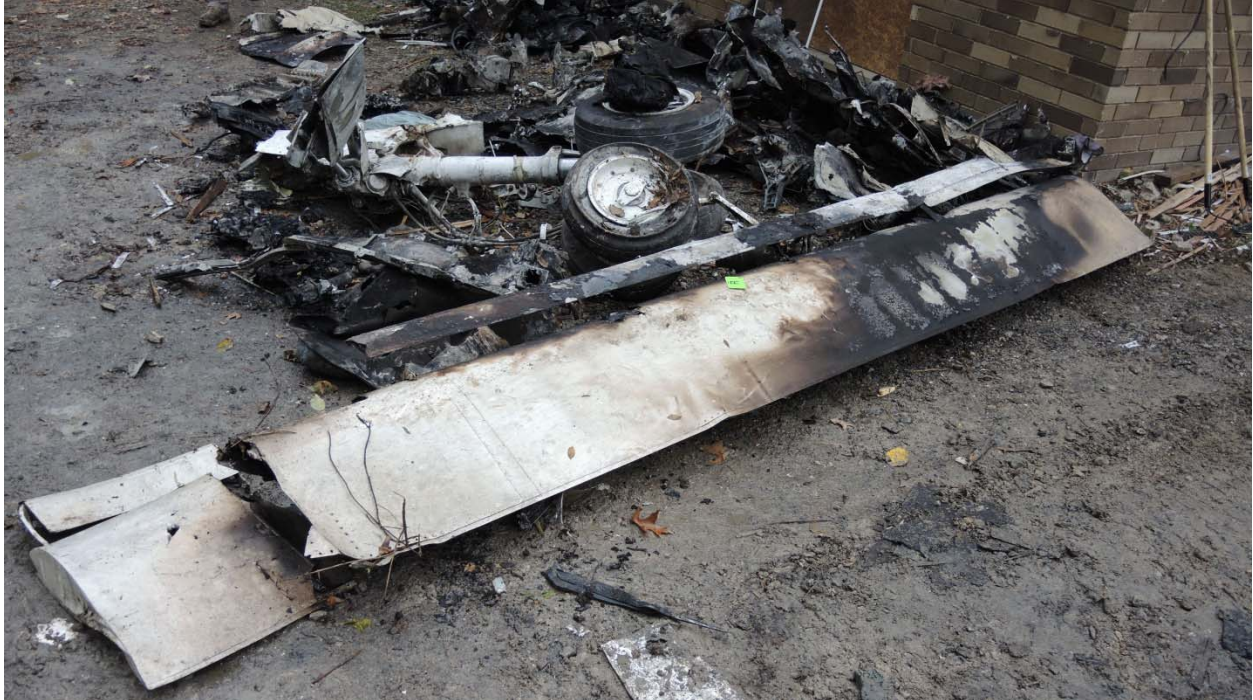
Figure 9 – Right flap

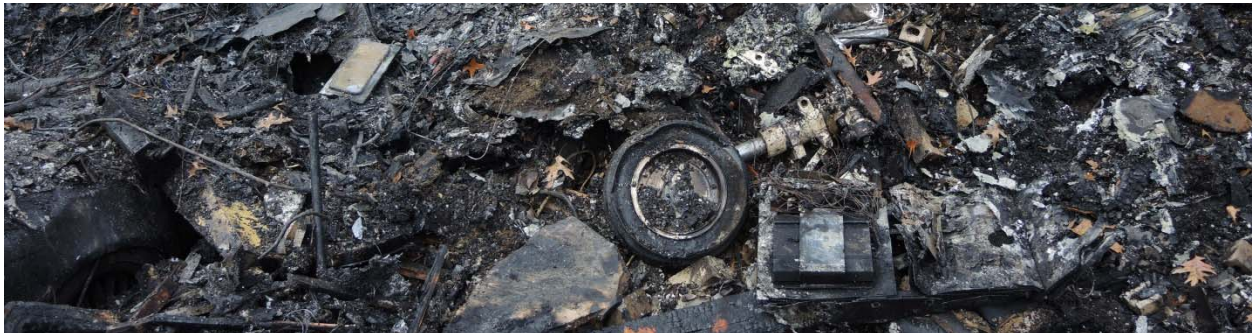
Figure 10 – Nose landing gear

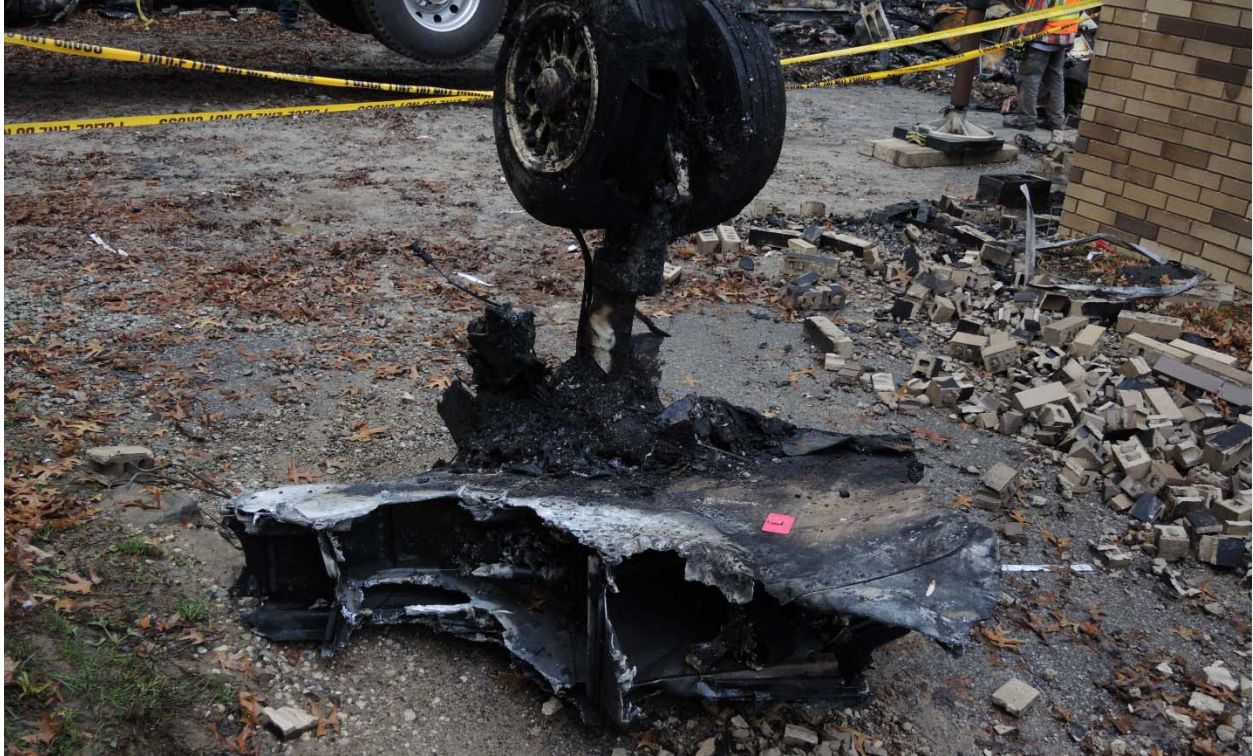
Figure 11 - Left main landing gear

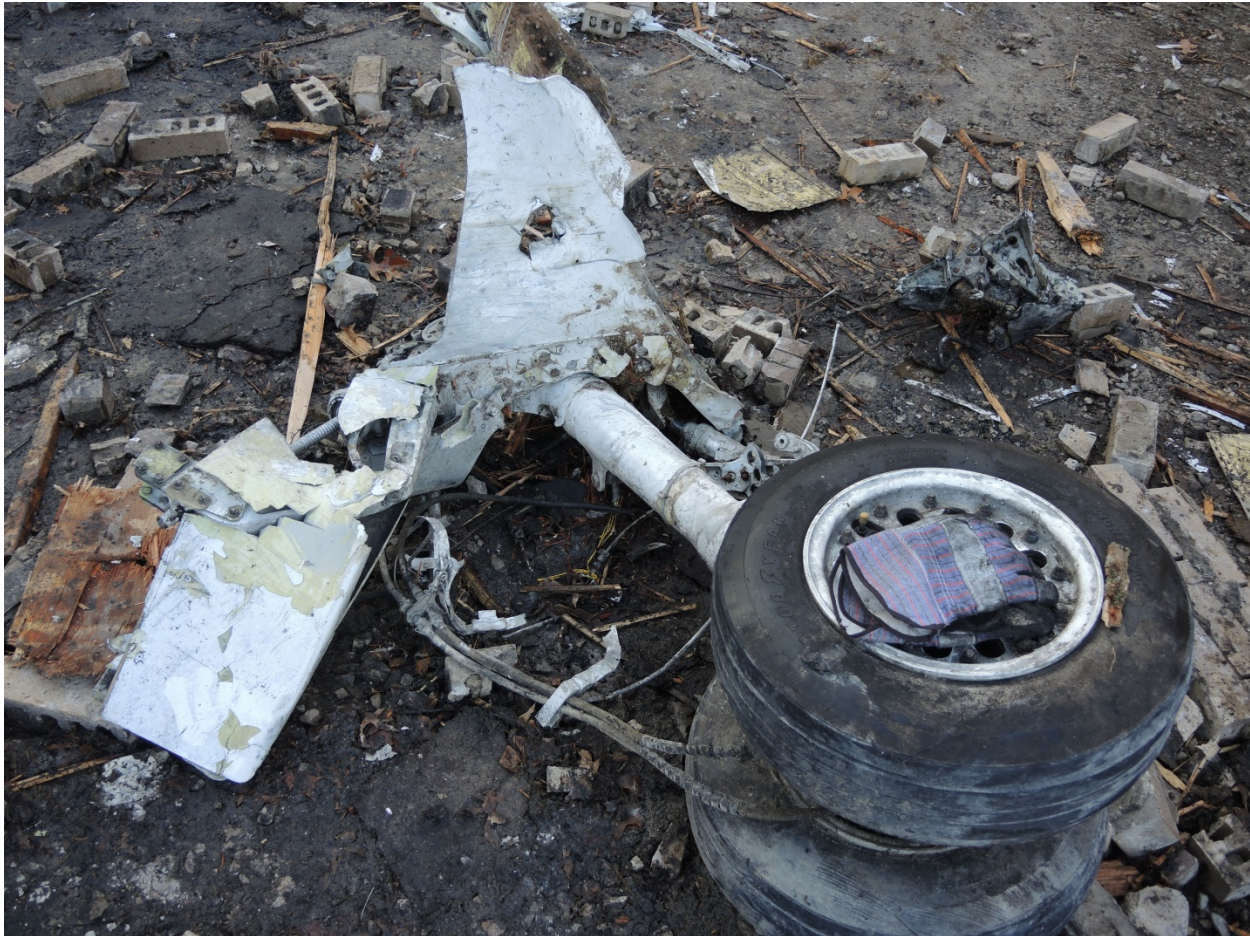
Figure 12 – Right main landing gear

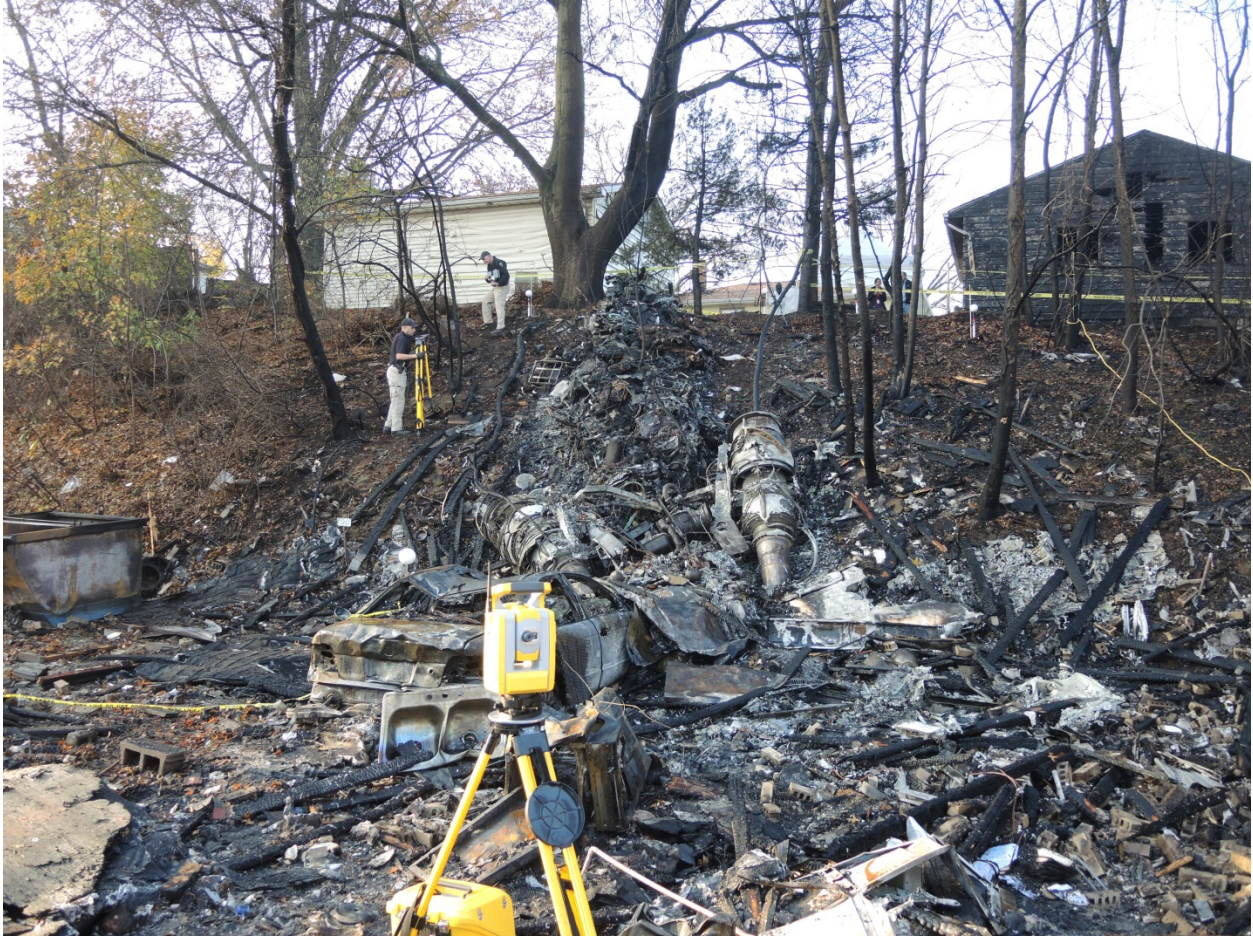
The entire fuselage, empennage and associated control surfaces were consumed by fire and identified by the remaining melted debris and associated hardware and systems components (Figure 13). The left wing from about rib 2 outboard to about rib 12 was consumed by fire and identified by the remaining melted debris and associated hardware and systems components. The right wing from about rib 2 to about rib 9 was consumed by fire and identified by the remaining melted debris and associated hardware and systems components.

Figure 13 – Fuselage and empennage
