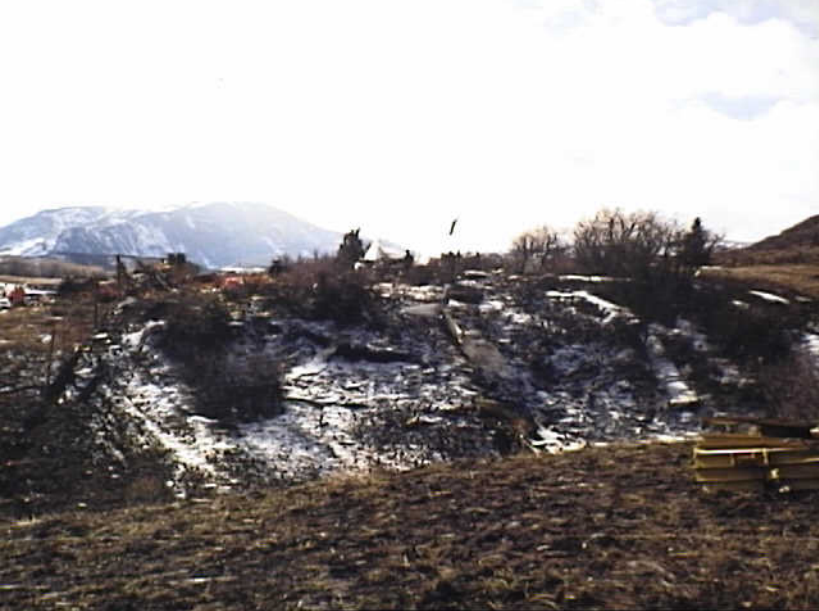
Structures/Maintenance 7 - Photo 1. Accident site with gully between initial impact point and wreckage debris.
