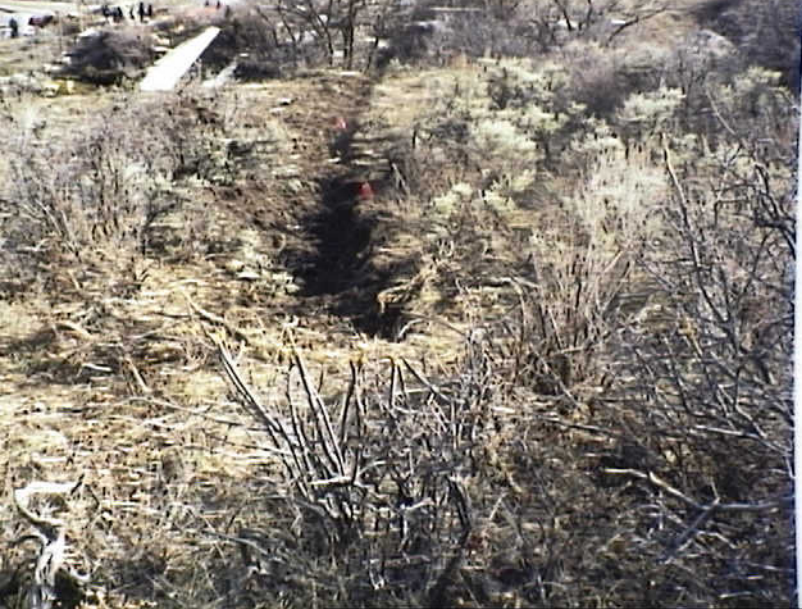
Structures/Maintenance 7 - Photo 3. Initial impact point. Note angle formed in vegetation before initial impact point.
