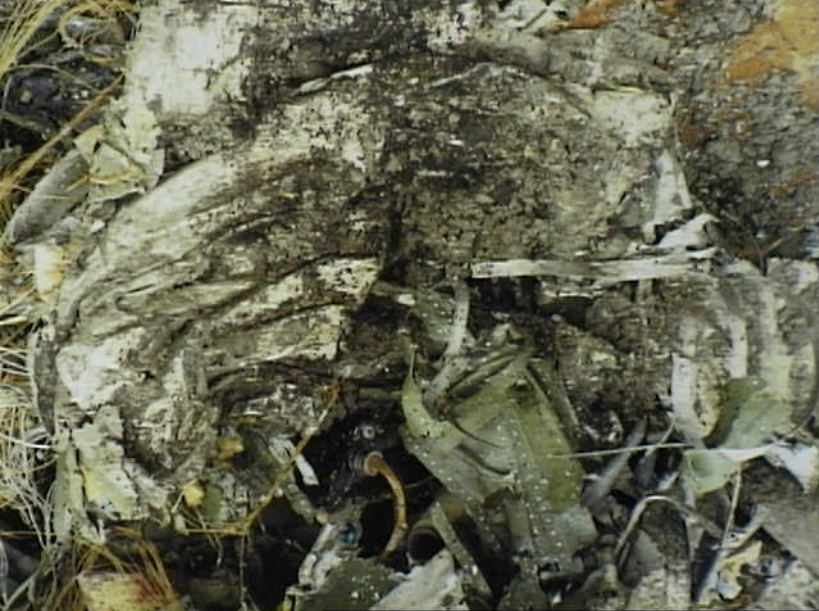
Structures/Maintenance 7 - Photo 6. Fuselage and component crushing. Note: Frayed wiring.
