NATIONAL TRANSPORTATION SAFETY BOARD

Group Chairman's Factual Report

STRUCTURES

DCA12IA113

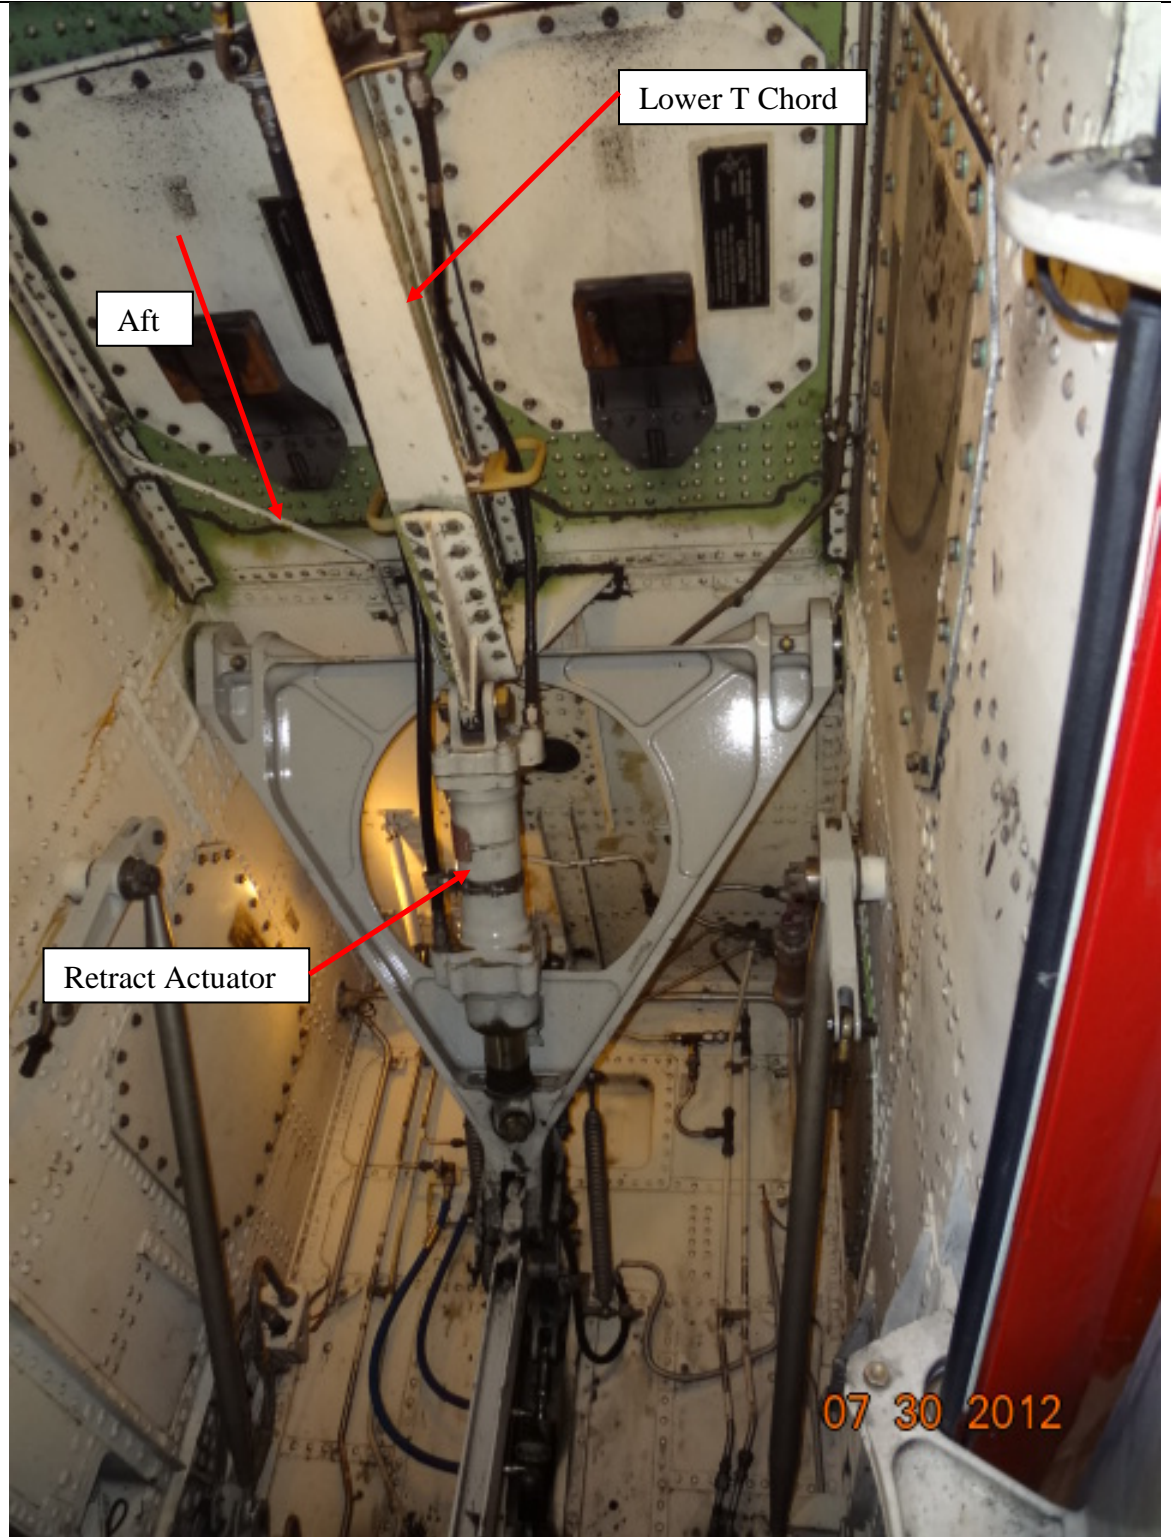
Description: Undamaged retract actuator beam lower T chord viewed looking aft.

Photo 1: Undamaged retract actuator beam lower T chord viewed looking aft

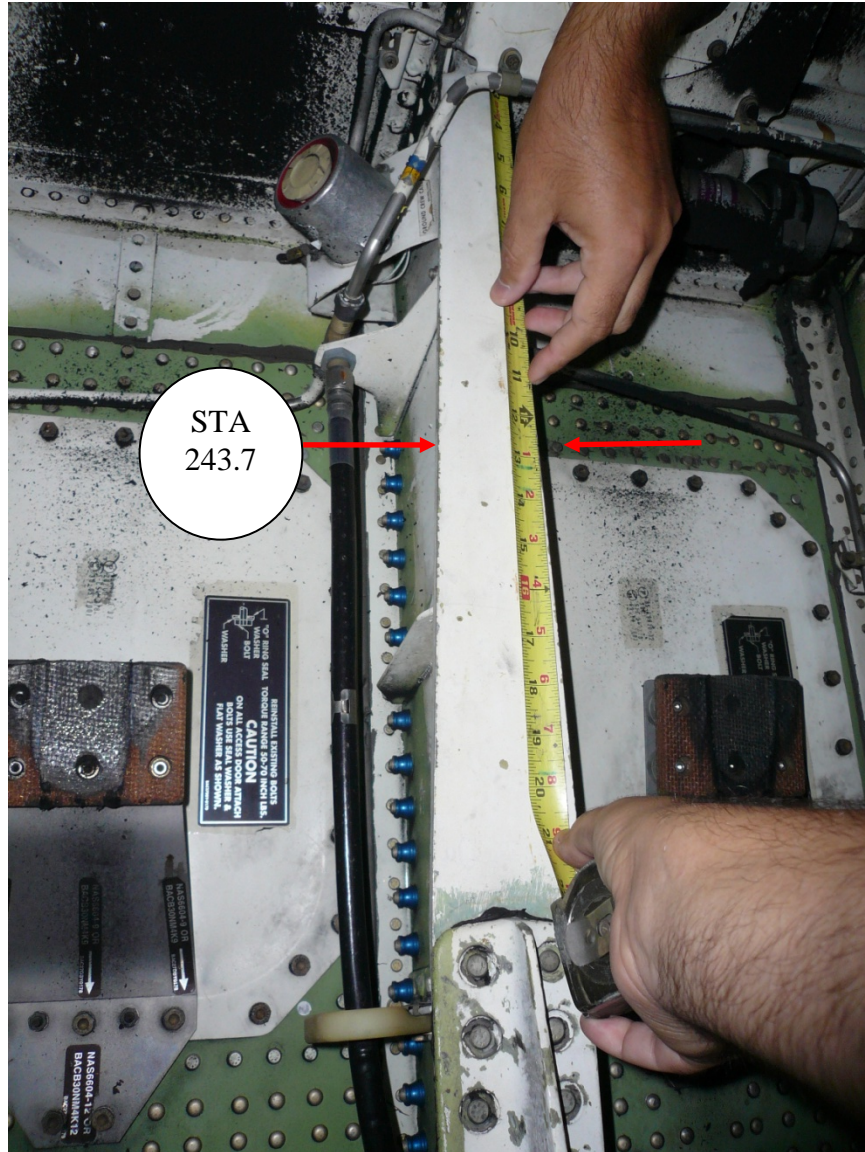
Description: Fractured lower T chord location shown on an undamaged structure.

Photo 2: Fractured lower T chord location shown on an undamaged structure

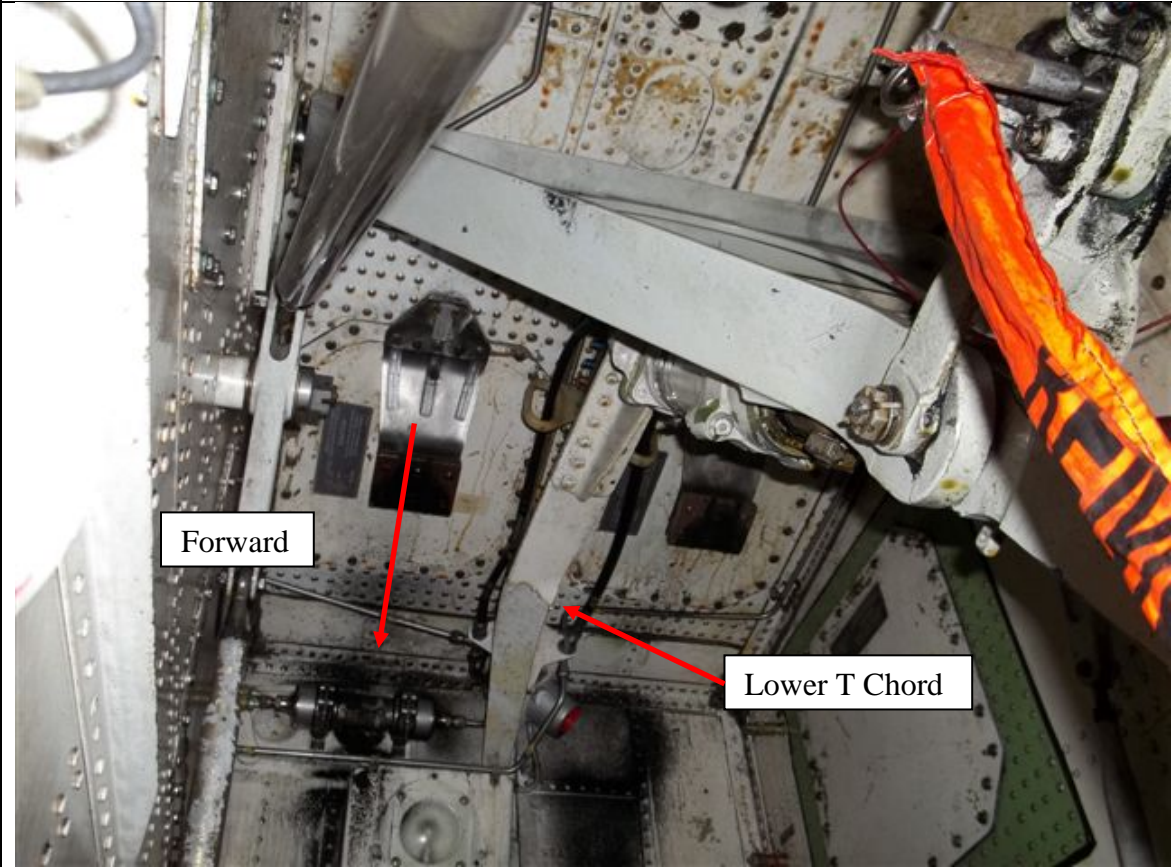
Description: N379SW fractured lower T chord at fuselage station 243.7.

Photo 3: N379SW fractured lower T chord at fuselage station 243.7

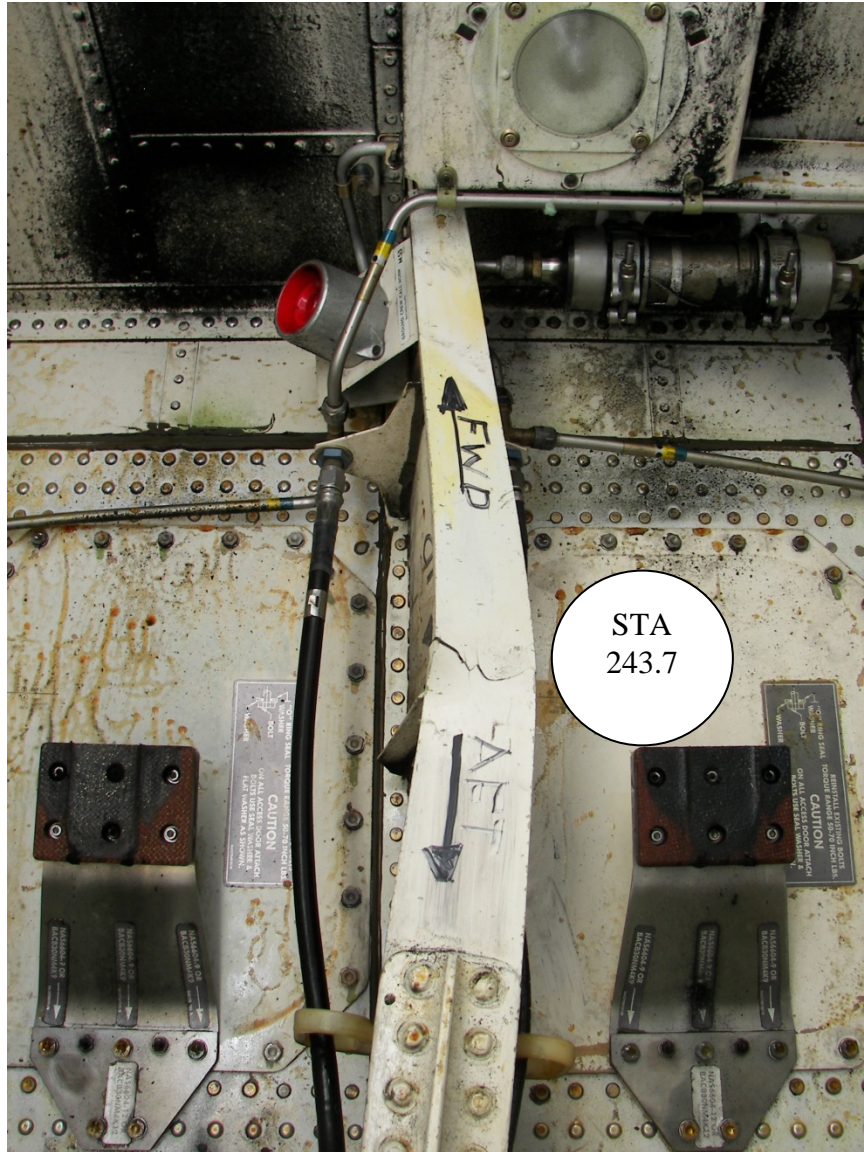
Description: N379SW fractured lower T chord.

Photo 4: N379SW fractured lower T chord

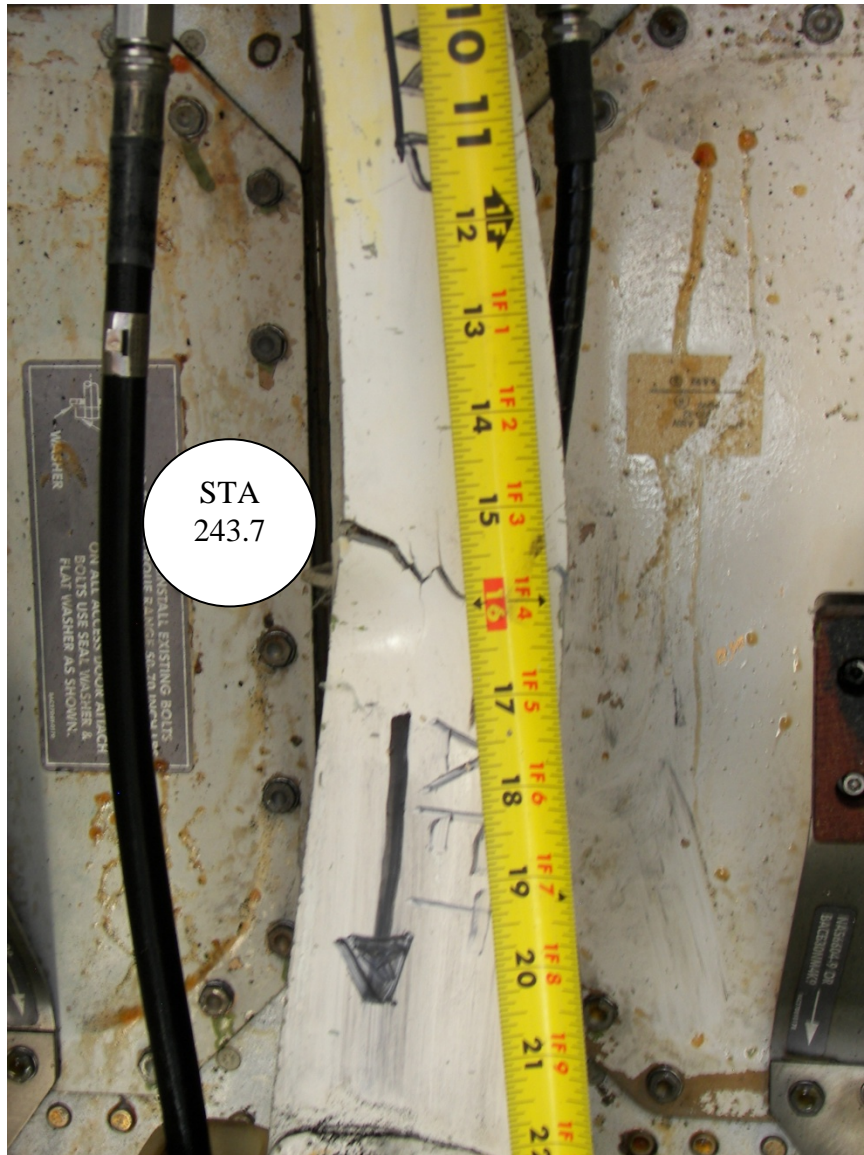
Description: N379SW fractured lower T chord located 16 inches aft of the nose wheel forward bulkhead.

Photo 5: Fractured lower T chord located 16 inches aft of the nose wheel forward bulkhead

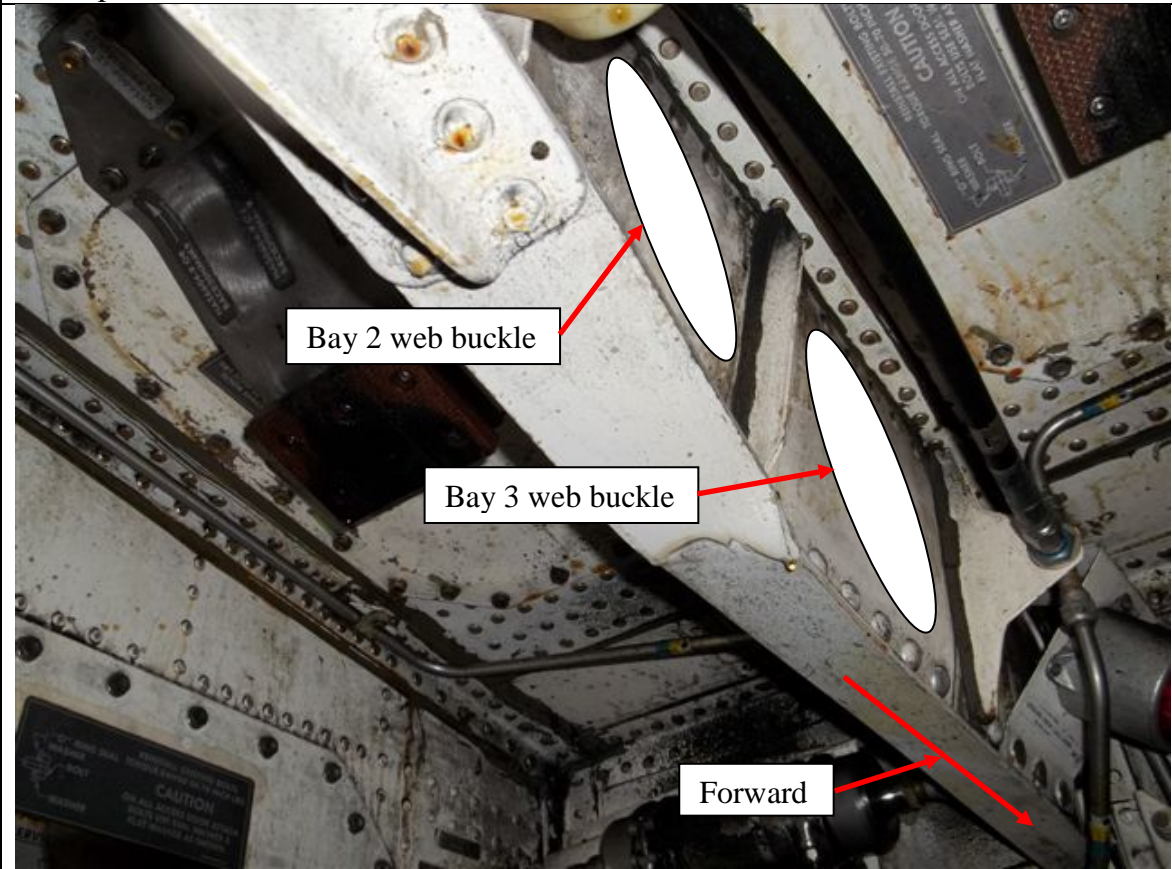
Description: N379SW fractured lower T chord and buckled webs.

Photo 6: N379SW fractured lower T chord and buckled webs

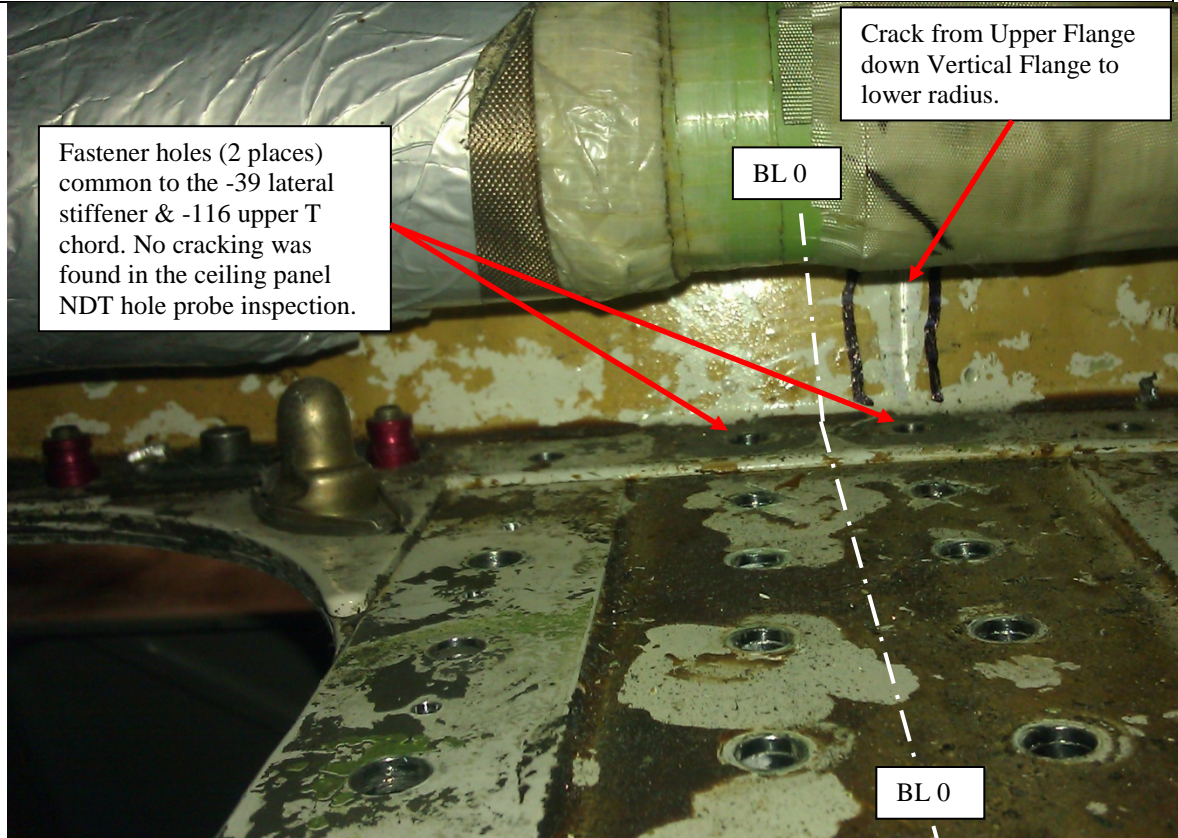
Description: N379SW fractured 65-45819-39 lateral stiffener at BL 0 looking aft.

Photo 7: N379SW fractured 65-45819-39 lateral stiffener at BL 0 viewed looking aft

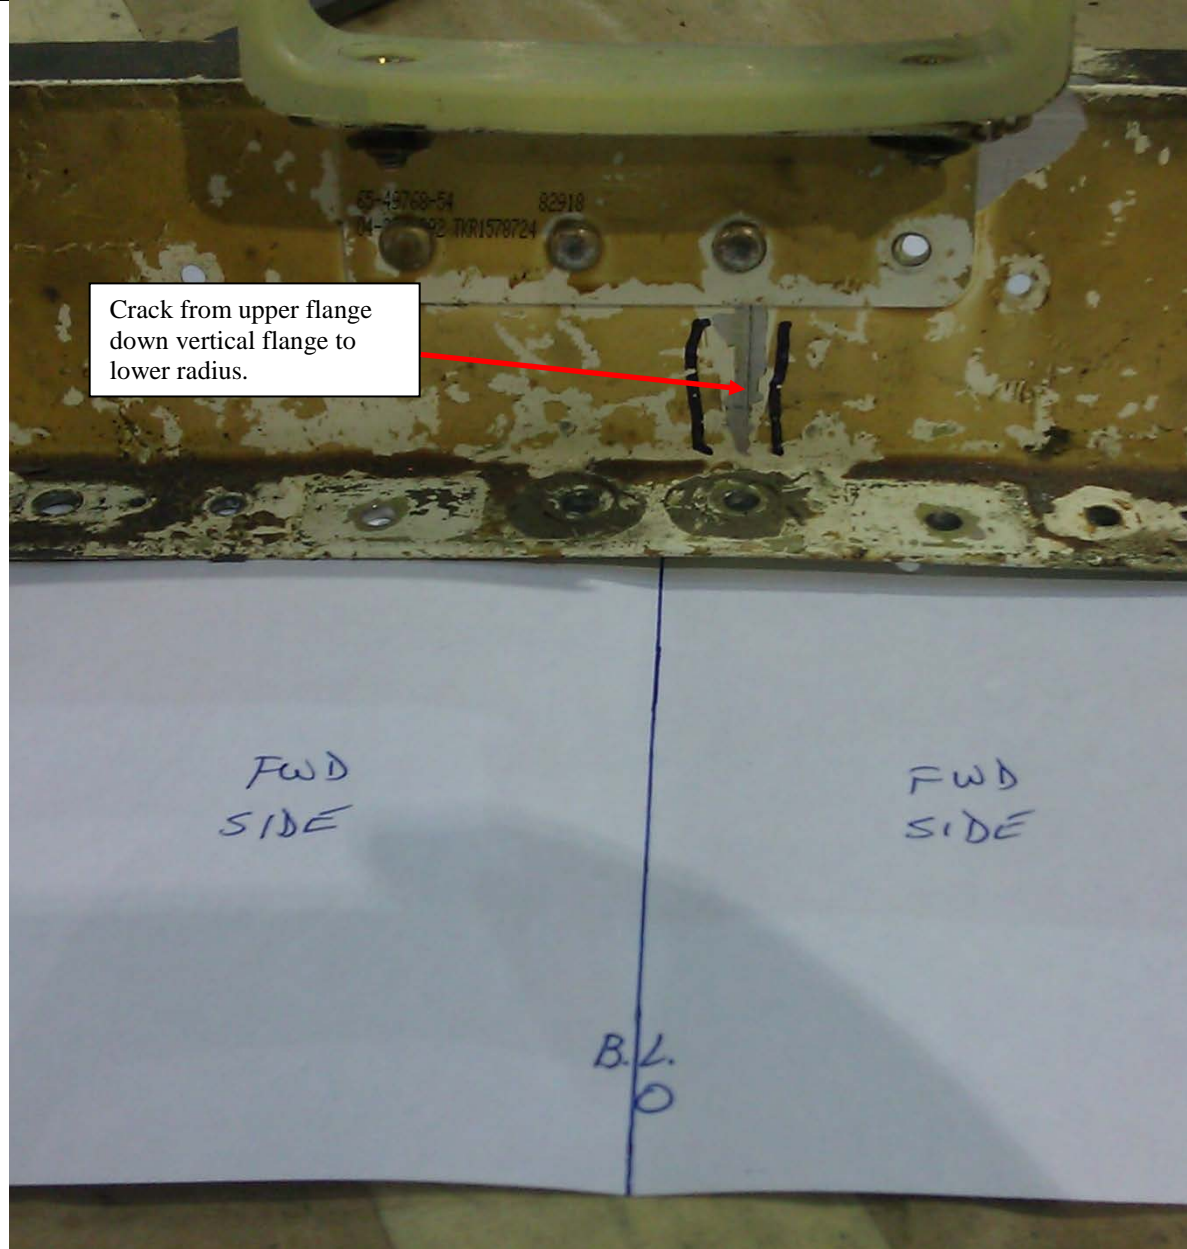
Description: N379SW forward side of the 65-45819-39 lateral stiffener.

Photo 8: N379SW forward side of the 65-45819-39 lateral stiffener

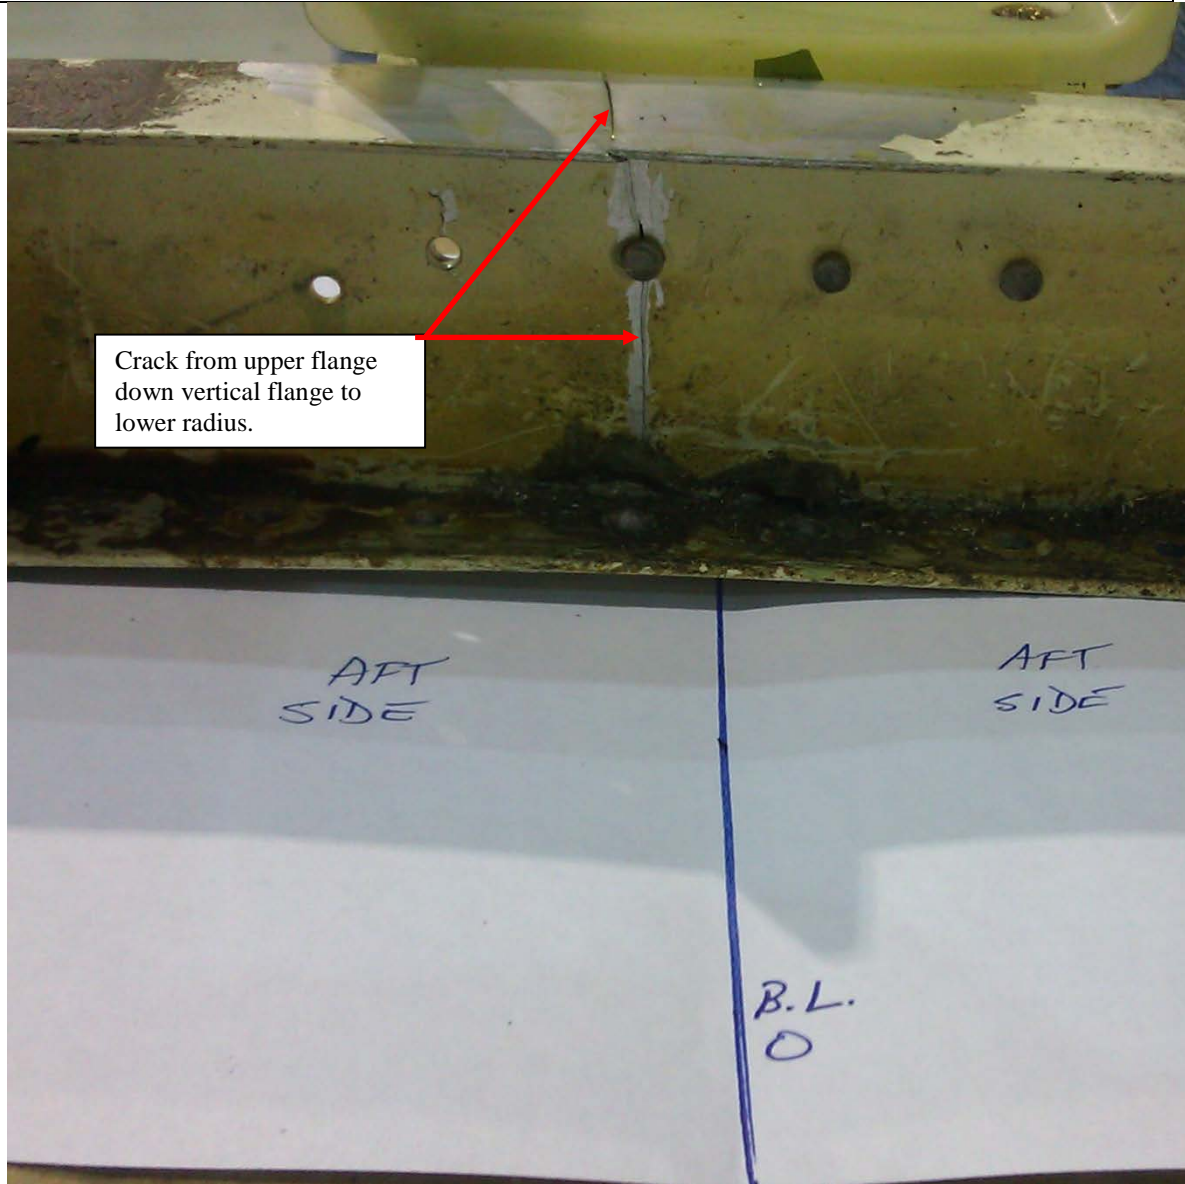
Description: N379SW aft side of the 65-45819-39 lateral stiffener.

Crack from upper flange
down vertical flange to
lower radius.

Photo 9: N379SW aft side of the 65-45819-39 lateral stiffener

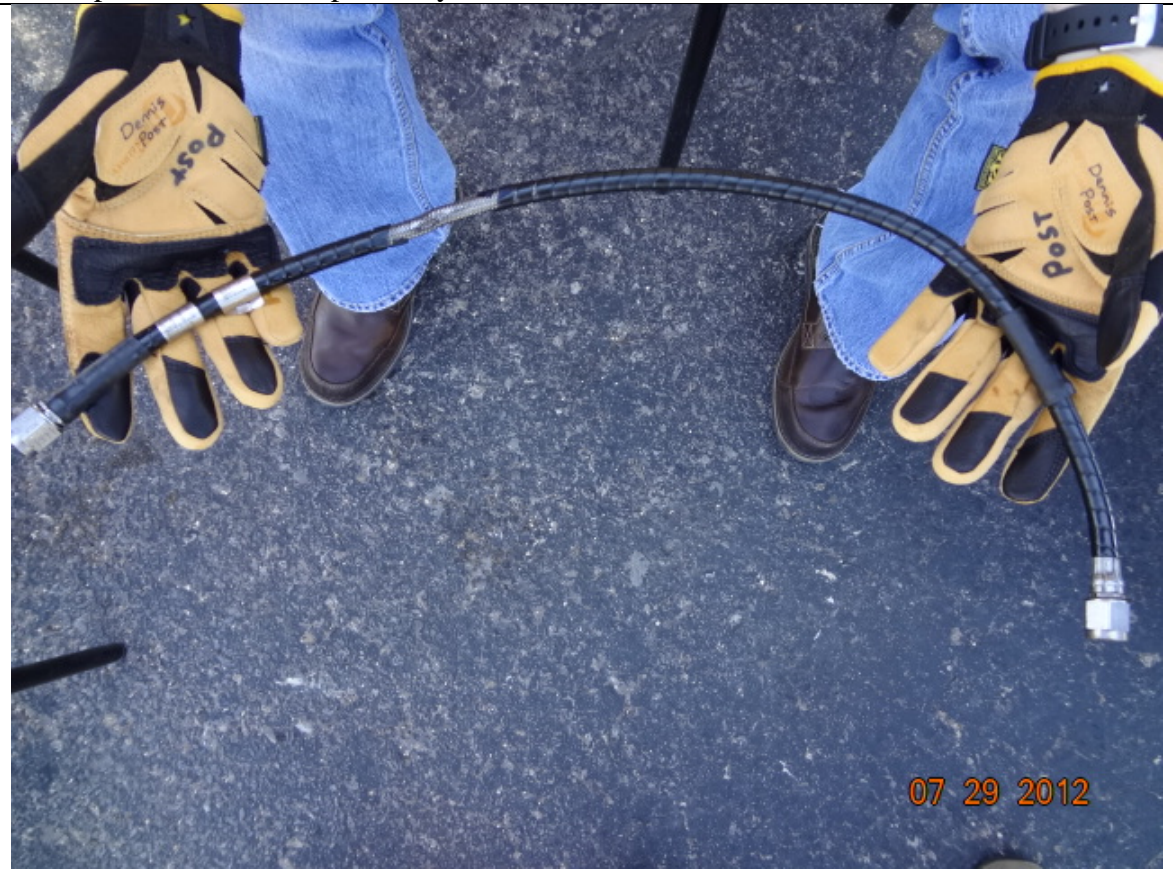
Description: N379SW ruptured hydraulic line.

Photo 10: N379SW ruptured hydraulic line

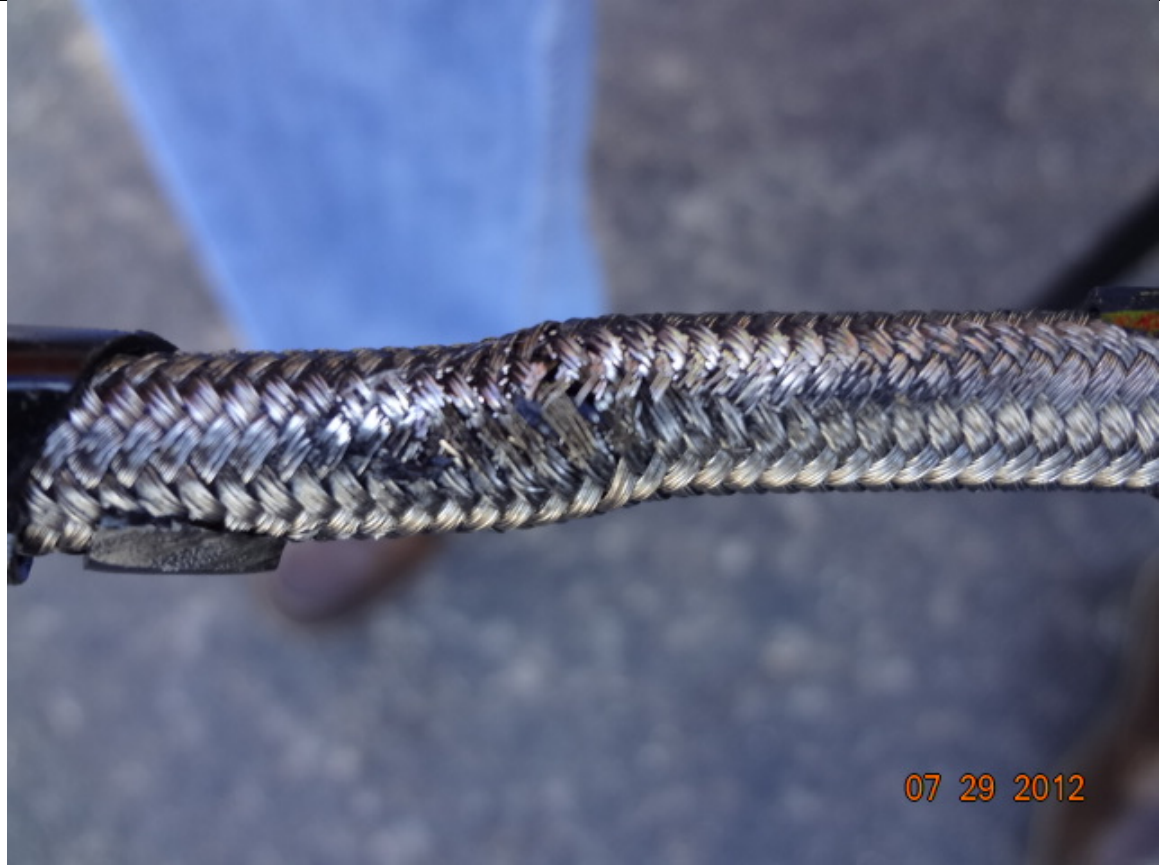
Description: N379SW ruptured hydraulic line.

Photo 11: N379SW ruptured hydraulic line
