Federal Express Flight 1478

Tallahassee, Florida

July 26, 2002

Federal Bureau of Investigation
Evidence Response Team

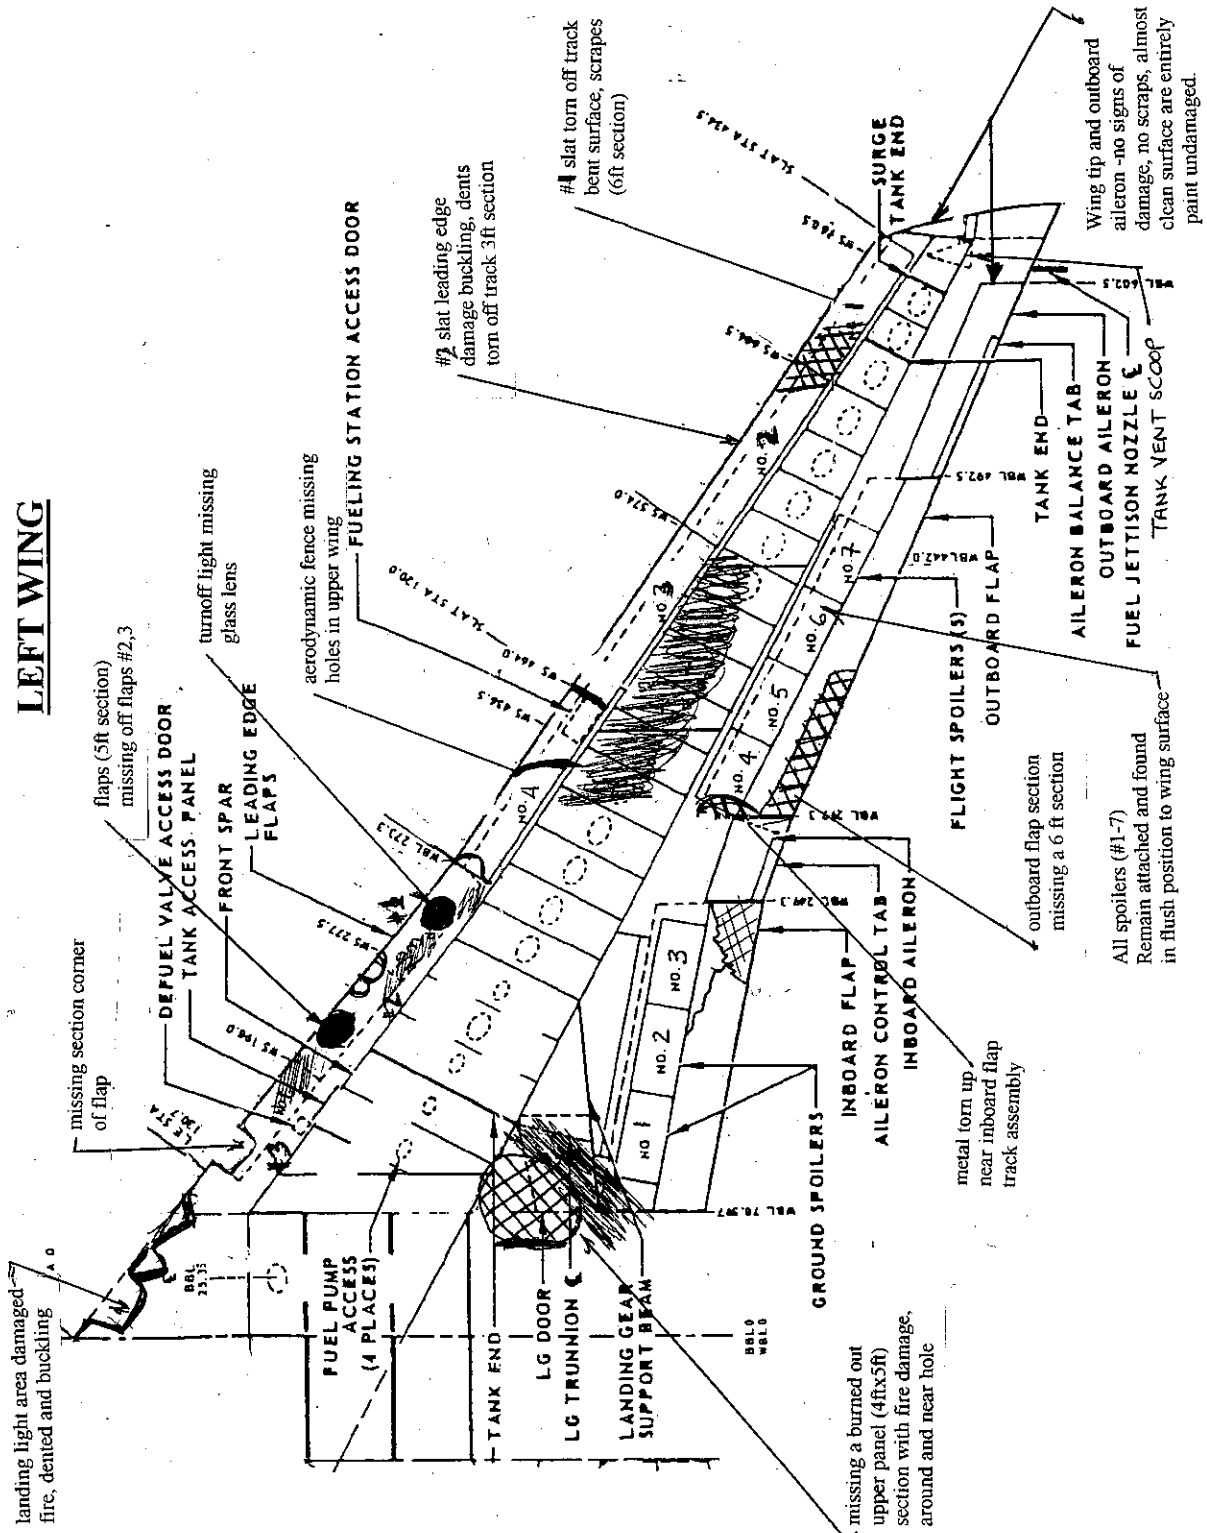
LEFT WING

landing light area damaged fire, dented and buckling

missing section corner of flap

flaps (5ft section) missing off flaps #2,3

turnoff light missing glass lens

aerodynamic fence missing holes in upper wing

#2 slat leading edge damage buckling, dents torn off track 3ft section

#4 slat torn off track bent surface, scrapes (6ft section)

missing a burned out upper panel (4ftx5ft) section with fire damage around and near hole

metal torn up near inboard flap track assembly

outboard flap section missing a 6 ft section

All spoilers (#1-7) Remain attached and found in flush position to wing surface

Wing tip and outboard aileron -no signs of damage, no scrapes, almost clean surface are entirely paint undamaged.
