NATIONAL TRANSPORTATION SAFETY BOARD

**ADDENDUM NUMBER 12 TO THE STRUCTURES GROUP CHAIRMAN'S
FACTUAL REPORT**

DCA02MA001

AAL 587 Airbus Structure Investigation
A300 / A310 Composite Fin Box
Rear Fin Box Attachment - Subcomponent Test Summary

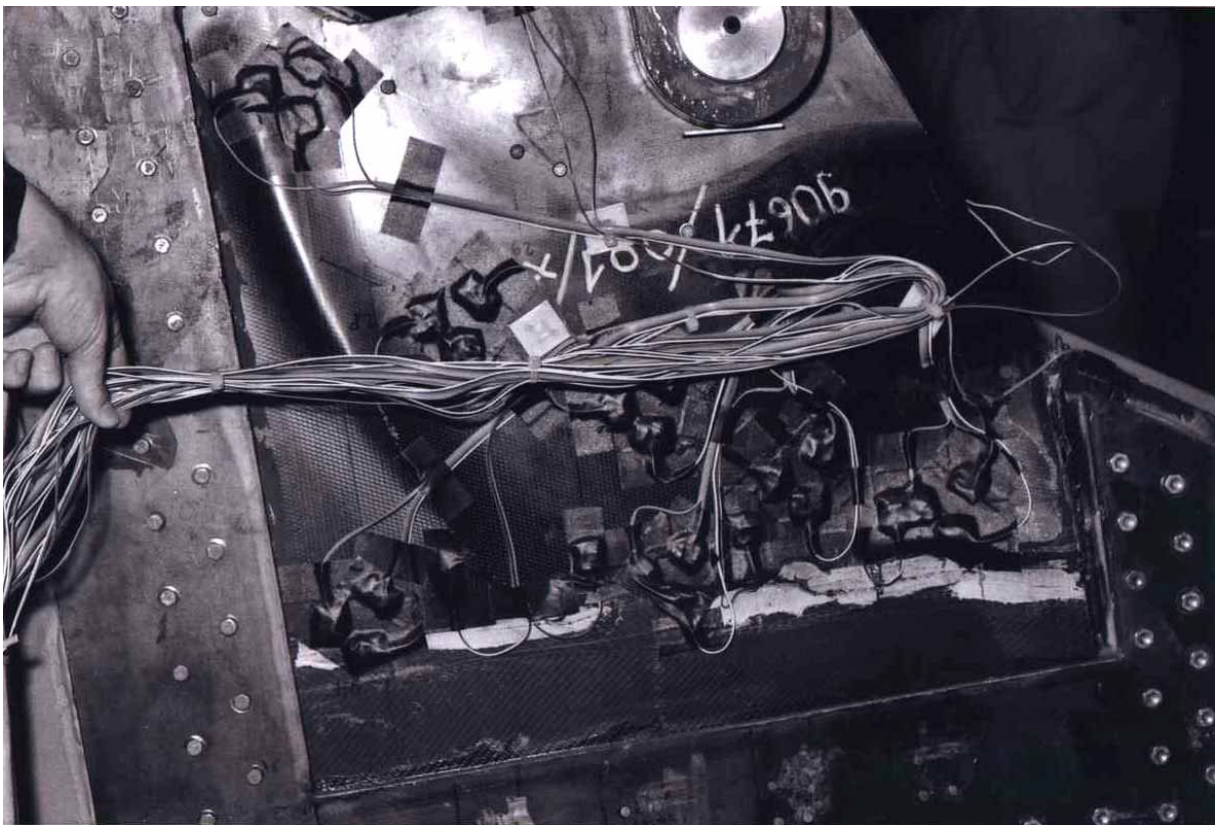
Figure 7

Test part	Kind of loading	Failure load [kN]
1	Compression	1003
2	tension	1036

The failure mode on test part 1 is a compression failure of skin and stringers below rib 4 (see figure 7).

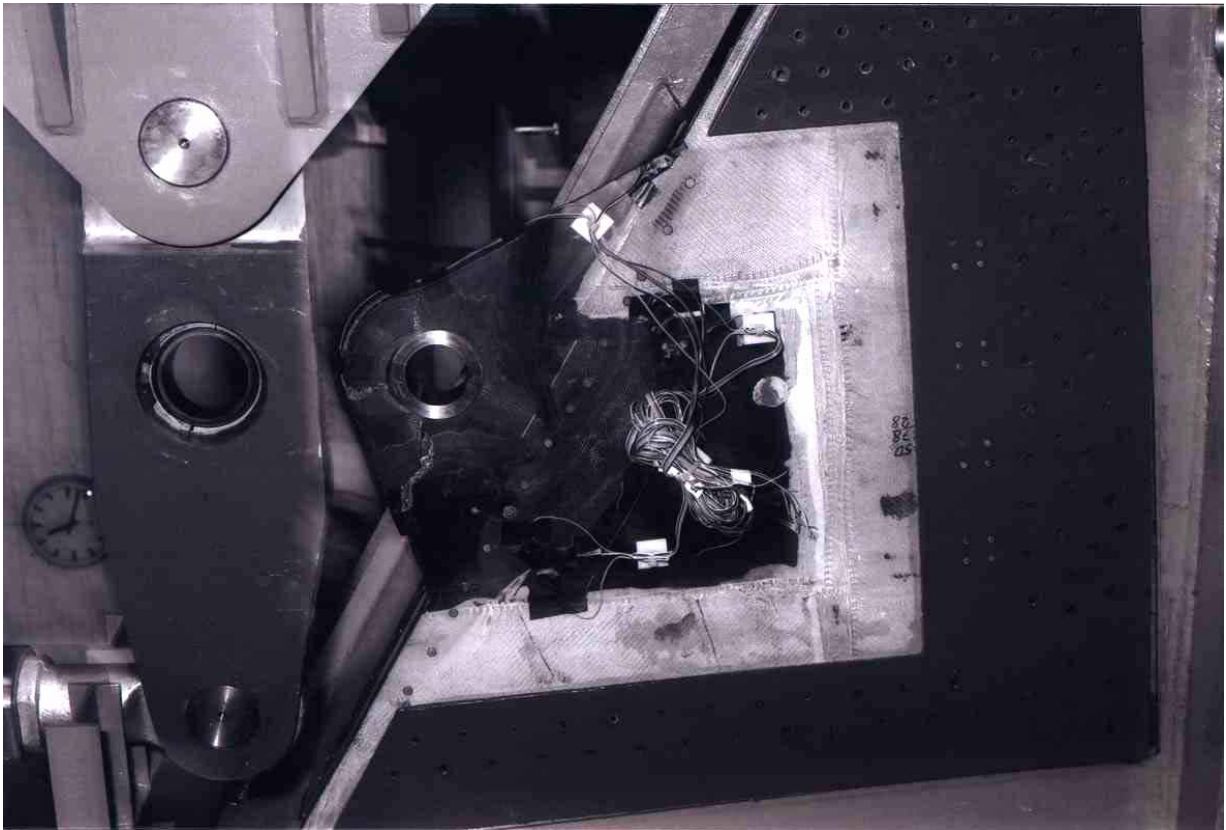
Figure 8

Test part 2 failed in a cleavage mode at the pin hole (see figure 8).
