**NATIONAL TRANSPORTATION SAFETY BOARD**

**ADDENDUM 2**

**STRUCTURES GROUP CHAIRMANS FACTUAL REPORT**

**DCA09MA026**

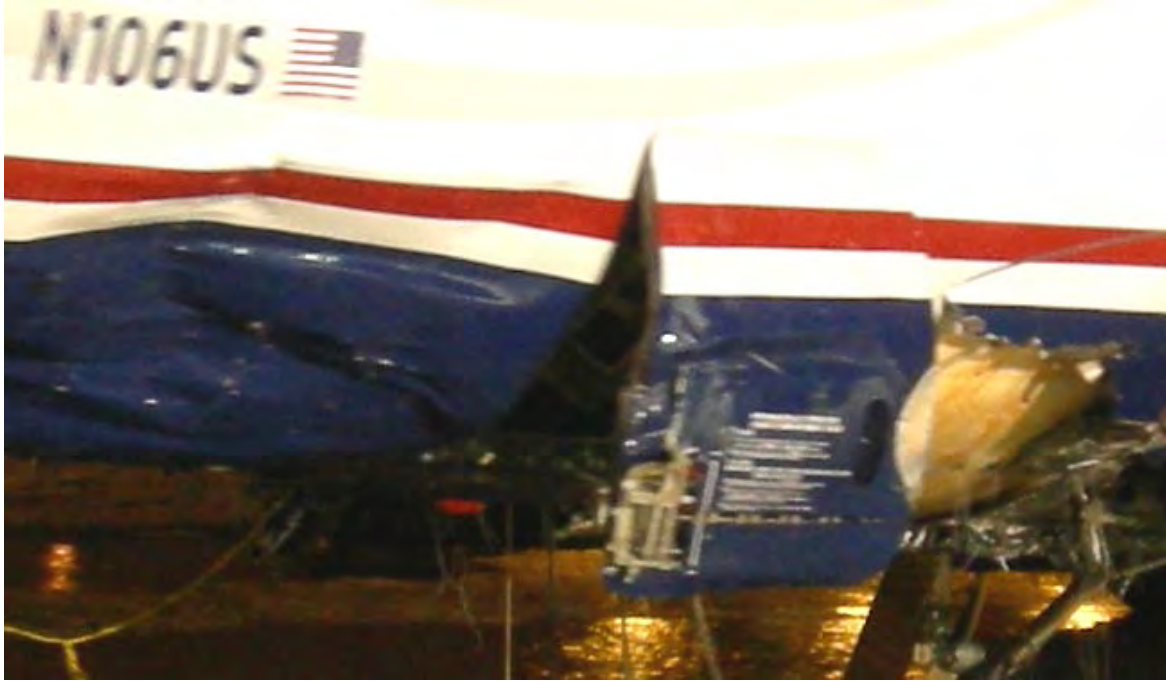
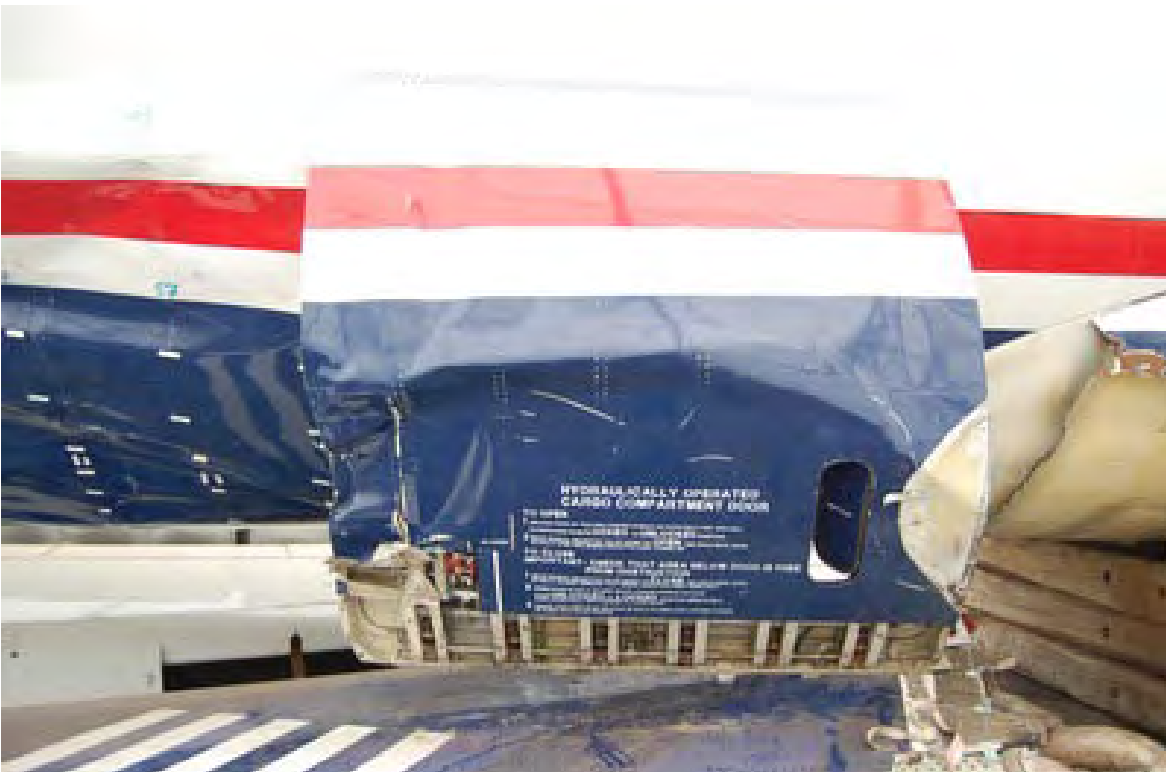
Figure 4

Description: General overview of aft cargo door and fuselage surround structure, during the recovery and at the storage facility.

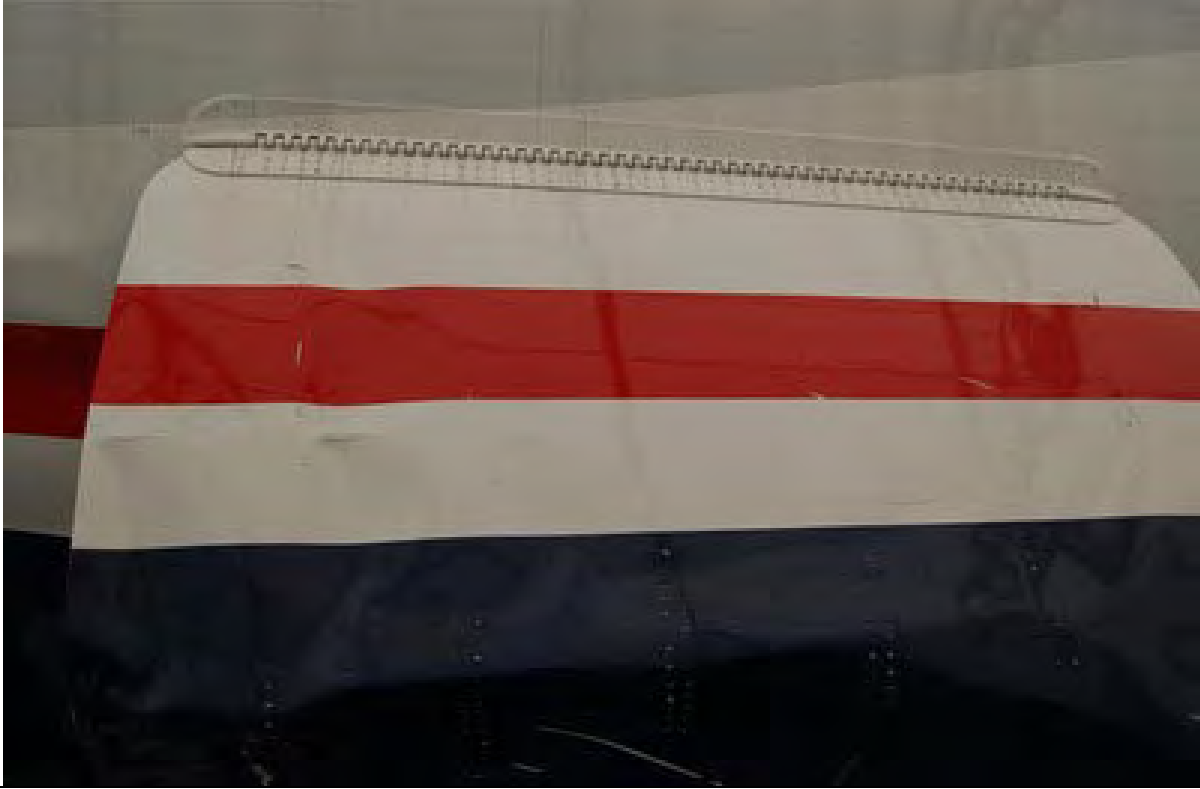
Figure 5

The aft cargo door hinge was intact with no evidence of damage to the fasteners or sealant. The door was able to rotate normally about the upper hinge pins and the hinge teeth were in good condition (refer to Figure 5).

Description: Aft cargo door hinge

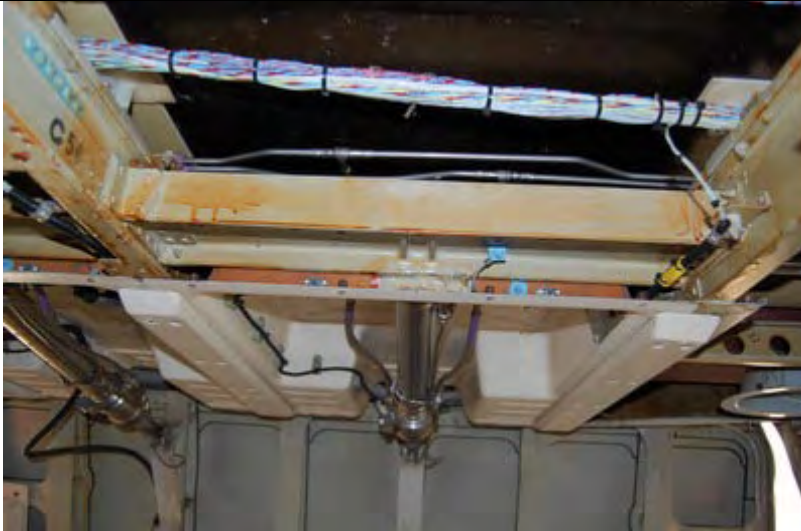
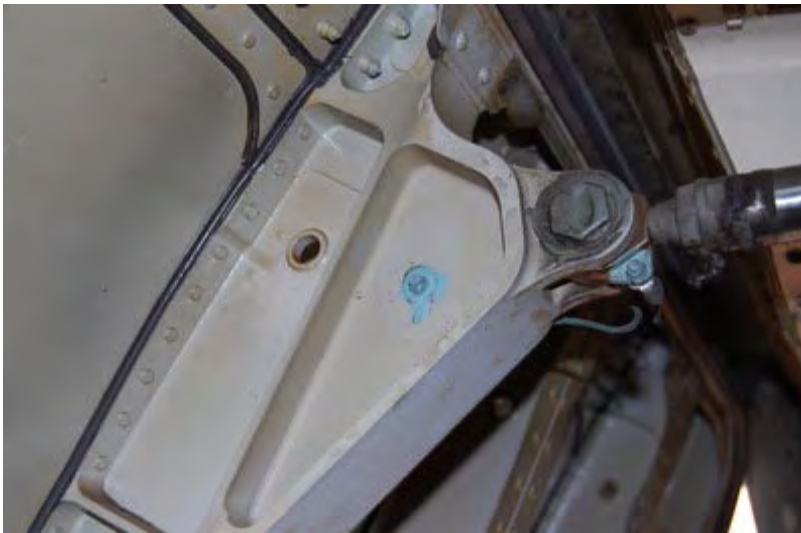
Figures 6 and 7

There was no visible damage to the fasteners or sealant on the fuselage side of the actuator connections or the cargo door attachment points (refer to Figures 6 and 7).

Description: Aft cargo door actuator connections.

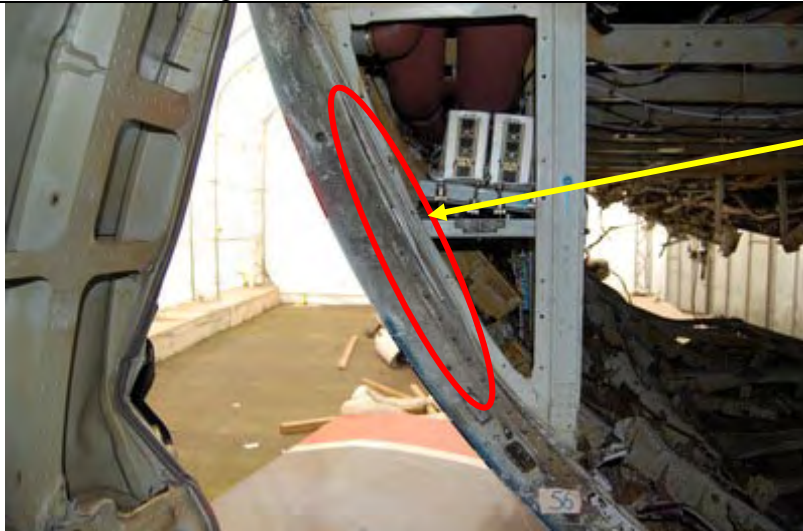
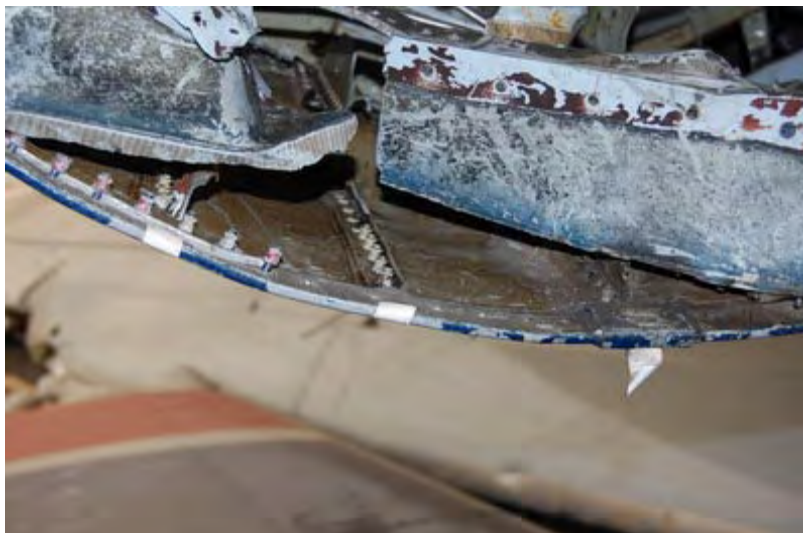
Figures 8 and 9

In the area of the damaged aft fuselage structure surrounding frame 56 between stringers 32RH and 38RH the seal striker was missing (refer to Figure 9). Above stringer 32LH the seal striker was present and deformed in the inboard direction. The remaining areas of the seal striker around door were undamaged and in good condition (refer to Figure 8).

Description: Seal striker on fuselage

Seal  
striker

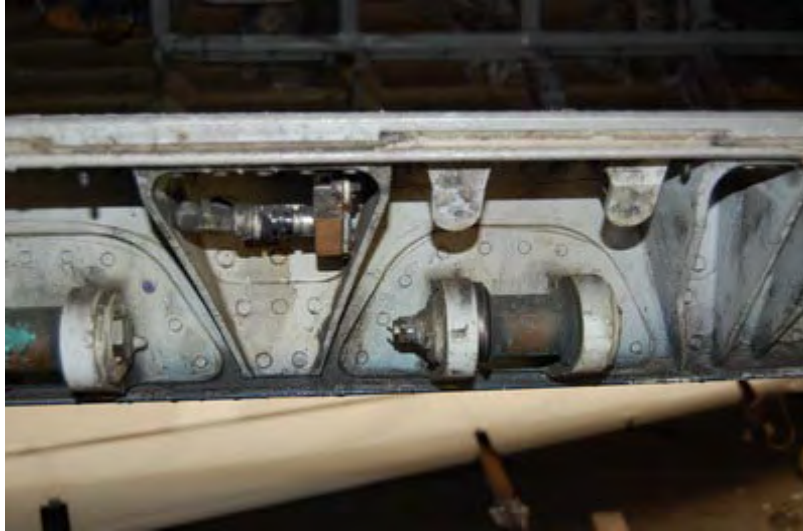
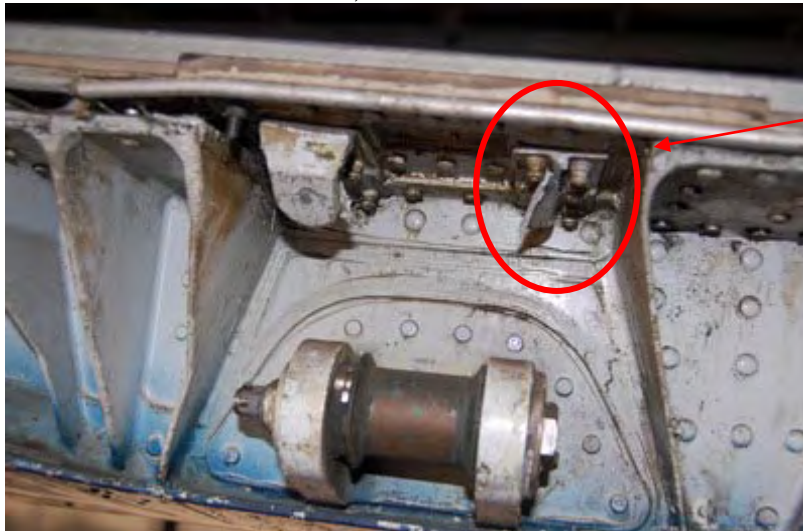
Figures 10 and 11

The door stops prevent the inward movement of the door caused by negative pressure loads encountered during flight and at closure of the cargo door. Four door stops are installed, two at frame 53 (the forward side of the cargo door) and two at frame 55A (the aft side of the cargo door). At frame 53, the two door stops on the fuselage and their mating parts on the door were intact and undamaged. Both door stops on the door side of frame 55A were intact and undamaged. On the fuselage side the forward stop was fractured and the aft was bent (refer to Figures 10 and 11).

Description: Aft cargo door stops.

Forward, frame 53

Aft, frame 55A

Fractured  
door stop  
bracket on  
fuselage  
side

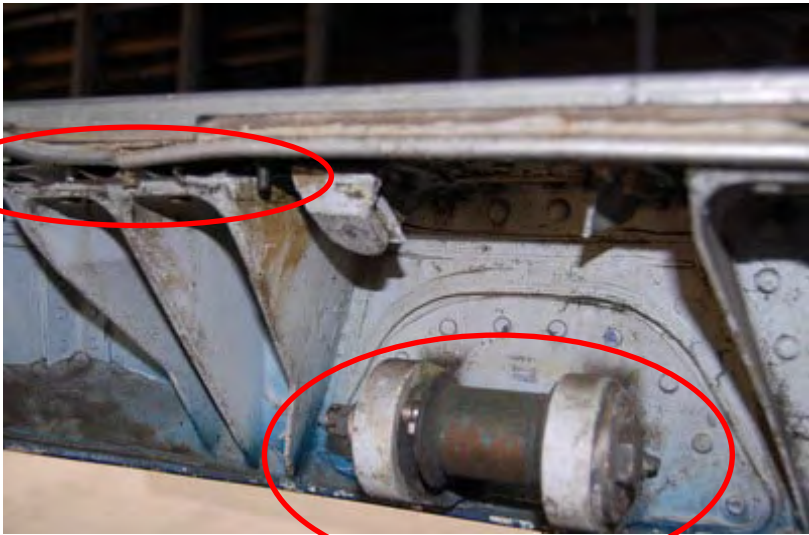
<p data-bbox="1234 709 1396 808">Typical latching spool</p>	
Figure 12

The aft portion of the door sill between frames 55A and 56 was deformed upward. The six latching spools and associated fork fittings were undamaged (refer to Figure 12).

Accident #: DCA09MA026	N106US
Description: Aft cargo door sill and latching spool.	
<p data-bbox="181 373 373 441">Damaged door sill</p>

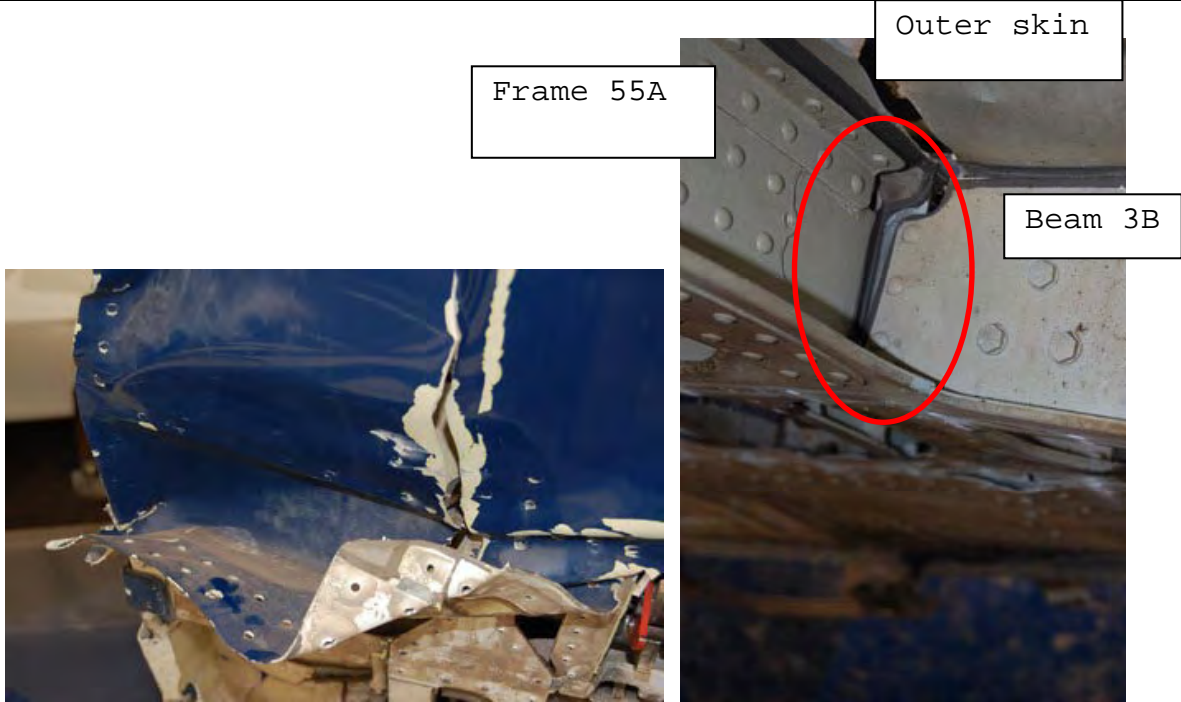
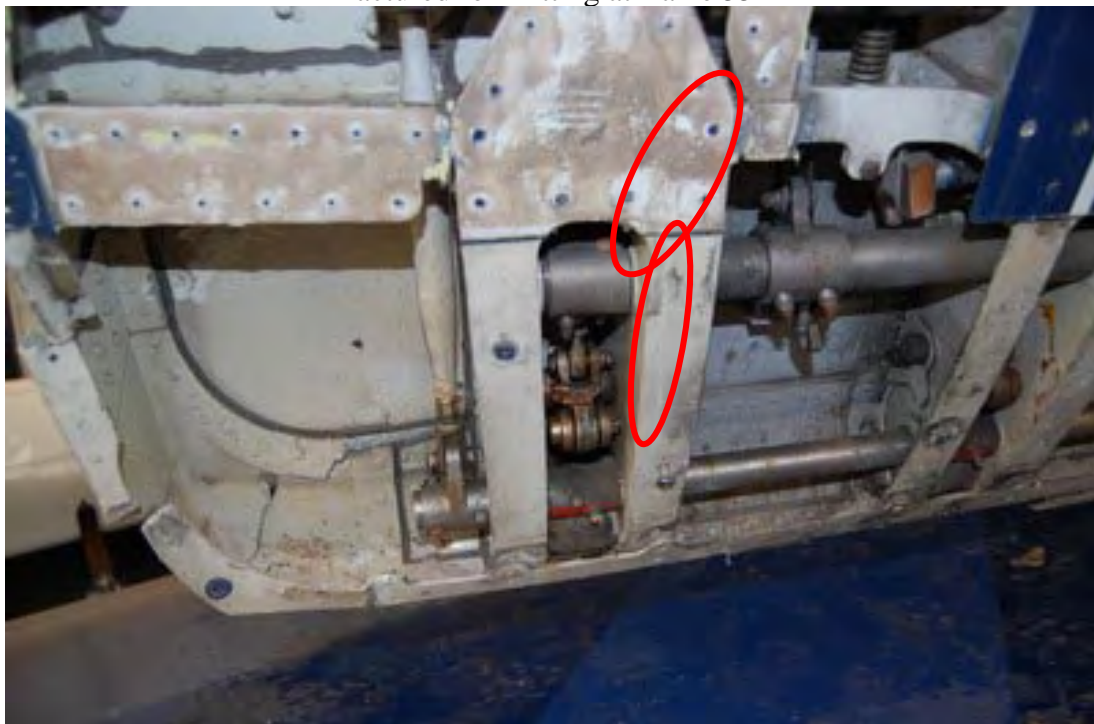
Figures 13, 14 and 15

Aft of frame 55A the skin peeled aft and fractured (refer to Figures 13 and 14). Beam 3B was disconnected from frame 55A, and the door fork fitting at frame 55A was cracked on the outboard side in multiple locations.

Description: Aft cargo door structure.

Fractured fork fitting at frame 55A

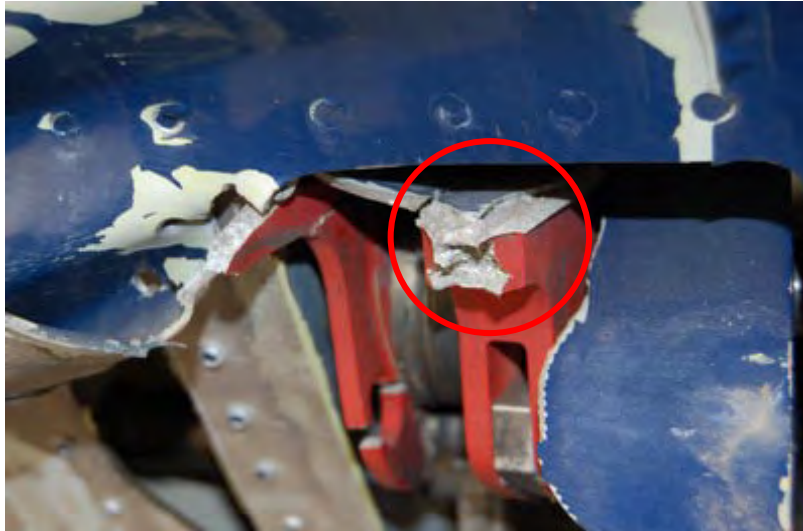
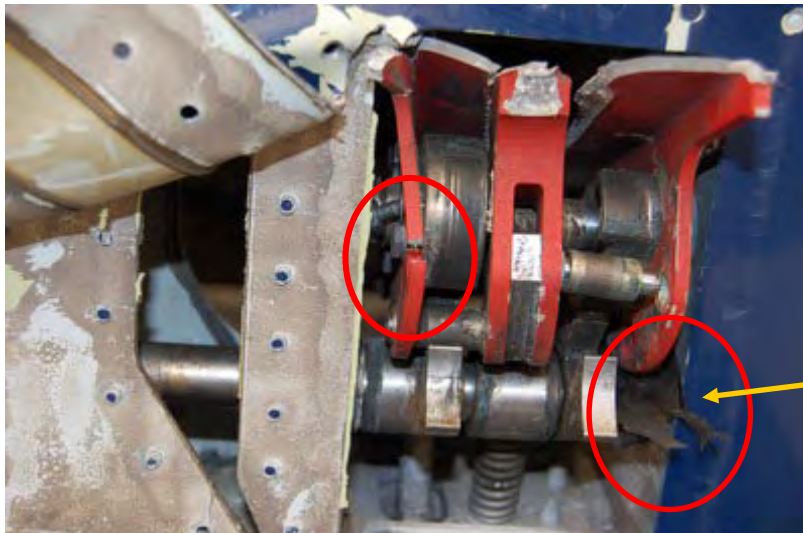
Figures 16 and 17

The locking shaft and connecting rods were undeformed and intact (refer to Figure 19 for schematic). No damage was visible to the link between the locking shaft and the drift pin mechanism. The forward and aft drift pins extended about 12 millimeters (mm) and 5.5 mm respectively from the edge of the forward and aft cargo door frames. The measured extensions exceed the normally expected tolerances for the cargo door when it is in the open and unlatched position. The vent door link to locking shaft via sequence shaft was undamaged and in good condition and the vent door was in open position. The latching shaft was bent between frames 55 and 55A, and the latching mechanism was seized in the fully unlatched position. Accordingly the six latching hooks were unlatched from the six latching spools. The cargo door handle was fractured into multiple pieces. Only the handle structure directly attached to the linkage mechanism remained attached to the door structure (refer to Figure 18). The handle body is attached to the handle mechanism using three shear fasteners on each side of the handle. One of the aft three fasteners exhibited features consistent with a ductile tension failure and the fastener was deformed in the aft direction (refer to Figures 17&18). A piece of carbon fiber reinforced plastic (CFRP) was wedged between the door handle and the door handle housing (refer to Figure. 17). The interlock mechanism did not show any signs of damage and functioned properly.

Description: Aft cargo door handle and latching mechanism.

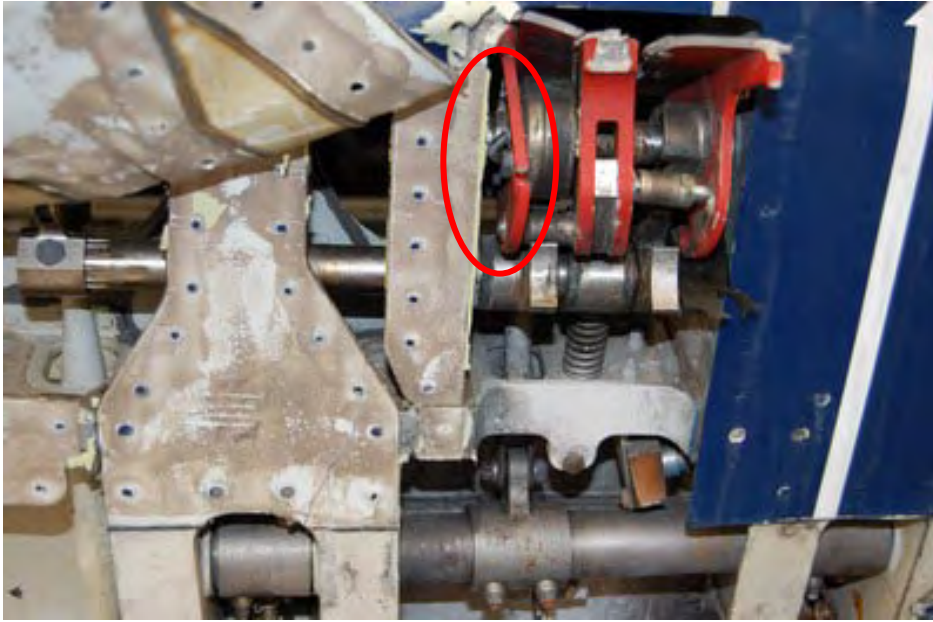
Figure 18

Description: Fractured aft cargo door handle (red) and mechanism.
