**ADDENDUM NUMBER 20 TO THE STRUCTURES GROUP CHAIRMAN'S
FACTUAL REPORT**

DCA02MA001

1. ***“Incoming inspection of the rear lug cut outs LH side shell of the fin box from the aircraft MSN 513 of the American airlines”***

Report Nr.: TN – ESWNG – 1238/03

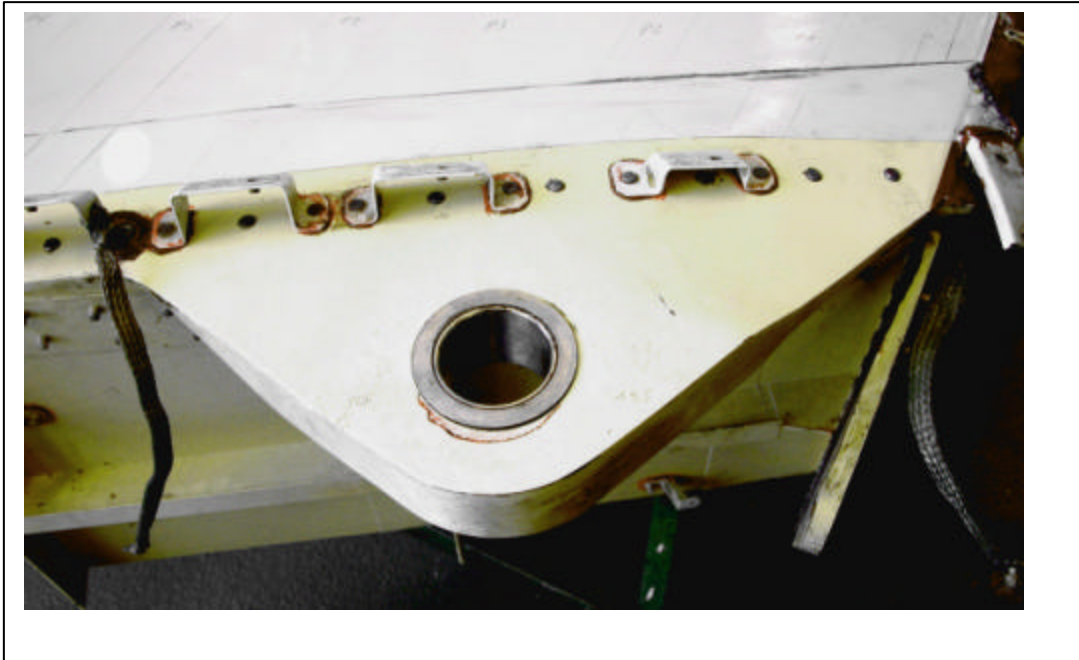
Delamination and cracks around the bushing were found.

Referred to the outboard side of the structure the indication area is in a depth of round about 3 mm (see figure 3 and 4).

- in this area no delamination was detected, only indications of cracks below reportable limits
- no gap between bushing and composite was detected

At the inspection in Hamburg on the lug a gap between bushing and CFRP structure of 0,3 mm to 0,5 mm is visible.

Figure 3: Area with cracks and delamination in a depth of 3 mm around the bushing (Inspected from the outboard side of the lug)

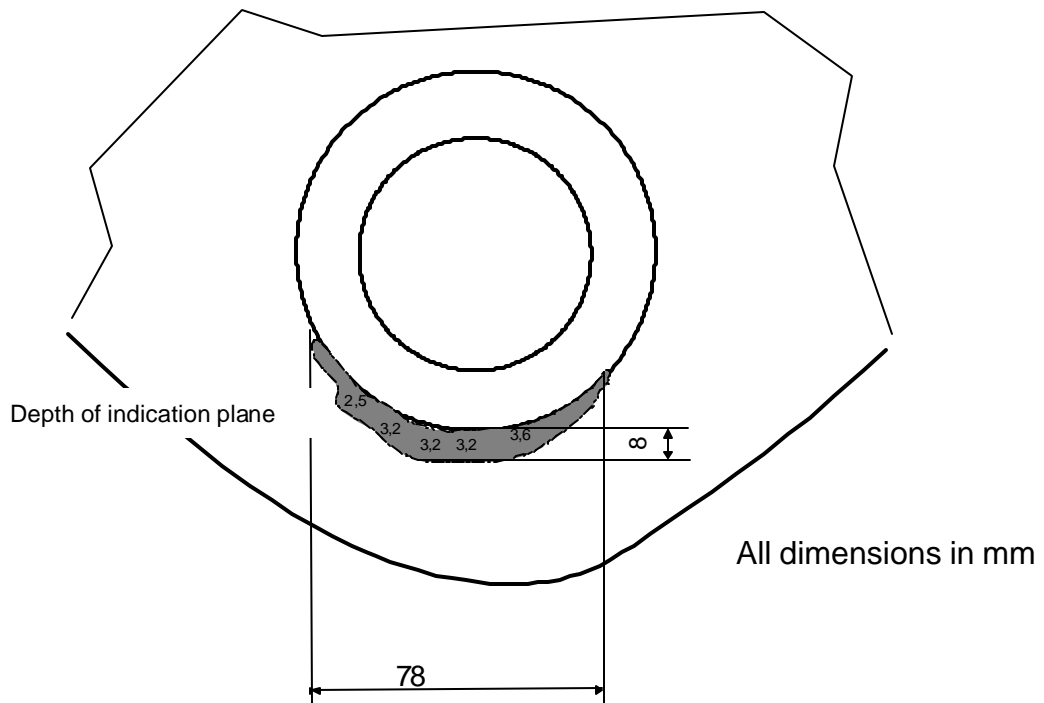
Figure 4: Delamination and cracks in the rear lug LH side (Inspected from the outboard side of the lug)

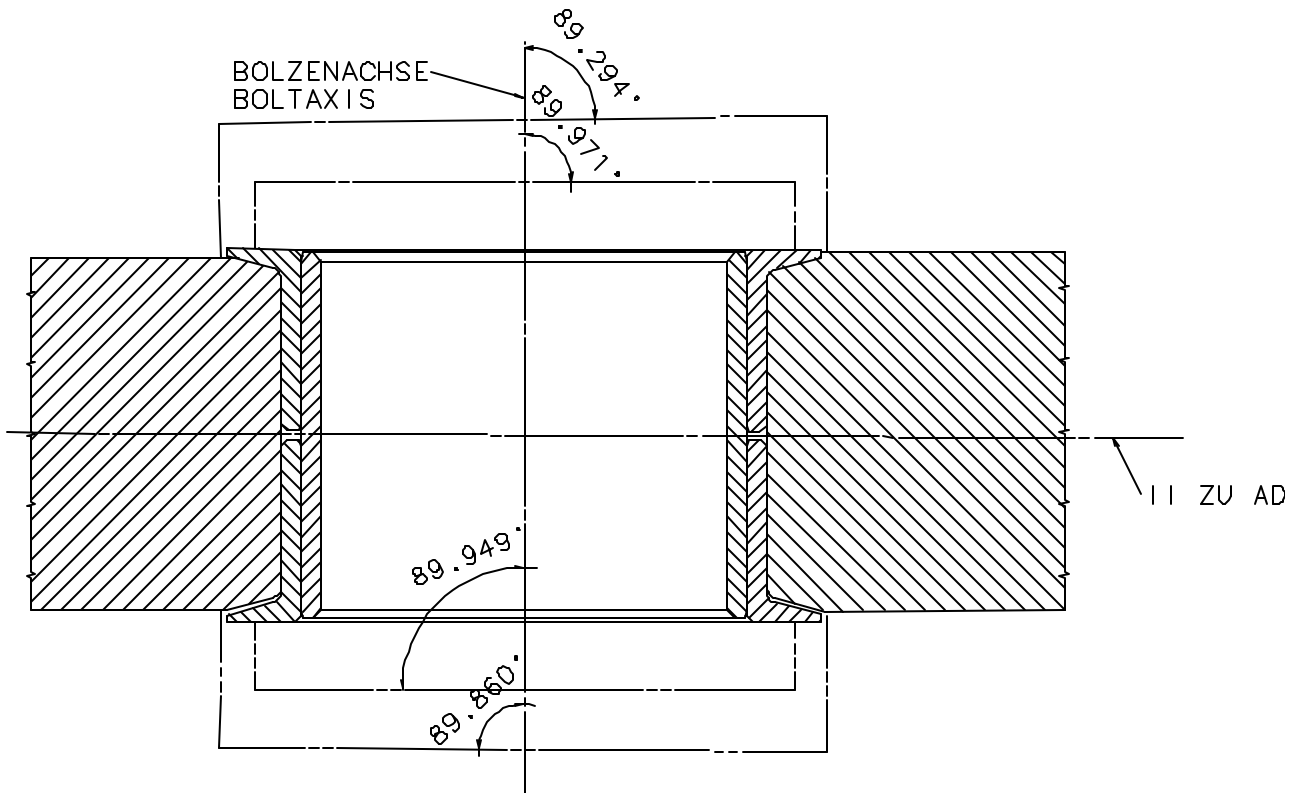
The result of a coordinate measuring device about the orientation of the bushing to the CFRP structure is described in the figures 5 and 6.

Figure5: Orientation of the bushing to the attached fitting in the direction of cut B15-B15 at the first incoming inspection (results of a coordinate measuring device)

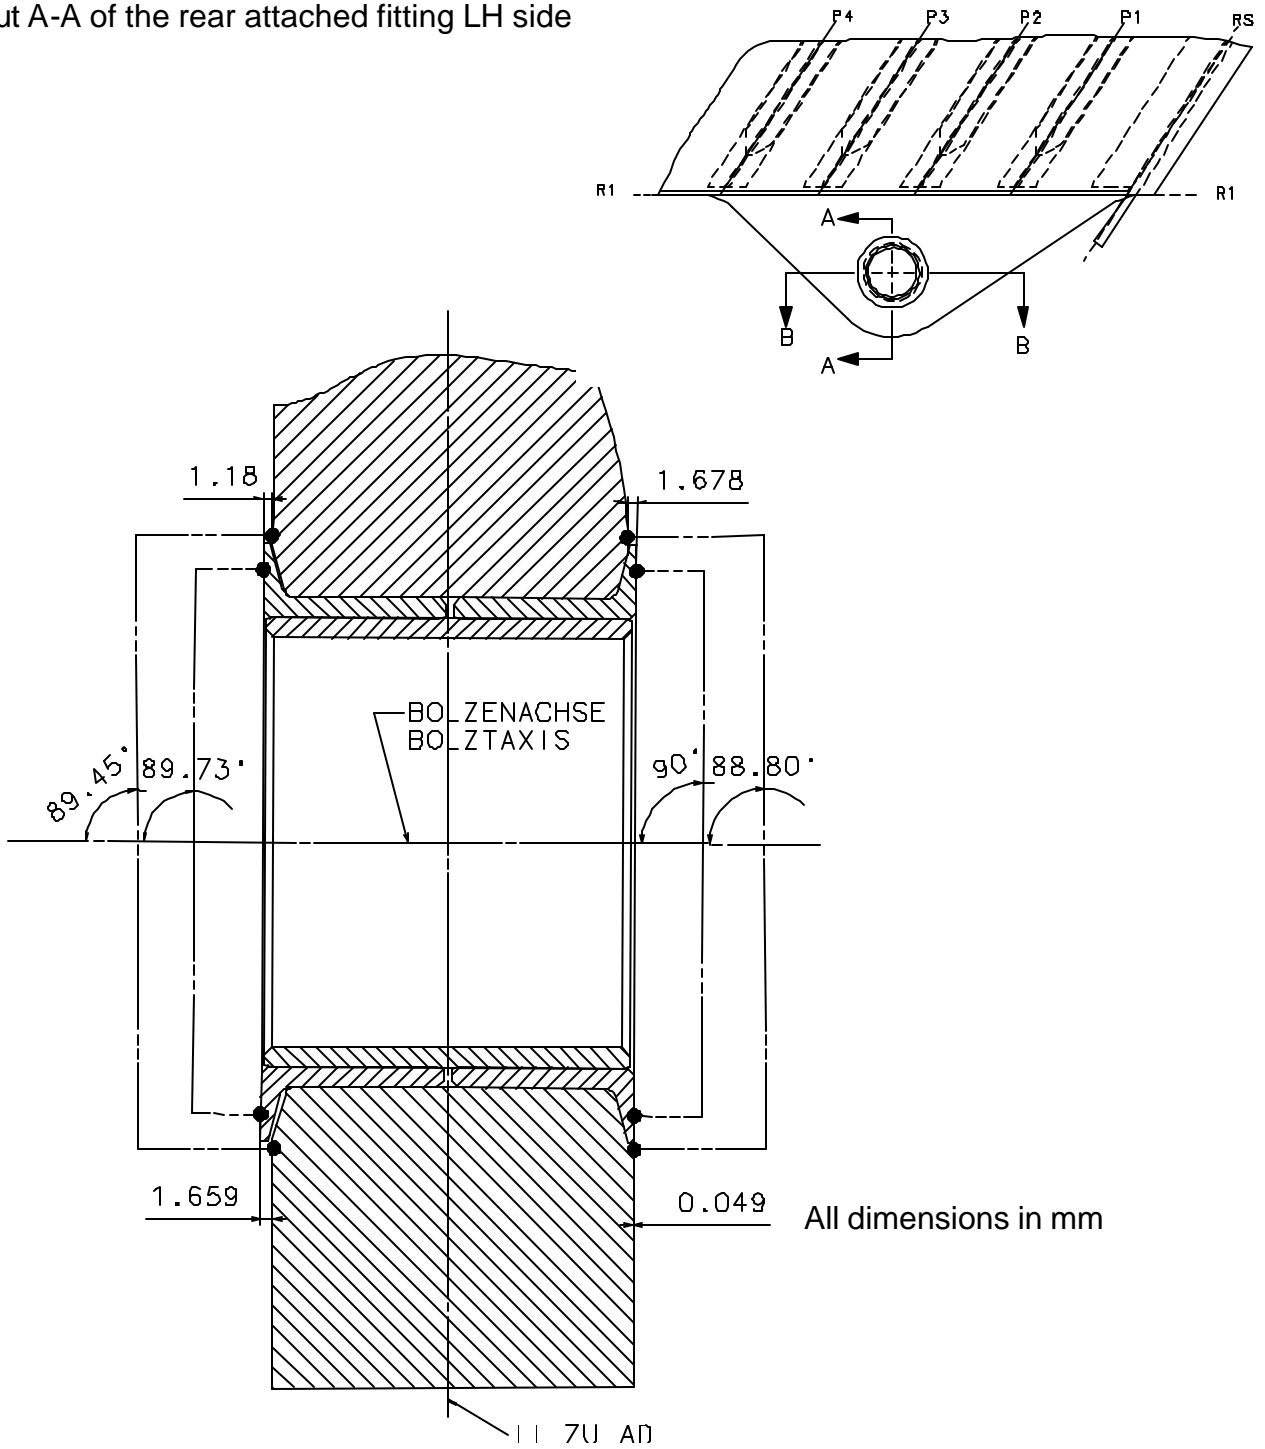
Figure 6: Orientation of the bushing to the attached fitting in the direction of cut A15-A15 at the first incoming inspection (results of a coordinate measuring device)

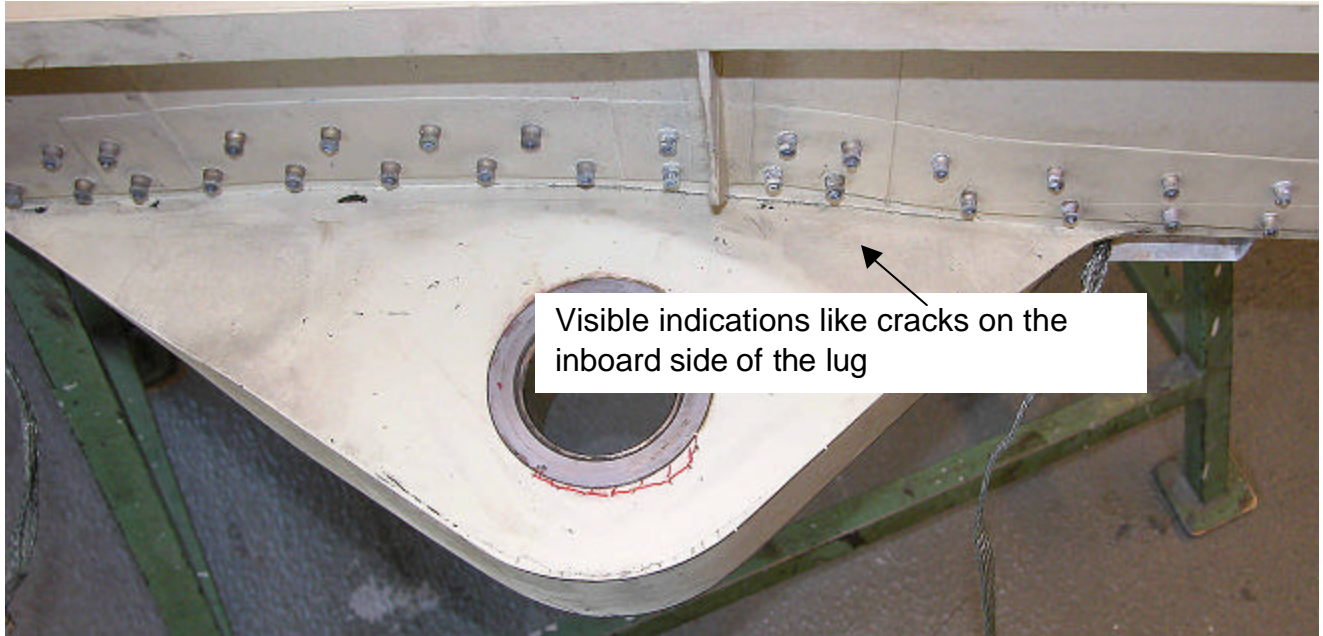
On the inboard side of the lug there are visible indications like cracks, as in figure 7 described.

This area was inspected with ultrasound, but no crack indications were found. (Wedge was handled as in non SSI NTM 55 30 01 described.)

Figure 7: Visible indications on the inboard side of the lug

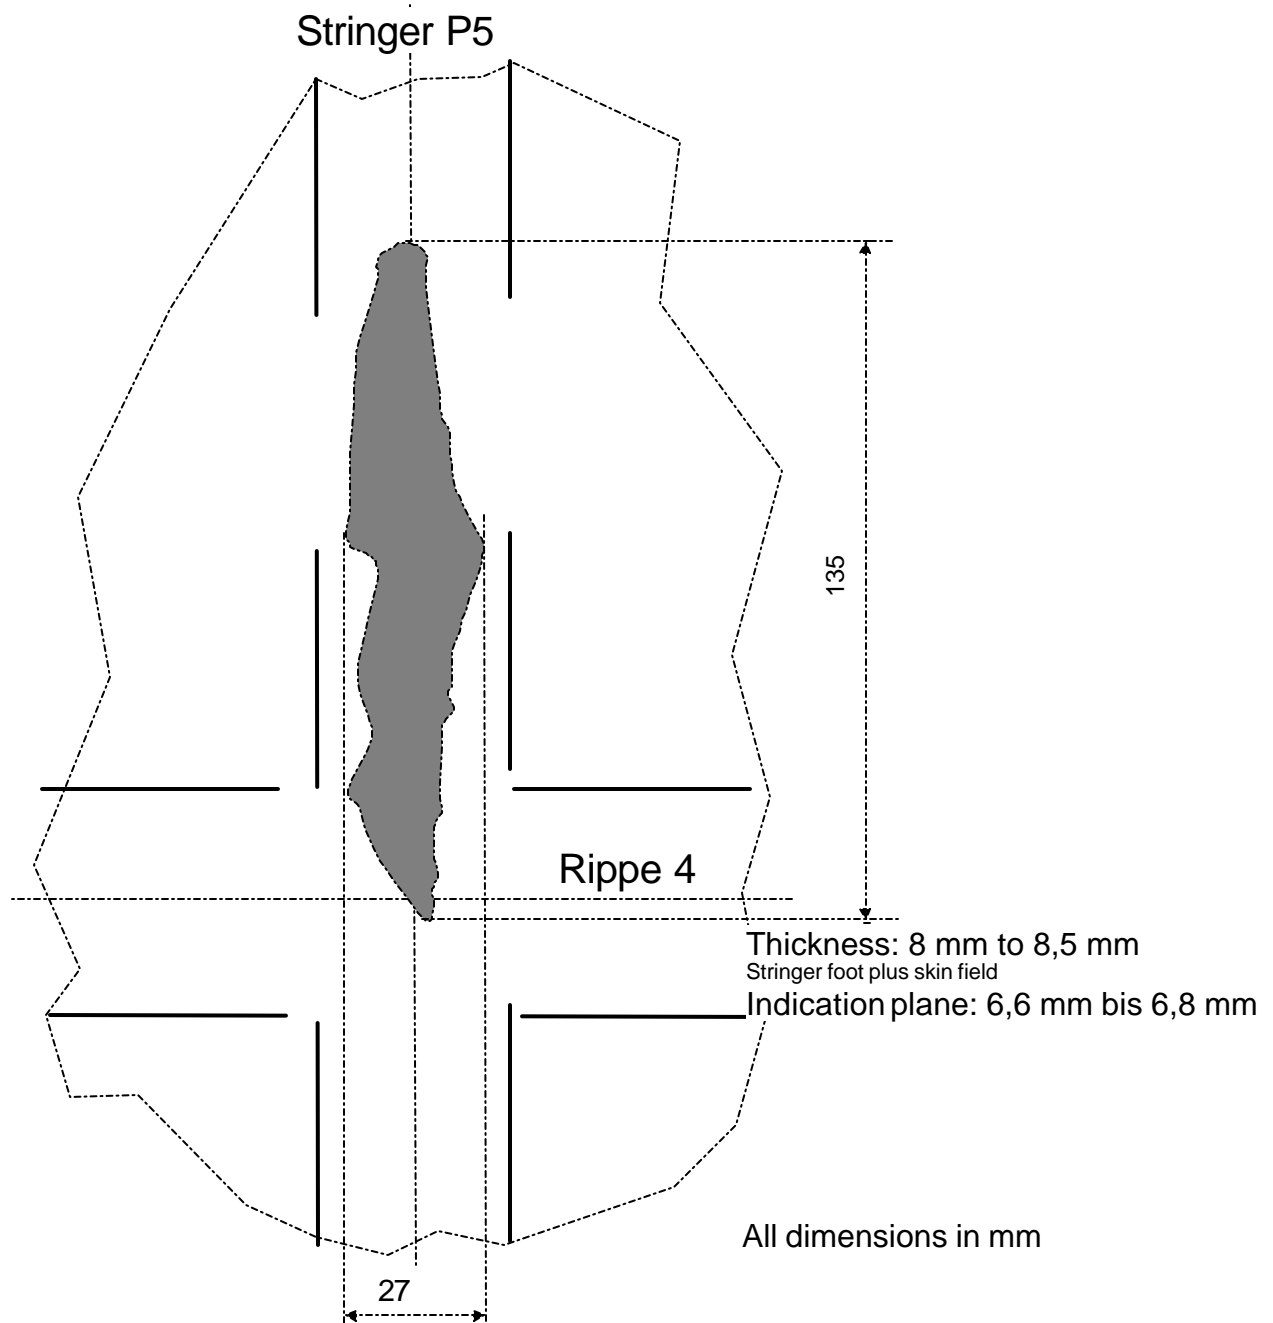
A delamination in the foot of stringer P5 near rib 4 was found (figure 8). When this area was inspected in Tulsa no defect indications were detected.

Figure 8: Delamination at stringer P5 on LH side shell

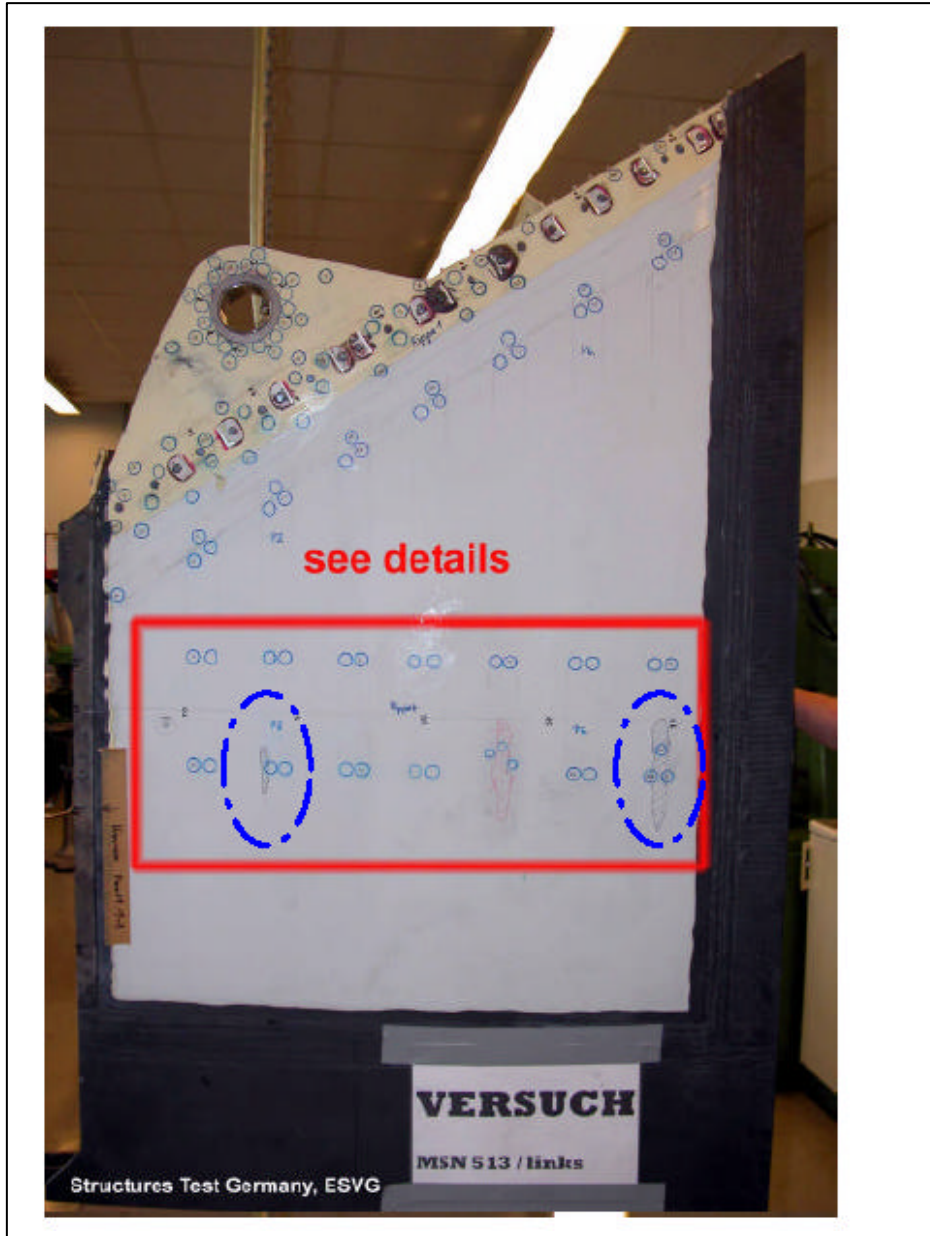
The indications of the first incoming test were confirmed and additional indications were found.

Figure9: Additional findings at the second incoming test in the cut out LH of the fin box of the MSN 513

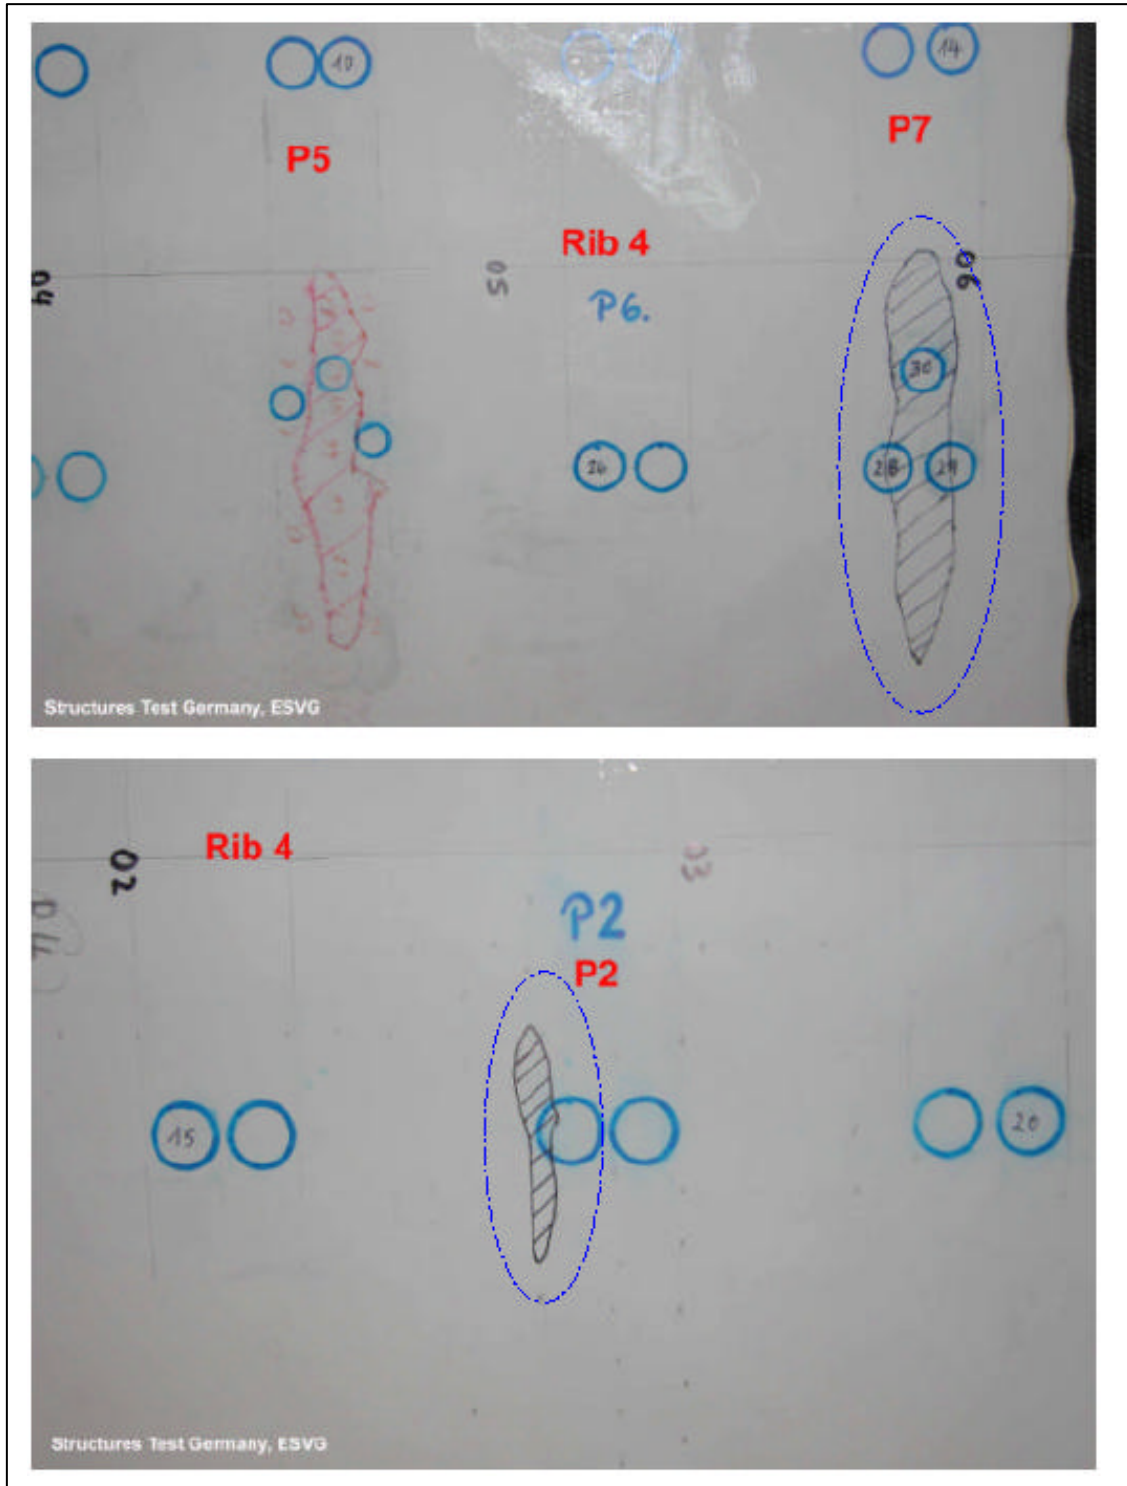
Figure 10: Details of the additional findings at the second incoming test

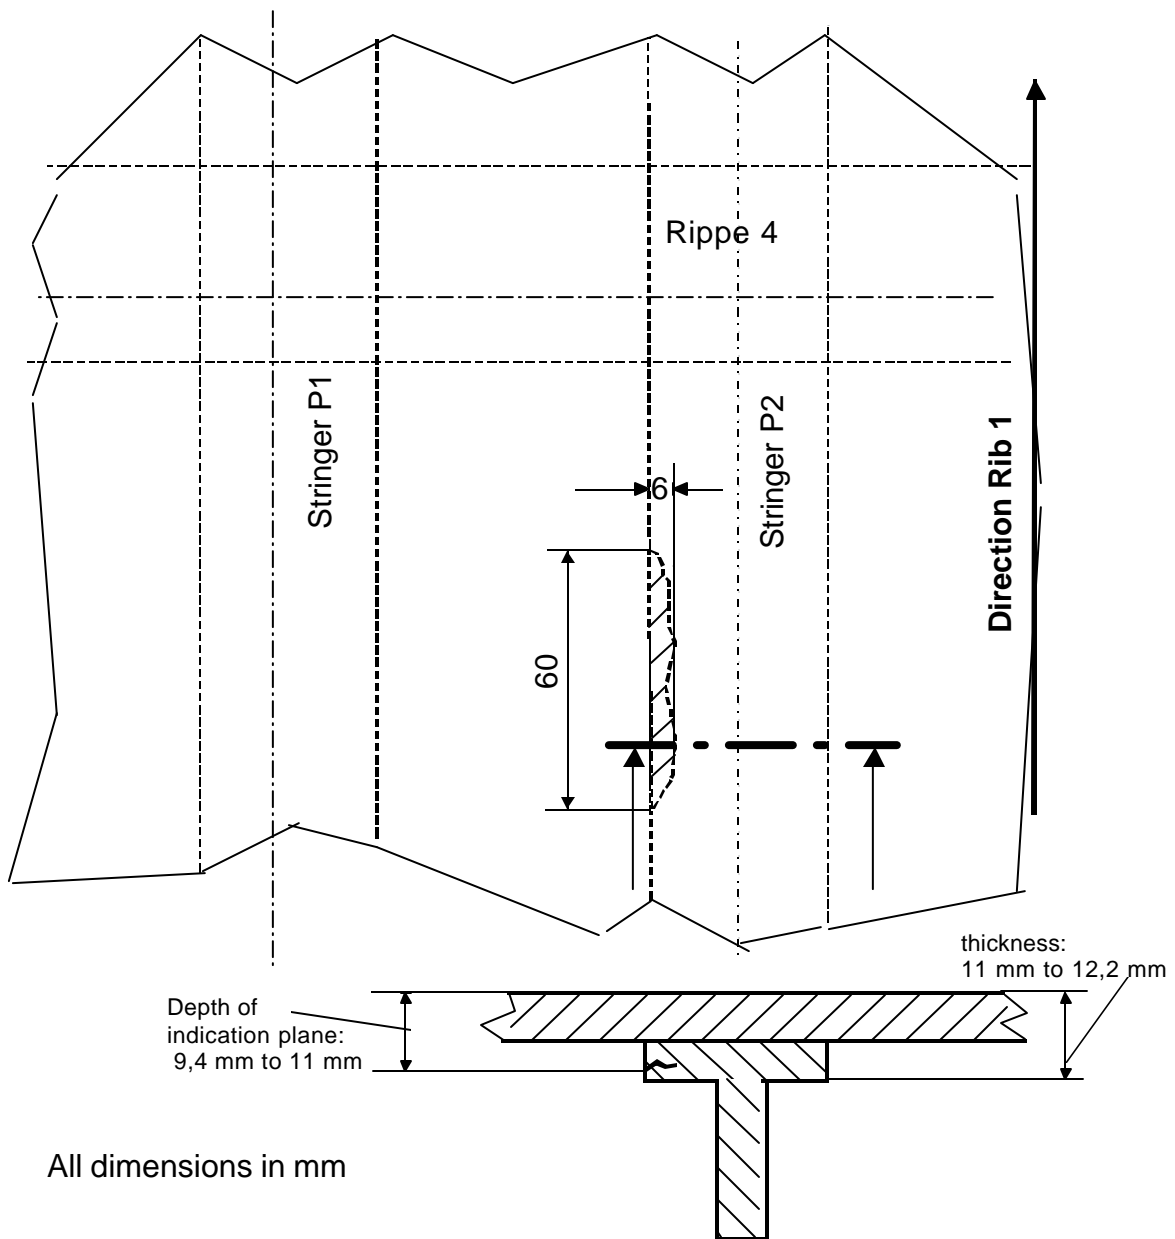
- Delamination in the foot of stringer P2 near rib 4 (figure 11)
- Delamination in the foot of stringer P7 near rib 4 (figure 12)

Figure 11: Delamination in the foot of stringer P2

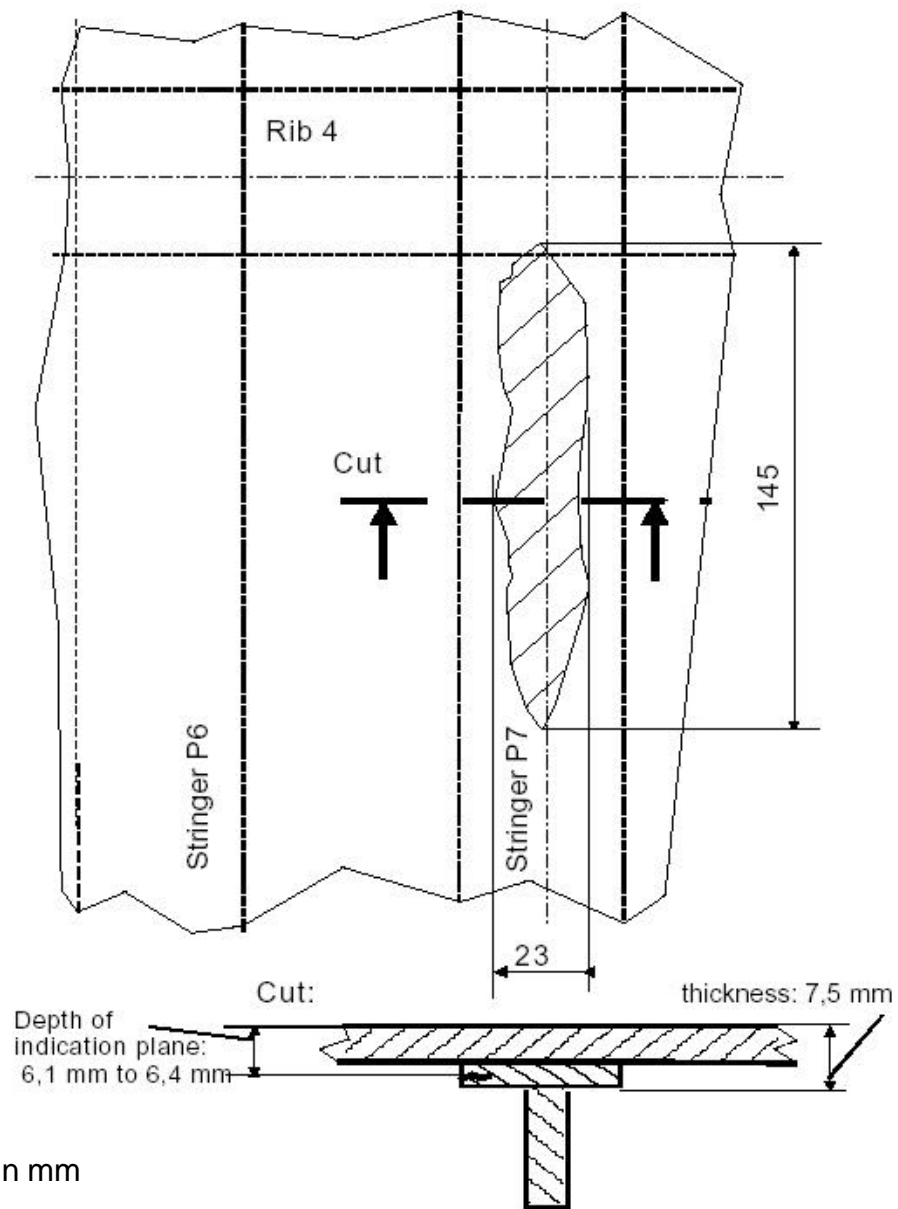
Figure 12: Delamination in the foot of stringer P7
