**NATIONAL TRANSPORTATION SAFETY BOARD**

**ADDENDUM NUMBER 21 TO THE STRUCTURES GROUP CHAIRMAN'S  
FACTUAL REPORT**

**DCA02MA001**

Incoming inspection of the rear lug cut out **RH** side shell of the fin box from the aircraft MSN 513 of the American airlines

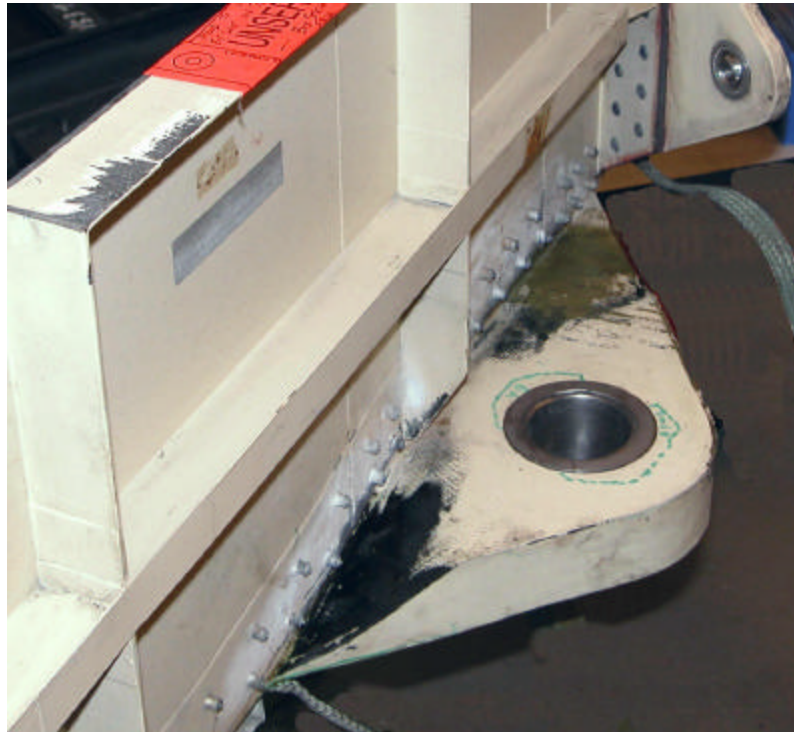
Delamination and cracks around the bushing were found.

- this area is increased (Figure 3 to 5)
- the gap between metal bushing and CFRP lug is increased. In Tulsa it was small, only a piece of paper could fit in. Now a gap between bushing and CFRP structure of 0,3 mm to 0,5 mm is visible.
- around the delaminated area a zone with cracks has developed. The depth of this plane is identical with that of the delamination.

Figure 3: Area with cracks and delaminations in a depth of 3 mm around the bushing (Inspected from the inboard side of the lug)

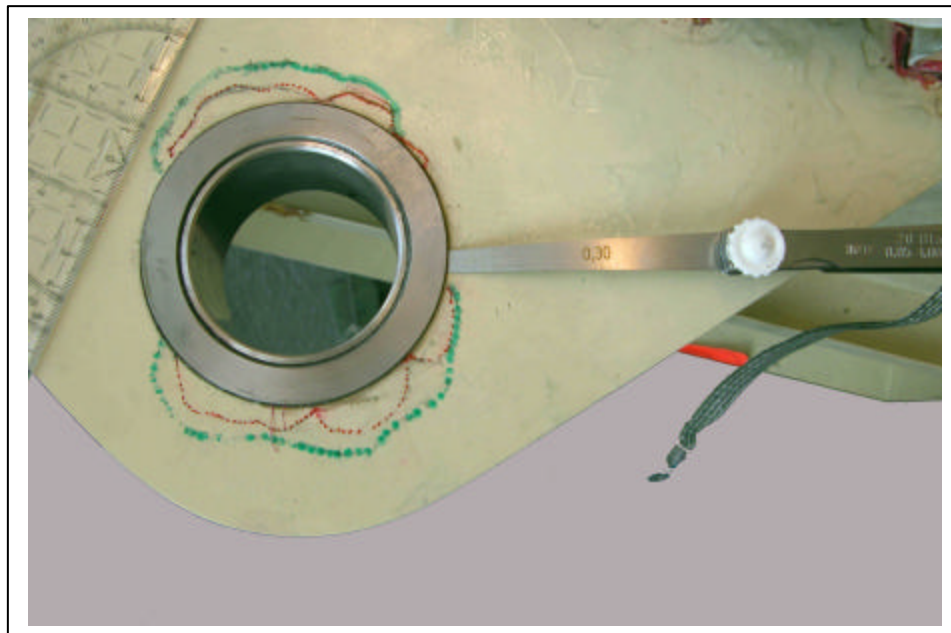
Figure 4: Delamination and cracks in the rear lug (Inspected from the outboard side of the lug)  
 Indication area from the inspection in Tulsa is marked red  
 Indication area from the incoming inspection at Airbus Hamburg is marked green

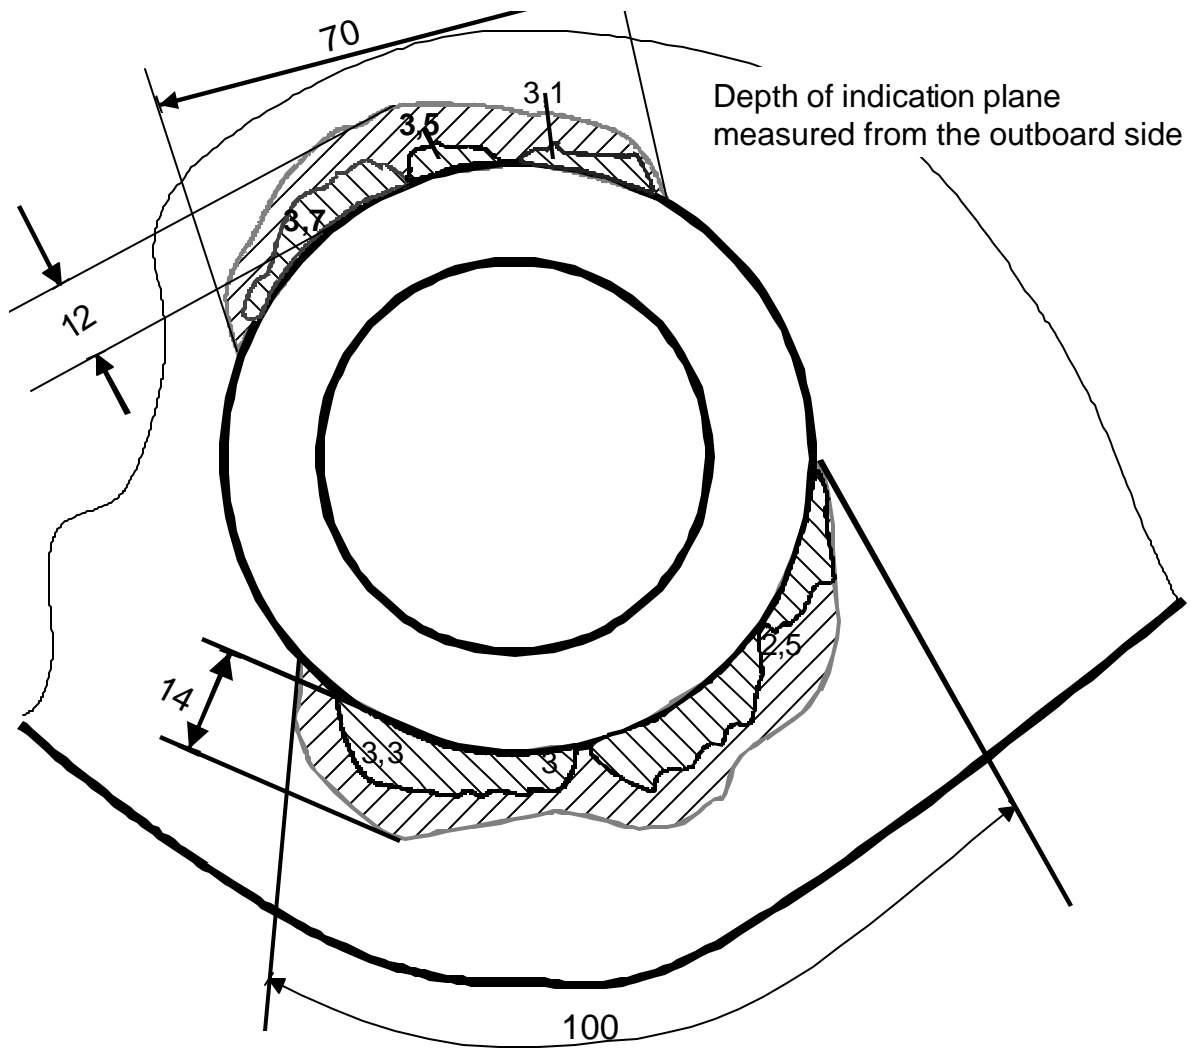
Area of the delamination at the inspection of the MSN 513 at AA in Tulsa

Area of the delaminations and cracks at the incoming inspection of the cut out in the structure test department

Figure 5: Delamination around the bushing of the rear lug

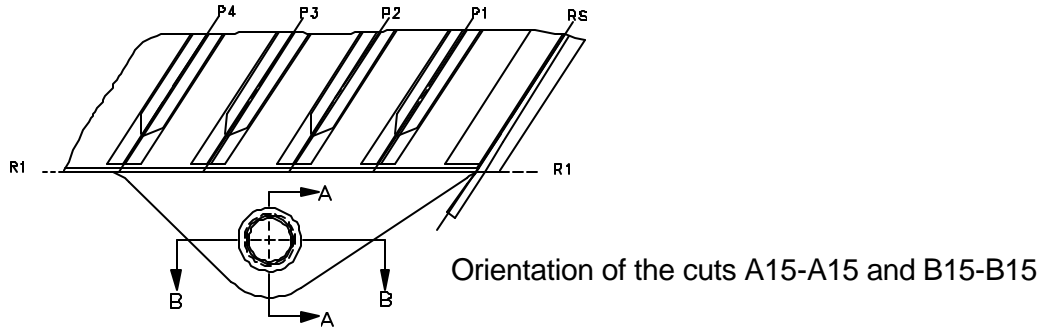
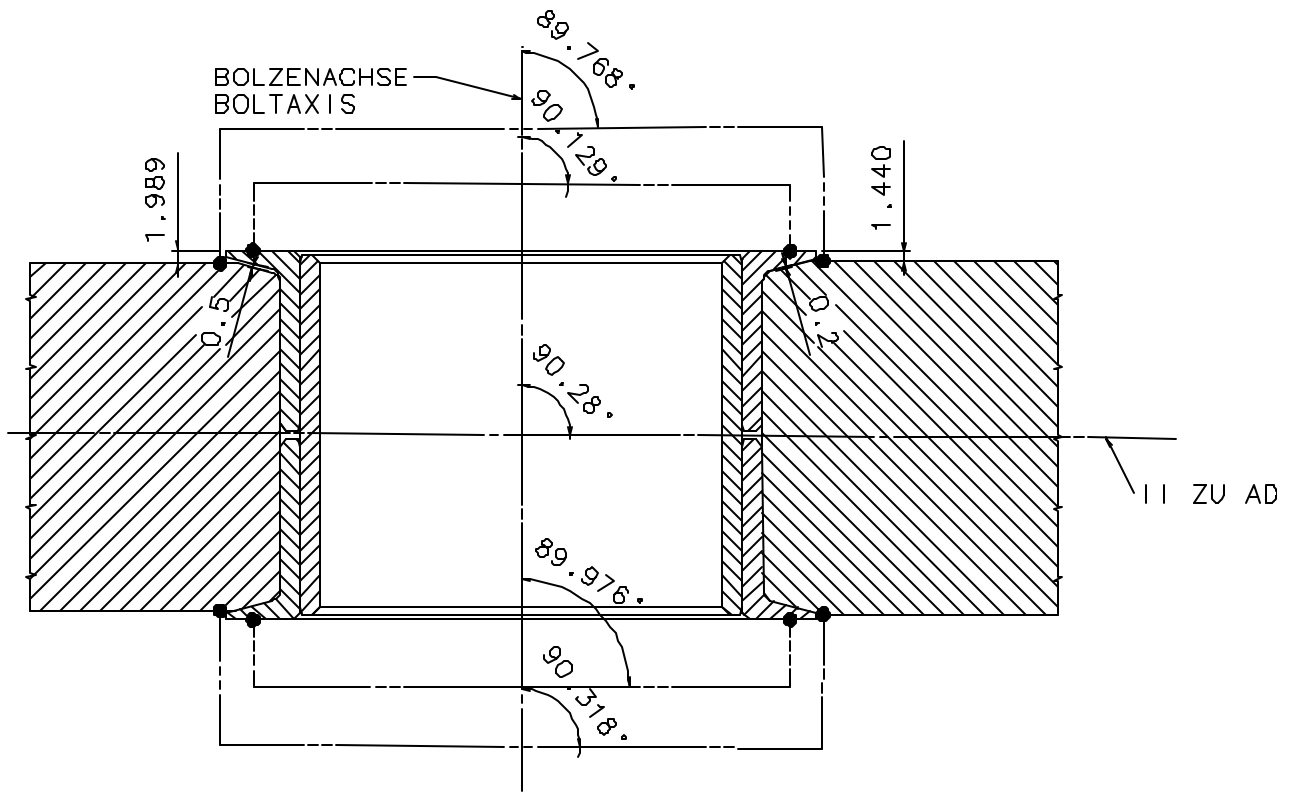
Referred to the outboard side of the structure the indication area is in a depth of round about 3 mm (see figure 6).

The result of a coordinate measuring device about the orientation of the bushing to the CFRP structure is described in the figures 6 and 7.

Figure6: Orientation of the bushing to the attached fitting in the direction of cut B15-B15 at the first incoming inspection (results of a coordinate measuring device)

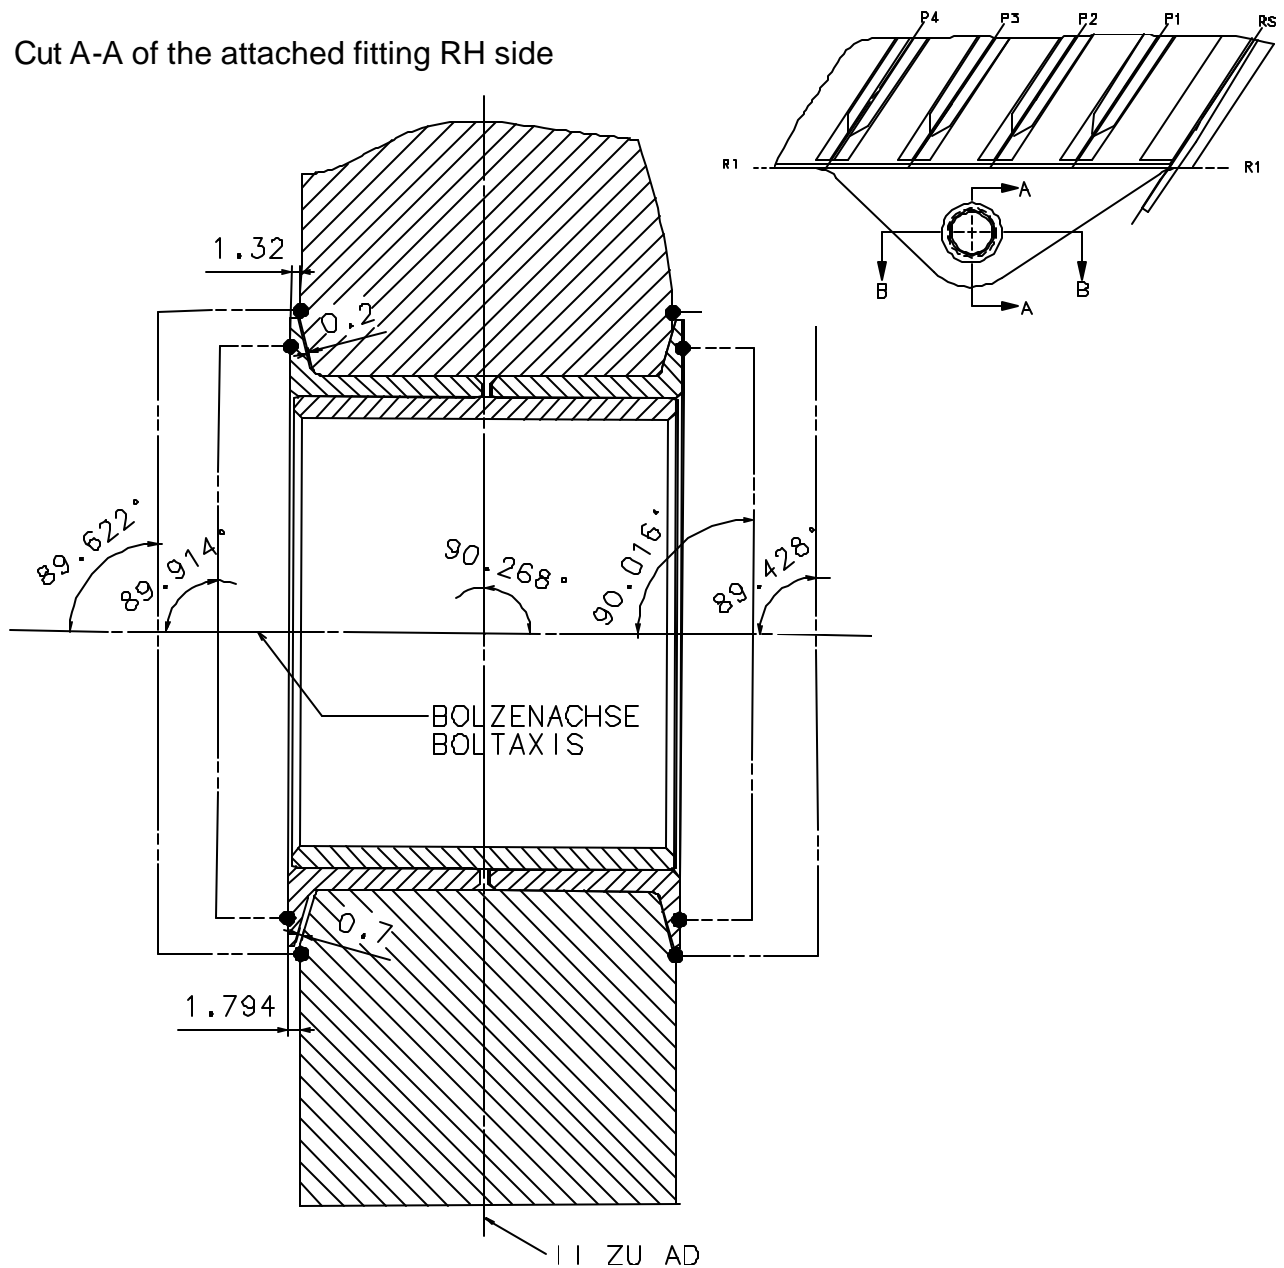
Figure 7: Orientation of the bushing to the attached fitting in the direction of cut A15-A15 at the first incoming inspection (results of a coordinate measuring device)

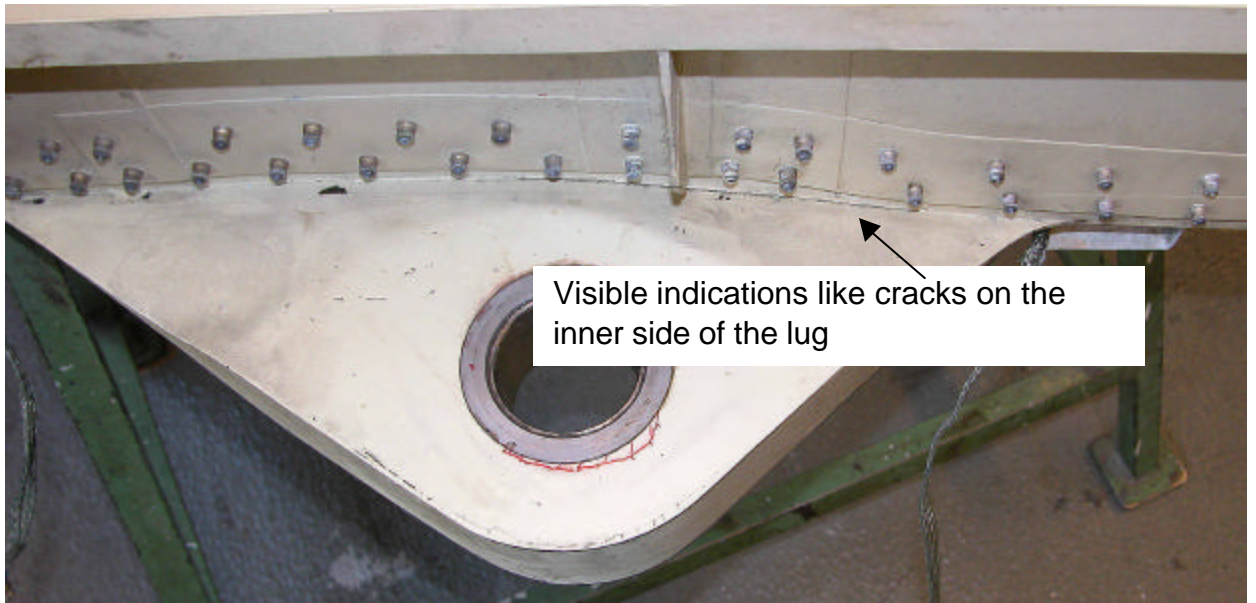
On the inboard side of the lug there are visible indications like cracks, as in figure 8 described.

This area was inspected with ultrasound, but no crack indications were found. (Wedge was handled as in non SSI NTM 55 30 01 described.)

Figure 8: Visible indications on the inboard side of the lugs  
(Picture shown is from left hand side)

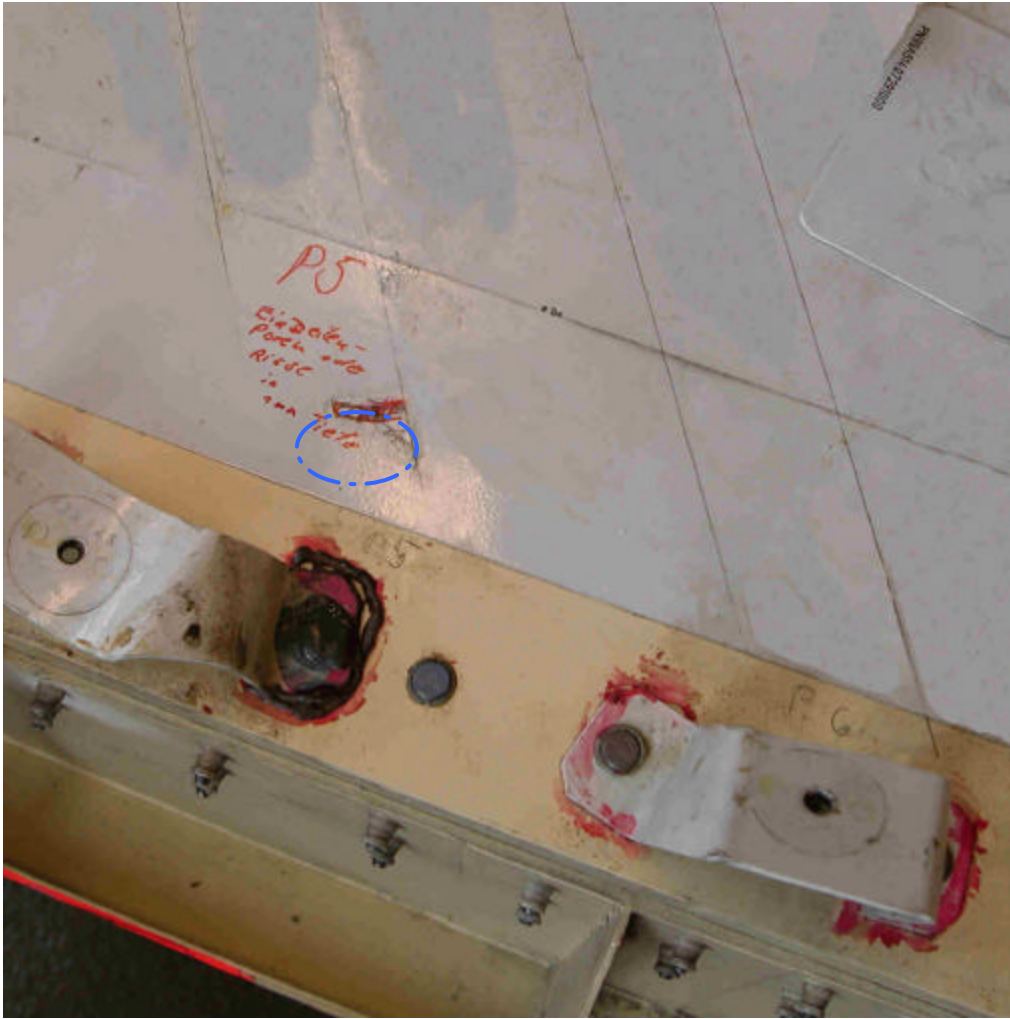
An area with single-depth pores or concentration of small cracks in a certain depth was found on stringer P5 at the connecting area of the rib 1 attachment angle and the skin panel. The indication plane is in a depth of 1 mm measured from the surface (See Figure 9 and 10).

Figure 9: Area stringer P5 / rib1 attachment angle  
Single depth porosity or concentration of small cracks

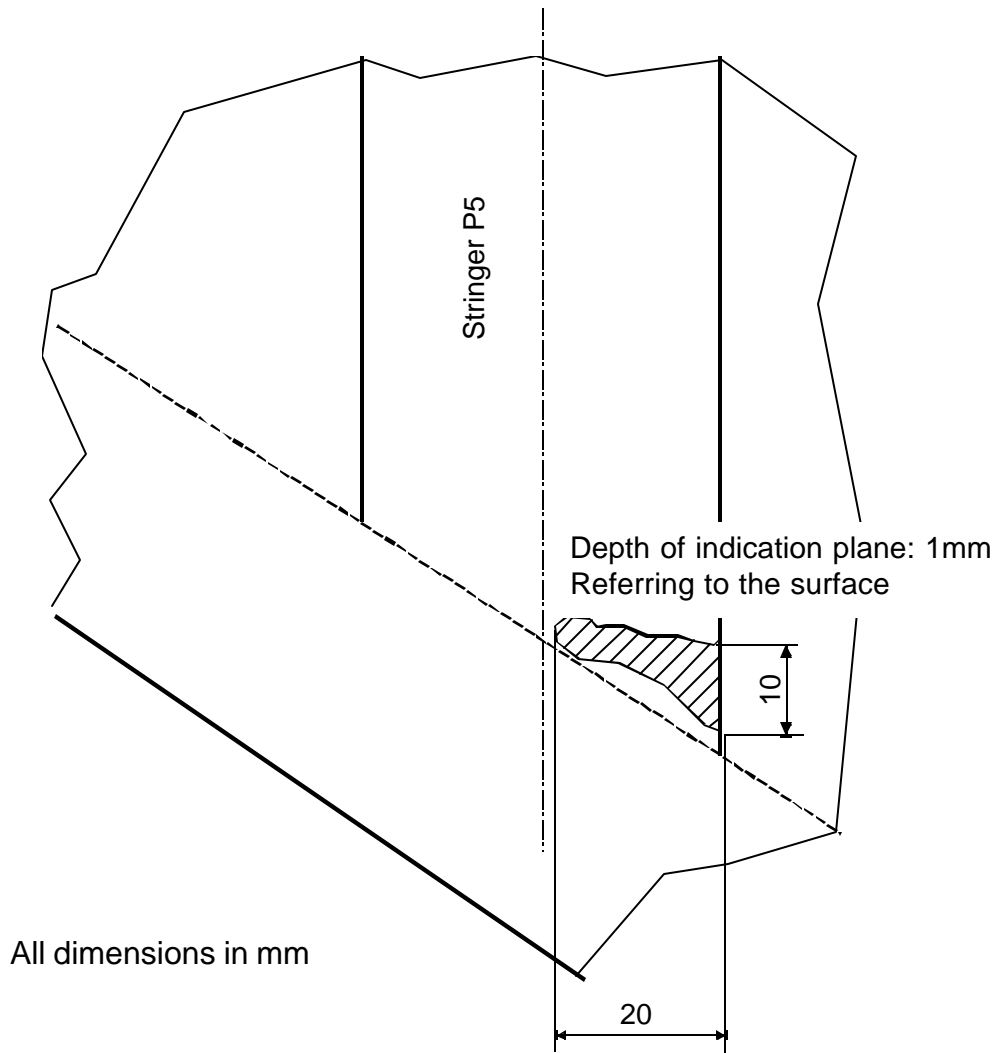
Figure10: Indications on stringer P1 / rib 1 attachment angle; dimensions  
(Location of single depth porosity or concentration of small cracks)

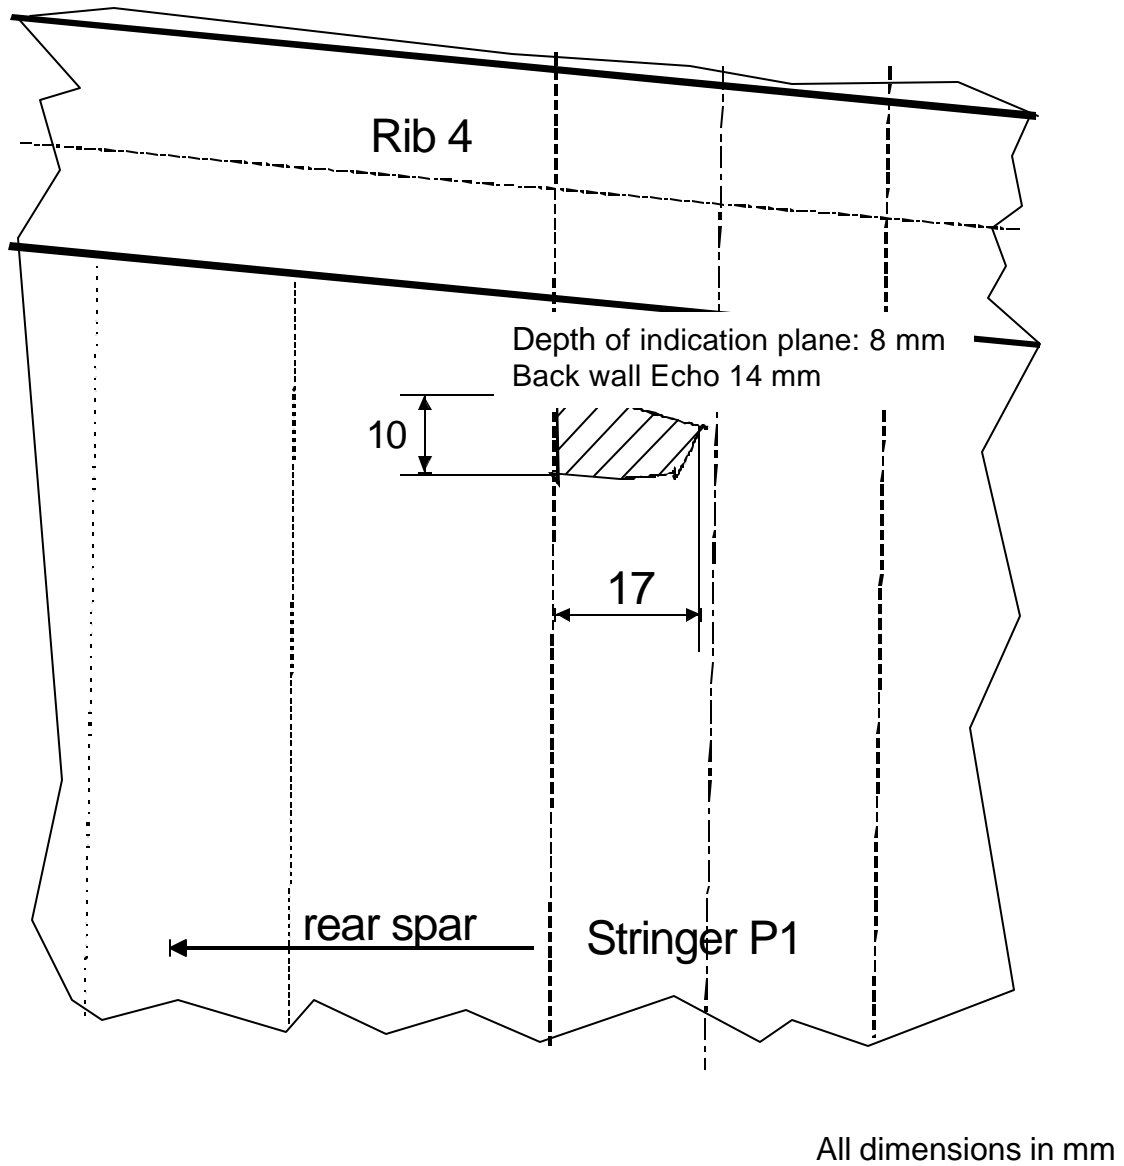
An area with single-depth pores or a concentration of cracks in the bonding of stringer P1 (Figure 11) was found.

The area of this indication is the same as in Tulsa. This indication was not published in the damage report, because this area was too small to be reported and the ultrasound echo from the indication plane was too small.

Figure 11: Dimension and location of the indication on stringer P1 / rib 4.  
(single depth porosity or cracks in the same depth)
