NATIONAL TRANSPORTATION SAFETY BOARD

Structural Analysis and Evaluation for the Airbus A300-
600R/MSN420 VTP and rudder for the accident flight AA587
Part 3: Analysis of the rupture sequence of the rudder following the accident

Technical Note

Part III: Analysis of the rupture sequence of the rudder following the accident

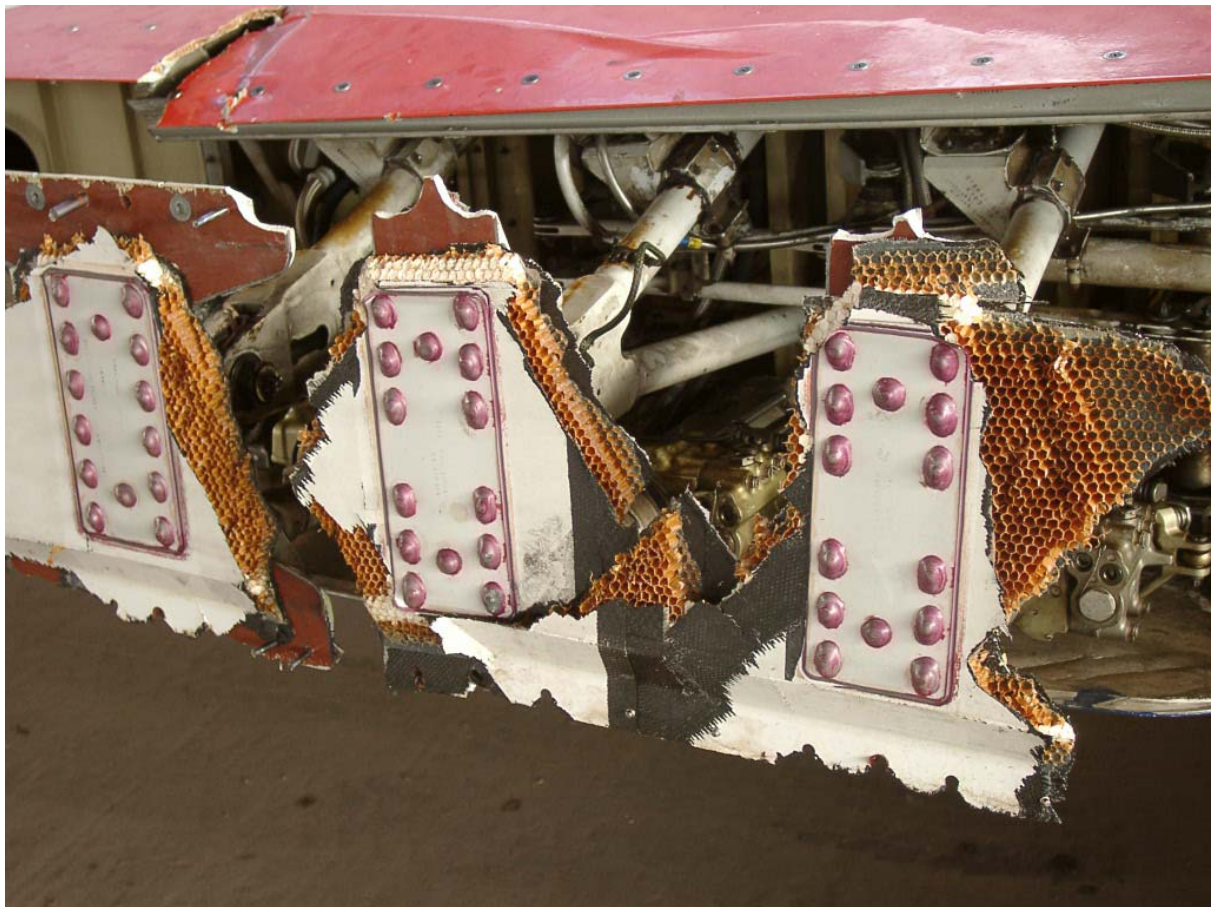
Figure 1

On the RHS of the rudder the hinge fittings BR2, BR3 and BR4 attachments ruptured by shear failure in the fitting flanges and due to bolt fracture (see figure 1).

The failure modes are identical to the observed ones at the fittings BR2, BR3 of the accident rudder (see figure 1).

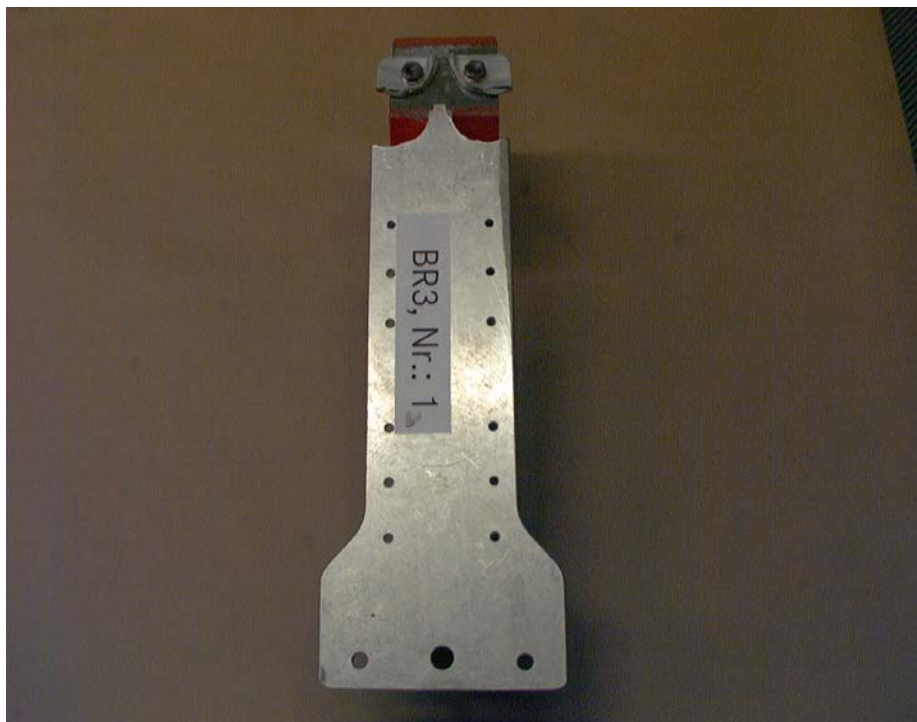
Figure 2

To establish the fitting damages test have been performed on 3 original fittings BR3 including the attach bolts as used on the rudder (see figure 2, 3).

At RHS of rudder hinge fitting BR3 and BR4 the attachment to the skin panels (see figure 23, 24) fails at this load level. Hinge fitting BR3 ruptures at RHS in the vicinity of the bolt holes (see figure 2 to 4) and at fitting BR4 five of six attach bolts rupture in tension (see figure 25).

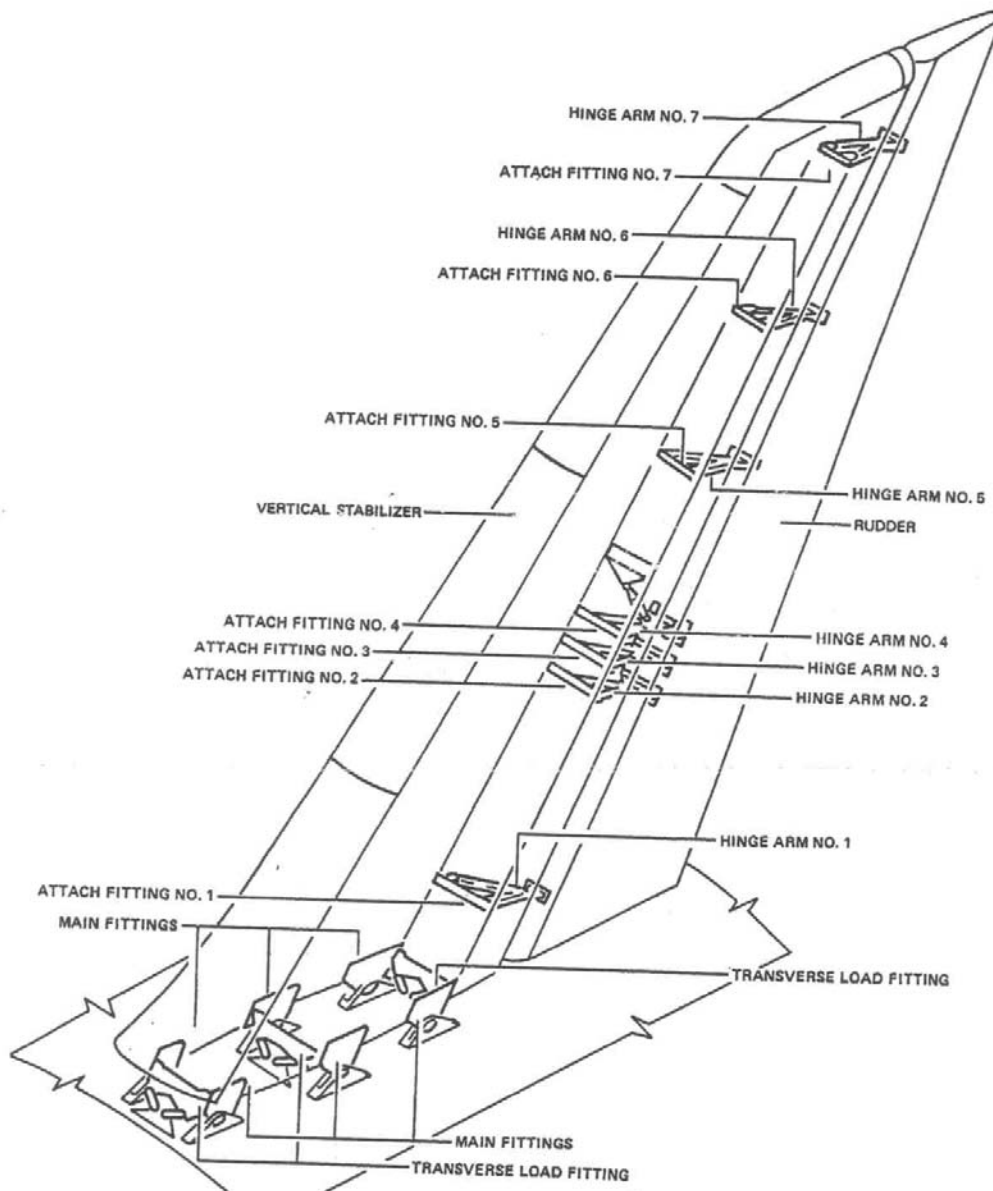
Figure 5

The strength of the hinge arm attach fittings (see figure 5, 6) has been tested during the certification program of the vertical stabilizer for fittings no. 1, 3, 4, 6 and 7.

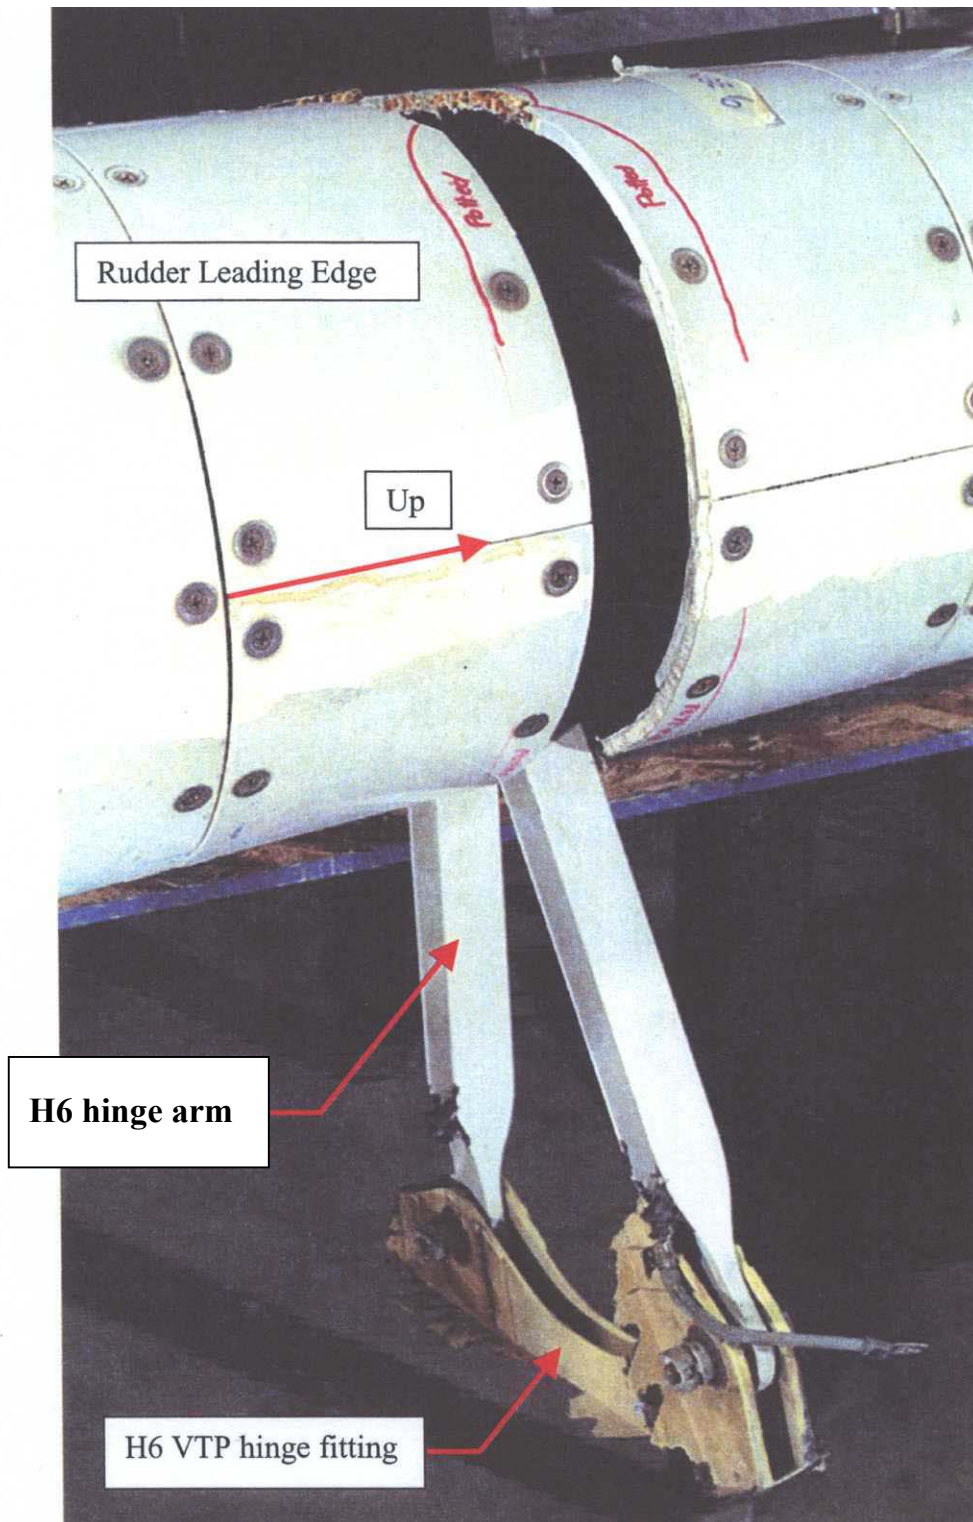
Figure 8

The failure mode of hinge fitting no. 6 in the test is similar to the observed damage at the accident rudder (see figure 8).

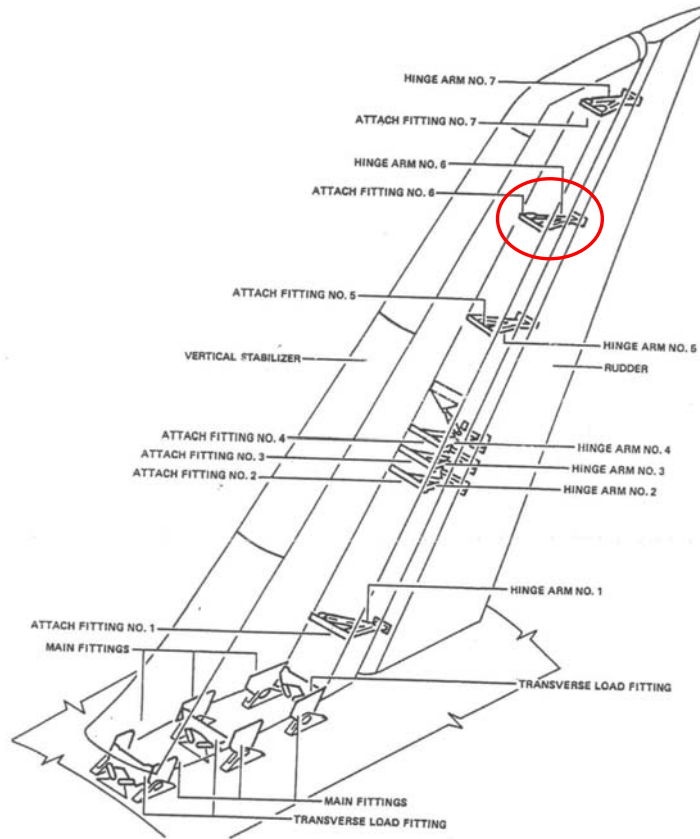
Figure 13

The analysis results indicate that hinge arm fitting no. 6 has exceeded its tension strength on RHS (see figure 7, 10, 13).

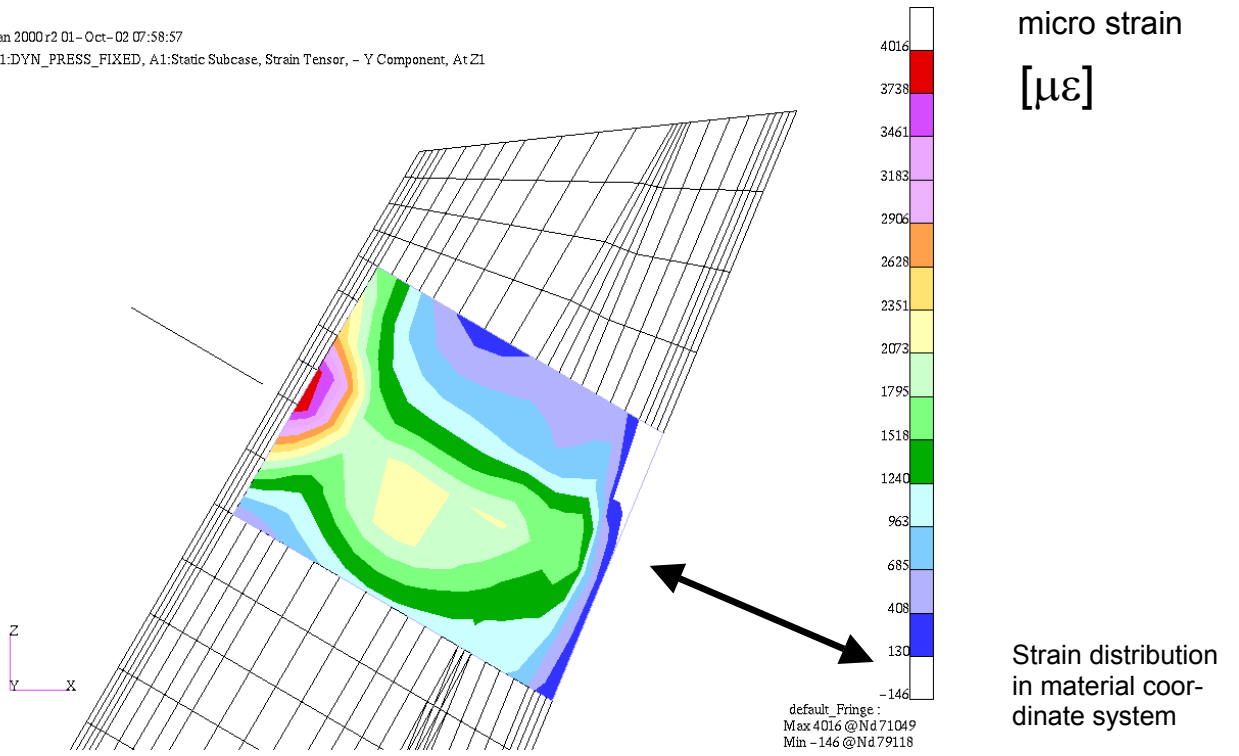
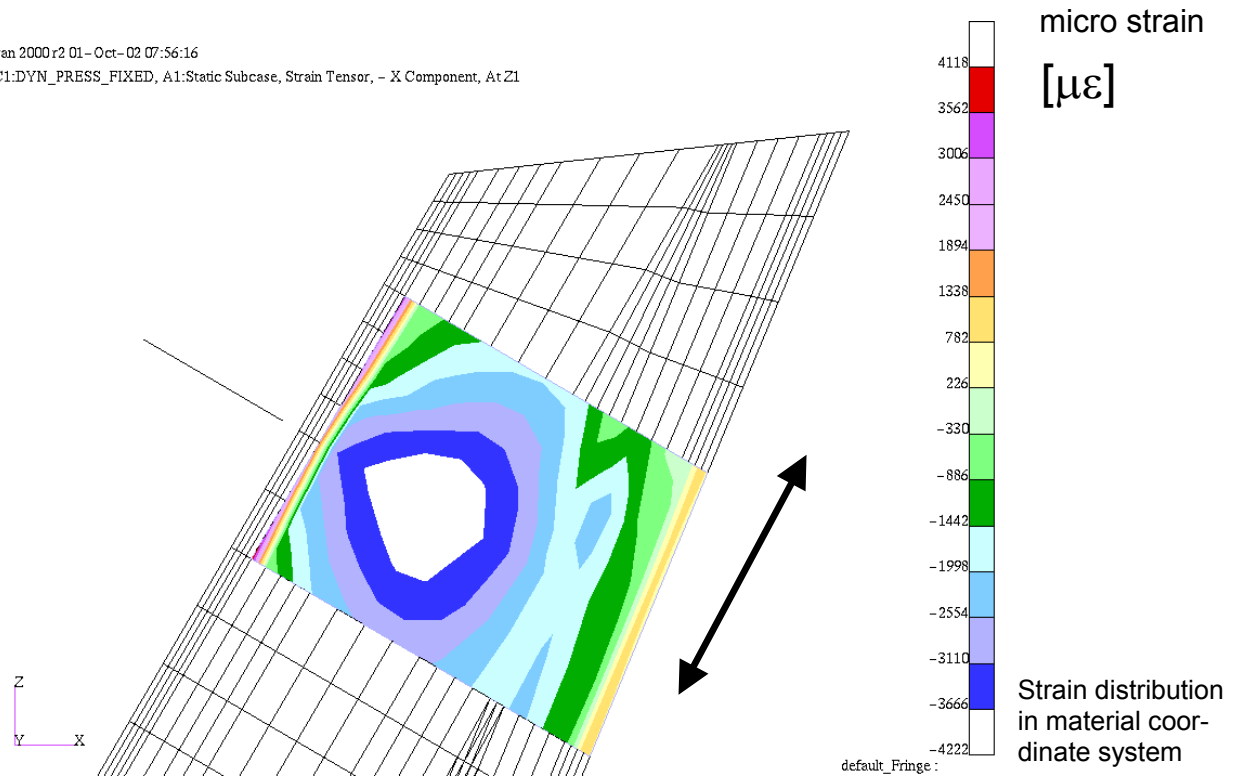
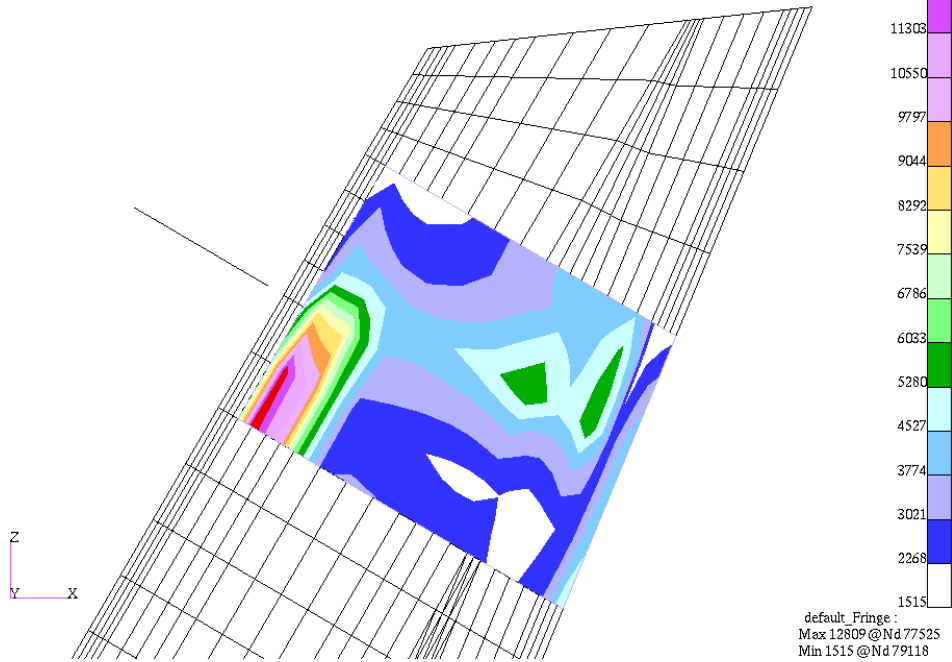
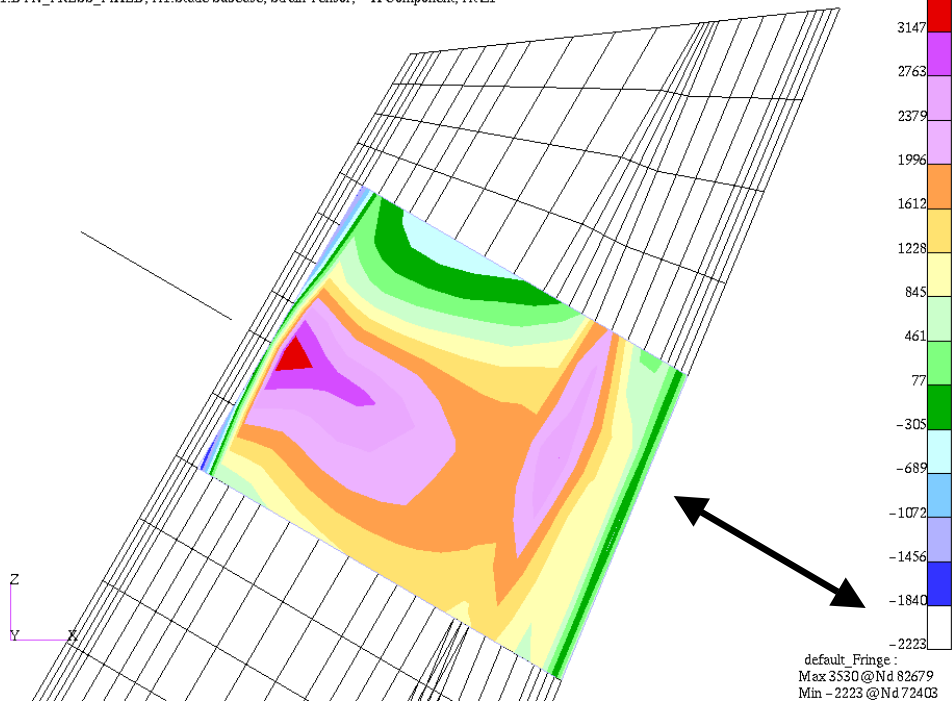
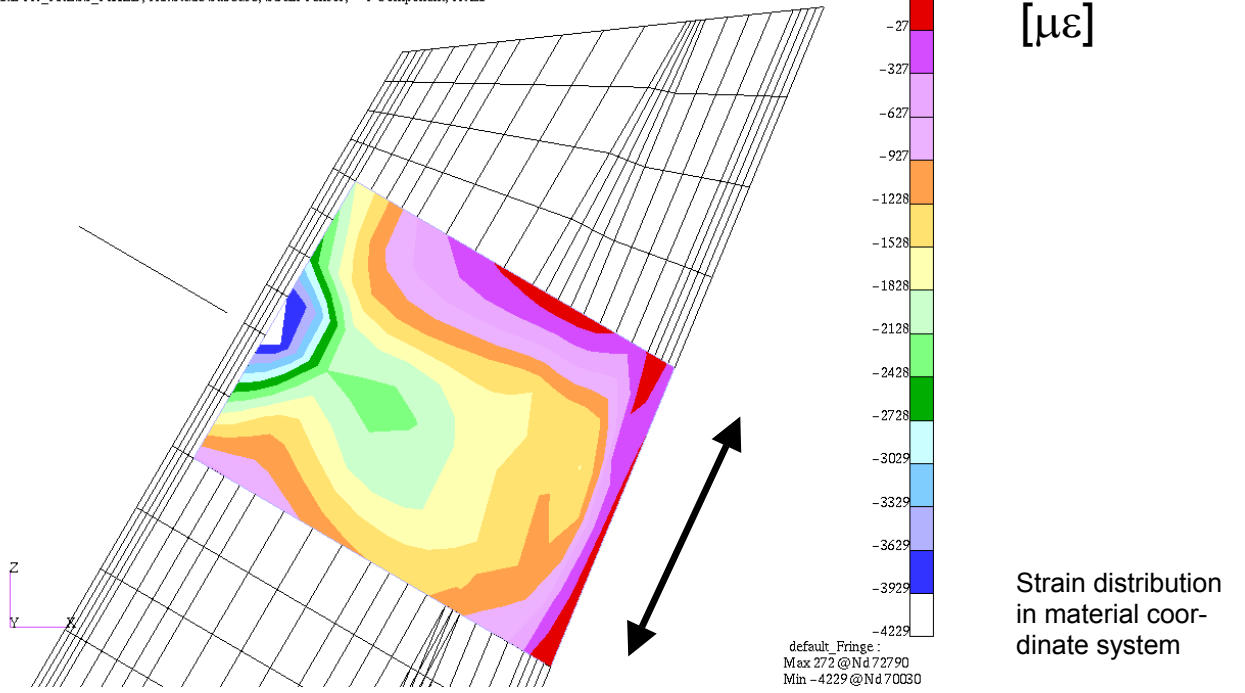
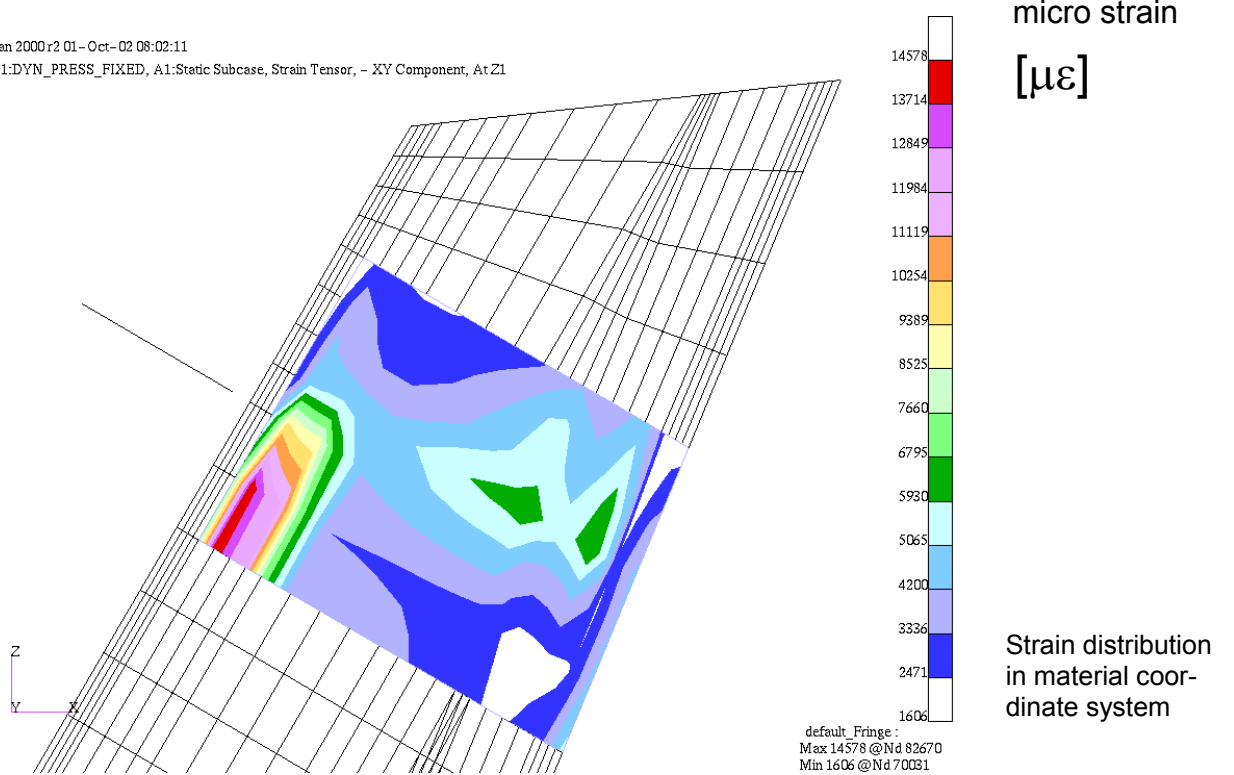
The local strain distribution around the rudder hinge fitting BR7 (see figure 16 to 21) indicates the rupture of the skin panels in the vicinity of the fitting attachment. The direction of x-component of strain is cordwise normal to the rudder spar plane and the y-component is spanwise.
