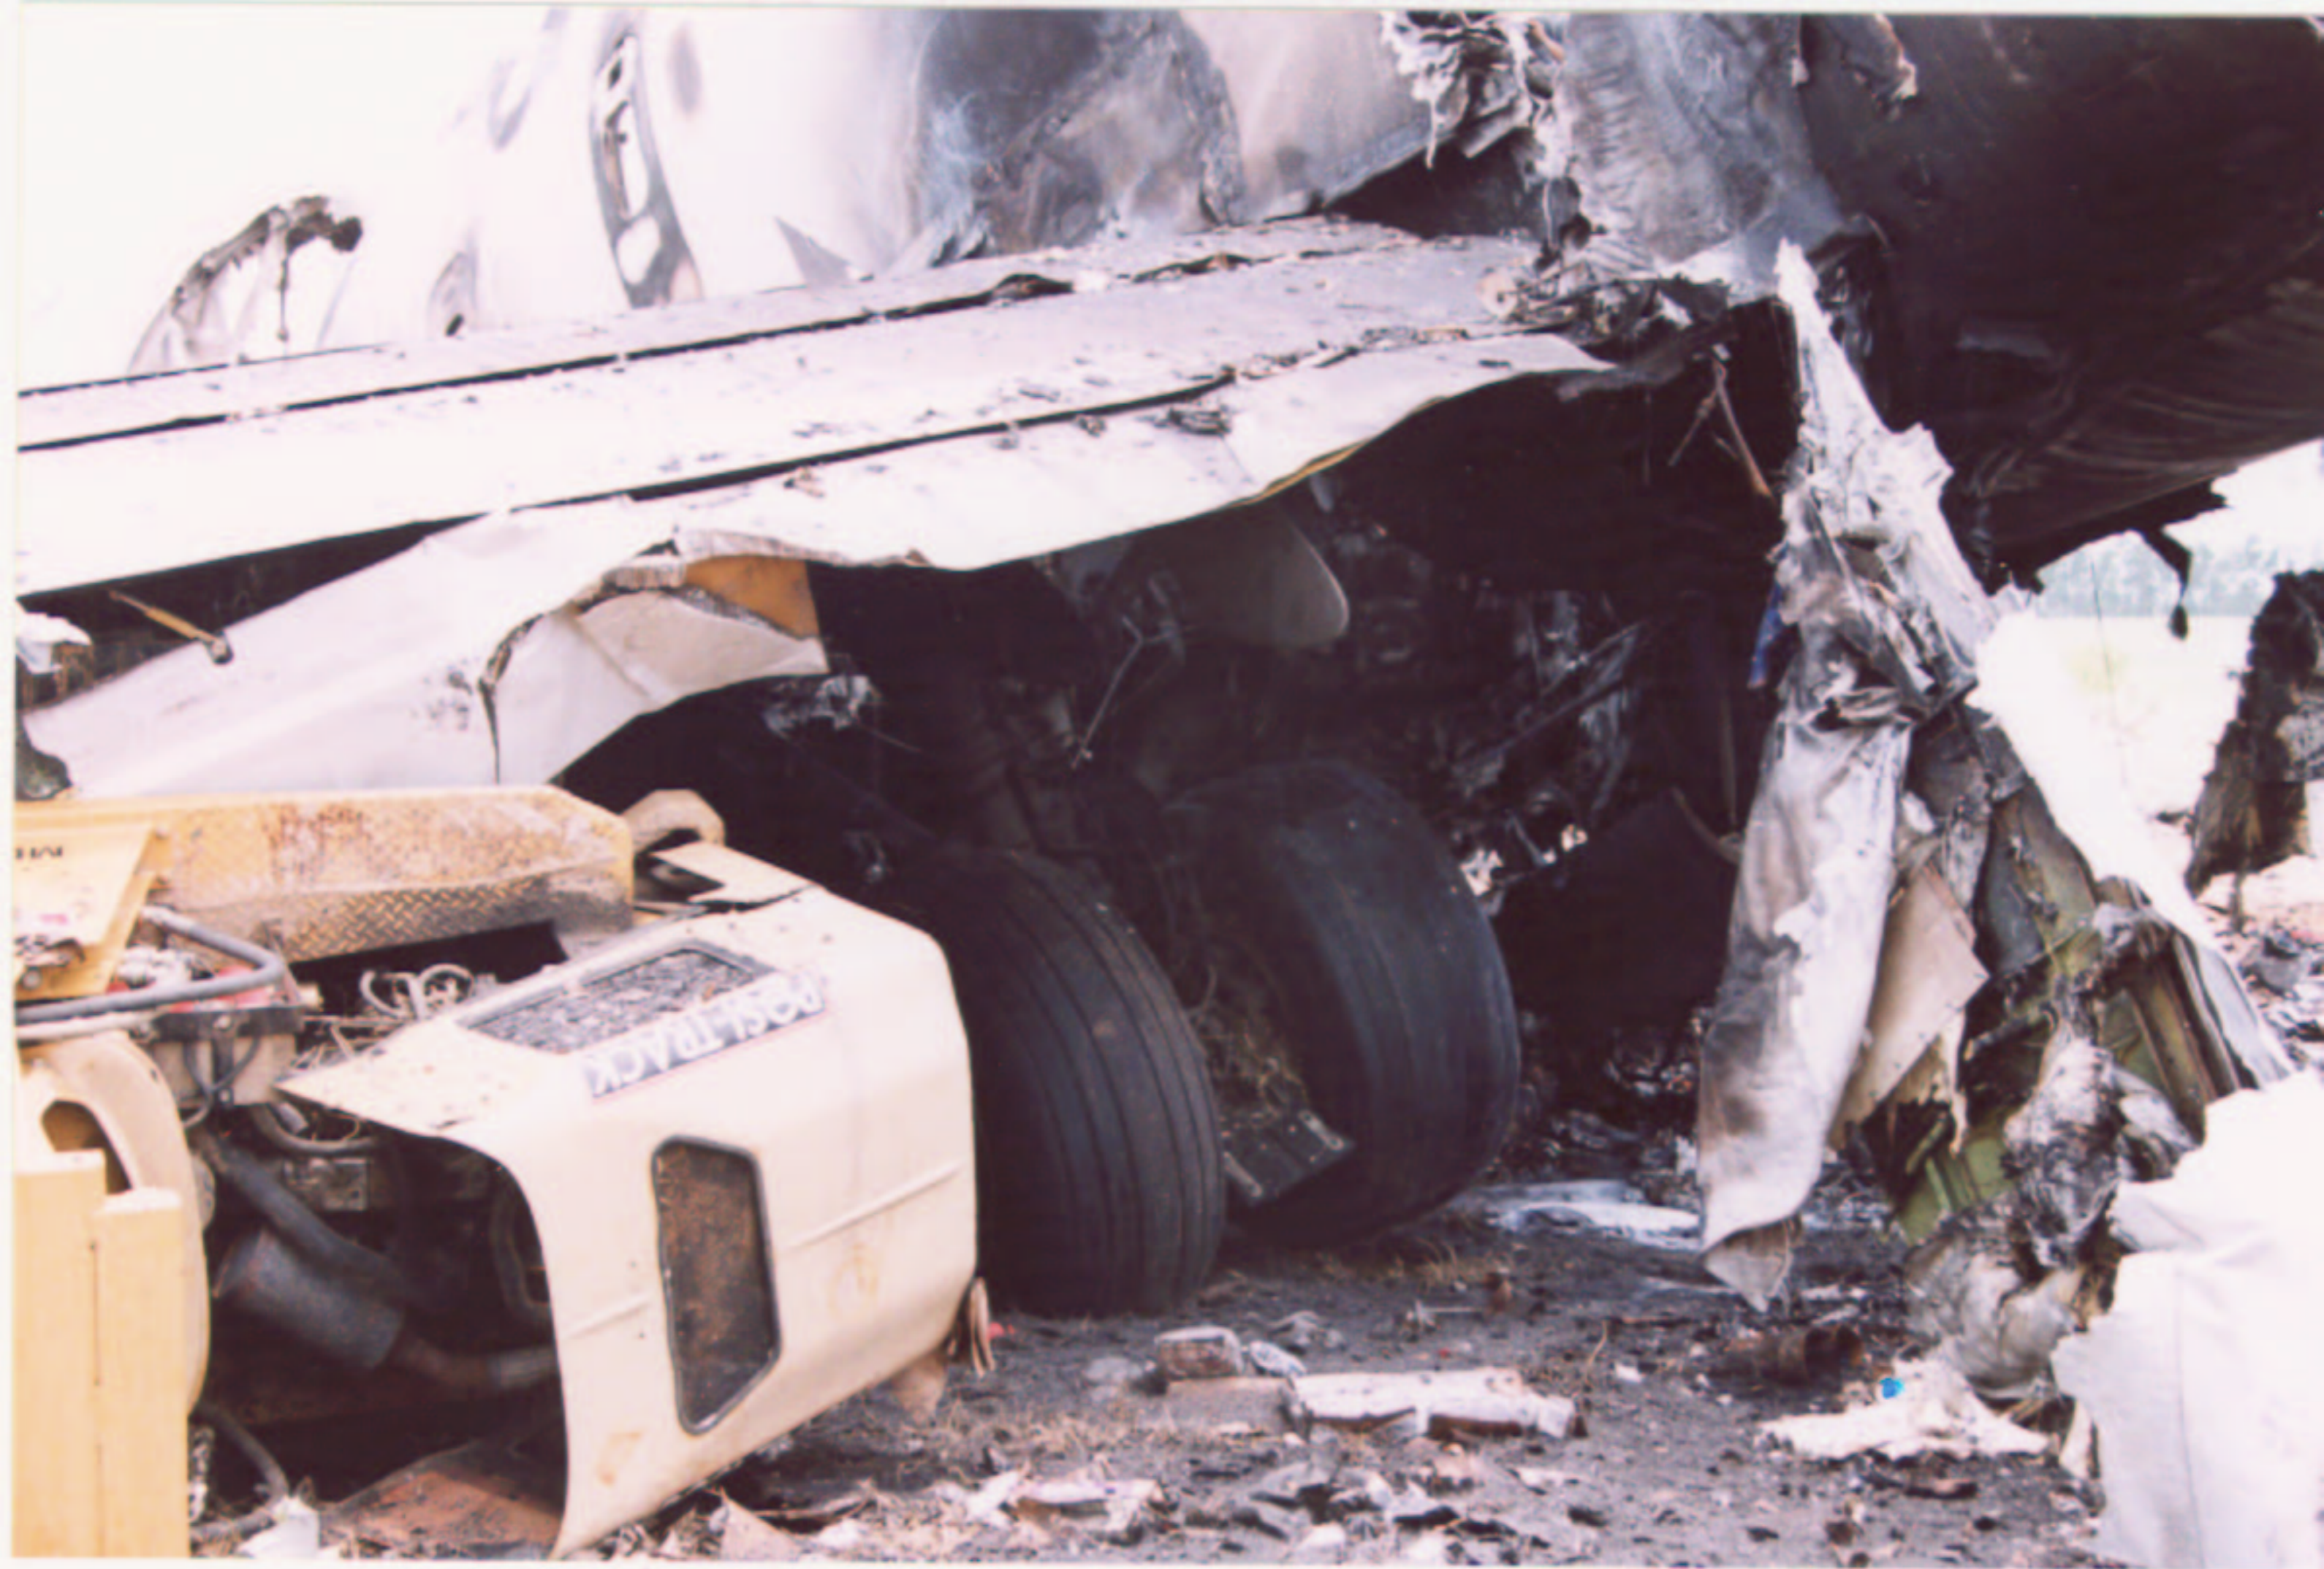
Appendix "B" Photo 17 - Damage to Right Main Landing Gear
