NATIONAL TRANSPORTATION SAFETY BOARD

STRUCTURES

Group Chairman's Factual Report

WPR12MA034

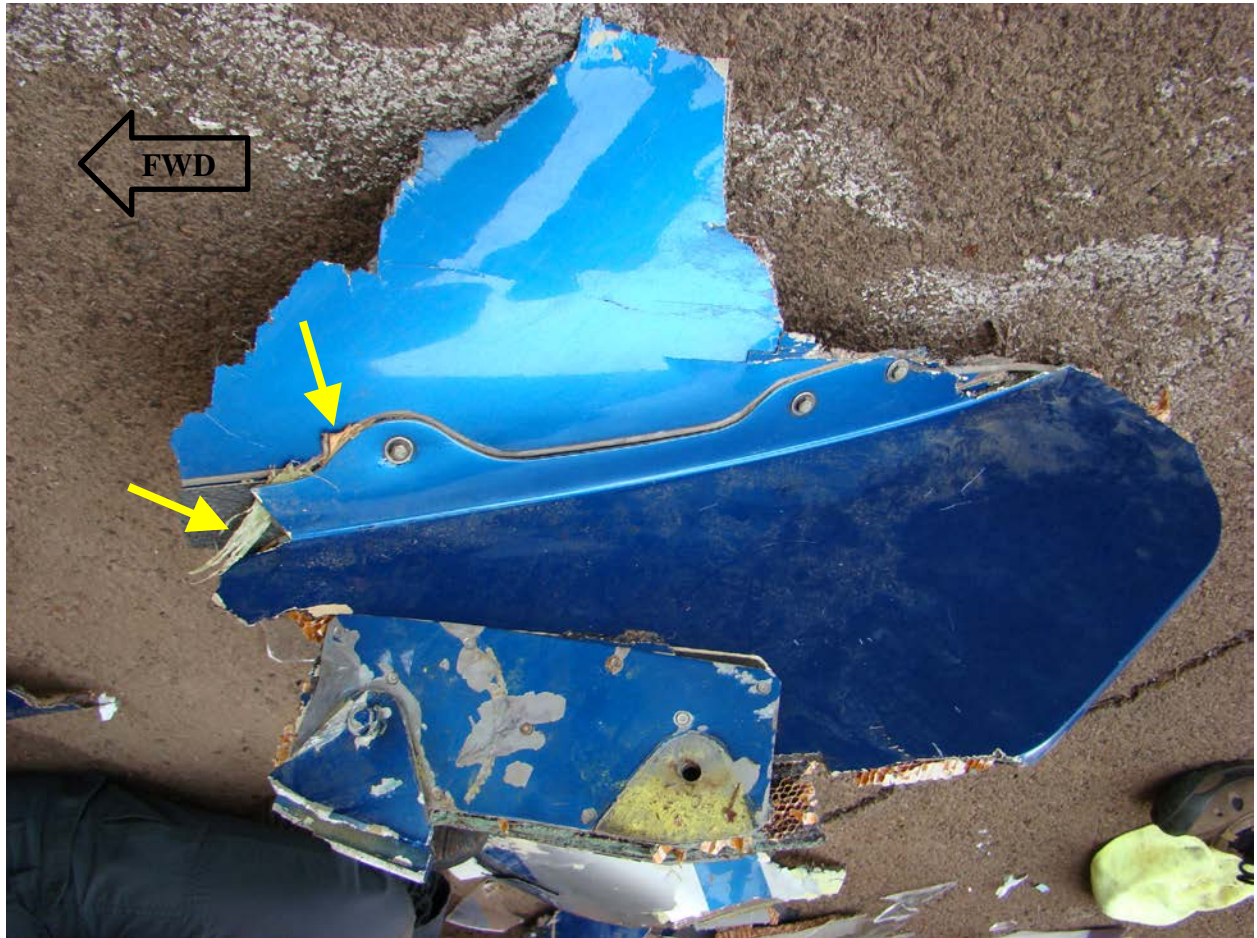
Figure 3 – Fenestron wreckage at stinger attach point

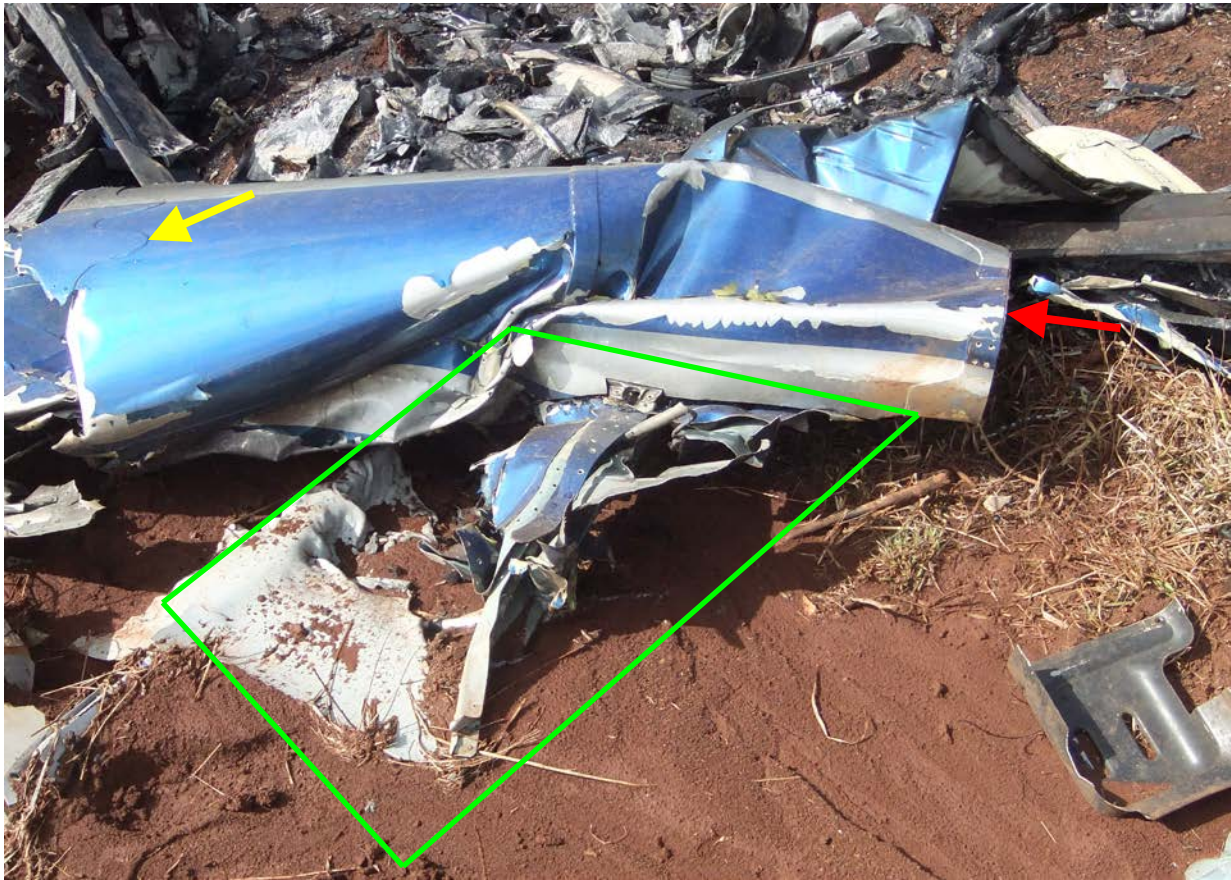
Figure 4 – Aft section of tailboom and right horizontal stabilizer as found at impact site

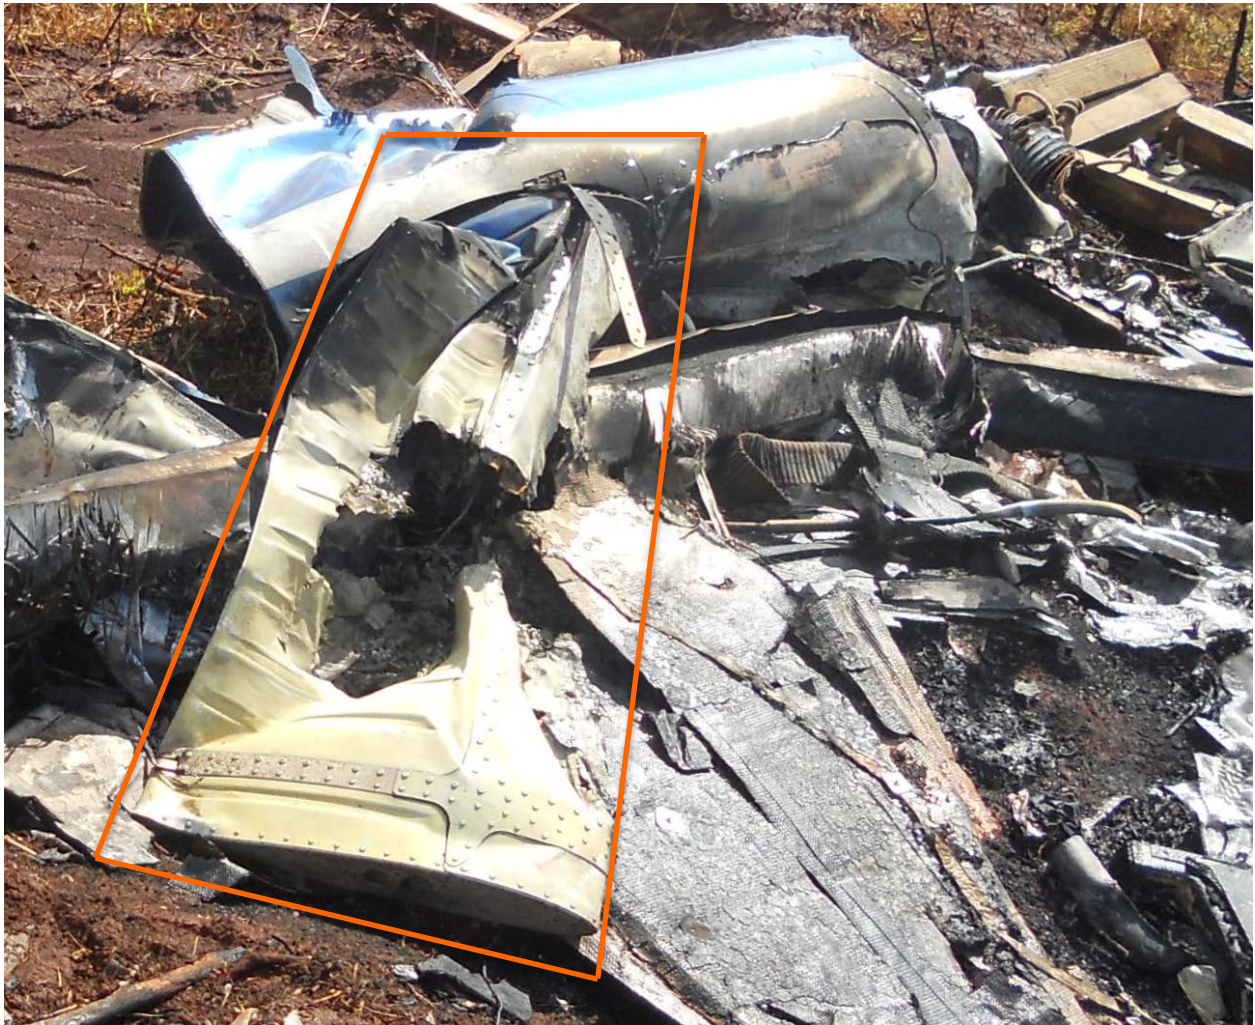
Figure 5 – Aft section of tailboom and left horizontal stabilizer as found at impact site

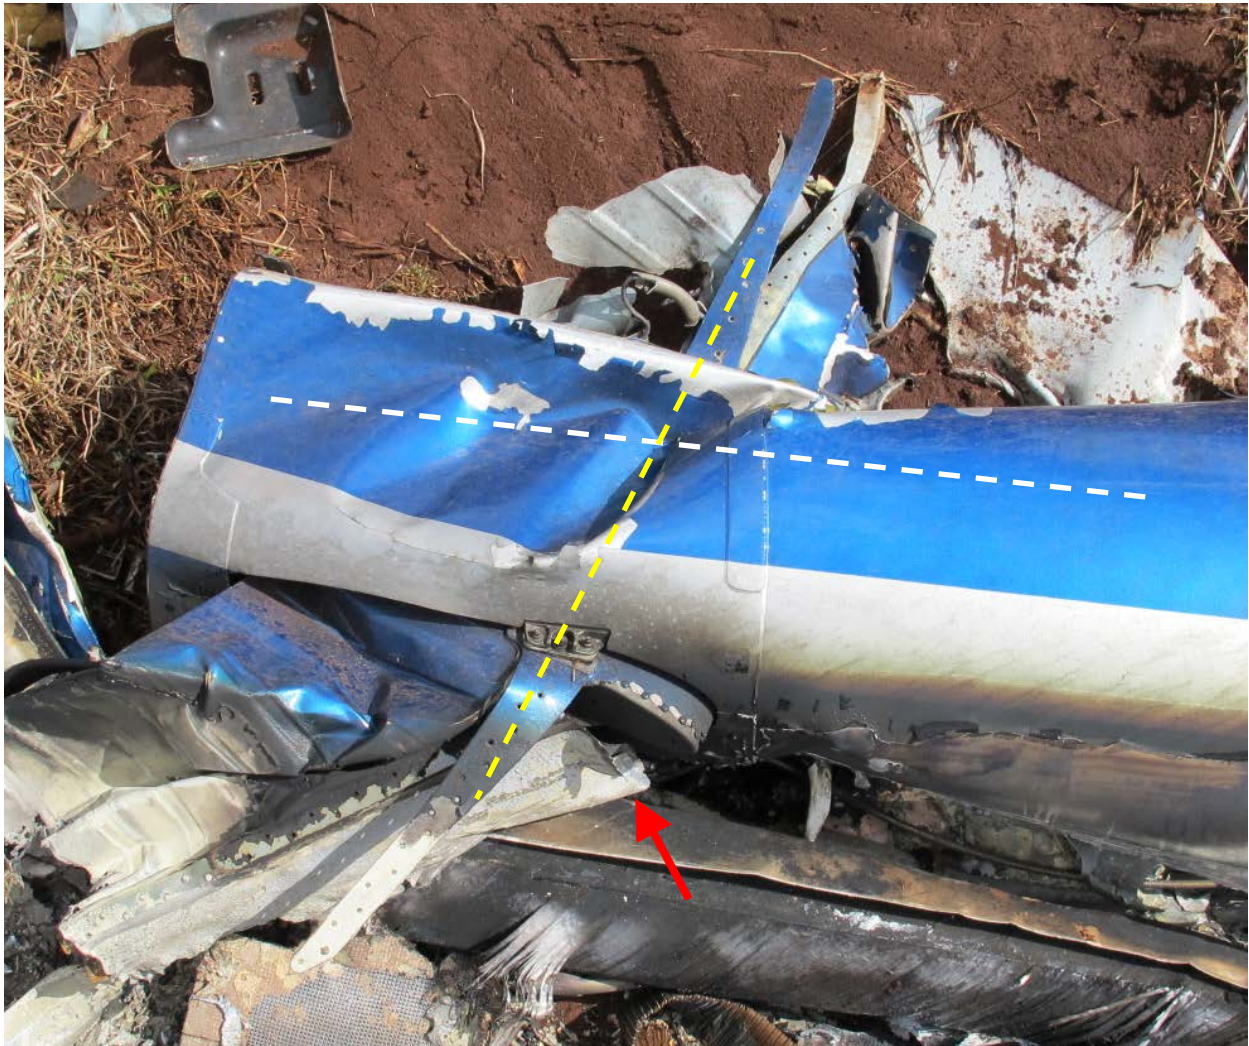
Figure 6 – Horizontal stabilizer deformation in tailboom as found at impact site

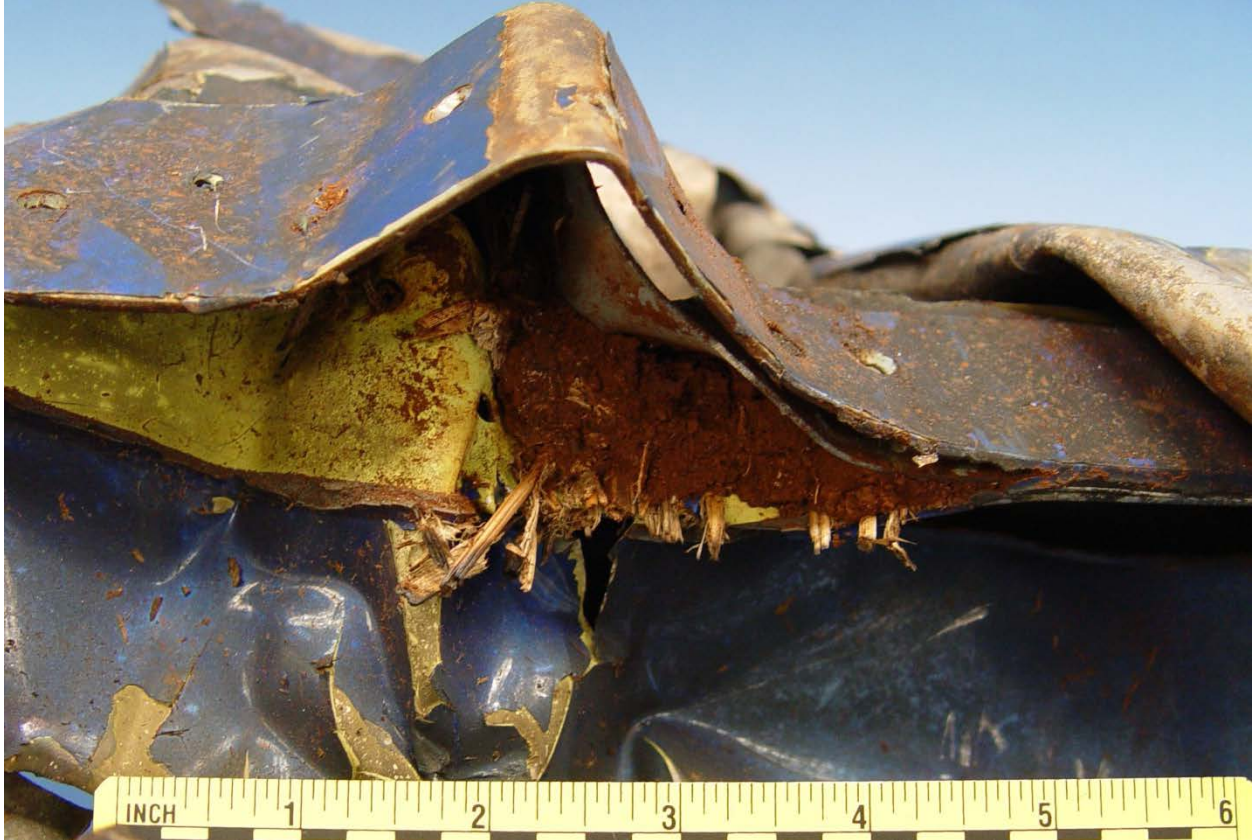
Figure 9 – Dirt and wood debris between right spar and spar strap

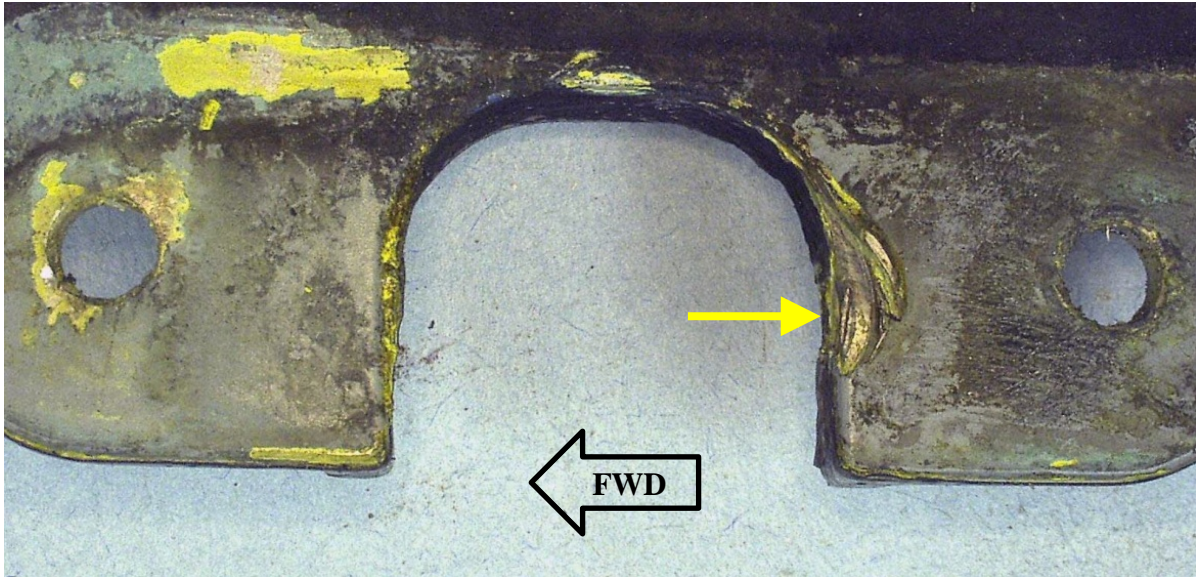
Figure 13 – Left, lower stabilizer attach fitting damage, looking down as installed

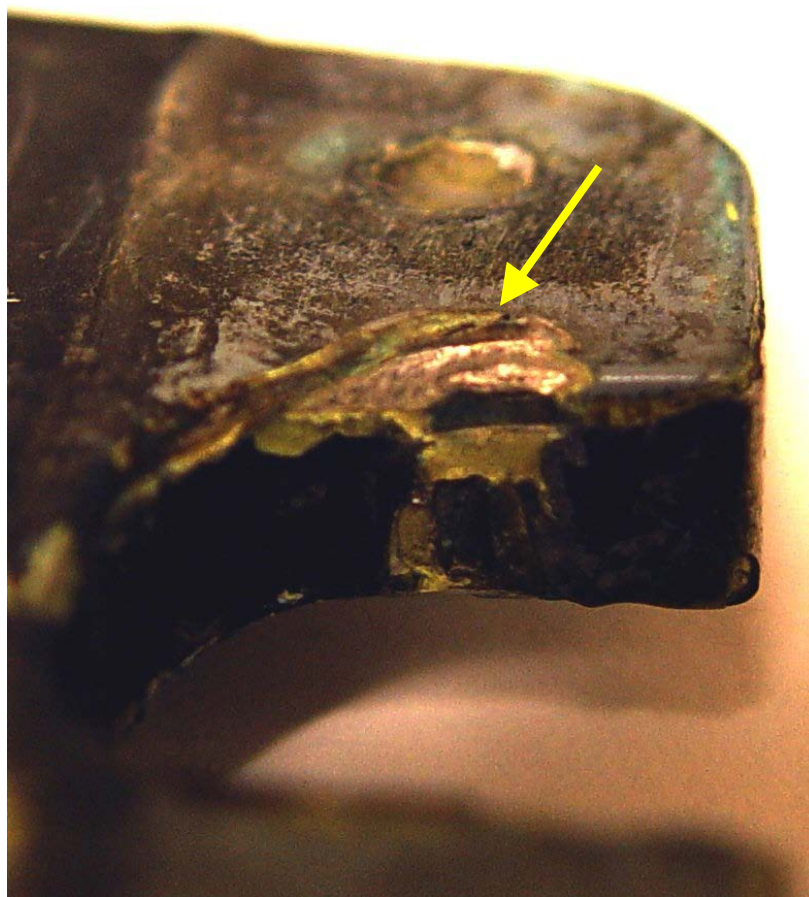
Figure 14 – Left, lower stabilizer attach fitting damage, looking aft as installed

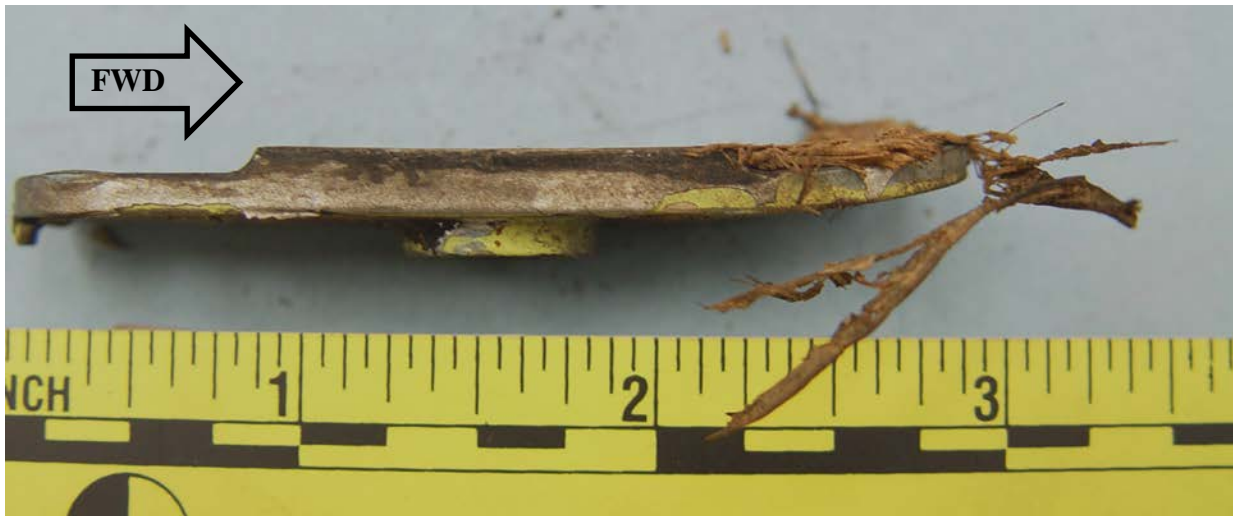
Figure 18 – Right, lower shim and wood debris

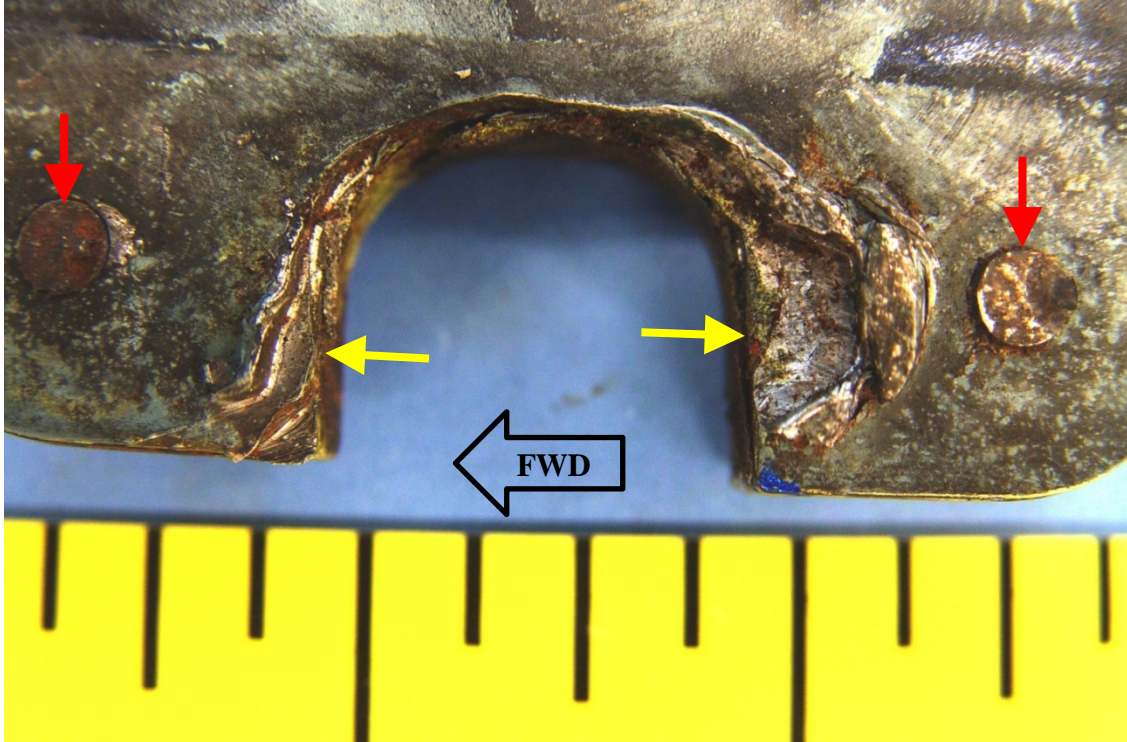
Figure 19 - Right, upper stabilizer attach fitting damage, looking up as installed

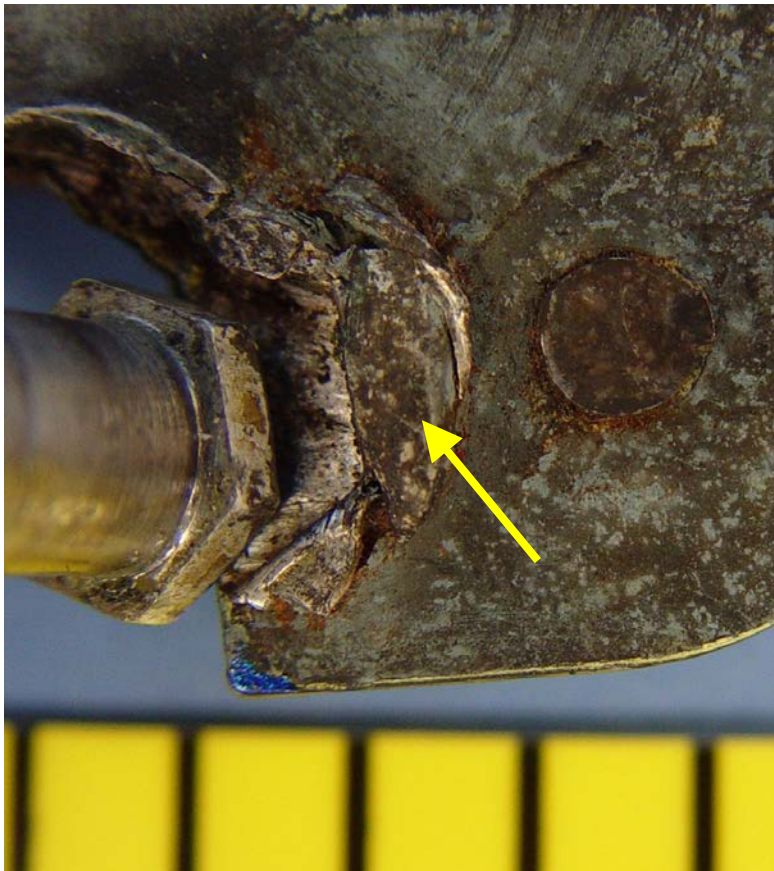
Figure 20 - Damage to lower, aft edge of right, upper stabilizer fitting

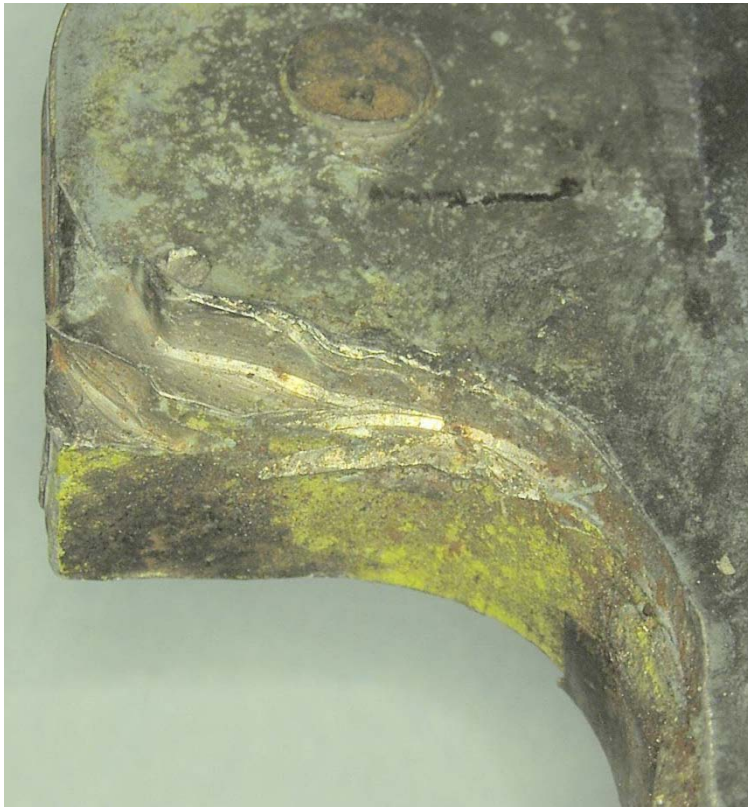
Figure 21 – Damage to lower, forward edge of right, upper stabilizer fitting

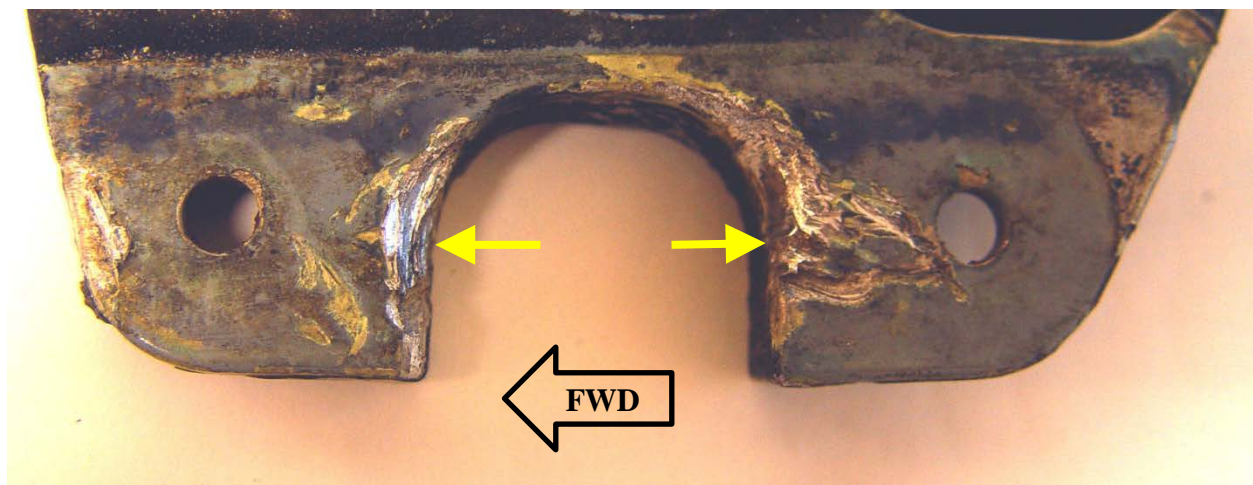
Figure 22 - Right, lower stabilizer attach fitting damage, looking down as installed

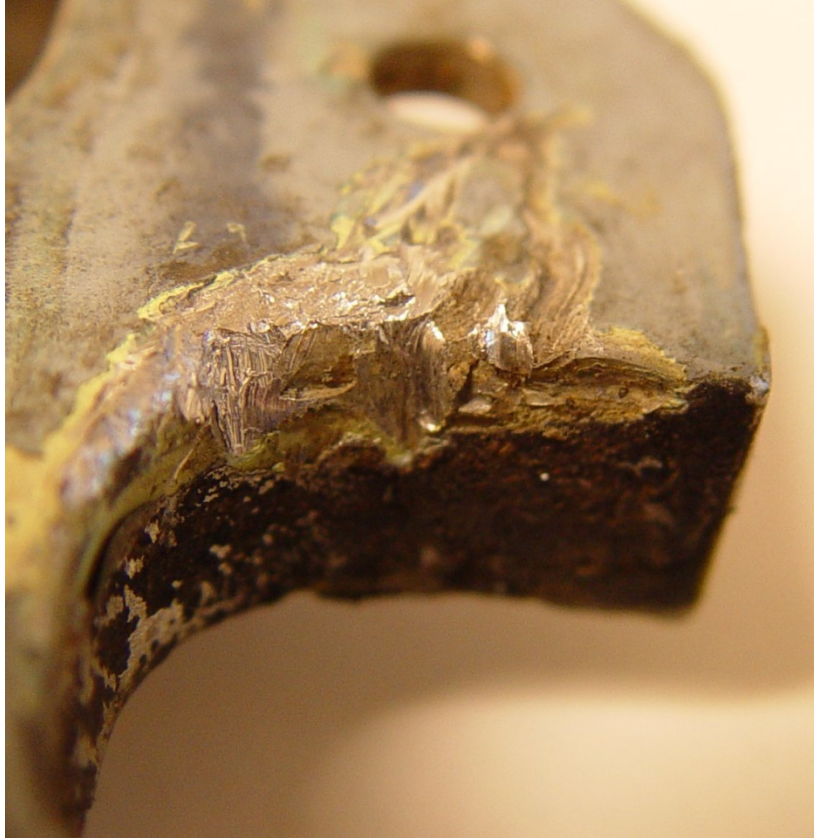
Figure 23 - Damage to upper, aft edge of right, lower stabilizer fitting

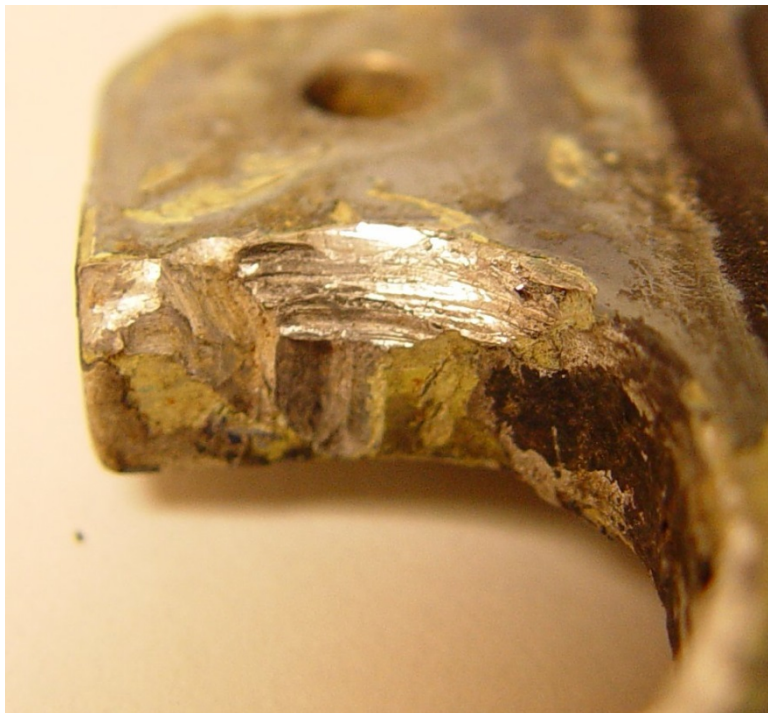
Figure 24 - Damage to upper, forward edge of right, lower stabilizer fitting

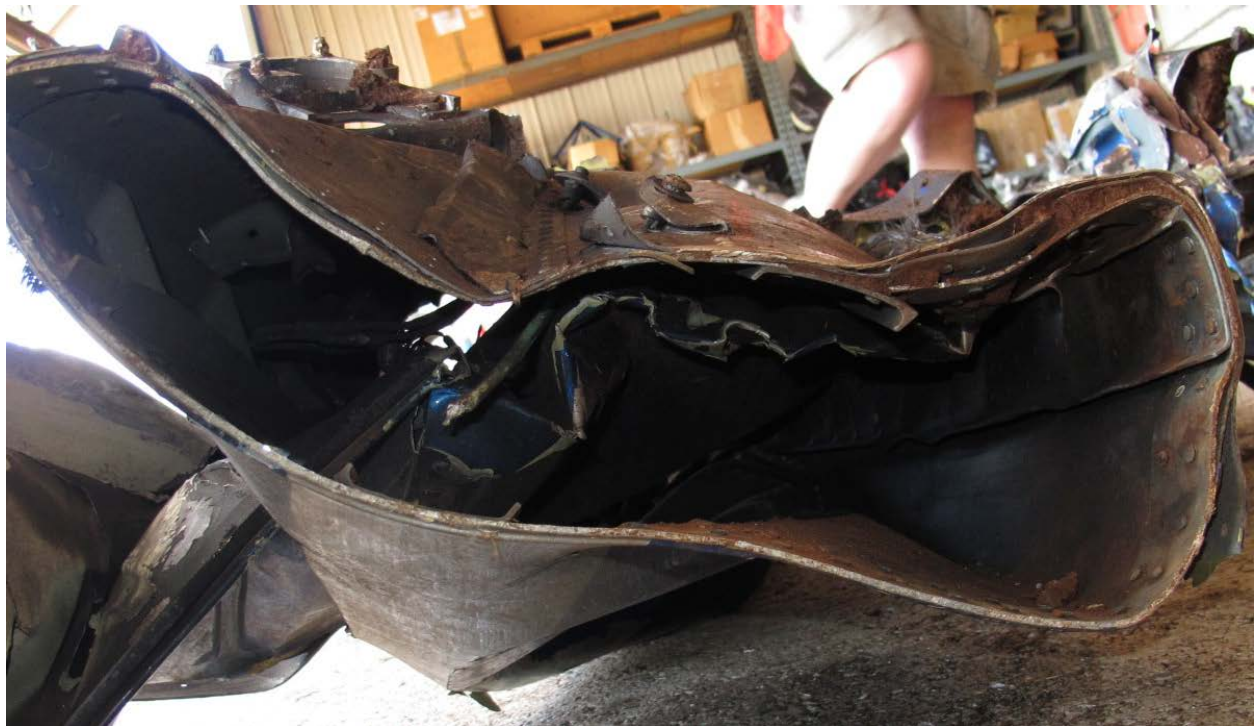
Figure 26 – Aft end of tailboom at junction frame fracture, looking forward

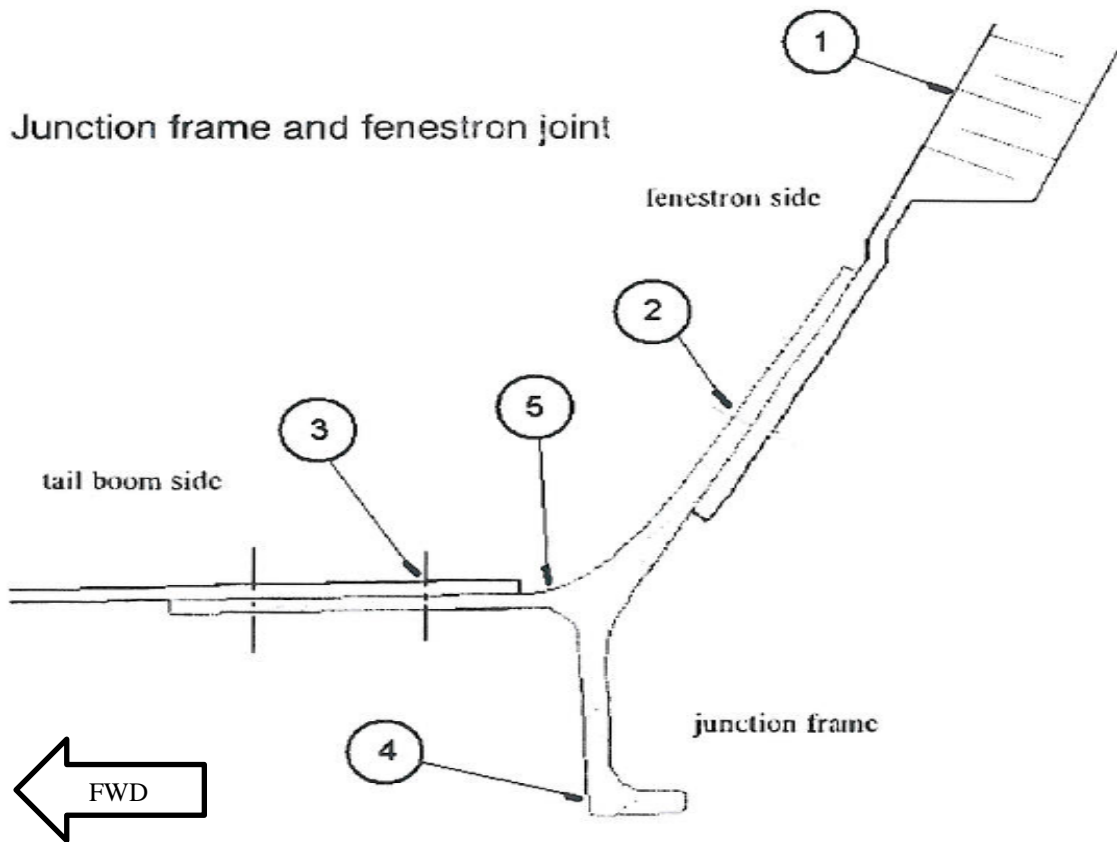
Figure 37 – Junction frame possible failure locations
