**NATIONAL TRANSPORTATION SAFETY BOARD**

**Group Chairman's Factual Report**

**STRUCTURES**

**DCA11MA075**

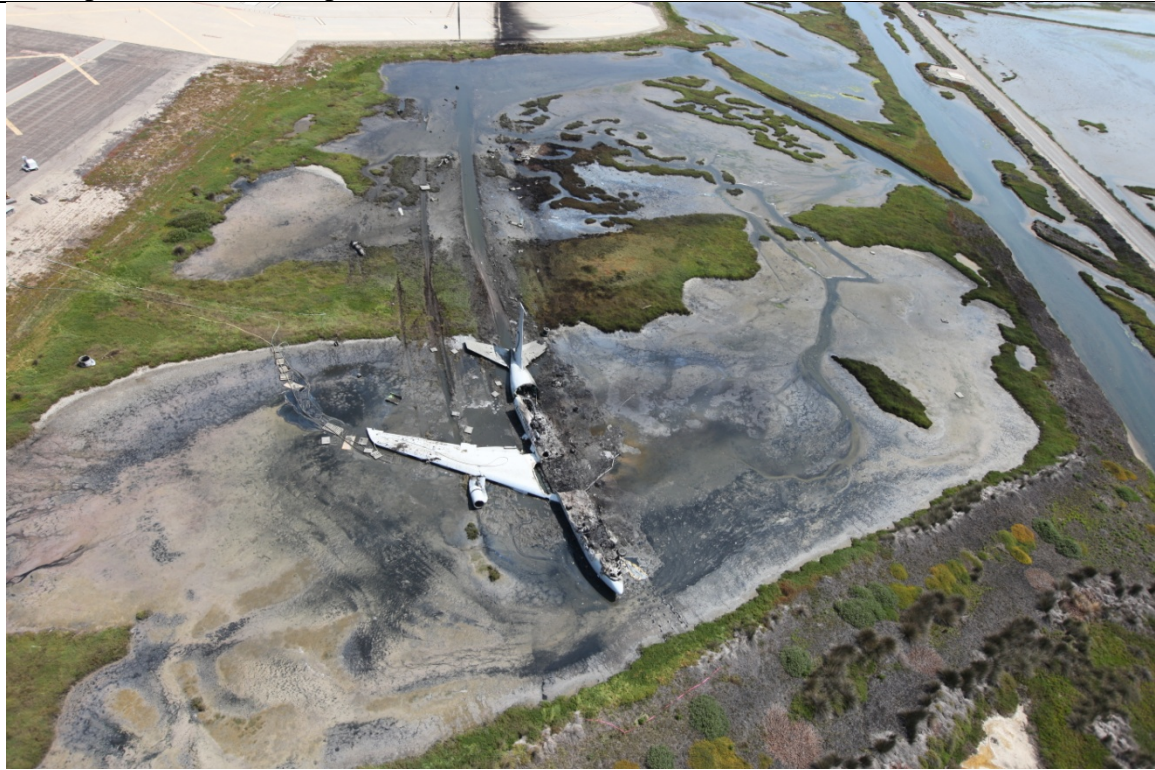
Figure 2: Accident airplane viewed from above

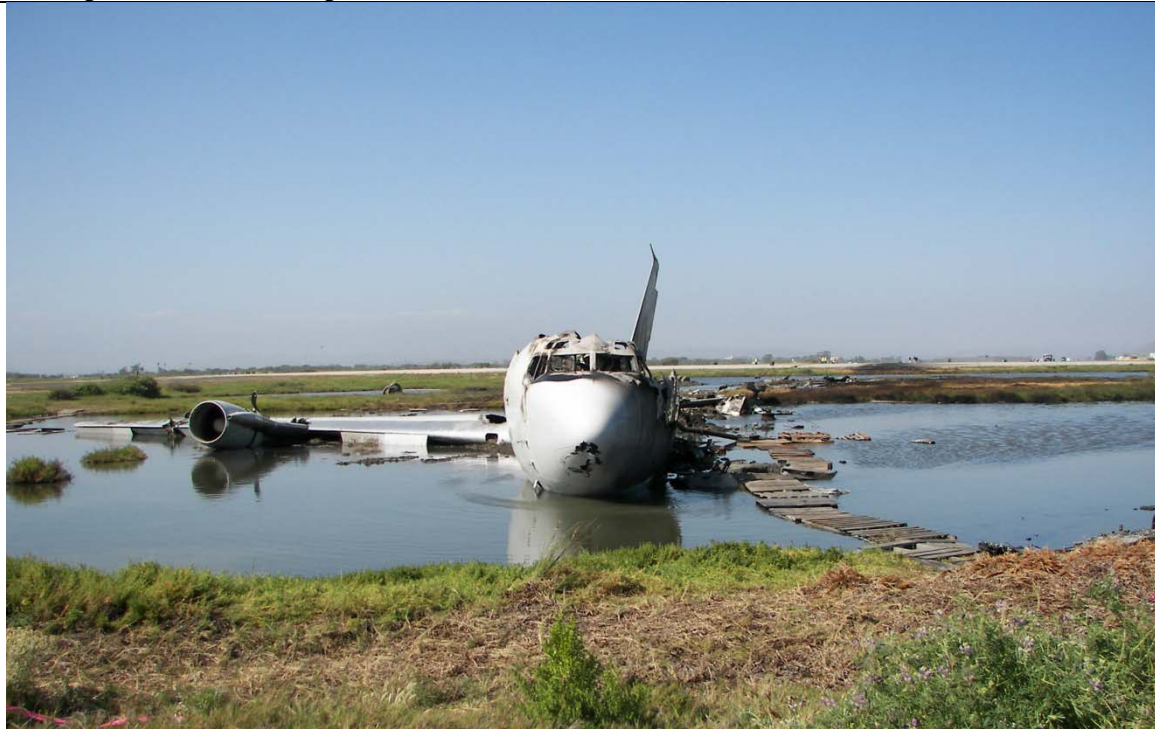
Figure 3: Accident airplane viewed looking aft

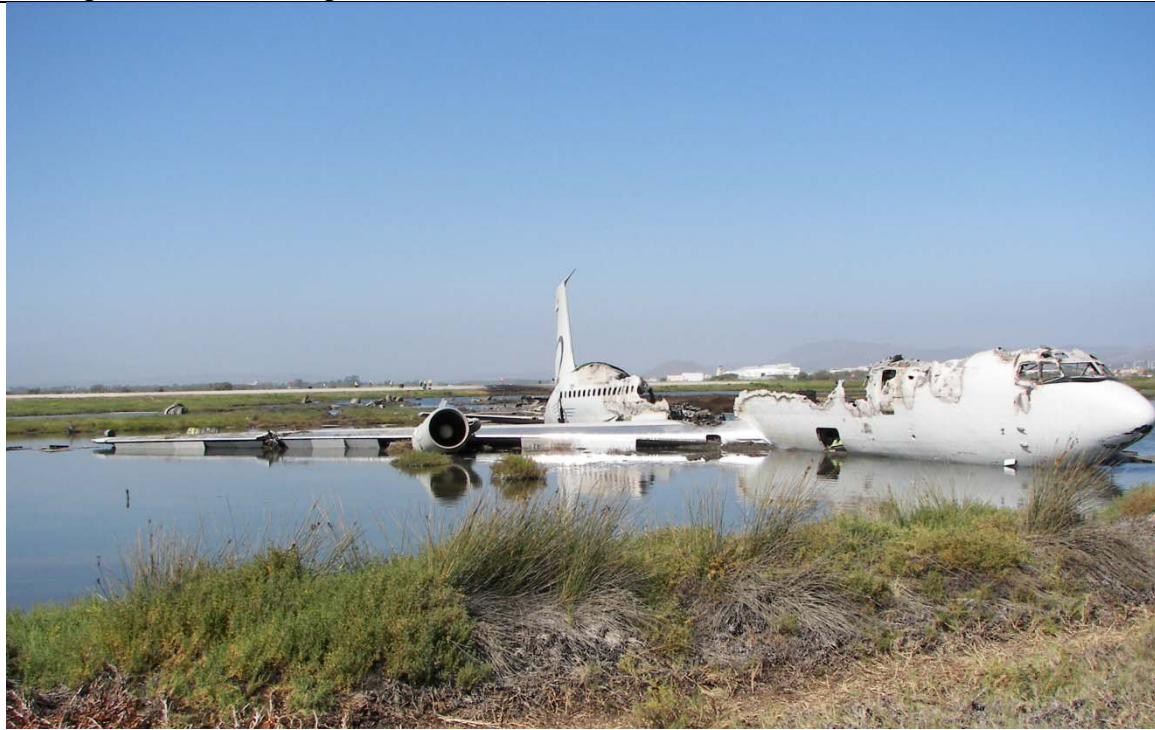
**Figure 4: Accident airplane viewed from the forward left**

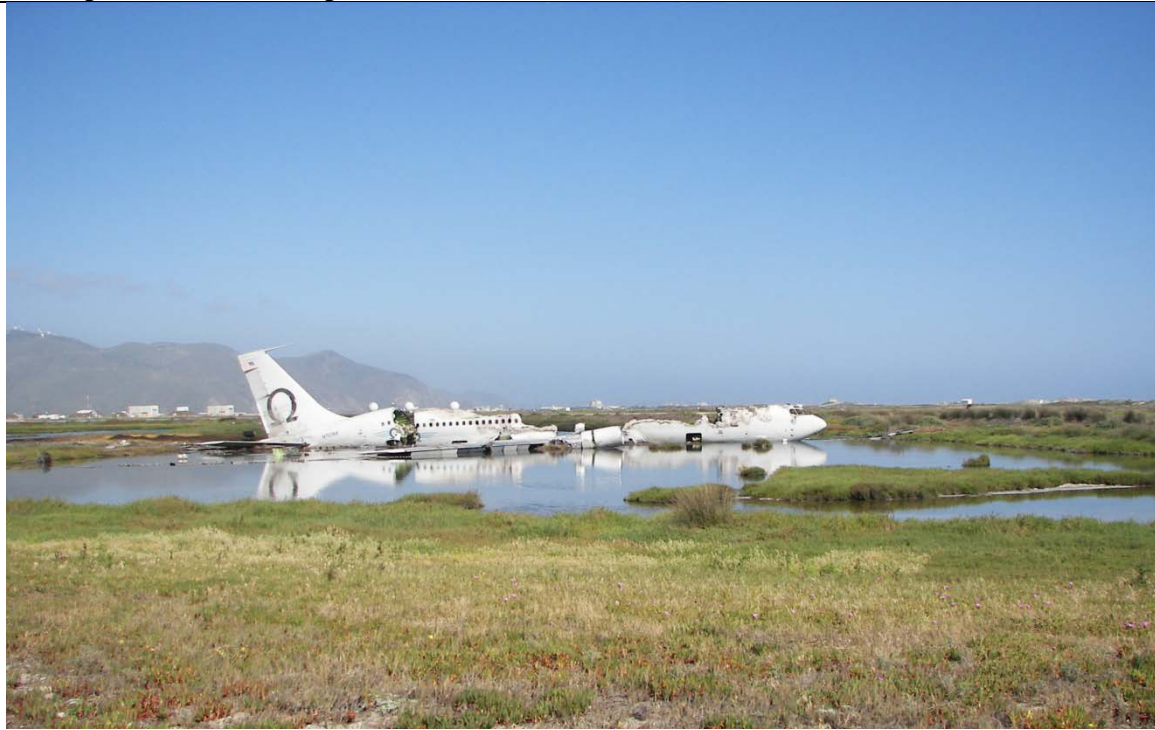
**Figure 5: Accident airplane viewed from the left**

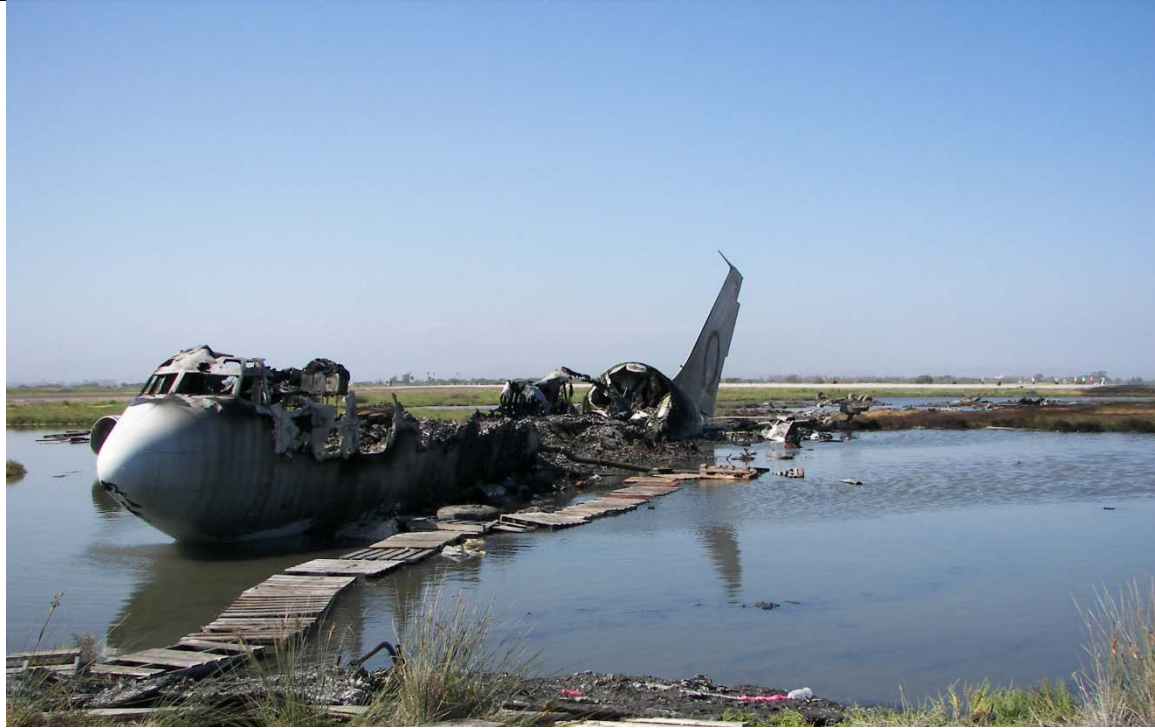
Figure 6: Accident airplane viewed from the forward right

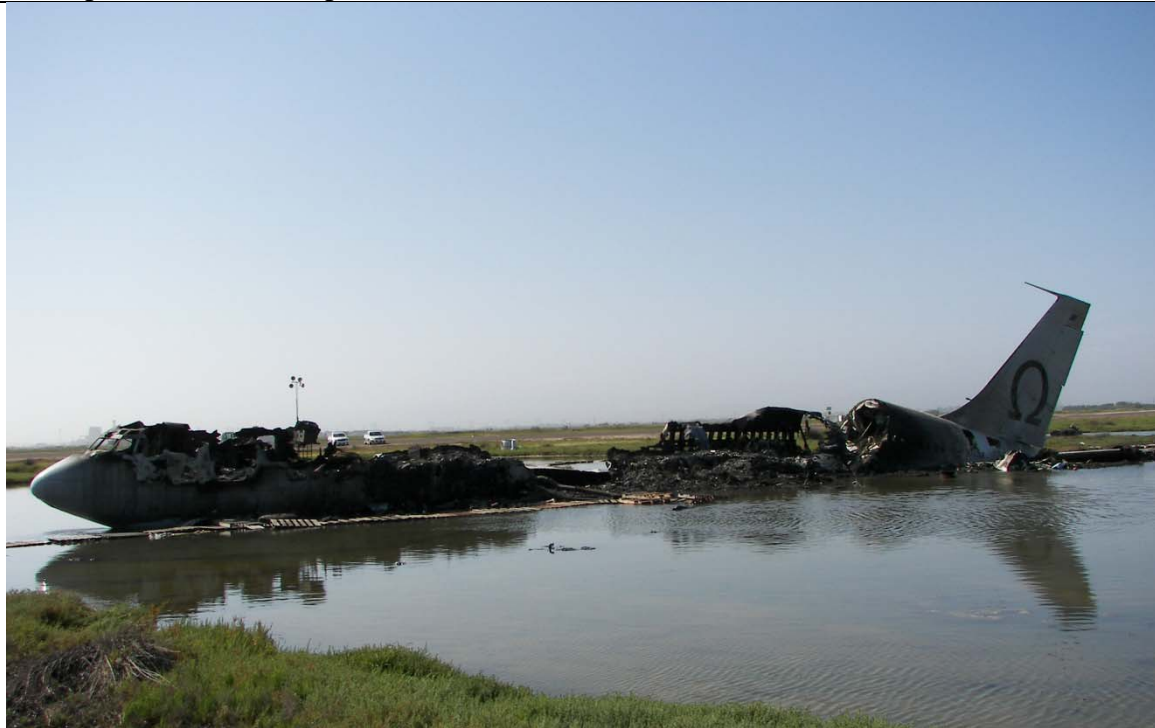
**Figure 7: Accident airplane viewed from the right**

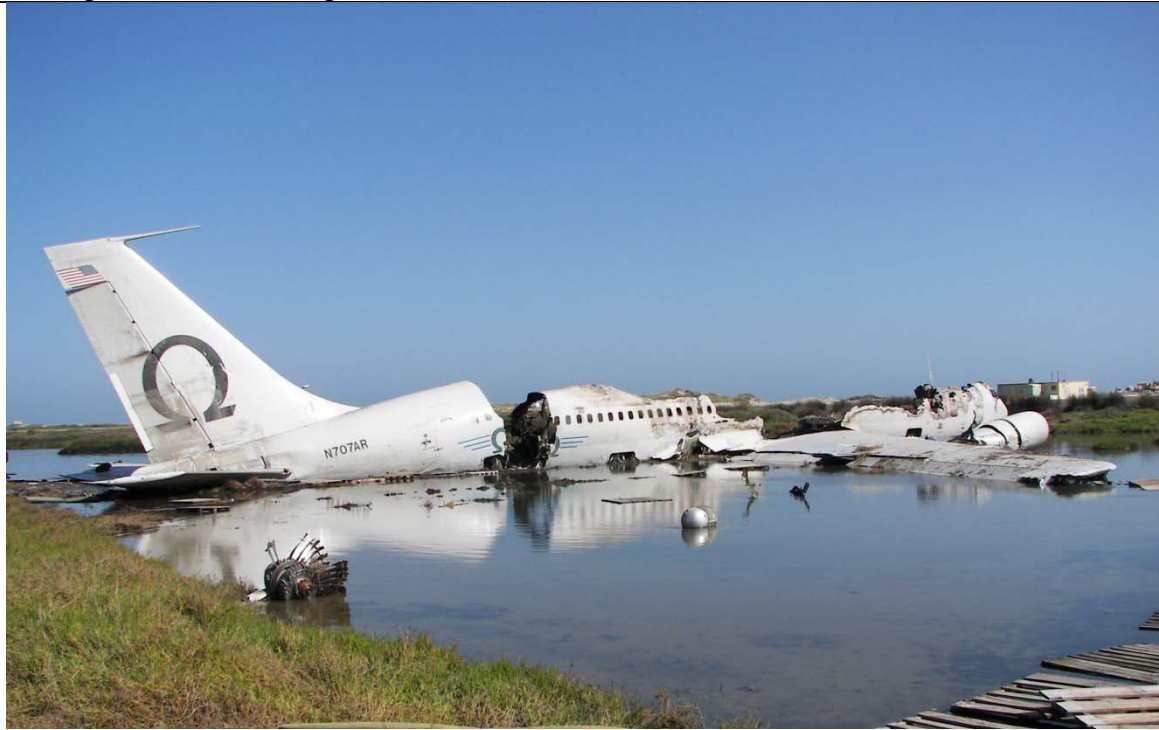
Figure 8: Accident airplane viewed from the aft right

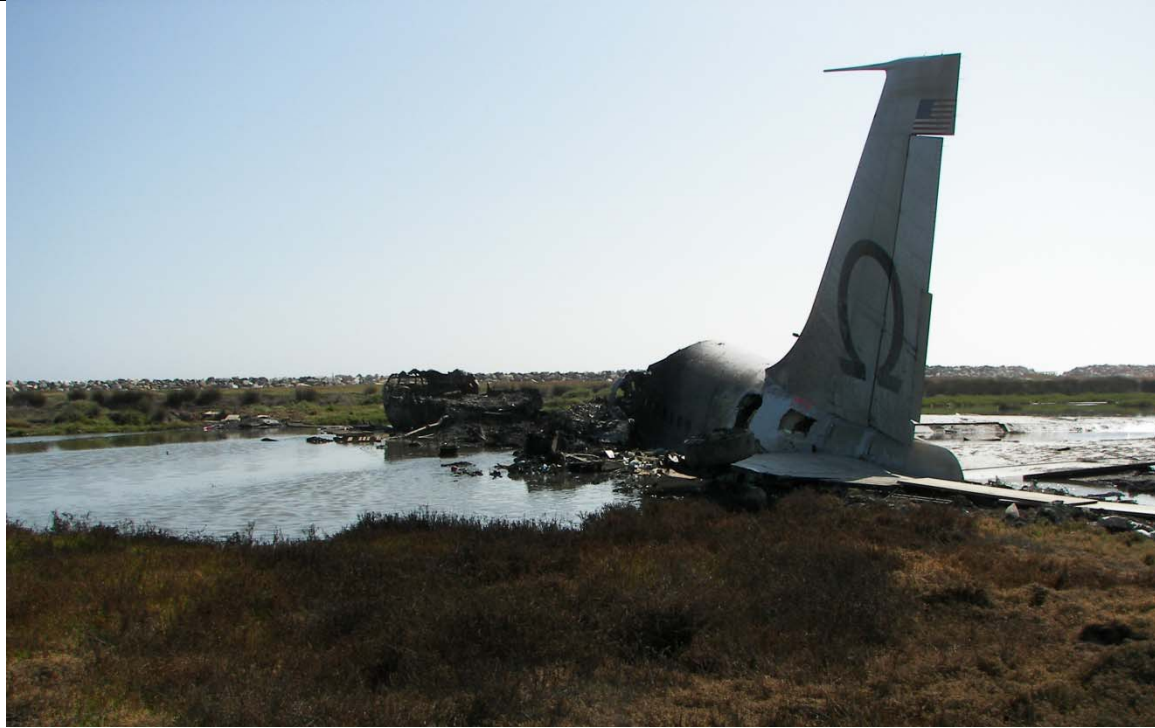
**Figure 9: Accident airplane viewed from the aft left**

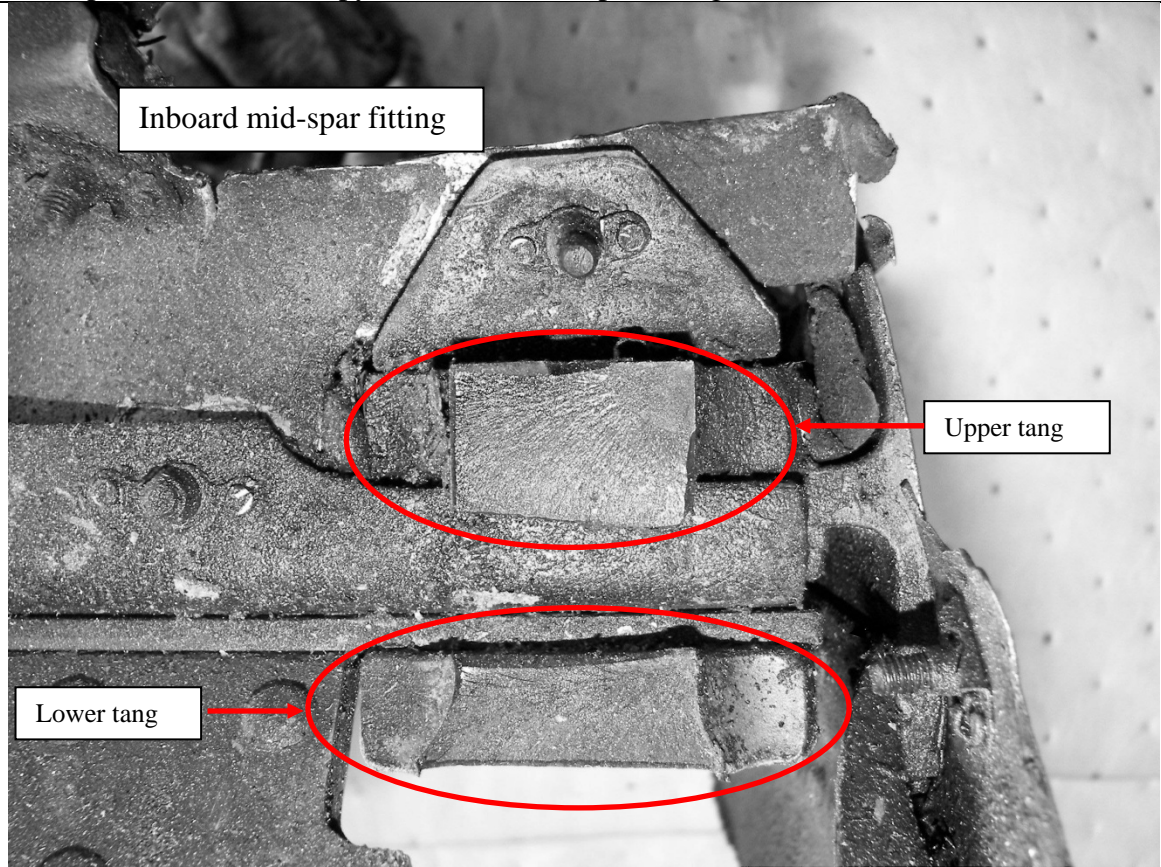
Figure 17: Number two pylon inboard mid spar fitting

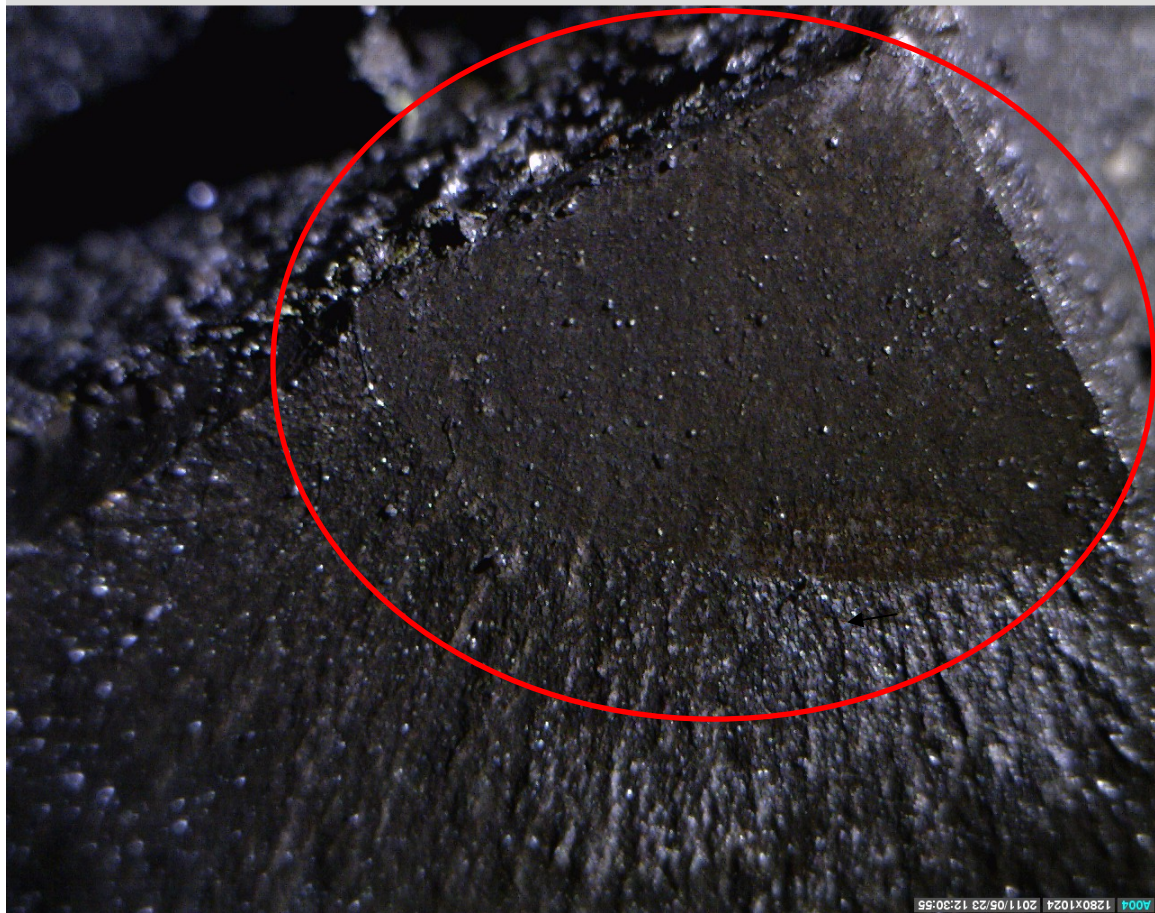
Description: Number two pylon Inboard mid-spar fitting upper tang fatigue region.

Figure 18: Number two pylon Inboard mid-spar fitting upper tang fatigue region

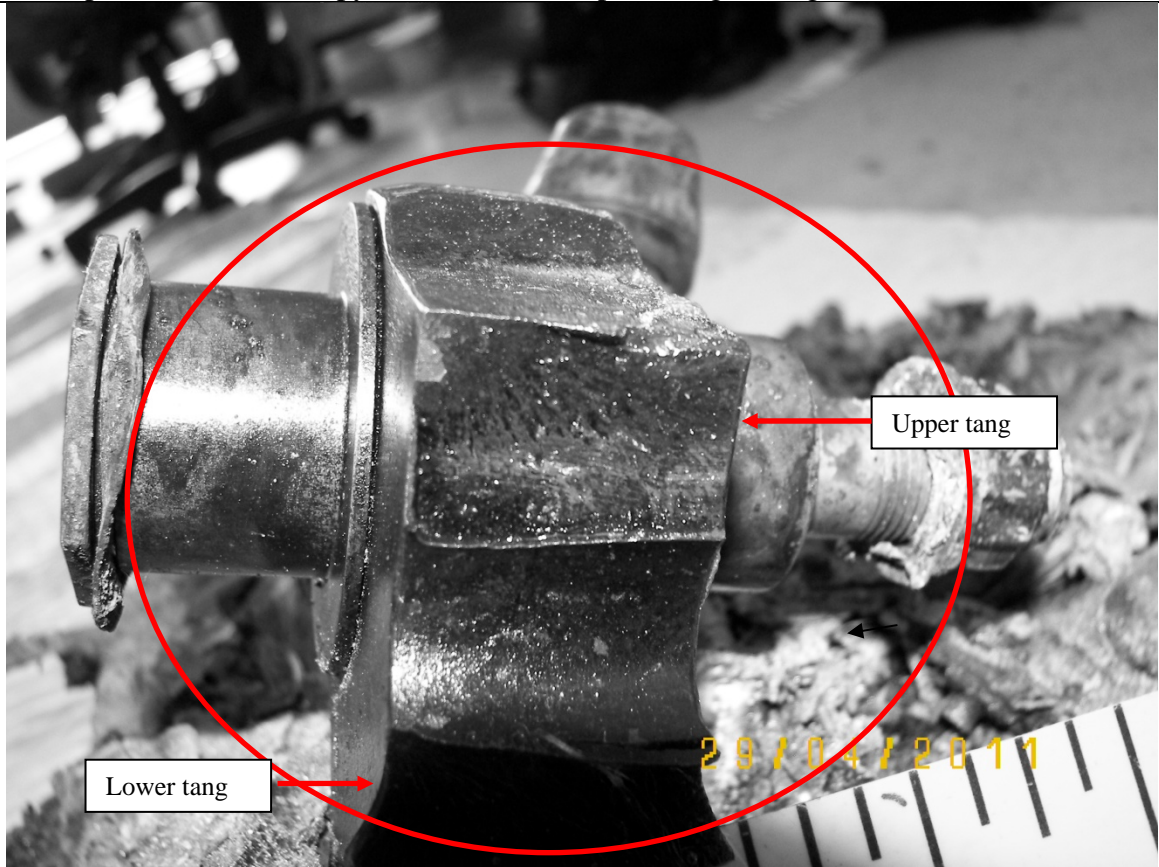
Description: Number two pylon Inboard mid-spar fitting mating fracture surface.

Figure 19: Number two pylon Inboard mid-spar fitting mating fracture surface
