NATIONAL TRANSPORTATION SAFETY BOARD

STRUCTURES GROUP CHAIRMANS FACTUAL REPORT

DCA06MA064

Attachment 2
Photo Documentation

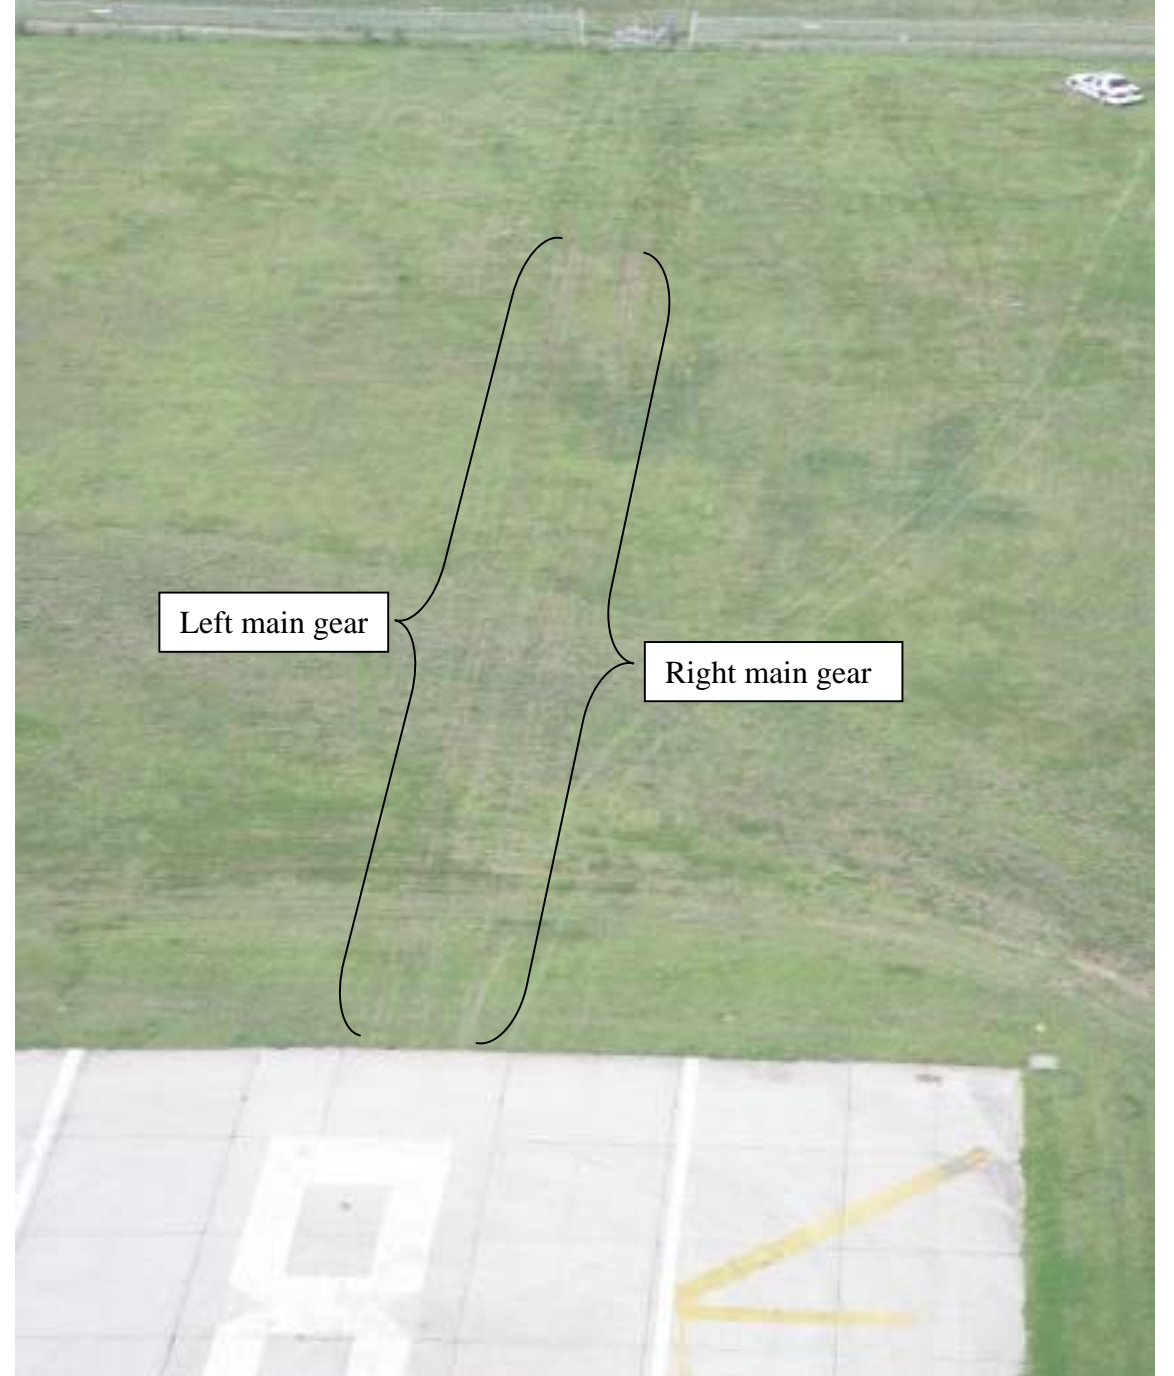
Figure 2

Description: Close-up of runway 26 overrun ground scars.

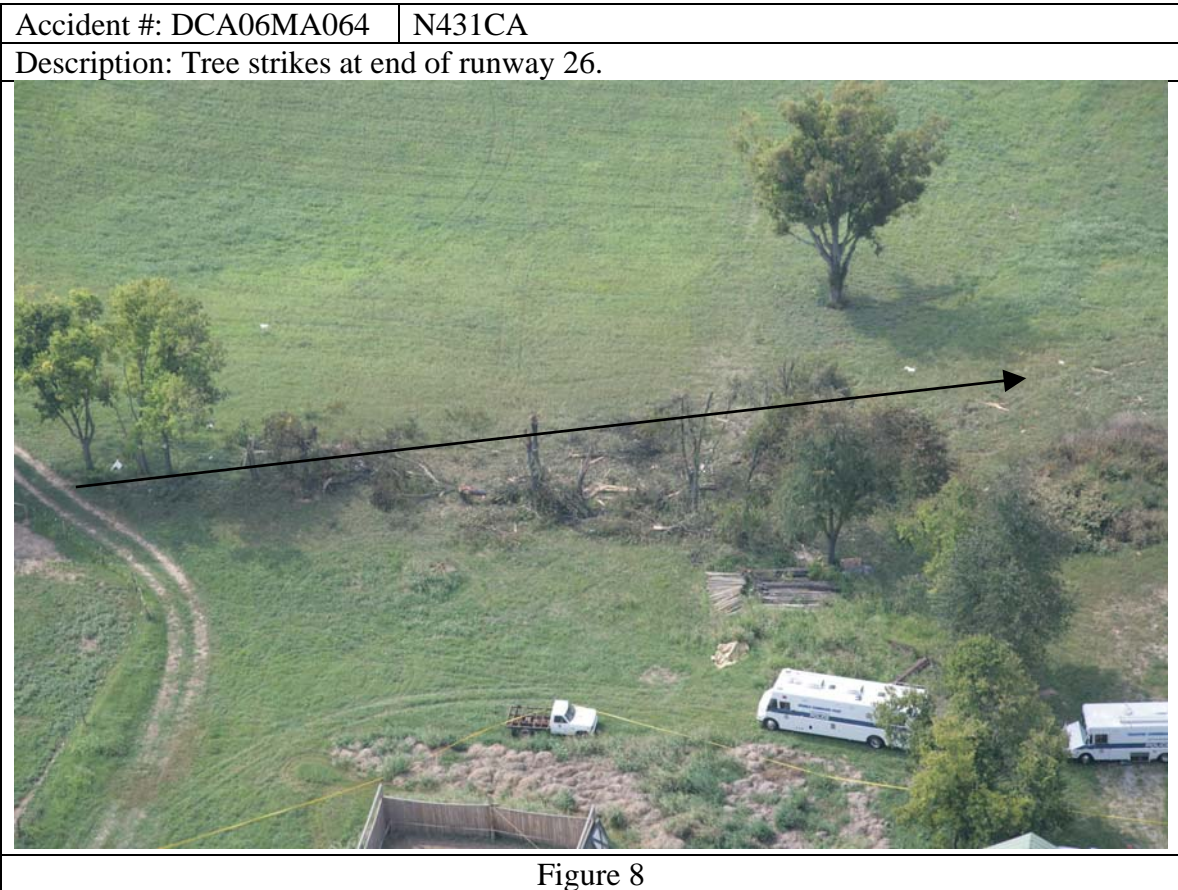
| Description: Overhead of tree strikes. | |

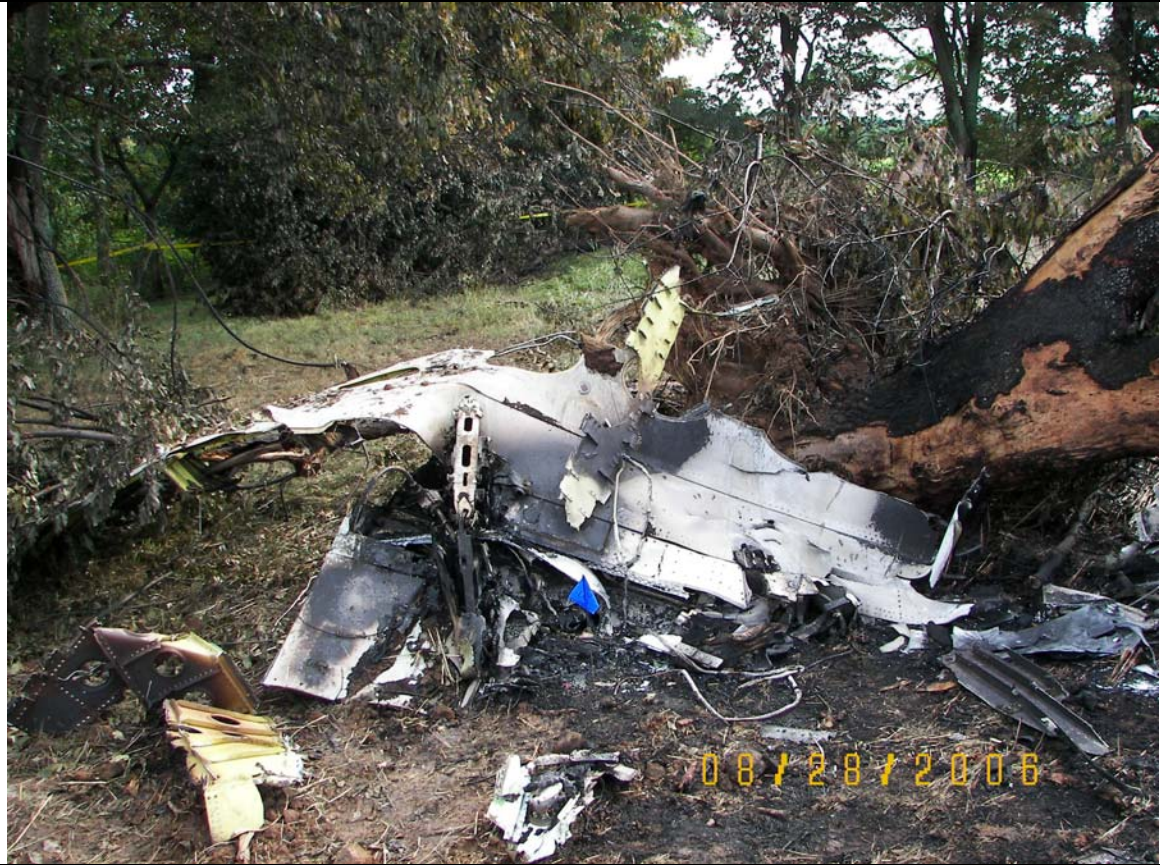
Description: Left wing lower wing skin.
