NATIONAL TRANSPORTATION SAFETY BOARD

WPR12MA034

EMERGENCY ALERT SERVICE BULLETIN

Check of the tail boom / Fenestron junction frame

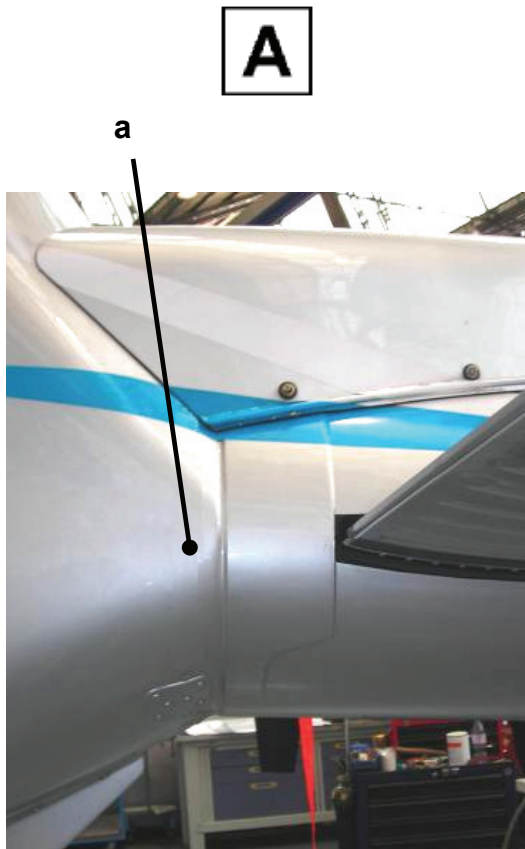
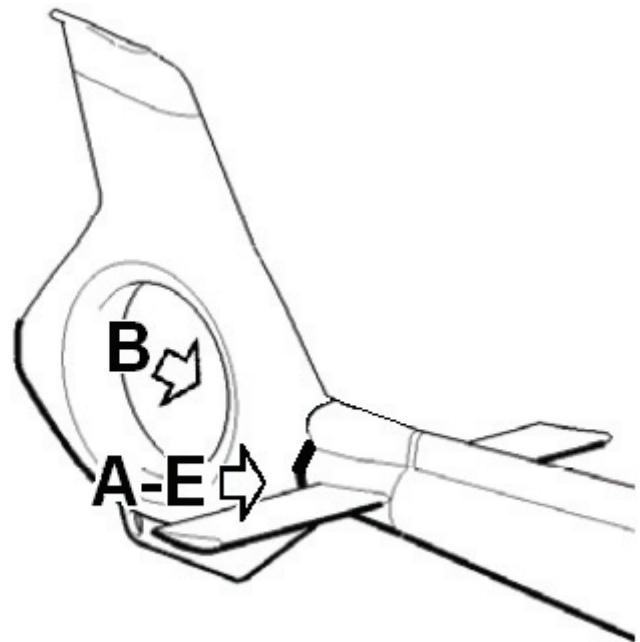
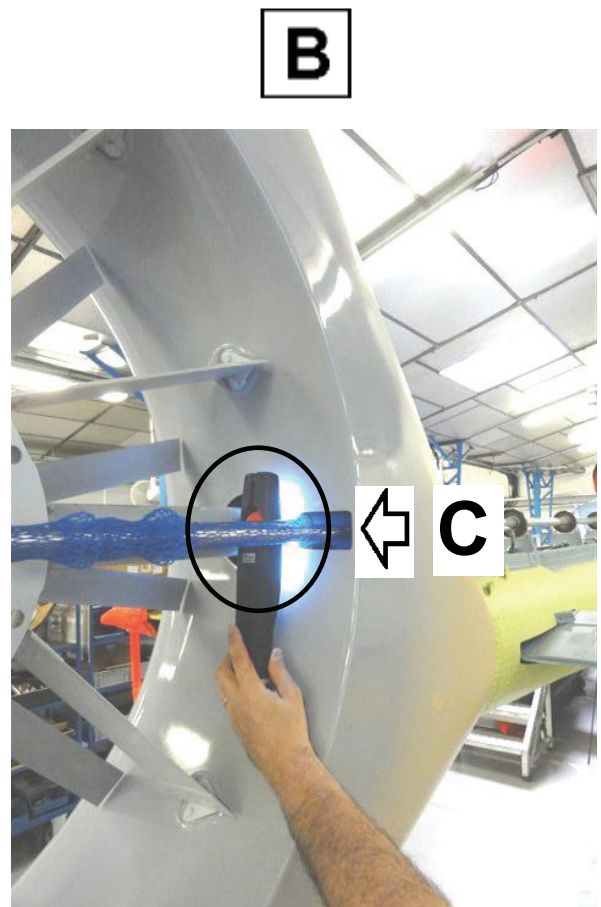
Figure 1

- Check that there is no crack in the web (c) of frame (a) on the RH side (Details C and D, Figure 2) using a light source positioned in front of the opening of the drive shaft tube and by looking through the yaw control opening in the Fenestron (Detail B, Figure 1).

- Check that there is no crack on the external surface of junction frame (a) (Detail A, Figure 1).
- Interpret the results in accordance with paragraph 1.E.2. a).

- If necessary, clean the web (c) of junction frame (a):
 - . Remove the horizontal stabilizer as per AMM Task 55-11-00,4-1.
 - . Clean junction frame (a) as per MTC Work Card 20.04.01.102.
 - . Install the horizontal stabilizer as per AMM Task 55-11-00,4-1.

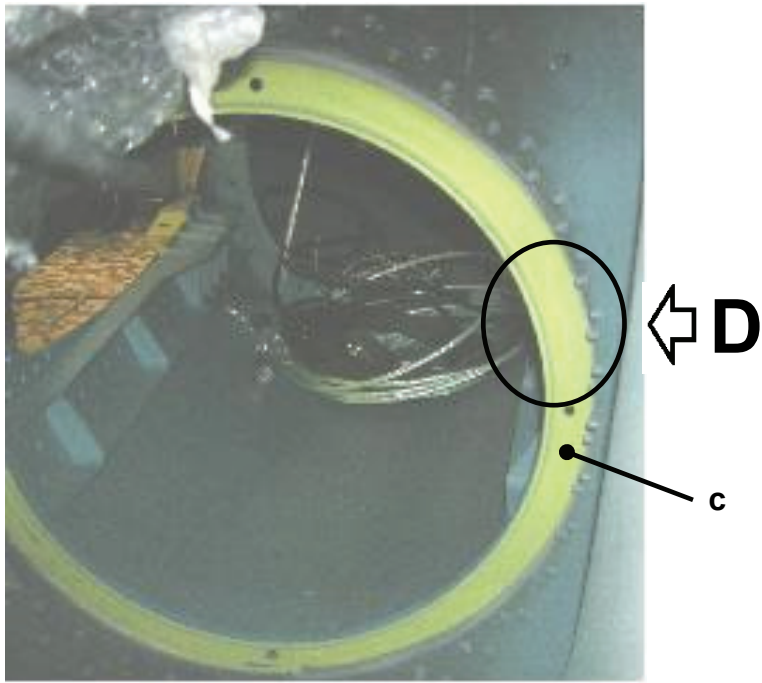
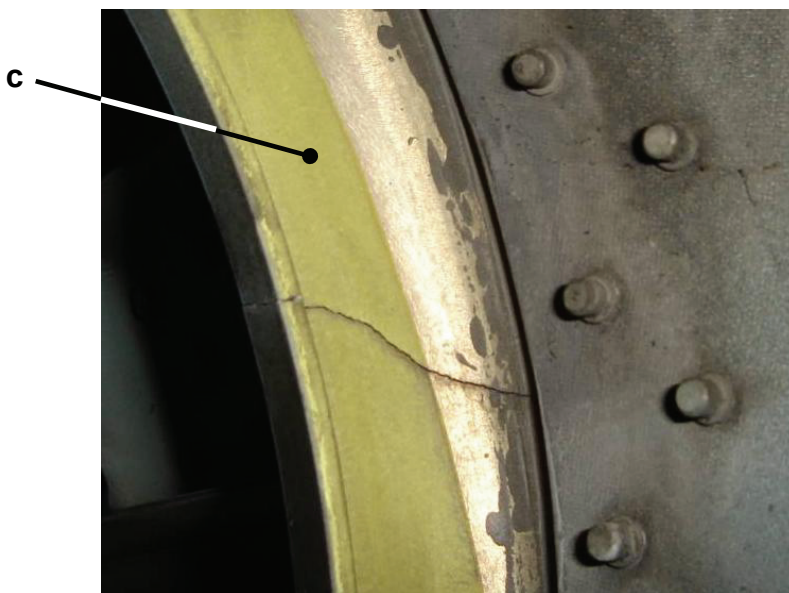
Figure 2

The cracks start in the plane of the rivet head countersinks on the RH side of the Fenestron (Detail E, Figure 3) and spread to the web of the frame (Details C and D, Figure 2).

- 1) Presence of a crack entirely crossing the web (c) of frame (a) (See detail D, Figure 2):
 - All flights are prohibited.
 - For the conditions for returning the helicopter to service, contact the Customer Service Technical Support Department. (See NOTE 5).

- 2) Presence of a crack crossing part of the web (c) of frame (a):
 - All flights are prohibited except for the ferry flight not exceeding 10 flying hours.

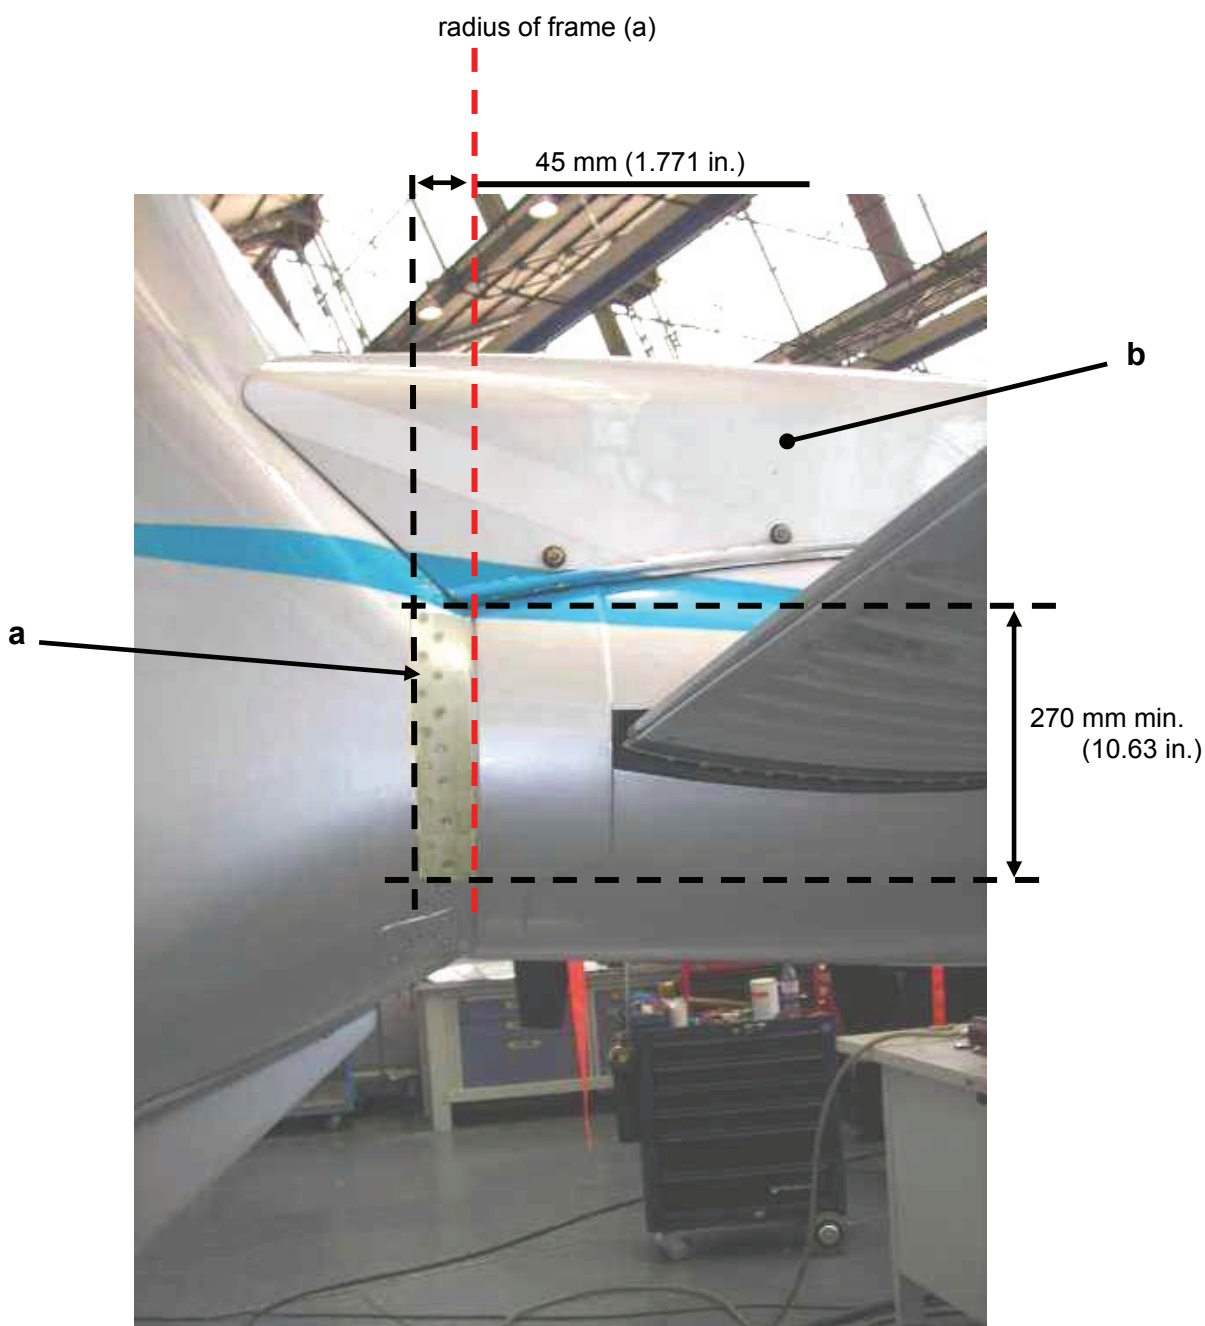
Figure 3

- 1) Presence of a crack reaching the radius of frame (a) (Figure 3):
 - All flights are prohibited beyond 85 flying hours following the inspection (compliance with paragraph 3.B.4. or the flight-related check (VLV)) prior to the one during which a crack, reaching the radius of frame (a), was detected, except for the ferry flight not exceeding 10 flying hours.

- 2) Presence of a crack not reaching the radius of frame (a) (Figure 3):
 - All flights are prohibited after 12 months from initial detection of a crack on the outside of the frame, except for the ferry flight not exceeding 10 flying hours.

- Strip the RH side of junction frame (a) on Fenestron side, as per Detail E and as per MTC Work Card 20.04.02.401:
 - . over a length of at least 270 mm (10.63 in.) from the cowling (b),
 - . over the visible width of 45 mm (1.771 in.) from the cowling (b).
- Apply a coat of primer (1) or (2) to the stripped area as per MTC Work Card 20.04.05.402.
- Apply varnish (3) to the stripped area as per MTC Work Card 20.02.07.403.

- Check that there are no cracks in the area stripped in accordance with paragraph 3.B.3.
- Interpret the results as per paragraph 1.E.2. b).
