NATIONAL TRANSPORTATION SAFETY BOARD

STRUCTURES GROUP CHAIRMANS FACTUAL REPORT

DCA06MA010

Attachment A
Figures

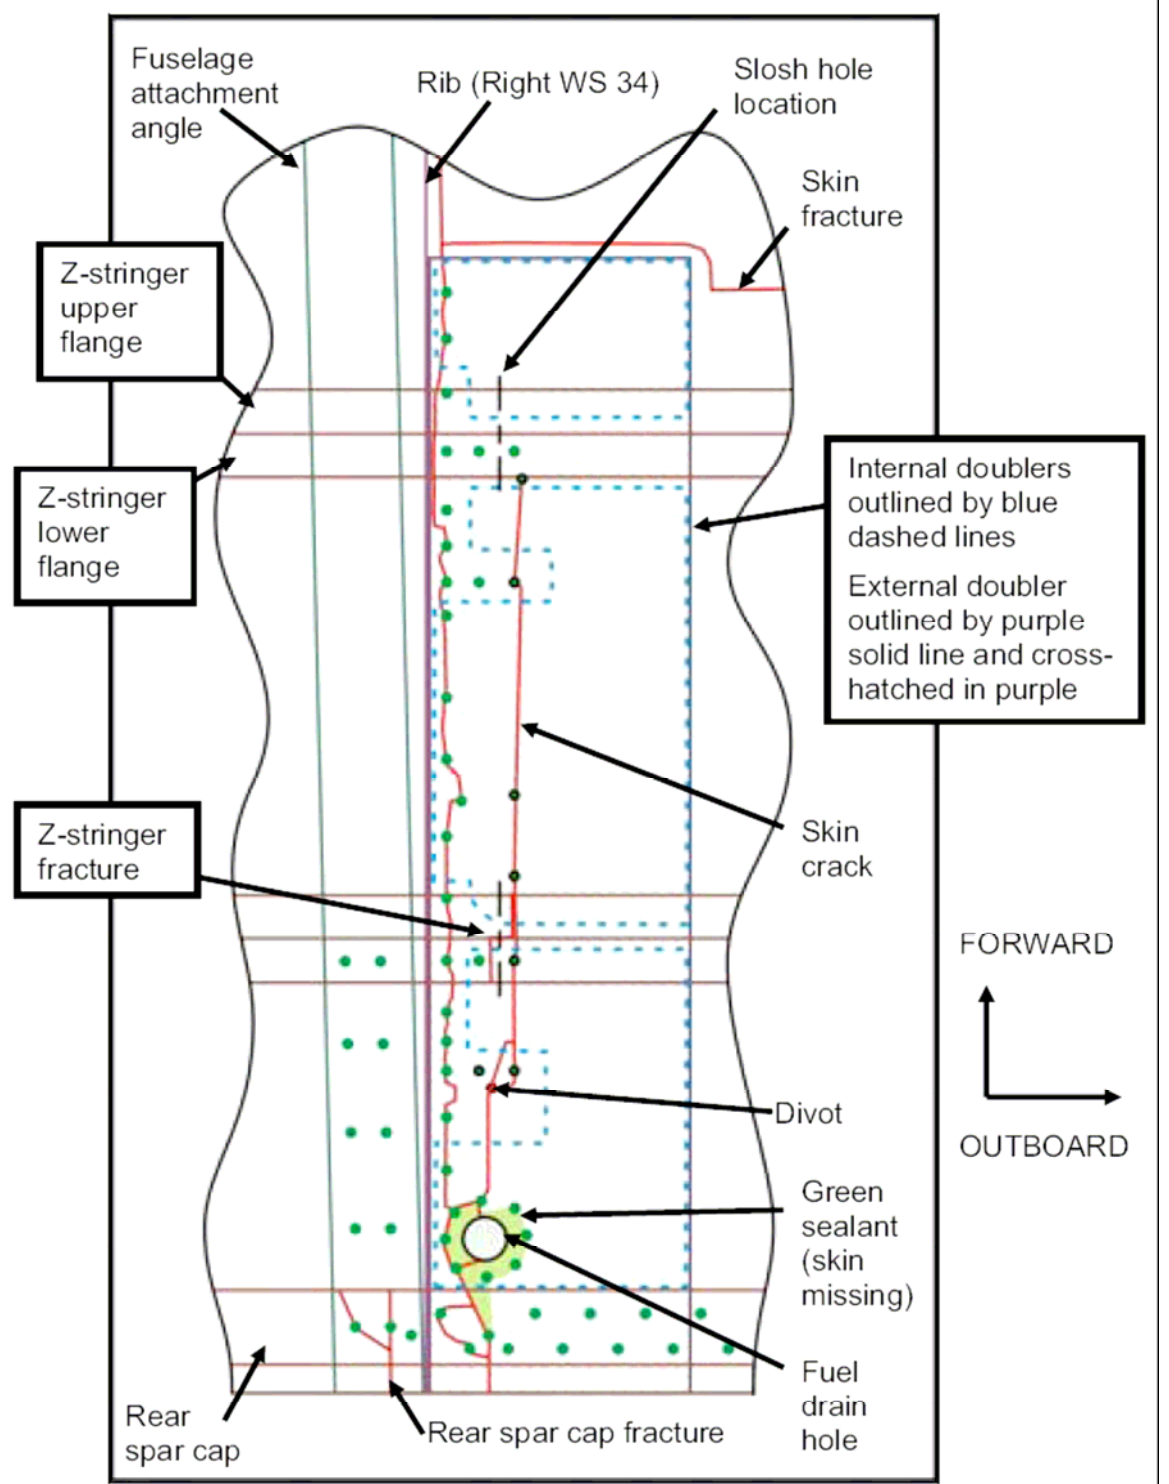
Figure 8

Description: Right wing skin, stringer and spar cap fractures overview at WS 34.

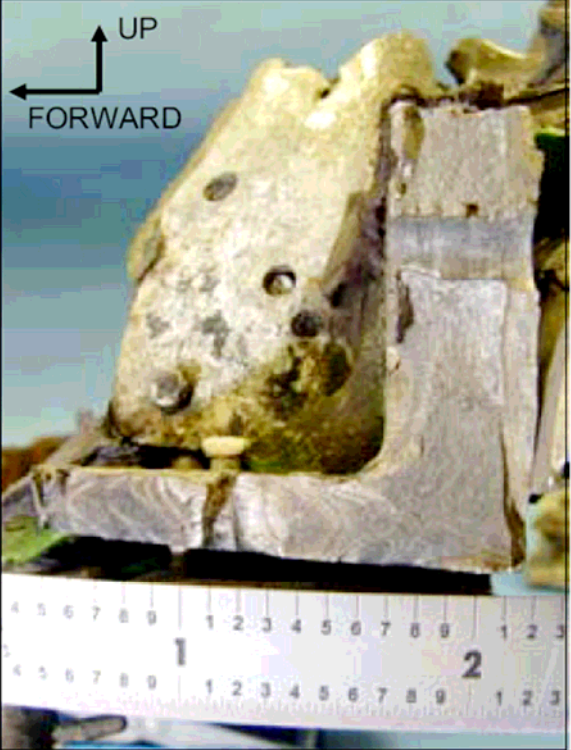
Accident #: DCA06MA010	N2969
Description: Right wing rear spar lower spar cap fracture at WS 34.

<p>Image No.:0512A00890, Project No.: 2005120013</p>	<p>Close view of the outboard side of the rear spar lower spar cap transverse fracture just inboard of right WS 34. Fatigue features emanated from a double drilled fastener hole.</p>
Figure 9

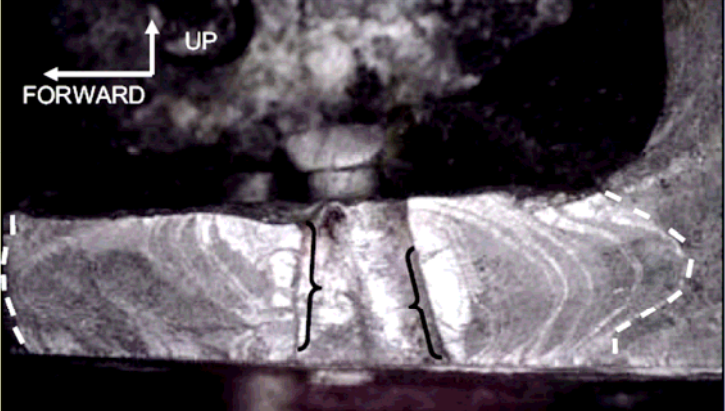
Accident #: DCA06MA010	N2969
Description: Right wing rear spar lower spar cap fatigue region.

<p>Closer view of the fatigue region on horizontal flange of rear spar lower spar cap. Dashed lines indicate the fatigue boundaries, and brackets indicate the fatigue origin areas.</p>
Figure 10

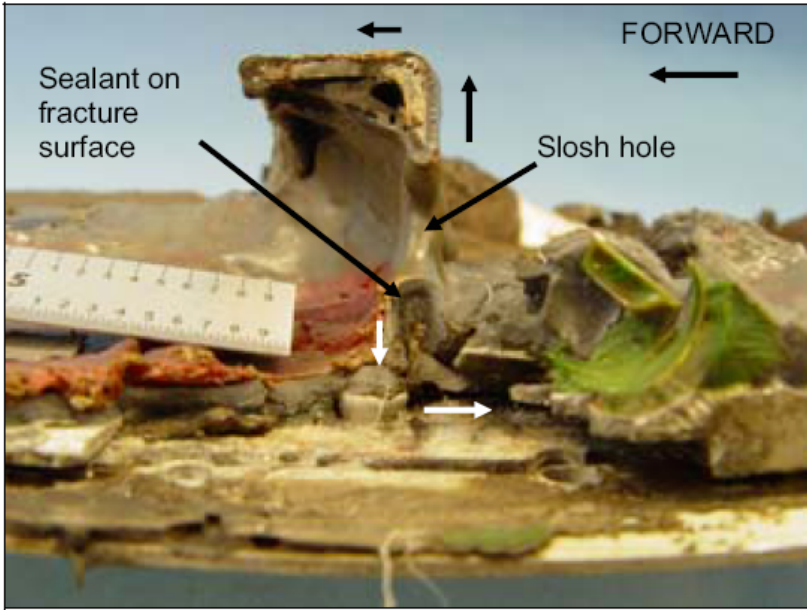
Figure 11

Description: Right wing aft Z-stringer fracture at WS 34 fuel slosh hole.

Close view of the rear Z-stringer fracture near right WS 34. Fatigue features emanated from a slosh hole in the stringer web as indicated with unlabeled arrows.

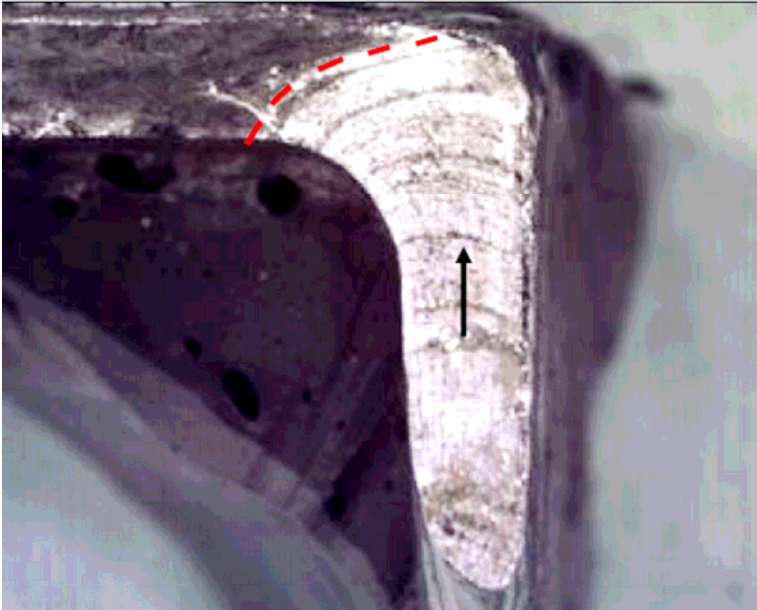
Figure 12

Description: Right wing aft Z-stringer fatigue region at WS 34.

Close view of fatigue at upper side of hole in rear Z-stringer fracture near right WS 34. A dashed line indicates the fatigue boundary, and an unlabeled arrow indicates the local fatigue propagation direction.

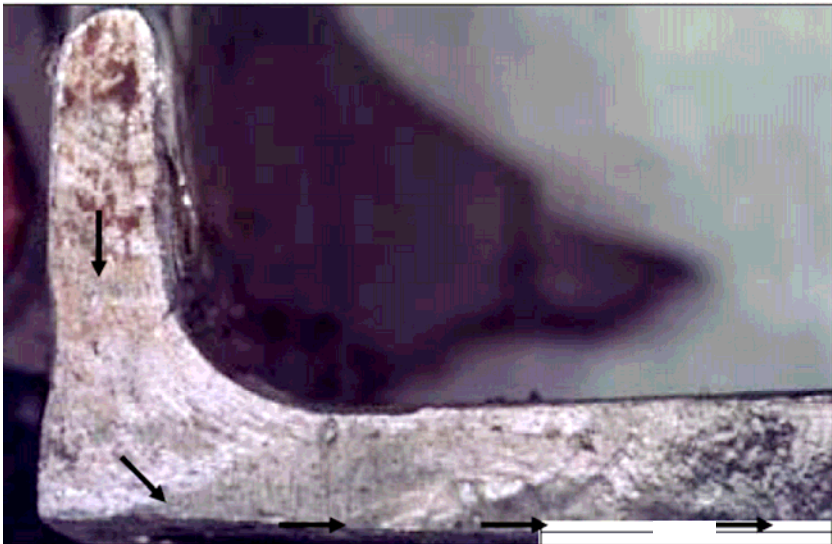
Accident #: DCA06MA010 N2969	
Description: Right wing aft Z-stringer fatigue region at WS 34.

<p>Close view of fatigue at the lower side of the slosh hole in the rear Z-stringer fracture near right WS 34. Unlabeled arrows indicate the local fatigue propagation directions.</p>
io.:0601A01200, Project No.: 2005120013	
Figure 13

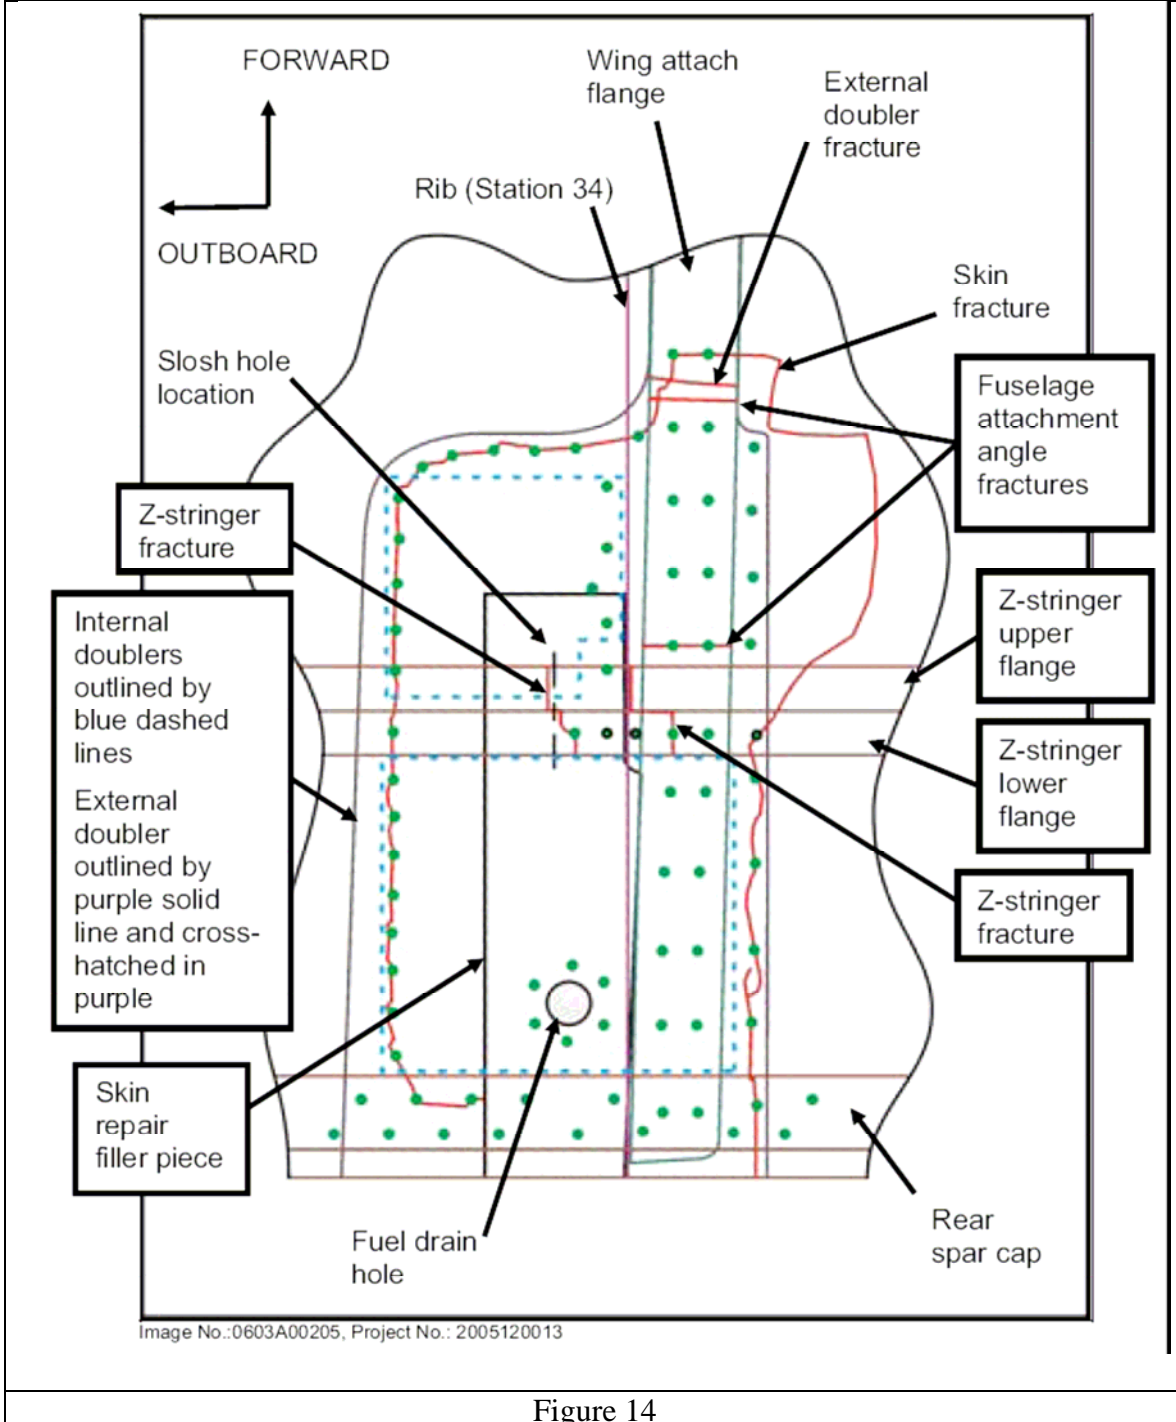
Figure 14

Description: Left wing skin, stringer and spar cap fractures overview at WS 34.

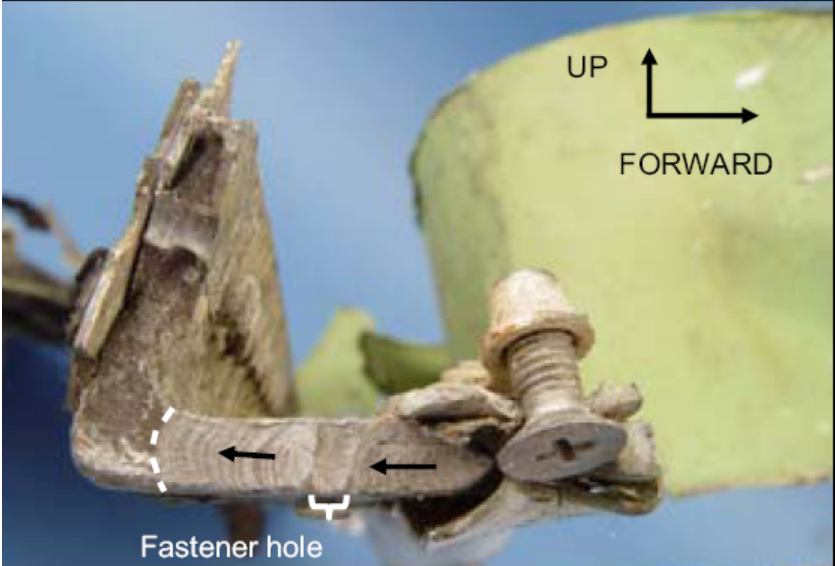
Accident #: DCA06MA010 N2969	
Description: Left wing front lower spar cap fracture at WS 34.

View of the outboard side of the fracture in the front spar lower spar cap 5 inches outboard of WS 34. A dashed line indicates the fatigue boundary, and unlabeled arrows indicate the direction of fatigue propagation.
Figure 15

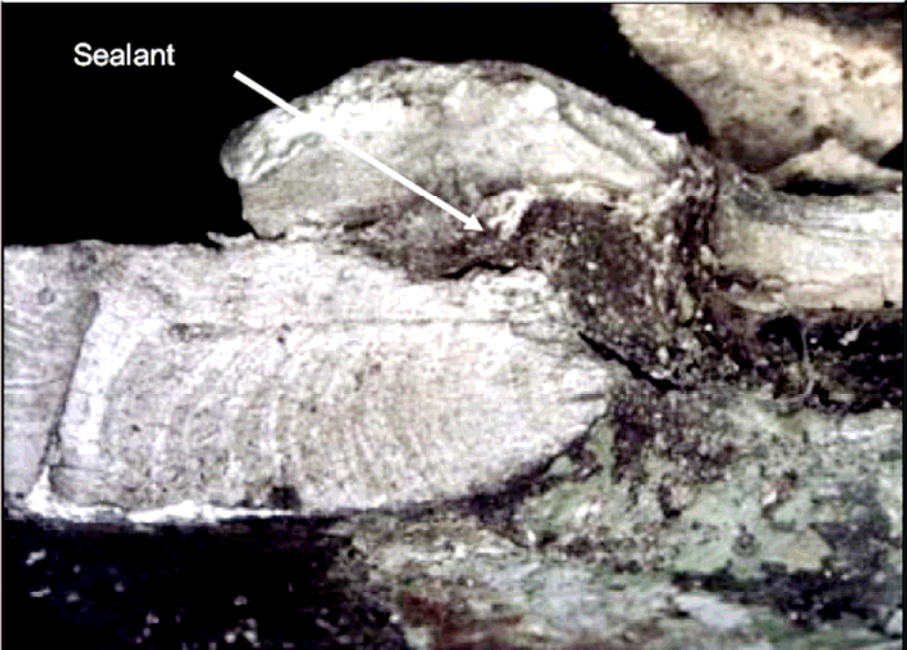
Accident #: DCA06MA010 N2969	
Description: Left wing front spar lower cap fatigue region.

Closer view of the fatigue origin area in the front spar cap fracture.
Figure 16

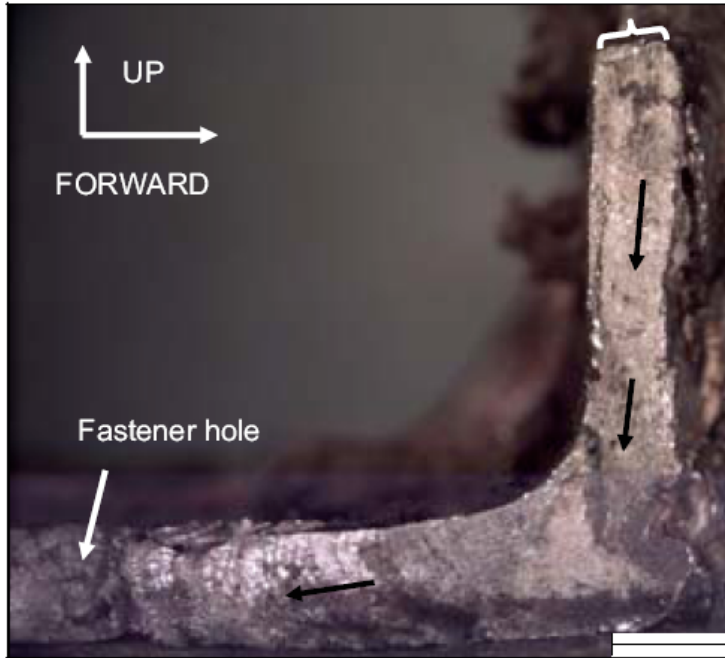
Figure 19

Description: Left wing aft Z-stringer fatigue region at WS 34.

Close view of fatigue features of the Z-stringer fracture shown in the previous figure at the lower side of the slosh hole. Unlabeled arrows indicate general fracture propagation directions and an unlabeled bracket indicates the origin area at the slosh hole.

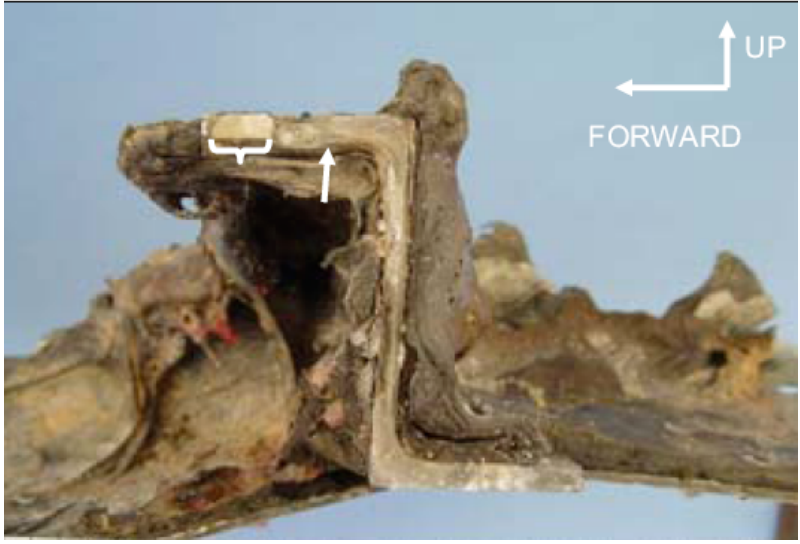
Figure 20

Accident #: DCA06MA010	N2969
Description: Left wing middle Z-stringer fracture at WS 34 at fuel slosh hole.

View of the fracture surface for the middle left Z-stringer. An unlabeled bracket indicates the extent of a fatigue region emanating from the forward side of a fastener hole, and an unlabeled arrow indicates a small fatigue region at the aft side of the fastener hole.

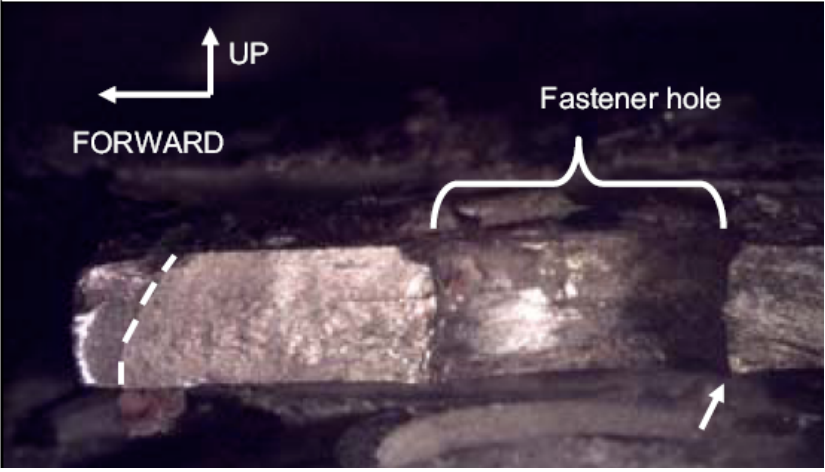
Figure 21

Accident #: DCA06MA010	N2969
Description: Left wing middle Z-stringer fatigue region at WS 34.

Close view of the fracture in upper flange of the left wing middle Z-stringer shown in the previous figure. A dashed line indicates the fatigue boundary for the region emanating from the forward side of the fastener hole, and an arrow indicates the smaller fatigue region at the aft side of the fastener hole.

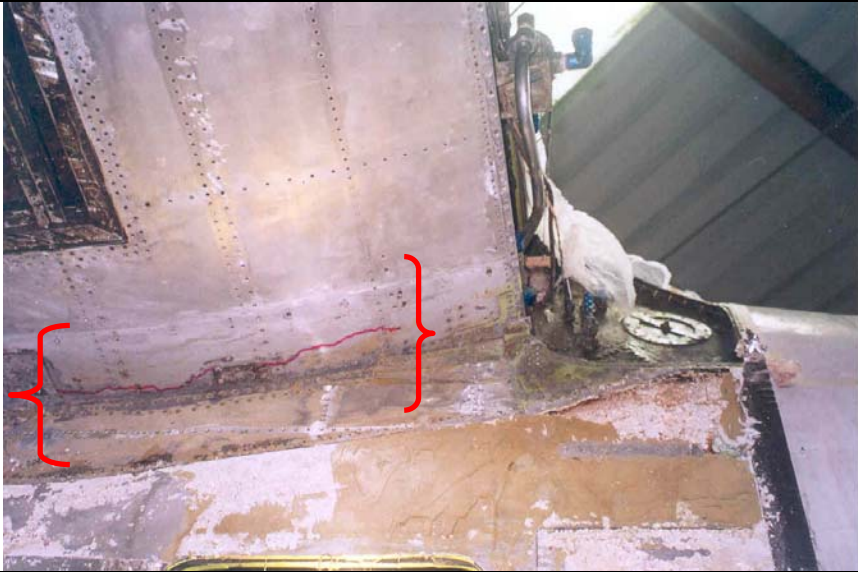
Figure 30 (Source John S. Patterson DER)

Accident #: DCA06MA010	N142PA (reference Attachment C)
Description: N142PA right wing lower surface skin crack (red line, June 2005).

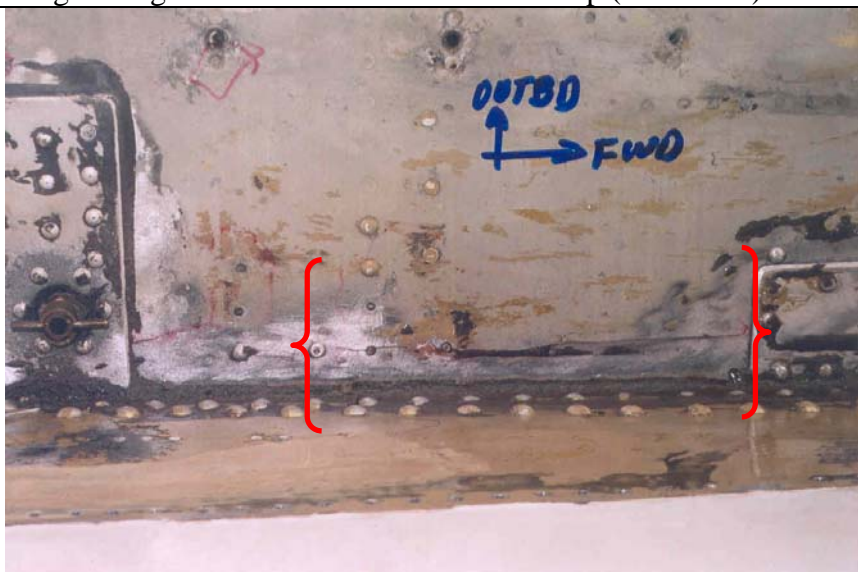
Figure 31 (Source John S. Patterson DER)

Accident #: DCA06MA010	N142PA (reference Attachment C)
Description: Right wing lower surface skin crack close-up (June 2005).

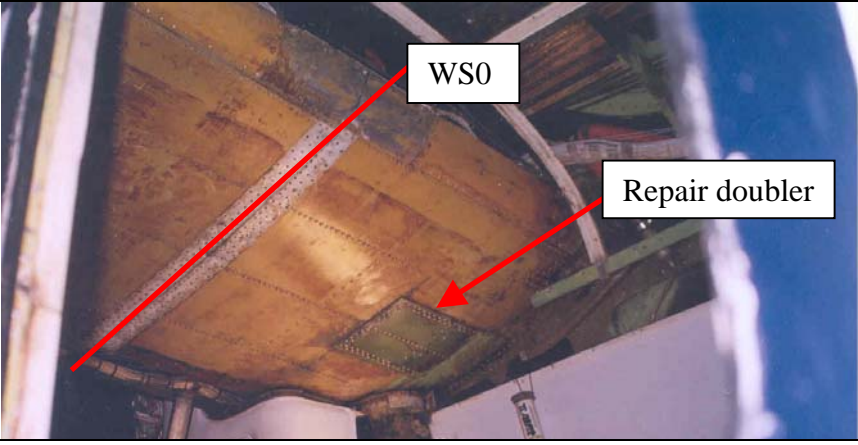
Accident #: DCA06MA010	N142PA (reference Attachment C)
Description: Left wing lower surface with previous wing skin repair & crack (June 2005).

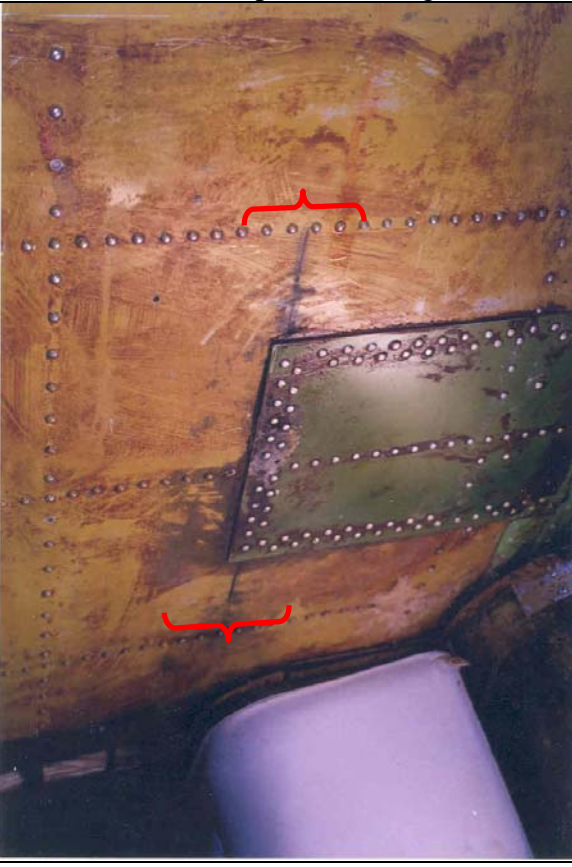
Accident #: DCA06MA010	N142PA (reference Attachment C)
Description: Left wing lower surface with previous wing skin & crack (June 2005).
