Attachment A Figures & Photographs

American Airlines Flt. 587 - Radar Based Flight Path & Debris Field

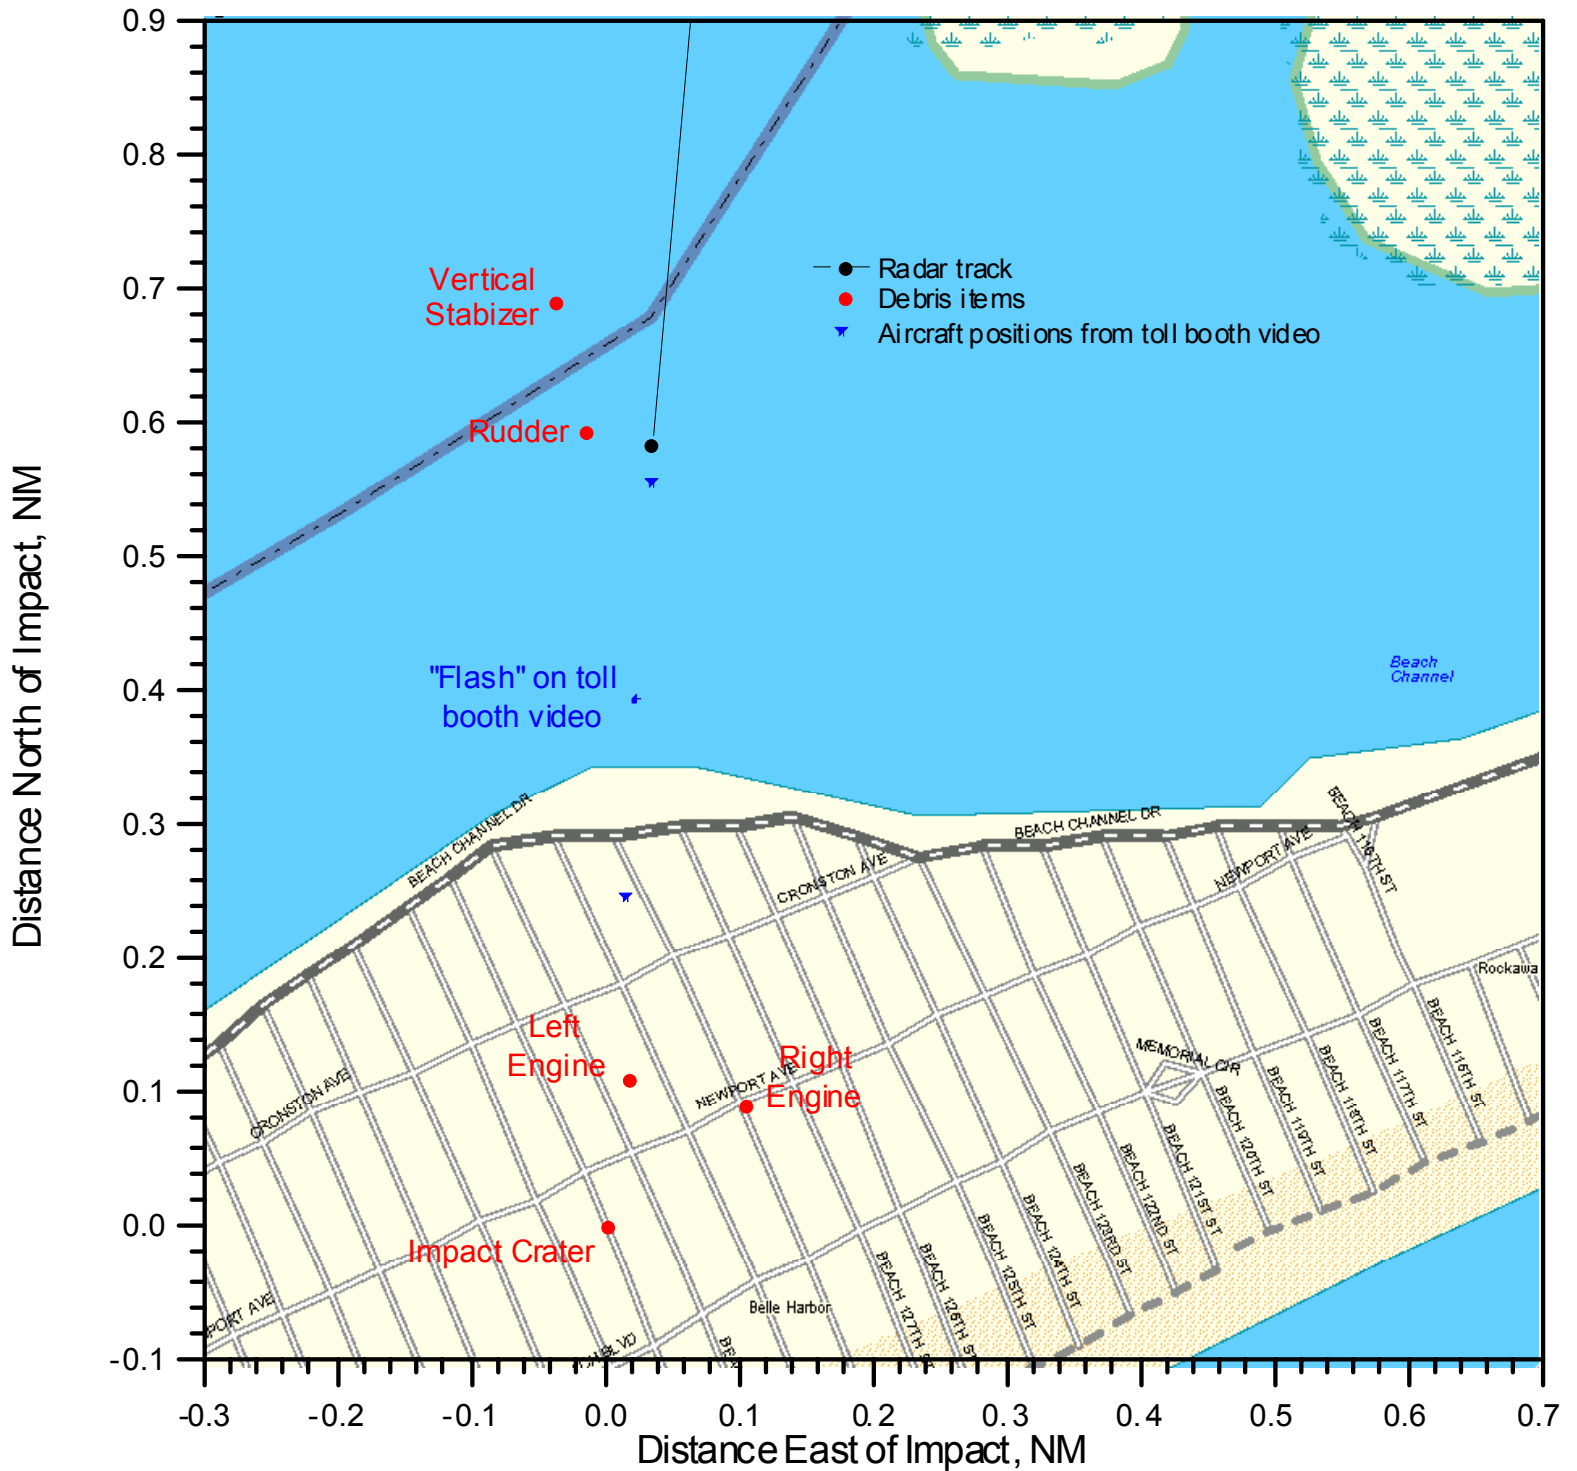
FIGURE 2

American Airlines Flt. 587 Wreckage Diagram (1)

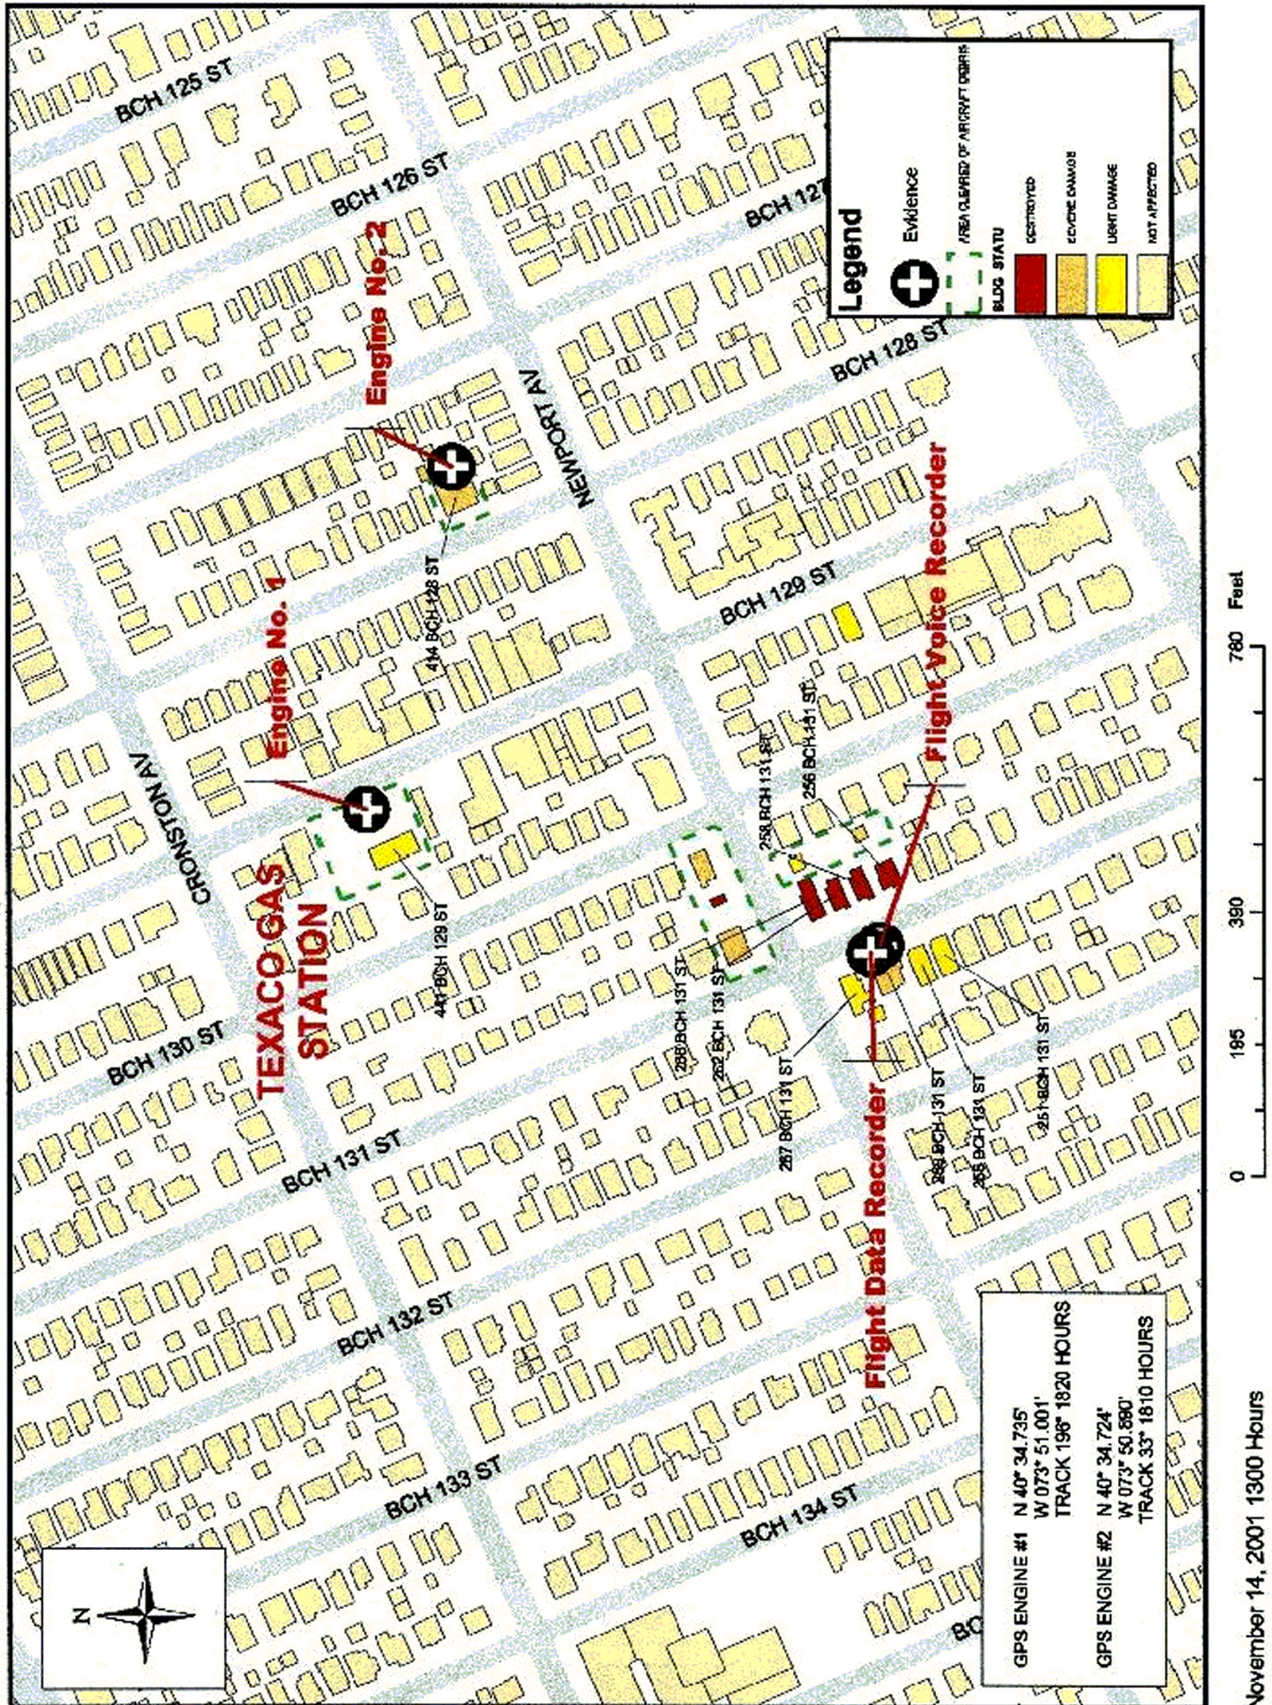
Figure 3

American Airlines Flt. 587 Wreckage Diagram (2)

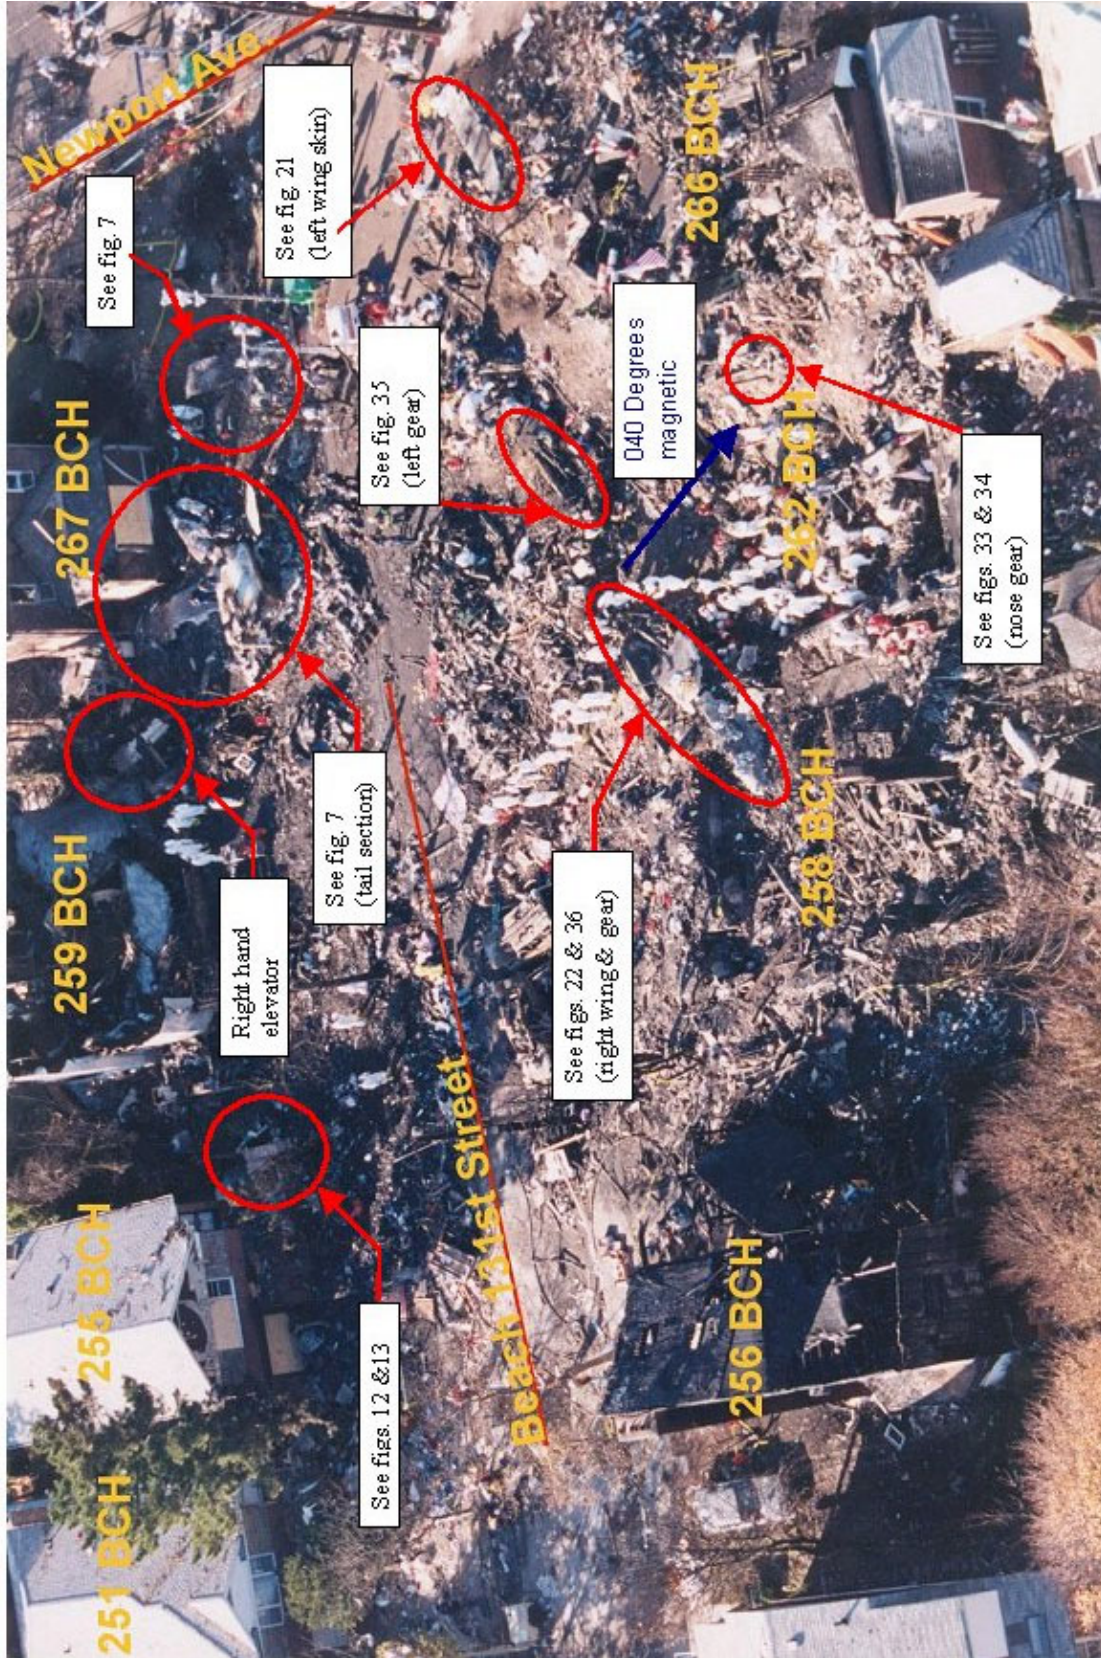
Figure 5

American Airlines Flt. 587 Wreckage Diagram (3)

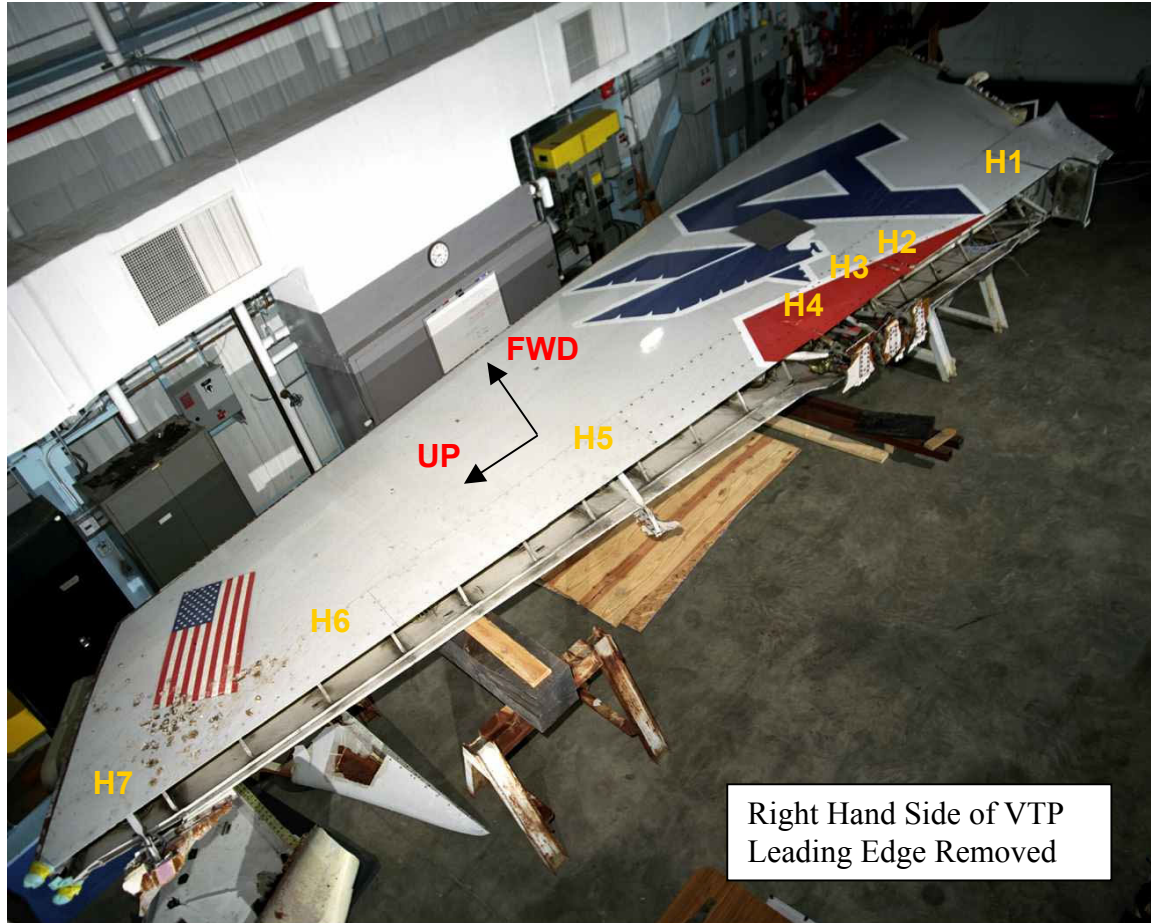
FIGURE 47

American Airlines Flight 587 Investigation
Vertical Fin
Over view of right skin and rear spar

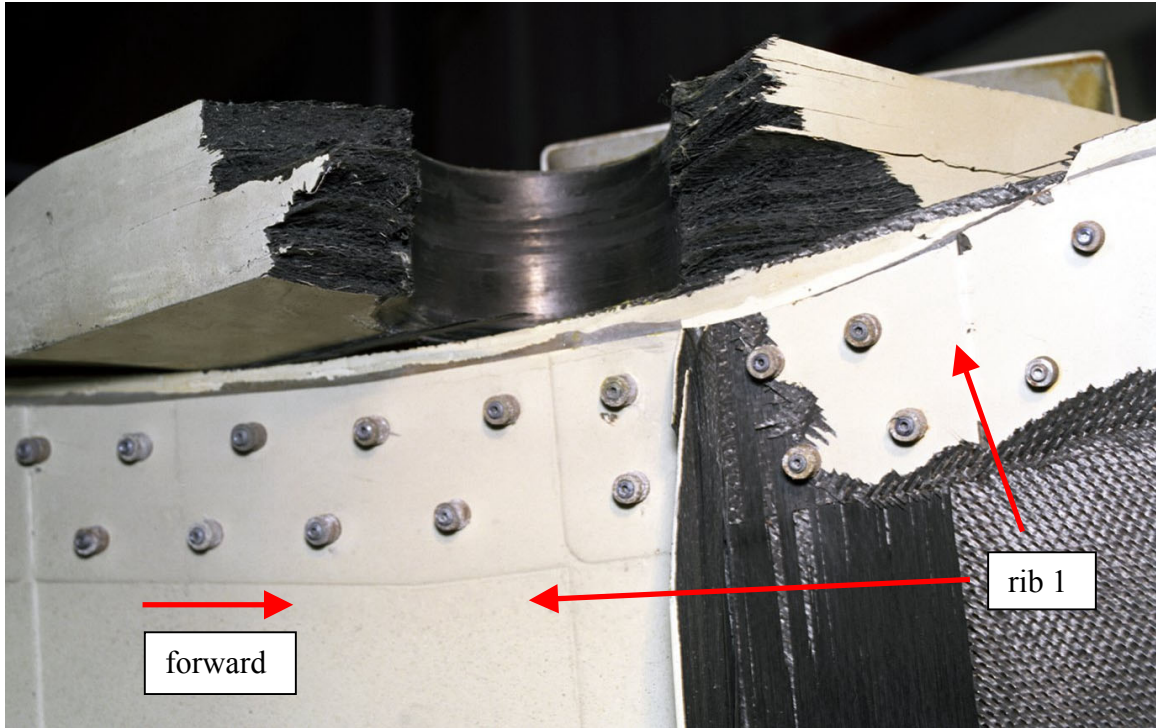
FIGURE 50

View of right aft main attach fitting
(see figures 43, 44 & 49)

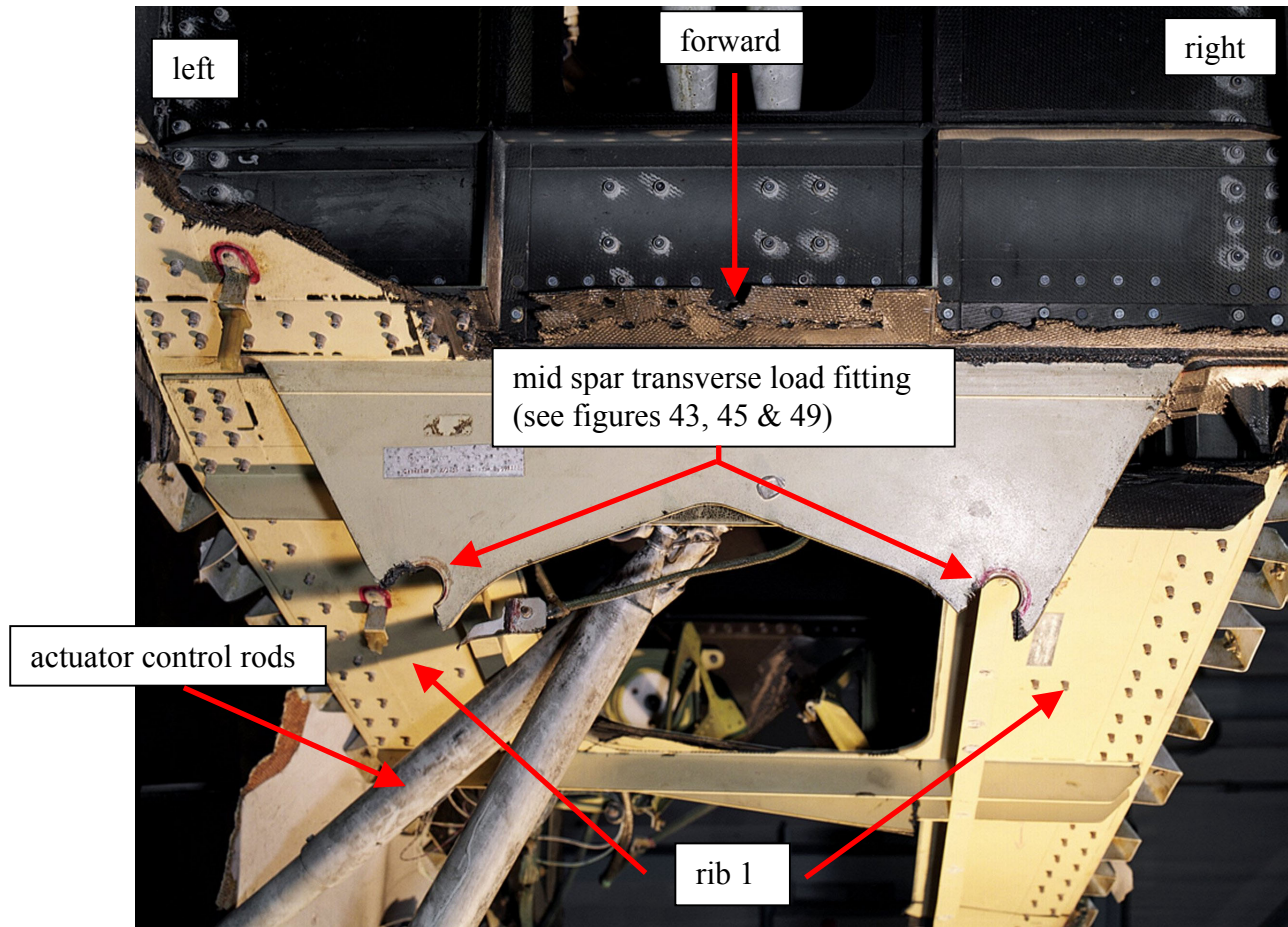
FIGURE 64

View of mid spar transverse load fitting interface
