Number: A3537
Original Issue: January 30, 2012
ATA System: 5410

SUBJECT: NACELLE - Inboard and Outboard Nacelle Strut Midspar Fitting - Inspection

Summary

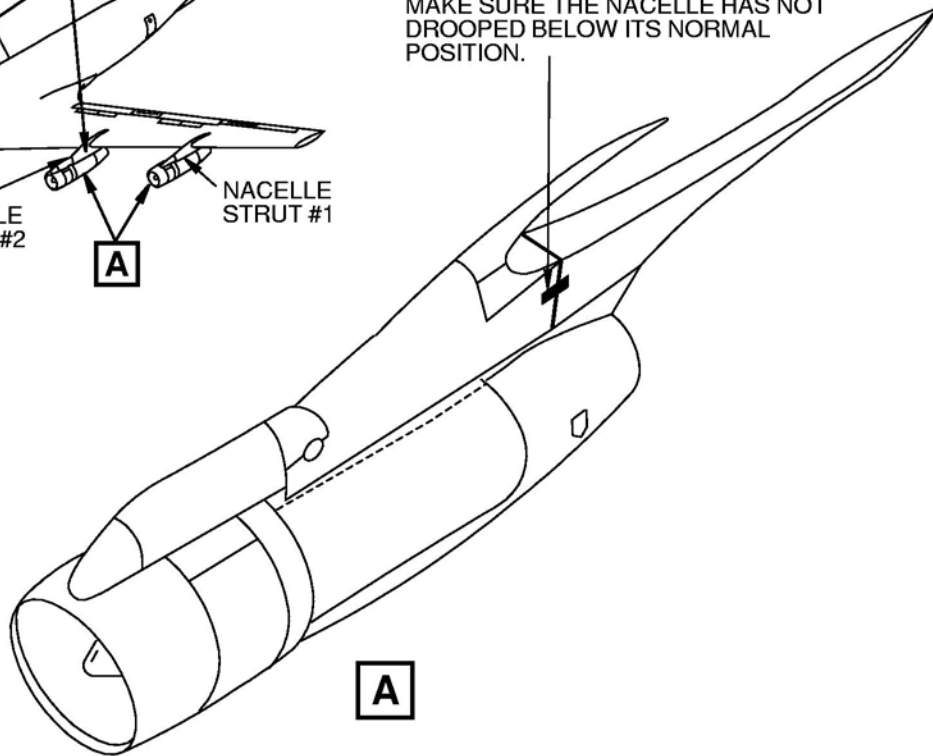
DO A GENERAL VISUAL INSPECTION OF THE NACELLE STRUT TO MAKE SURE IT IS NOT DROOPED BELOW ITS NORMAL POSITION AND APPLY STRIPE. MAKE SURE THE NACELLE HAS NOT DROOPED BELOW ITS NORMAL POSITION.

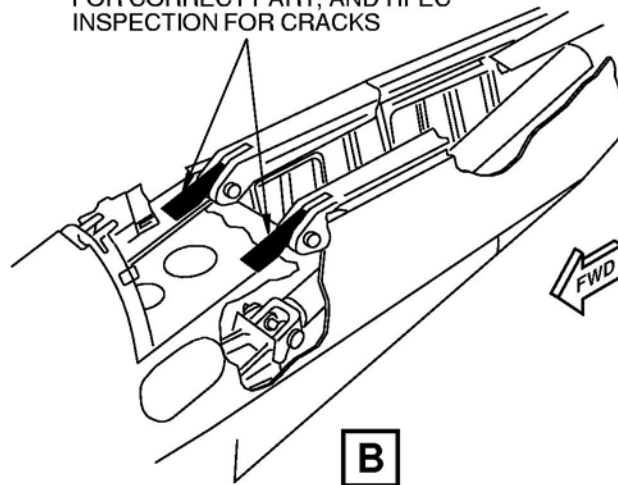
DO A ONE TIME DETAILED INSPECTION OF THE NUMBER 2 AND NUMBER 3 NACELLE STRUT MID SPAR FITTINGS FOR CORRECT PART, AND HFEC INSPECTION FOR CRACKS

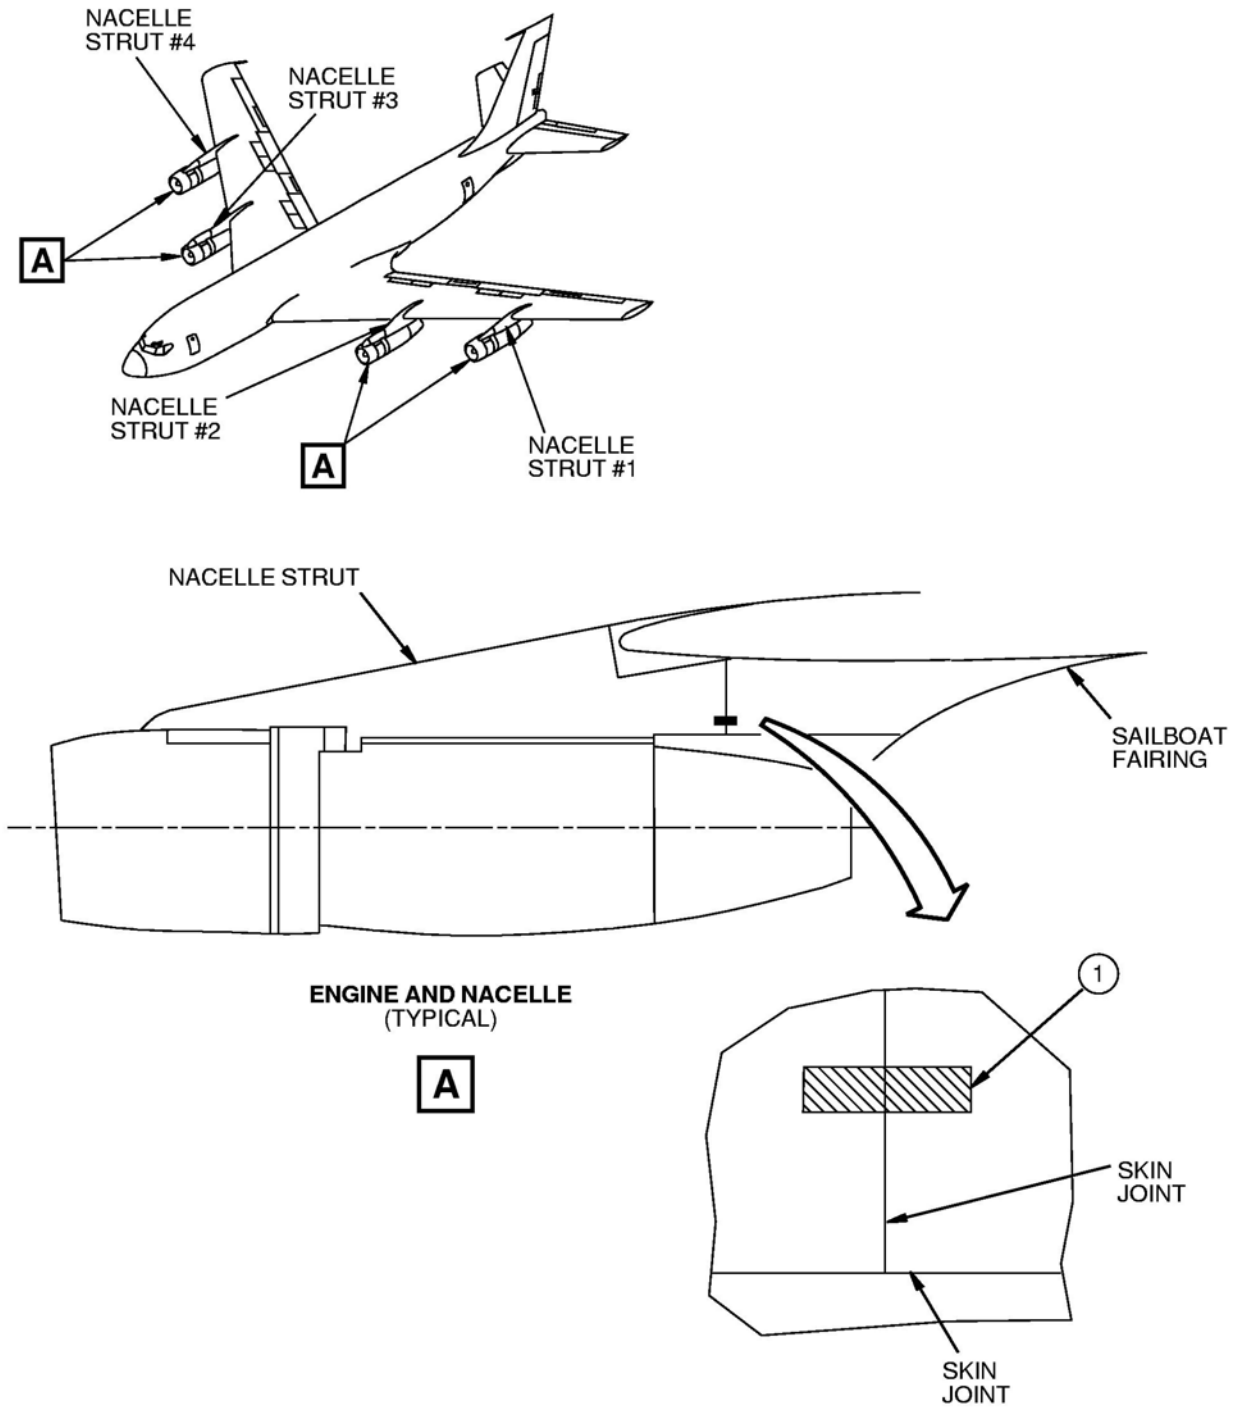
FIGURE 2: NACELLE STRUT DROOP
(SHEET 1 OF 2)

Step	Task	Name	Identification	Qty	More Data
1	Inspect	Nacelle Strut and Aft Fairing	-	8	Do a general visual inspection (a) (b)
(a) Look at the nacelle strut to see if it has drooped below normal position. Look at the stripe if present for misalignment. In addition, look at the fairing straps, access panels and fairings between strut and wing for buckles, wrinkles, cracks, elongated holes and loose or broken fasteners. Noticeable nacelle droop or flexure damage to sheet metal may indicate that one or both midspar fittings are broken.					
(b) The recommended verification, prior to each flight, does not have to be accomplished by a qualified mechanic.

(1) If a nacelle strut has drooped below its normal position, contact Boeing for repair instructions and do the repair instructed by Boeing.

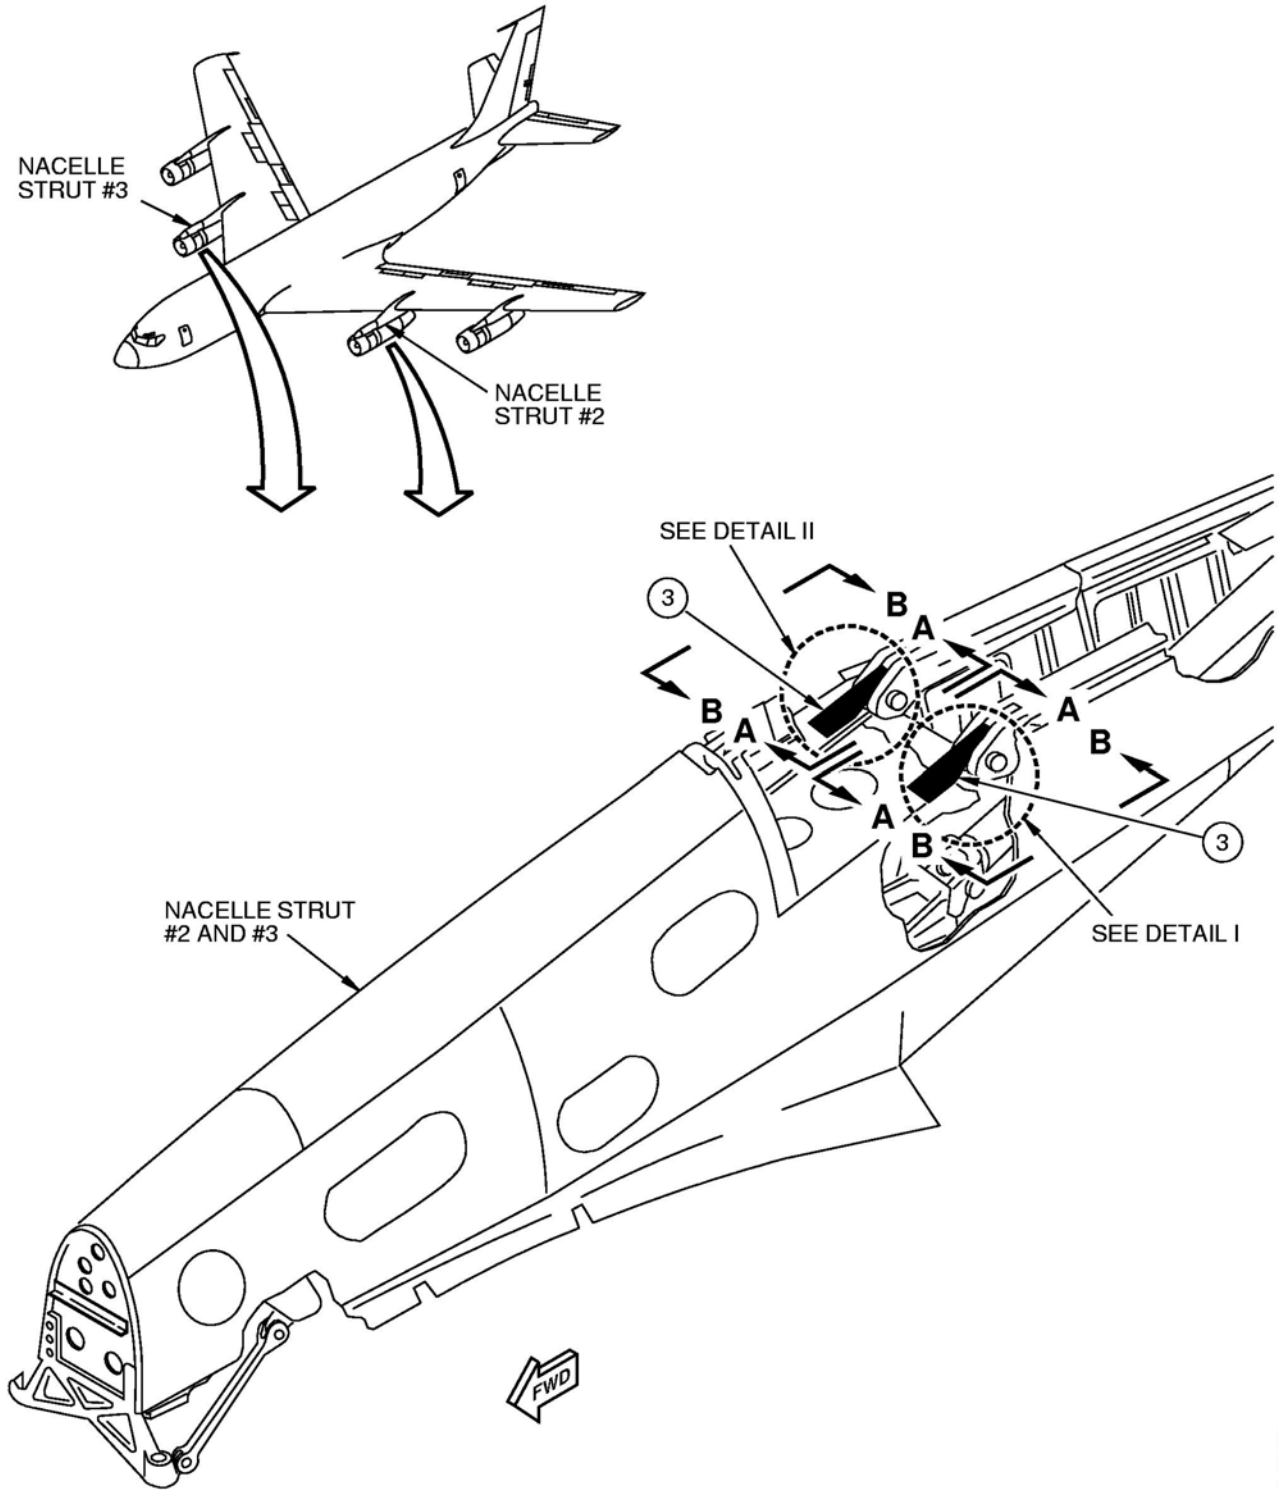
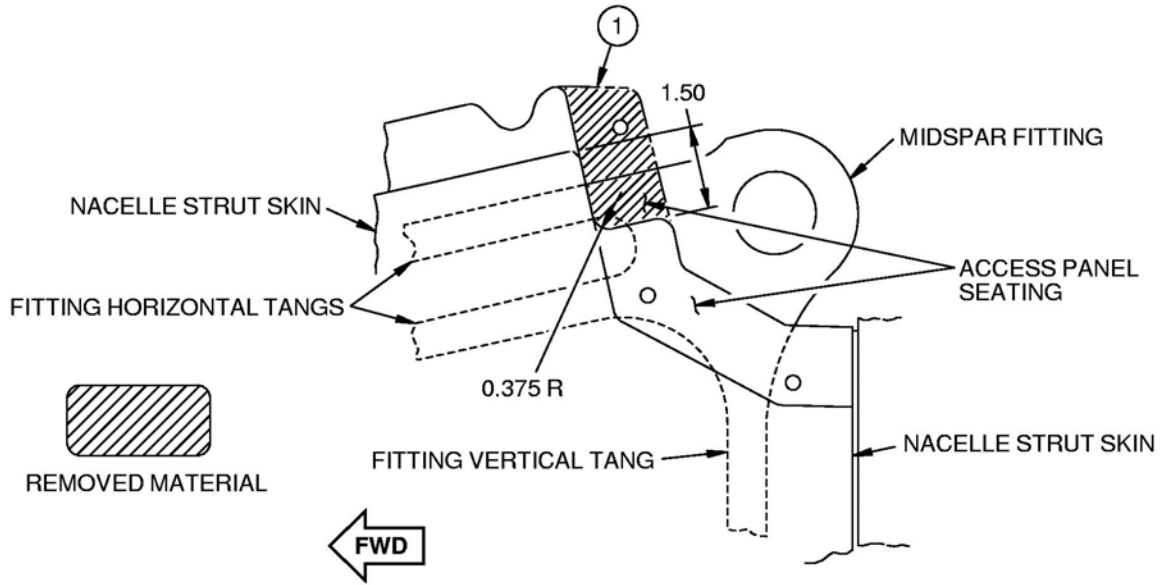
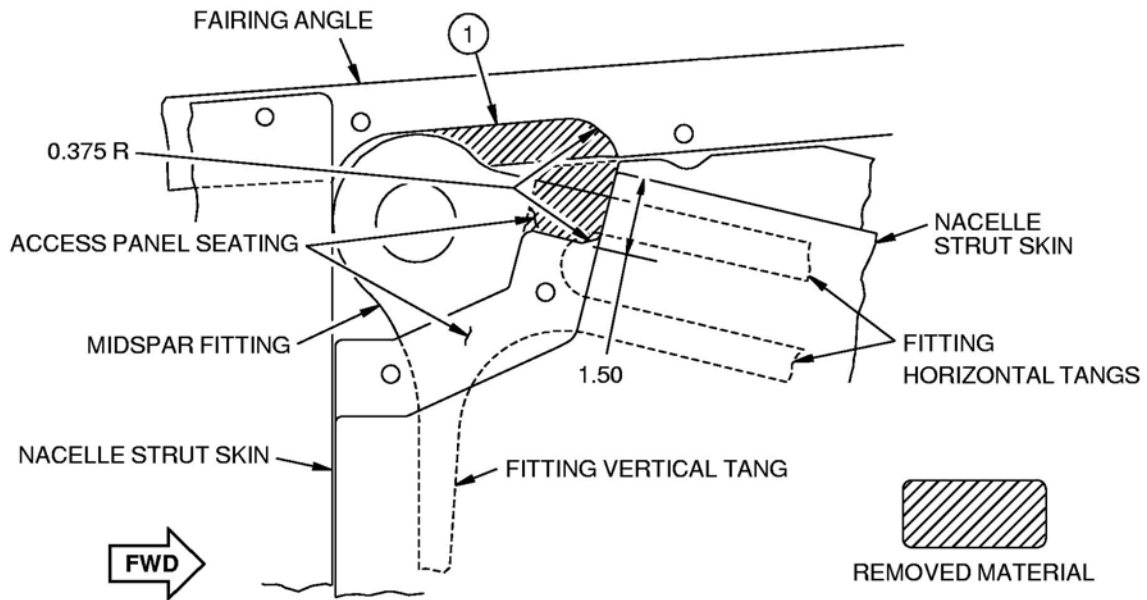
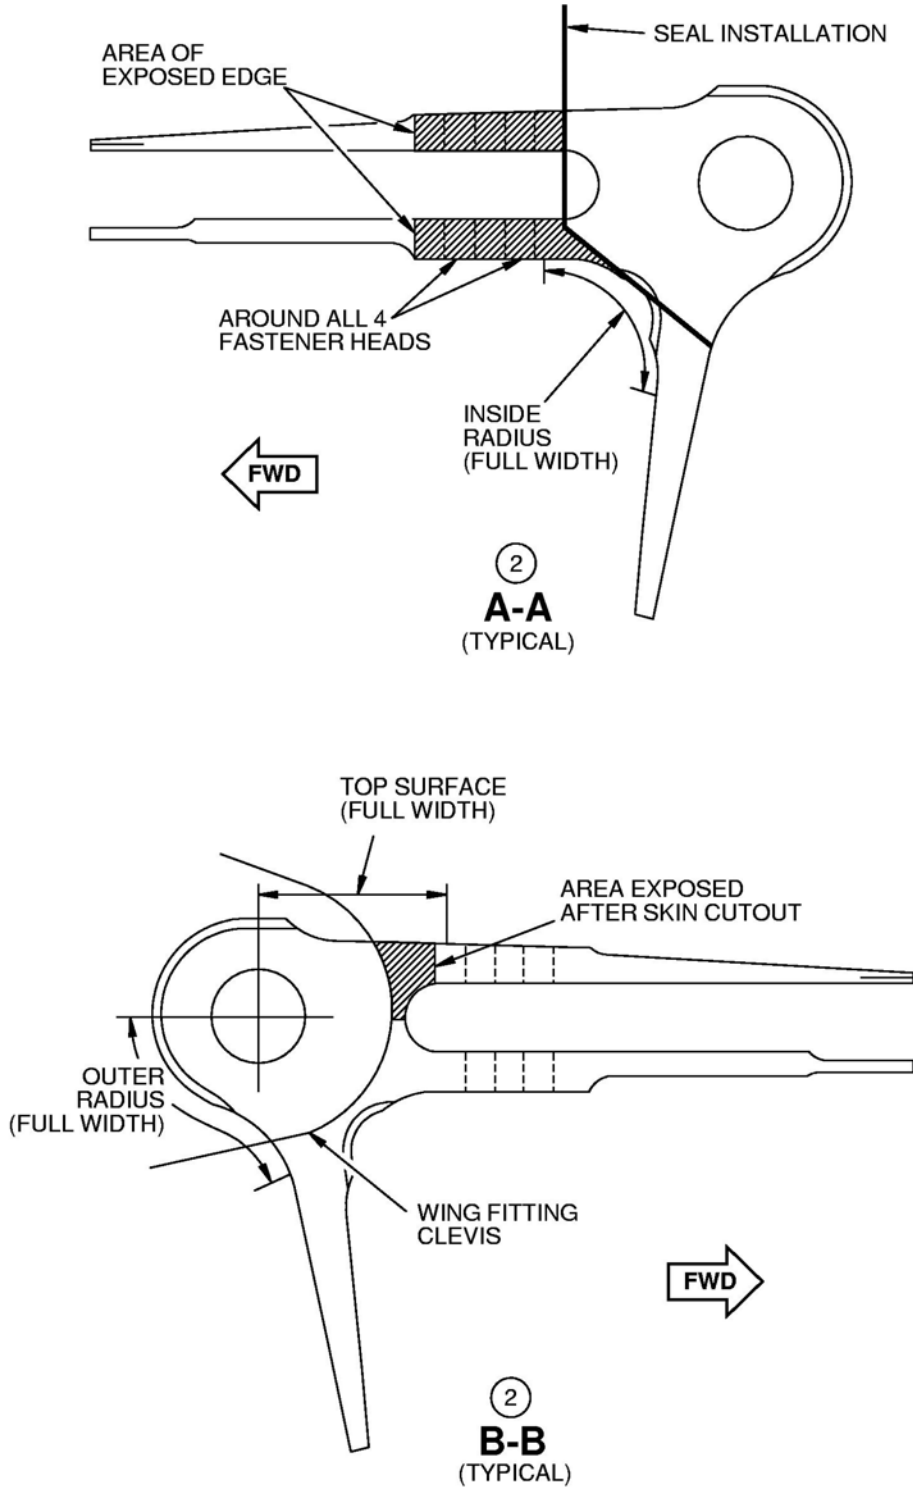
FIGURE 4: ENGINE NUMBER 2 AND ENGINE NUMBER 3 NACELLE STRUT MIDSPAR FITTINGS HFEC INSPECTION (SHEET 1 OF 4)

DETAIL I
OUTBOARD MIDSPAR FITTING
(ACCESS PANEL AND DRAG FITTING CLEVIS NOT SHOWN FOR CLARITY)
STRUT #2 SHOWN, STRUT #3 OPPOSITE

DETAIL II
INBOARD MIDSPAR FITTING
(ACCESS PANEL AND DRAG FITTING CLEVIS NOT SHOWN FOR CLARITY)
STRUT #2 SHOWN, STRUT #3 OPPOSITE

(1) If any crack is found in the inboard or outboard midspar fittings, contact Boeing for repair instructions and do the repair instructed by Boeing.

(g) If no cracks are found in the midspar fittings, spray exposed areas of fittings with organic corrosion inhibitor.
