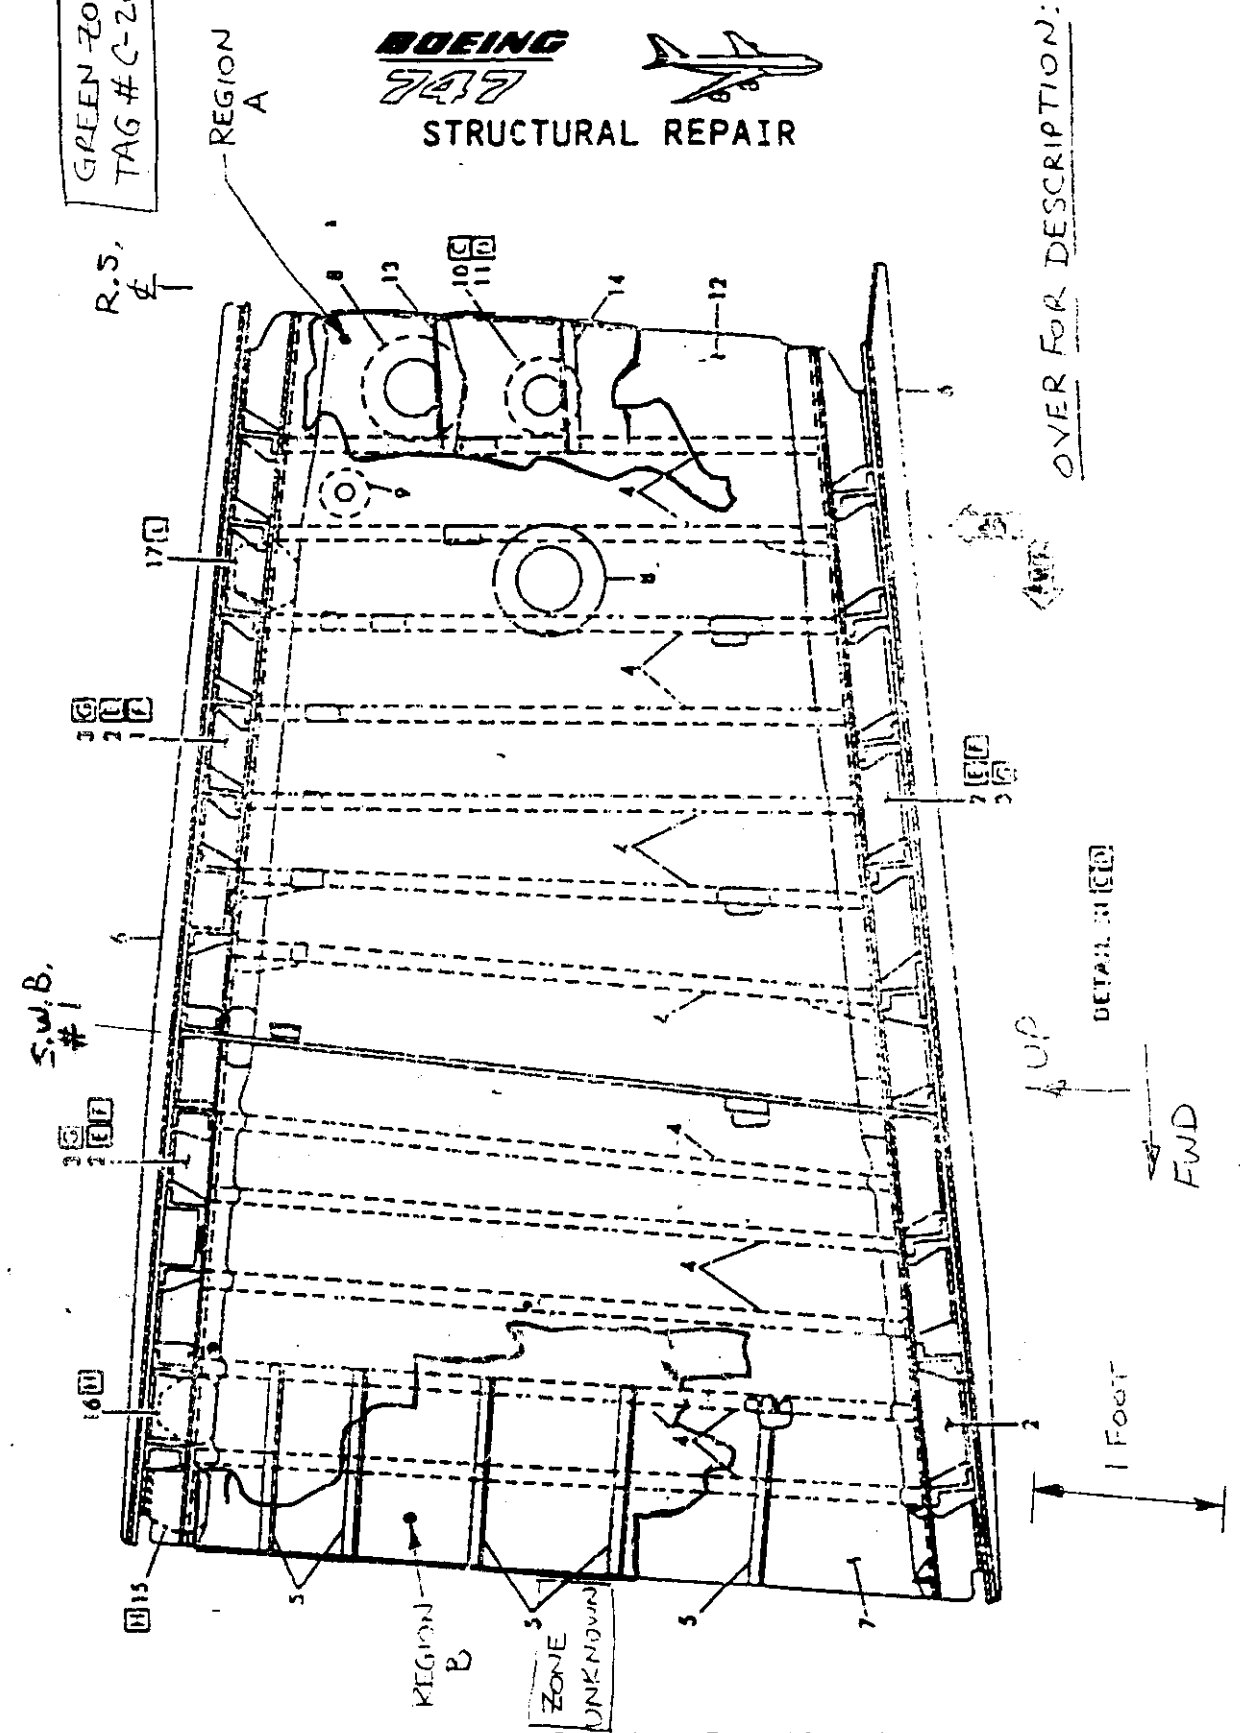
Wing Center Section Structure Identification
Figure 2 (Sheet 8)

- 1) FWD FRACTURE SURFACE SHOWS INDICATION OF CHARRING & POSSIBLY HEAT DAMAGE.
- 2) FWD, LWR, LEFT HAND SURFACE CHARRED
- 3) PIPE CLAMP ON UPPER HORIZONTAL STIFFENER IS STILL ATTACHED BUT IS IN TWO PIECE, EACH ONE SHOWING HEAT DAMAGE (MELTING). PIPE CLAMP ON LWR HORIZ. STIFF IS MISSING
- 4) THE VERTICAL CHORD AT THE REAR SPAR EDGE OF THE PANEL IS STIFF ATTACHED TO THE PANEL (FWD/AFT FLANGE ONLY)
- 5) THE RIGHT HAND SURFACE OF THE PANEL IS CONSIDERABLY CHARRED
- 6) THE LWR FRACTURE SURFACE IS CHARRED & SHOWS APPARENT HEAT DAMAGE
- 7) FWD STIFFENER LEG WHICH ATTACHES TO THE PANEL REMAINS ATTACHED
- 8) PANEL IS BOWED TOWARD THE RIGHT HAND SIDE. (CONVEX TO THE RIGHT)

- 1) PANEL SHOWS CHARRING ON BOTH LEFT & RIGHT HAND SIDES.
- 2) THE TWO UPPER HORIZONTAL STIFFENERS TERMINATE AT THEIR AFT END AT THE EDGE OF PANEL AS DRAWN. THE TWO LOWER HORIZONTAL STIFFENERS REMAIN COMPLETE PORTIONS OF VERTICAL STIFFENERS REMAIN ATTACHED ON RIGHT HAND SIDE OF PANEL ON THE AS-DRAWN VERTICAL EXTENT OF THE PANEL
- 3) PANEL IS BOWED TO THE RIGHT HAND SIDE (CONVEX TO THE RIGHT), THE BOWING BECOMES MORE OF A "BEND" AT THE TOP. ALSO, A PART OF THE LOWER EDGE (MID PANEL) IS BENT TOWARD THE LEFT AND UPWARD.
- 4) THE FWD/AFT LEG OF THE ATTACHMENT CHORD OF THE MID-SPAR BULKHEAD REMAINS ATTACHED TO THE PANEL ALONG THE LENGTH INDICATED.

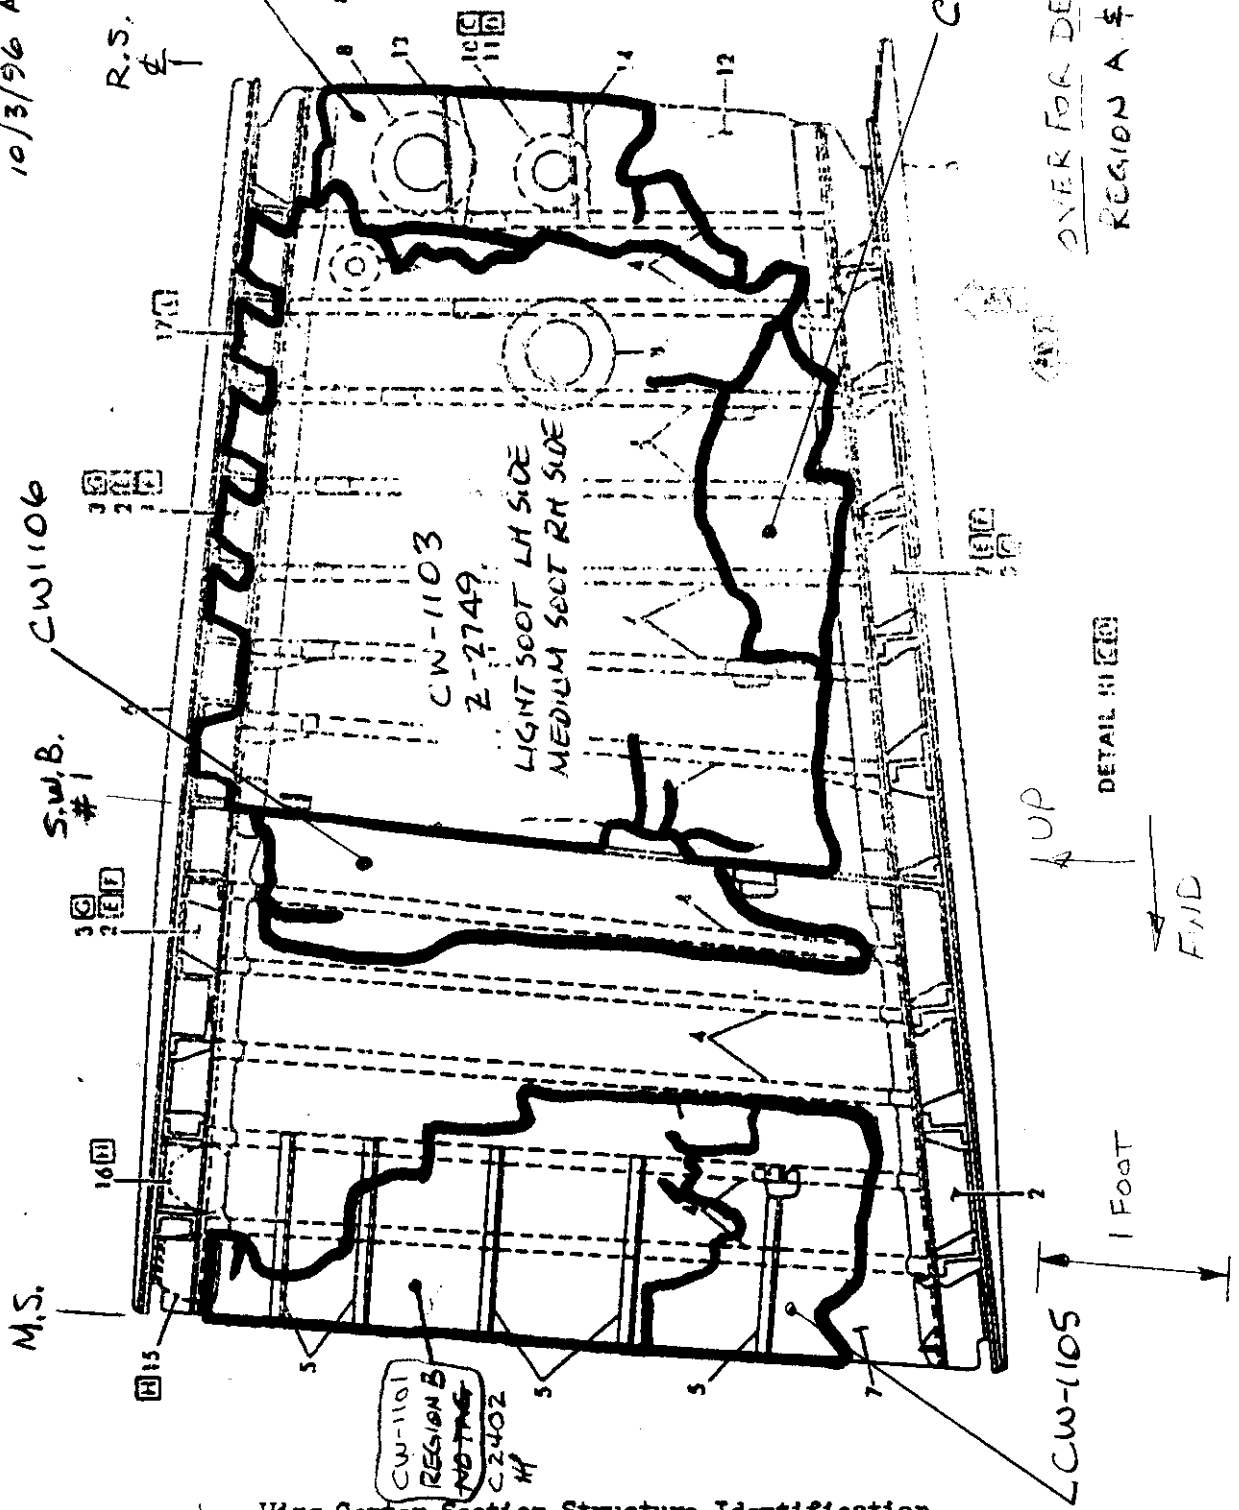
CW-1102
REGION A
GREEN TAG
C-2077

- 1) FWD FRACTURE SURFACE SHOWS INDICATION OF CHARRING & POSSIBLY HEAT DAMAGE.
- 2) FWD, LWR, LEFT HAND SURFACE CHARRED
- 3) PIPE CLAMP ON UPPER HORIZONTAL STIFFENER IS STILL ATTACHED BUT IS BROKEN INTO TWO PIECE, EACH ONE SHOWING HEAT DAMAGE (MELTING). PIPE CLAMP ON LWR HORIZ STIFFENER IS MISSING
- 4) THE VERTICAL CHORD AT THE REAR SPAR EDGE OF THE PANEL IS STIFF ATTACHED TO THE PANEL (FWD/AFT FLANGE ONLY)
- 5) THE RIGHT HAND SURFACE OF THE PANEL IS CONSIDERABLY CHARRED
- 6) THE LWR FRACTURE SURFACE IS CHARRED & SHOWS APPARENT HEAT DAMAGE
- 7) FWD STIFFENER LEG WHICH ATTACHES TO THE PANEL REMAINS ATTACHED
- 8) PANEL IS BOWED TOWARD THE RIGHT HAND SIDE. (CONVEX TO THE RIGHT)

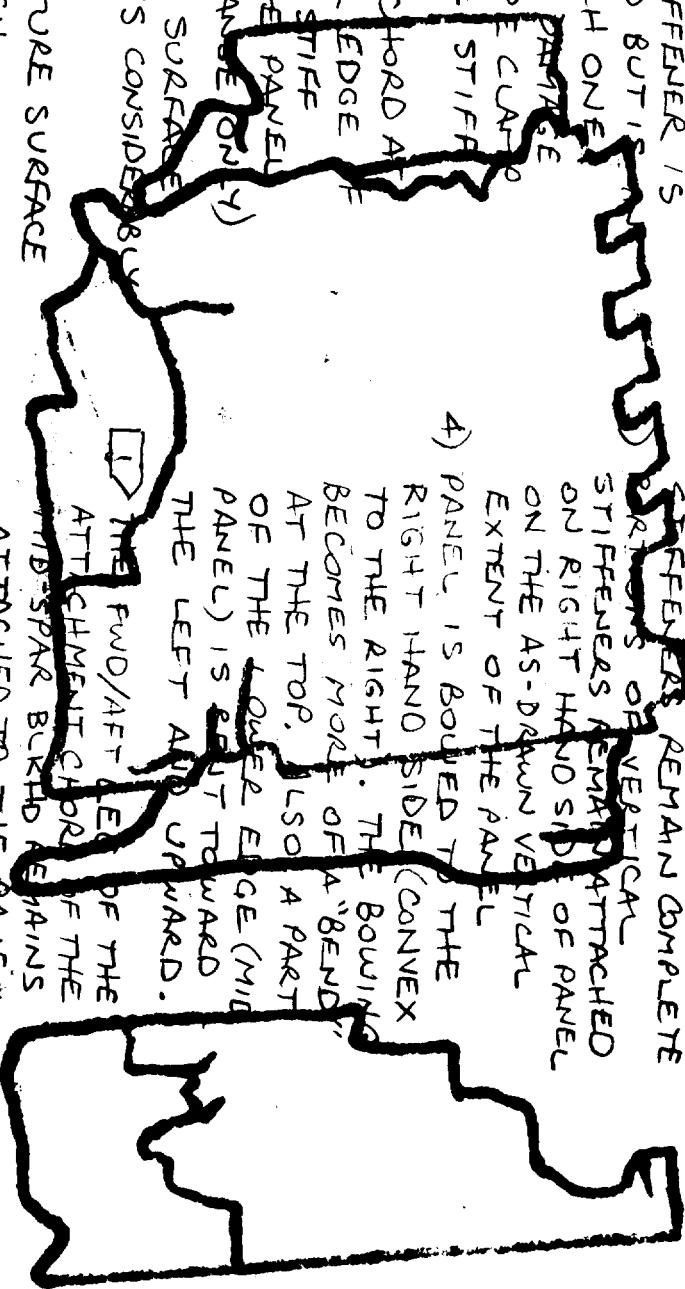
CW-1101
REGION B
NO TAGS
C-2402
M

- 1) PANEL SHOWS CHARRING ON BOTH LEFT & RIGHT HAND SIDES.
- 2) THE TWO UPPER HORIZONTAL STIFFENERS TERMINATE AT THEIR AFT END AT THE EDGE OF PANEL AS DRAWN. THE TWO LOWER HORIZONTAL STIFFENERS REMAIN COMPLETE PORTIONS OF VERTICAL STIFFENERS REMAIN ATTACHED ON RIGHT HAND SIDE OF PANEL ON THE AS-DRAWN VERTICAL EXTENT OF THE PANEL
- 3) PANEL IS BOWED TO THE RIGHT HAND SIDE (CONVEX TO THE RIGHT). THE BOWING BECOMES MORE OF A "BEND" AT THE TOP. ALSO A PART OF THE LOWER EDGE (MID-PANEL) IS BENT TOWARD THE LEFT AND UPWARD.
- 4) THE FWD/AFT LEG OF THE ATTACHMENT CHORD OF THE MID-SPAR BULKHEAD REMAINS ATTACHED TO THE PANEL ALONG THE LENGTH INDICATED.
