REAR SPAR - WING CENTER TANK

CW-1003
C-2143
GREEN

CW-2 PART A CW-1003 NO TAG

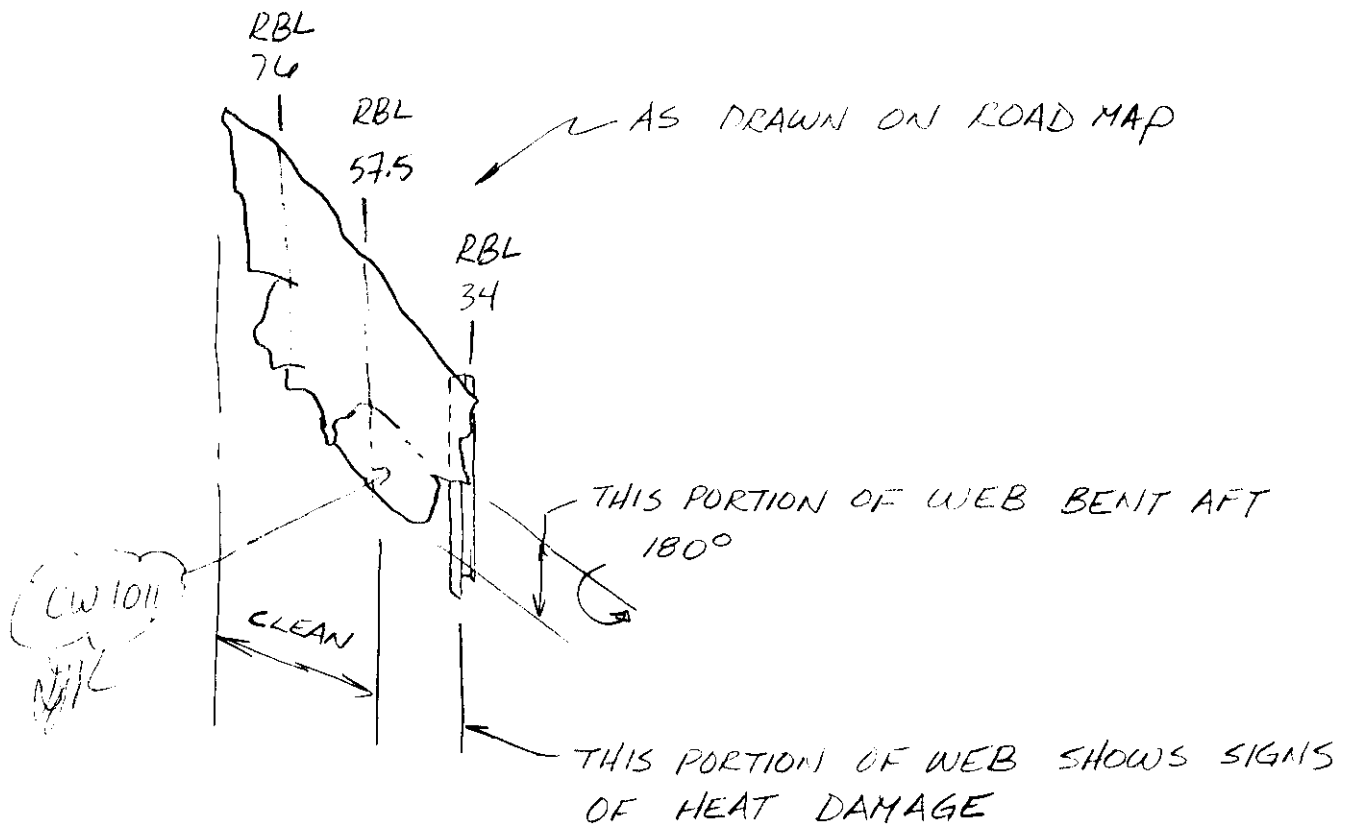
The web has a jagged tear on the lower side that is 12" above the lower chord at the inboard end, 6" in the middle and 20" at the outboard end. The stiffeners at RBL 75 and 57, as described in CW-1002, separated from the web at the fasteners. 24 out of 33 holes are open. The stiffener at RBL 85 is detached and the fasteners remain in the holes. The fasteners remaining in the holes exhibit combination of tensile and shear failure with the direction going outboard. The upper 12" of the stiffener of RBL 63 is missing with the fasteners showing a tension failures. The lower 18" of RBL 63 stiffener only has the web flange remaining with the fastener intact. The RBL 46 stiffener is missing with the remaining fasteners exhibiting a shear failure in the upper direction. There is 29" of the lower end of RBL 33 stiffener still attached. The lower 16" of the stiffener is not attached to any web and the fasteners remaining in the hole exhibit tension and shear failures. The tension failures are common to the lower 10" of the stiffener and shear failures from 10" above the lower chord to 16" above the lower chord.

The inbd end of the this segment shows a higher level of soot deposit than the outbd end. The interface of the stiffener to the web where the stiffeners are missing shows soot deposits. See the Fire and Explosion Group report for complete information.

- STIFFENER IS COMPLETELY SOOTED ALL AROUND
- AFT FACE OF WEB HAS PAINT BURNED OFF / PEE LING BTWN RBL 30 & 57.5. OUTB'D OF RBL 57.5 WEB IS BROWNISH DIRTY.
