REAR SPAR - WING CENTER TANK

CW-1004
C-2139
GREEN

CW2 PART B
CW-1007

ASSOCIATED WITH
GREEN DEBRIS FIELD

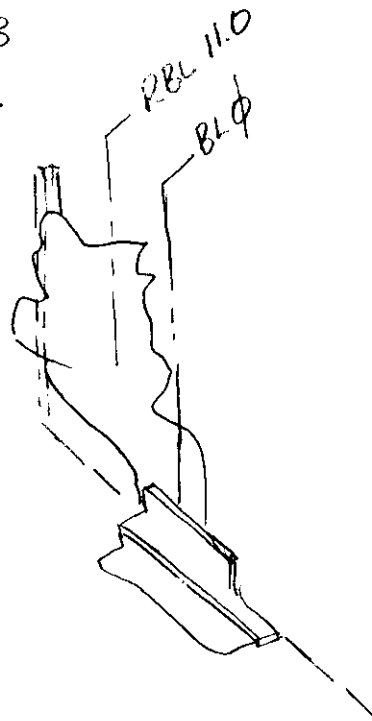
VIEW AS SITUATED ON KEEL BEAM RDK

STIFF IS
HEAVILY
SOOTED

THIS FRACTURE FACE
IS SOOTED

DARK SOOTING

GREEN PRIMER
INTACT

HEAT
DAMAGE

TENSION
FAILURE
ON WEB

'ANGLE'
FRACTURE
FACE ON
WEB

AFT FACE - HEAVY SOOTING INBD RBL 9, OUTBD RBL 9
PAINT BURNED OFF
