REAR SPAR - WING CENTER TANK

CW-1008	CW-1013	CW-1015
C-1051	C-2284	Z-2652
GREEN	GREEN	GREEN

PORTIONS OF LEFT REAR SPAR PICKLE FORK AND LBL 98 STIFFENER

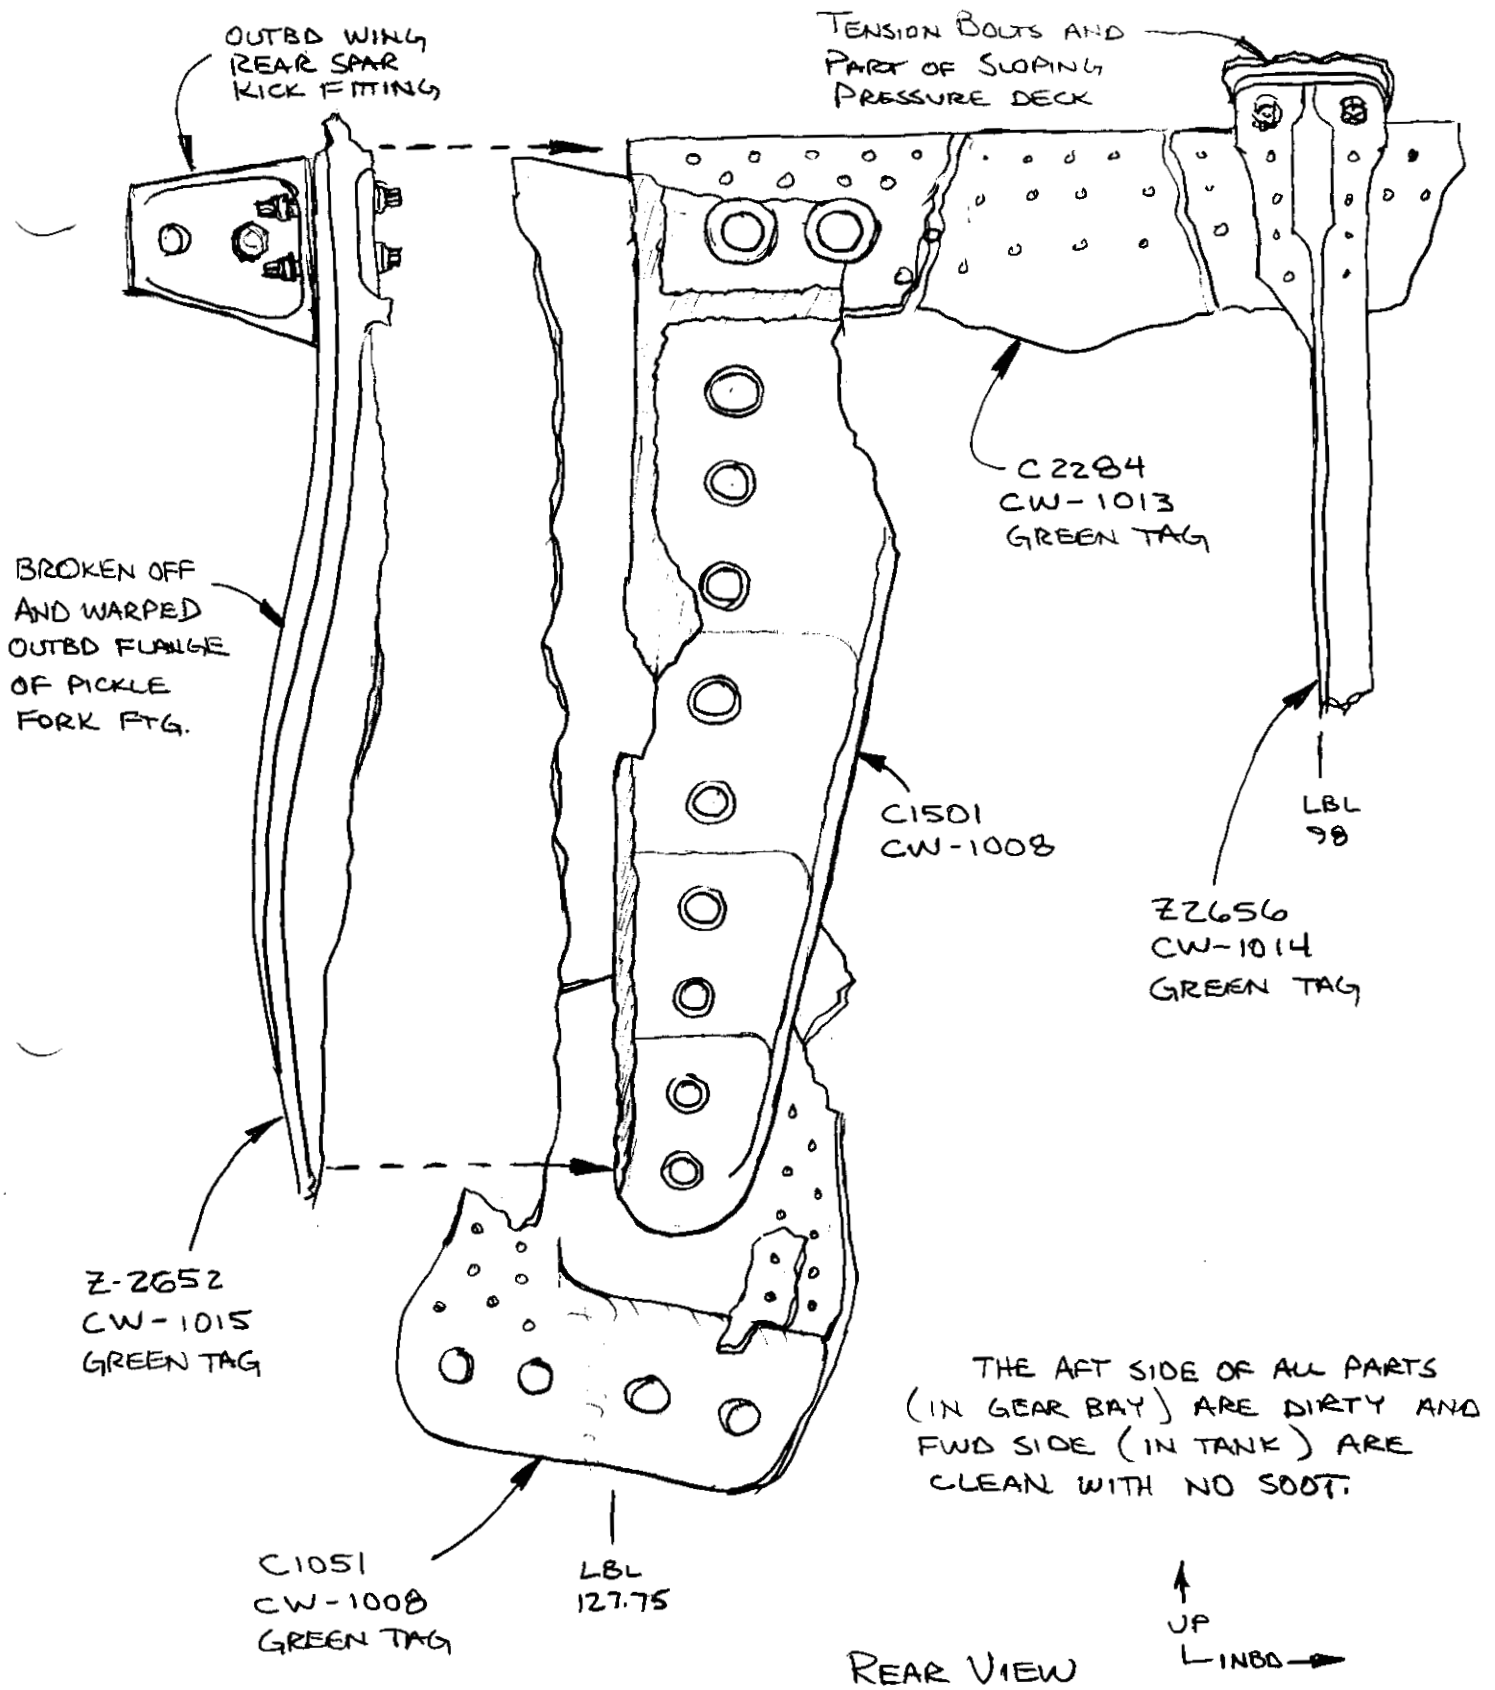
These segments are the outboard leg of the left hand rear spar pickle fork fitting near the side of body and also the center section portion of the left hand rear spar terminal fitting and center section web adjacent to the fitting.

The terminal fitting on CW-1008 is fractured on the inbd side at approximately the inboard edge of the pickle fork. The 12" portion of the CW-1013 web is common to the upper spar chord and extends inbd from the two 1.125" diameter bolts common to the pickle fork and the web. All of the fasteners common to this web and the upper spar chord are intact. The eleven 1.125" diameter fasteners common to the pickle fork and terminal fitting on CW-1008 remain intact. The outboard aft flange of the pickle fork (CW-1015) was broken from CW-1008 by rotating CW-1015 ~~inboard~~*. The fracture is primarily down the fillet radius between the two portions of the fitting. The lower spar chord is missing from the attachment to the terminal fitting on CW-1008 and there are no fasteners in the hole. The holes in the terminal fitting show deformation down and inbd. There are marks on the outbd side of the fail-safe strap on CW-1015 that are coincident with the fastener locations on the adjacent outboard wing segment and impact damage and drag marks on the outboard wing segment that indicate contact and relative movement between the two parts. The center section components moved aft relative to the outbd wing.

The aft side of all the parts are dirty and the forward side of all of the components (fuel tank side) are clean with no soot. See Fire and Explosion Group notes for complete description.
