UPPER SKIN PANEL - WING CENTER TANK

CW-101
C-808
GREEN

WING CENTER SECTION UPPER SKIN
 ← AFT

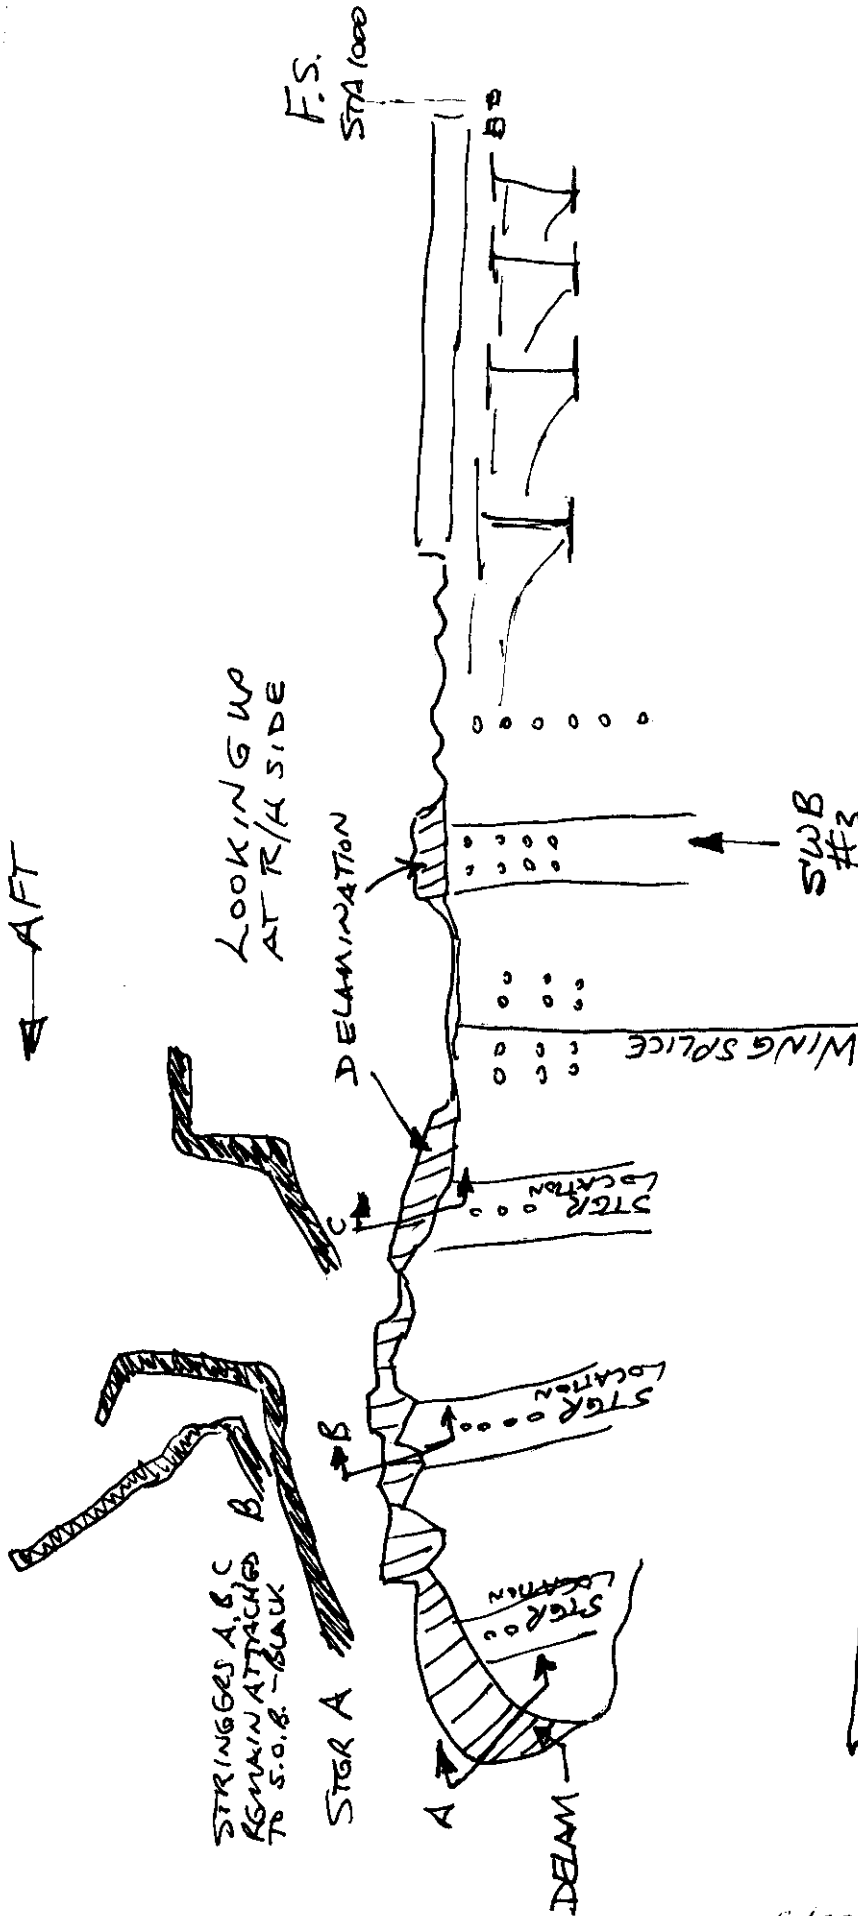
This is the section of upper skin panel, stringers, and floor beams that extends from the right S.O.B. to LBL 30 and from S-22 to the front spar.

The fracture edge at the right SOB includes a portion of the double plus chord. The underside of the skin panel contains a large percentage of the stringers from S-22 to S-33 and includes the skin flange of the front spar upper chord. The floor beam at LBL 11.33 remains intact from the front spar to S-27 except a portion of the upper chord. The floor beam at RBL 11.33 remains intact from the front spar to S-27. The floor beam at RBL 34 minus the upper chord remains intact from the FS to S-22. The floor beam at RBL 57.50 remains intact from the front spar to SWB3. The floor beam at RBL 76.00 remains intact from FS to S-23. A portion of the floor beam at RBL 98.6 remains from FS to S-23. The floor beams are separated from the skin at various locations.

The panel is bowed up about 12" in the middle at RBL 57.5 and the stringer at S-31,32 and 33 are buckled and broken at RBL 57.5. The stringer free flange at S-29, 30 and 31 are buckled and bent both forwards and backwards at multiple locations from RBL 57.5 to RBL 98. The free flanges of the attached stringers inbd of RBL 57.5 have generally remained straight. The tension fittings at SWB3 remain intact on the lower side of the skin panel as well as the portion that remains attached to the floor beam on the upper surface. See sketch in CW-602 for complete definition of remaining tension fitting on the lower surface. The stringer free flanges are fractured and are missing at multiple locations but generally the skin flanges of all stringers remain attached. The skin flange of the front spar upper chord remains attached to the skin. A portion of the front spar stiffener/skin shear ties remain attached to the FS chord skin flange. See the shear tie/bolt hole elongation study for complete definition. The end of the panel at LBL 30.00 has a very jagged fracture and has portions curled upwards as much as 45° and downwards 30°.

The stringer splice fittings at RBL 127.5 (which attach to the right SOB) from S-30 to S-33 remain attached to the stringer. The fitting fastener holes common to the double plus chord are

elongated outboard at the lower surface of the hole.

There is evidence of small metal fragments embedded in the sealant on the inner surface of this panel. Refer to attached sketch for exact location.

There is no evidence of pre-existing cracks or corrosion on this section of the panel.

There is some evidence of soot venting from below the skin at the shear tie fastener holes for SWB #3. This sooting is on the upper surface of the skin.

There is some sooting on the inner surface of the panel. See the fire and explosion group notes for complete documentation.

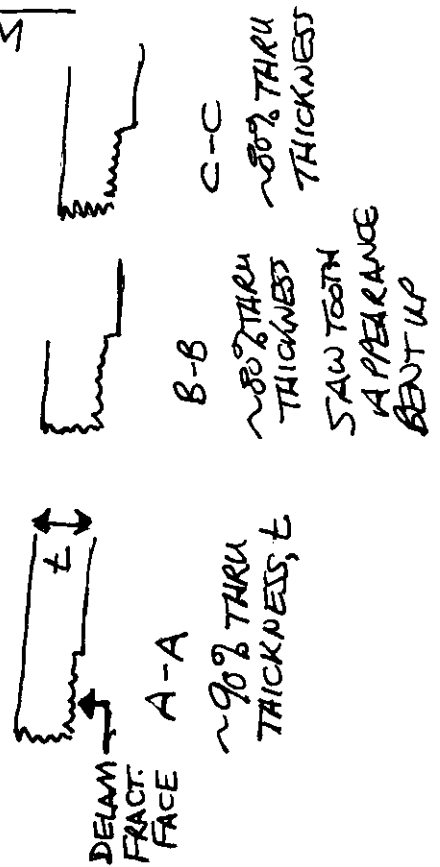
WING CENTER SECTION
UPPER SKIN

① LEFT SIDE OF MAT'L RETRIEVED

F.S. TO S.W.B. NO 3 THEN BACK ALMOST TO SWB NO. 2
SOME BENDING UP; RAPID TEARING; ABOUT 4 TEARS
BETWEEN S.W.B. # 3 AND # 2 (15-20 IN. LONG)
NEAREST TEAR TO S.W.B. NO. 2 BENT UP THEN NEXT
TWO BENT DOWN (GOING FWD)

DELAMINATION APPEARS ABOUT MID-THICKNESS LOOKING
DOWN ON FRACTURE (DELAMINATED) SURFACES.

② RIGHT SIDE

"SAW TOOTH" APPEARANCE OF FRACTURE AND
DELAMINATIONS VISIBLE LOOKING UP FROM
NEAR R/H S.O.B. SUGGESTS RAPID TEARING
("SAW TOOTH") AND BENDING (SOME SKIN FRACTURE
TIPS BENT UP), SAWTOOTH ABOUT 2" PEAK-TO-PEAK.
DELAMINATIONS NEAR AFT SURFACE WERE ABOUT
1.5-2.0 INCHES LONG

SKIN APPEARED TO HAVE BEEN PUSHED UP AT APEX AND
PEELED AWAY FROM R/H S.O.B.

NOTE: WHERE FASTENERS AND SKIN ARE INTACT AT S.O.B. SOME
BENDING UP IS INDICATED BY FRACTURES AT REMNANT
SKIN AND AT DOUBLE PLUS CHORD. SOME STRINGERS
ARE BENT UP AND BLACKENED WHERE ATTACHED AT S.O.B.

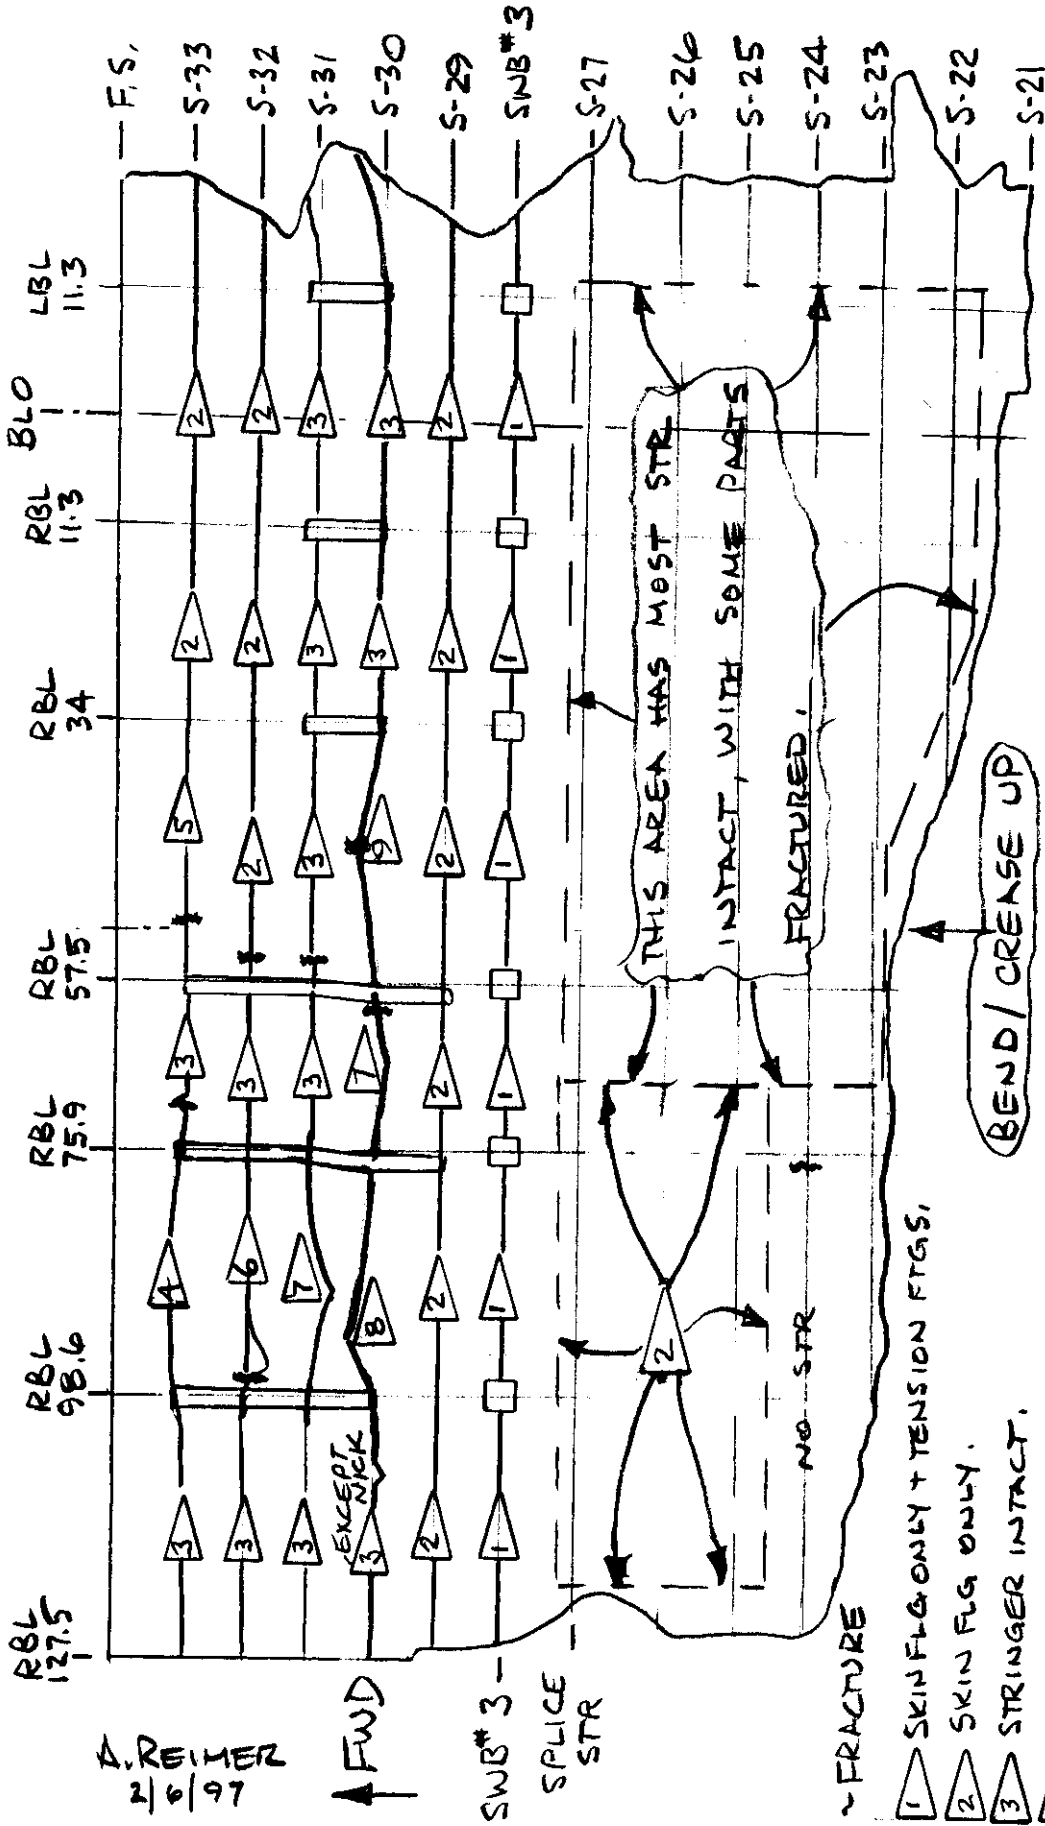
WING CENTER SECTION ~ CW-101 PANEL ~ LWR SIDE

BOTTOM SIDE
VIEW LOOKING UP

- 1 > SKIN FLG ONLY + TENSION FTGS,
 - 2 > SKIN FLG ONLY.
 - 3 > STRINGER INTACT.
 - 4 > FREE FLG INTACT - WEB FLG BROKEN TOP & BOTTOM.
 - 5 > SKIN FLG + PARTIAL WEB FLG,
 - 6 > FRACTURE + WEB FLG BENT AFT.
 - 7 > FREE FLG BENT AFT - HIT BY SHARP OBJECT A WEB BENT / SHEARED ABOUT SKIN FLG, (BRUCKLED)
 - 8 > FREE + WEB FLG BENT FWD 4", WEB SHEARED AT SKIN FLG, SCRAPED UP SKIN FOR 1/2".
 - 9 > SIMILAR TO 8 EXCEPT SKIN SCRAPE SMALLER 1" LONG.
- NOTES: 1. STABILIZATION STRAPS ~ PARTIAL AS SHOWN,
2. SHEAR LIP EXISTS ON S-28 & S-29 INDICATING FWD MOVEMENT.
