UPPER SKIN PANEL - WING CENTER TANK

CW-102
C-224
GREEN

SECTION 11

CW-102

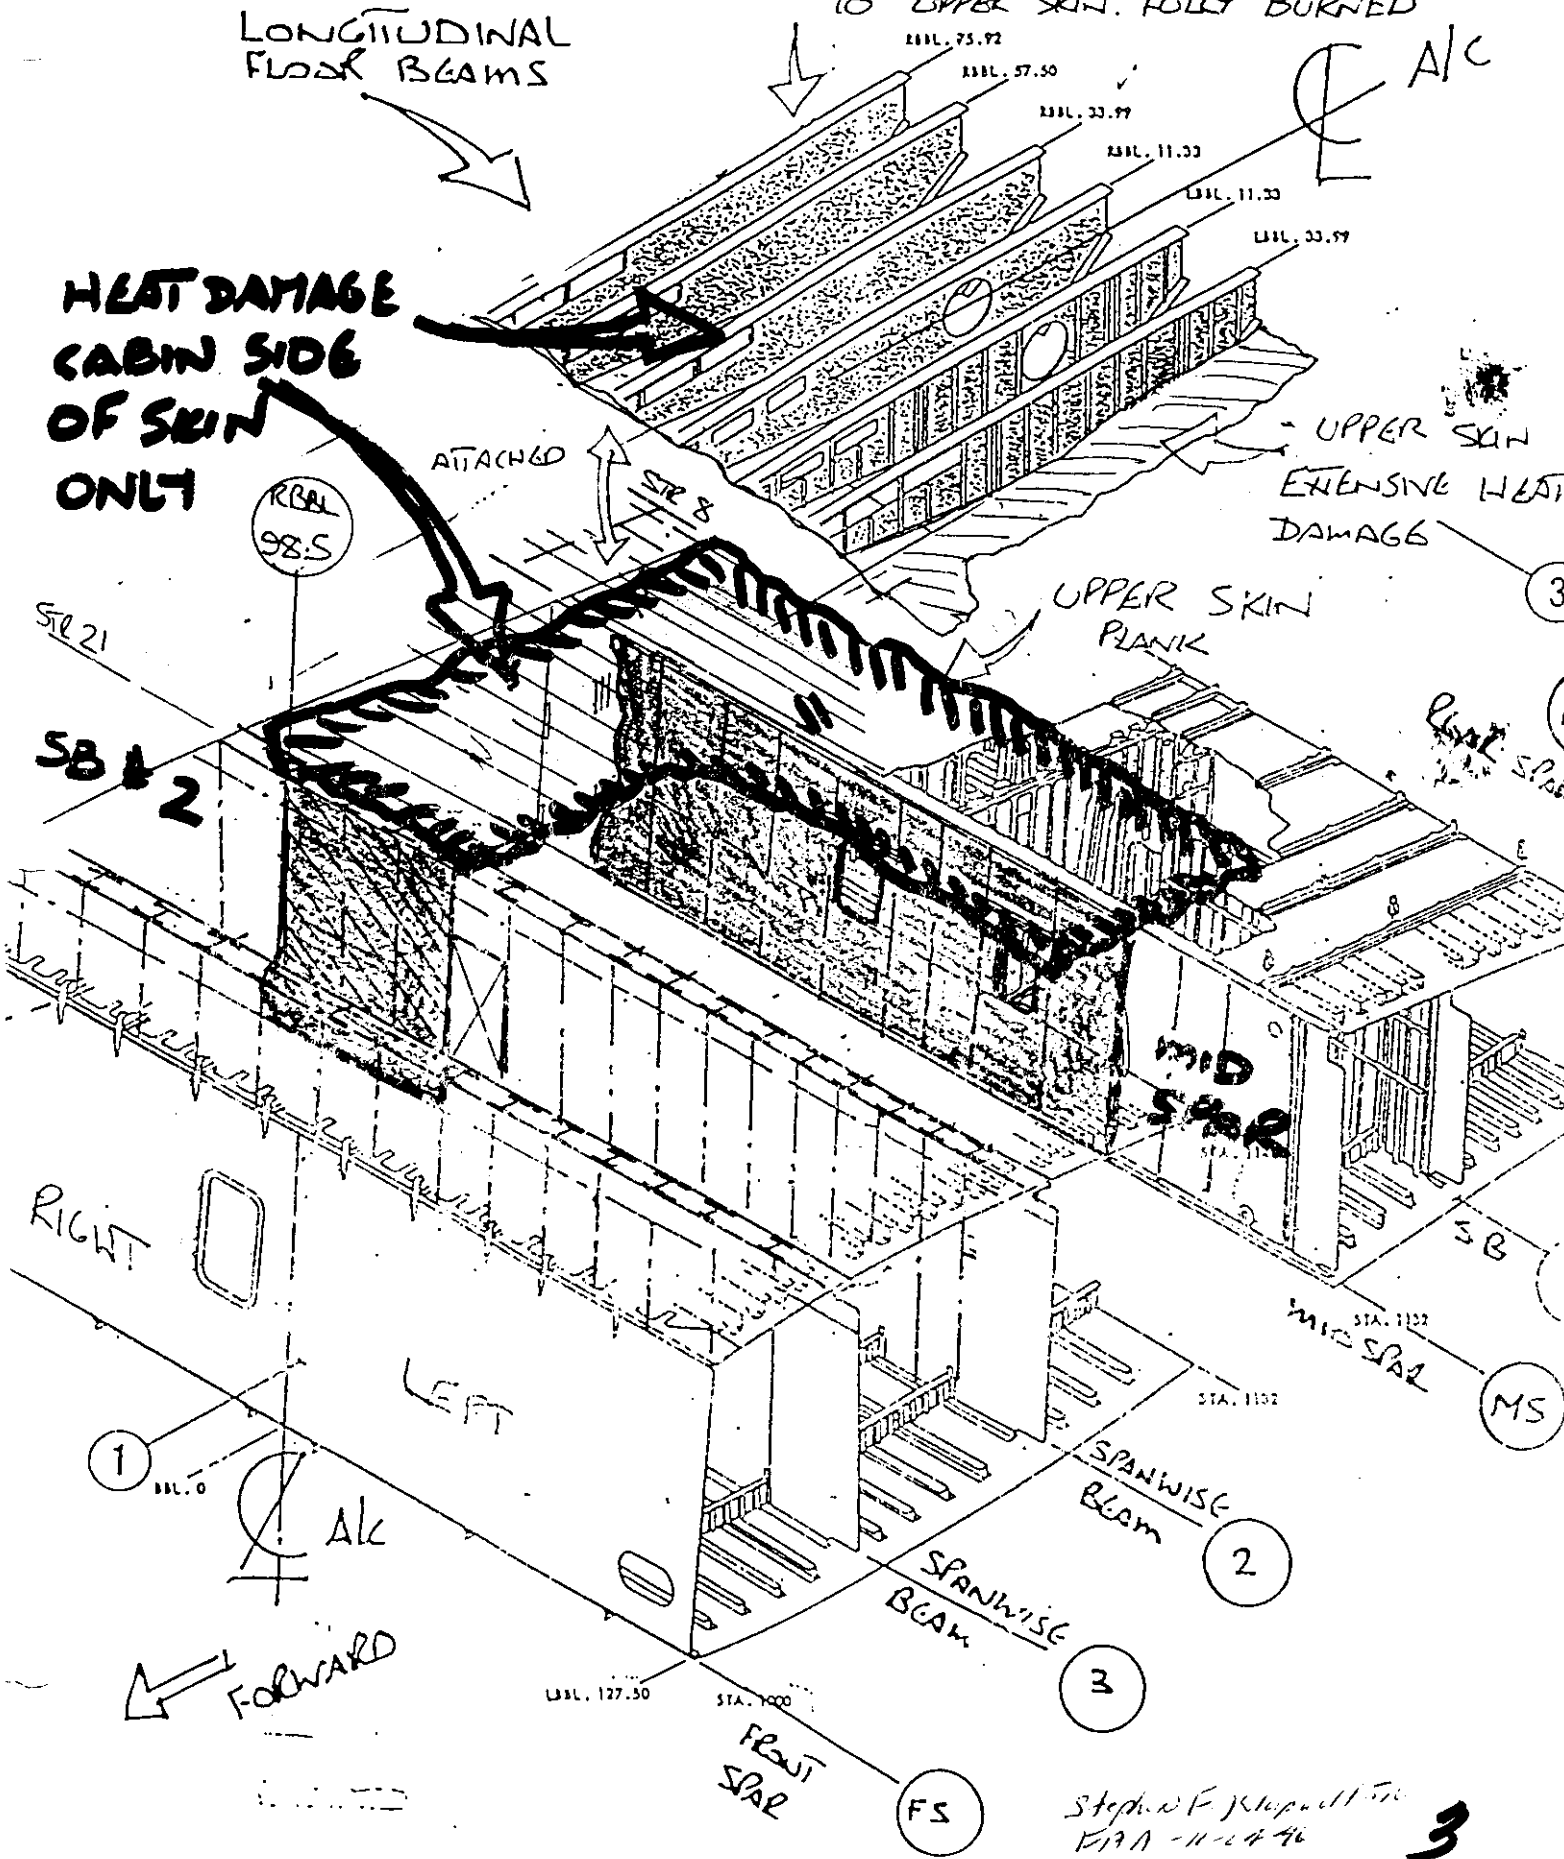
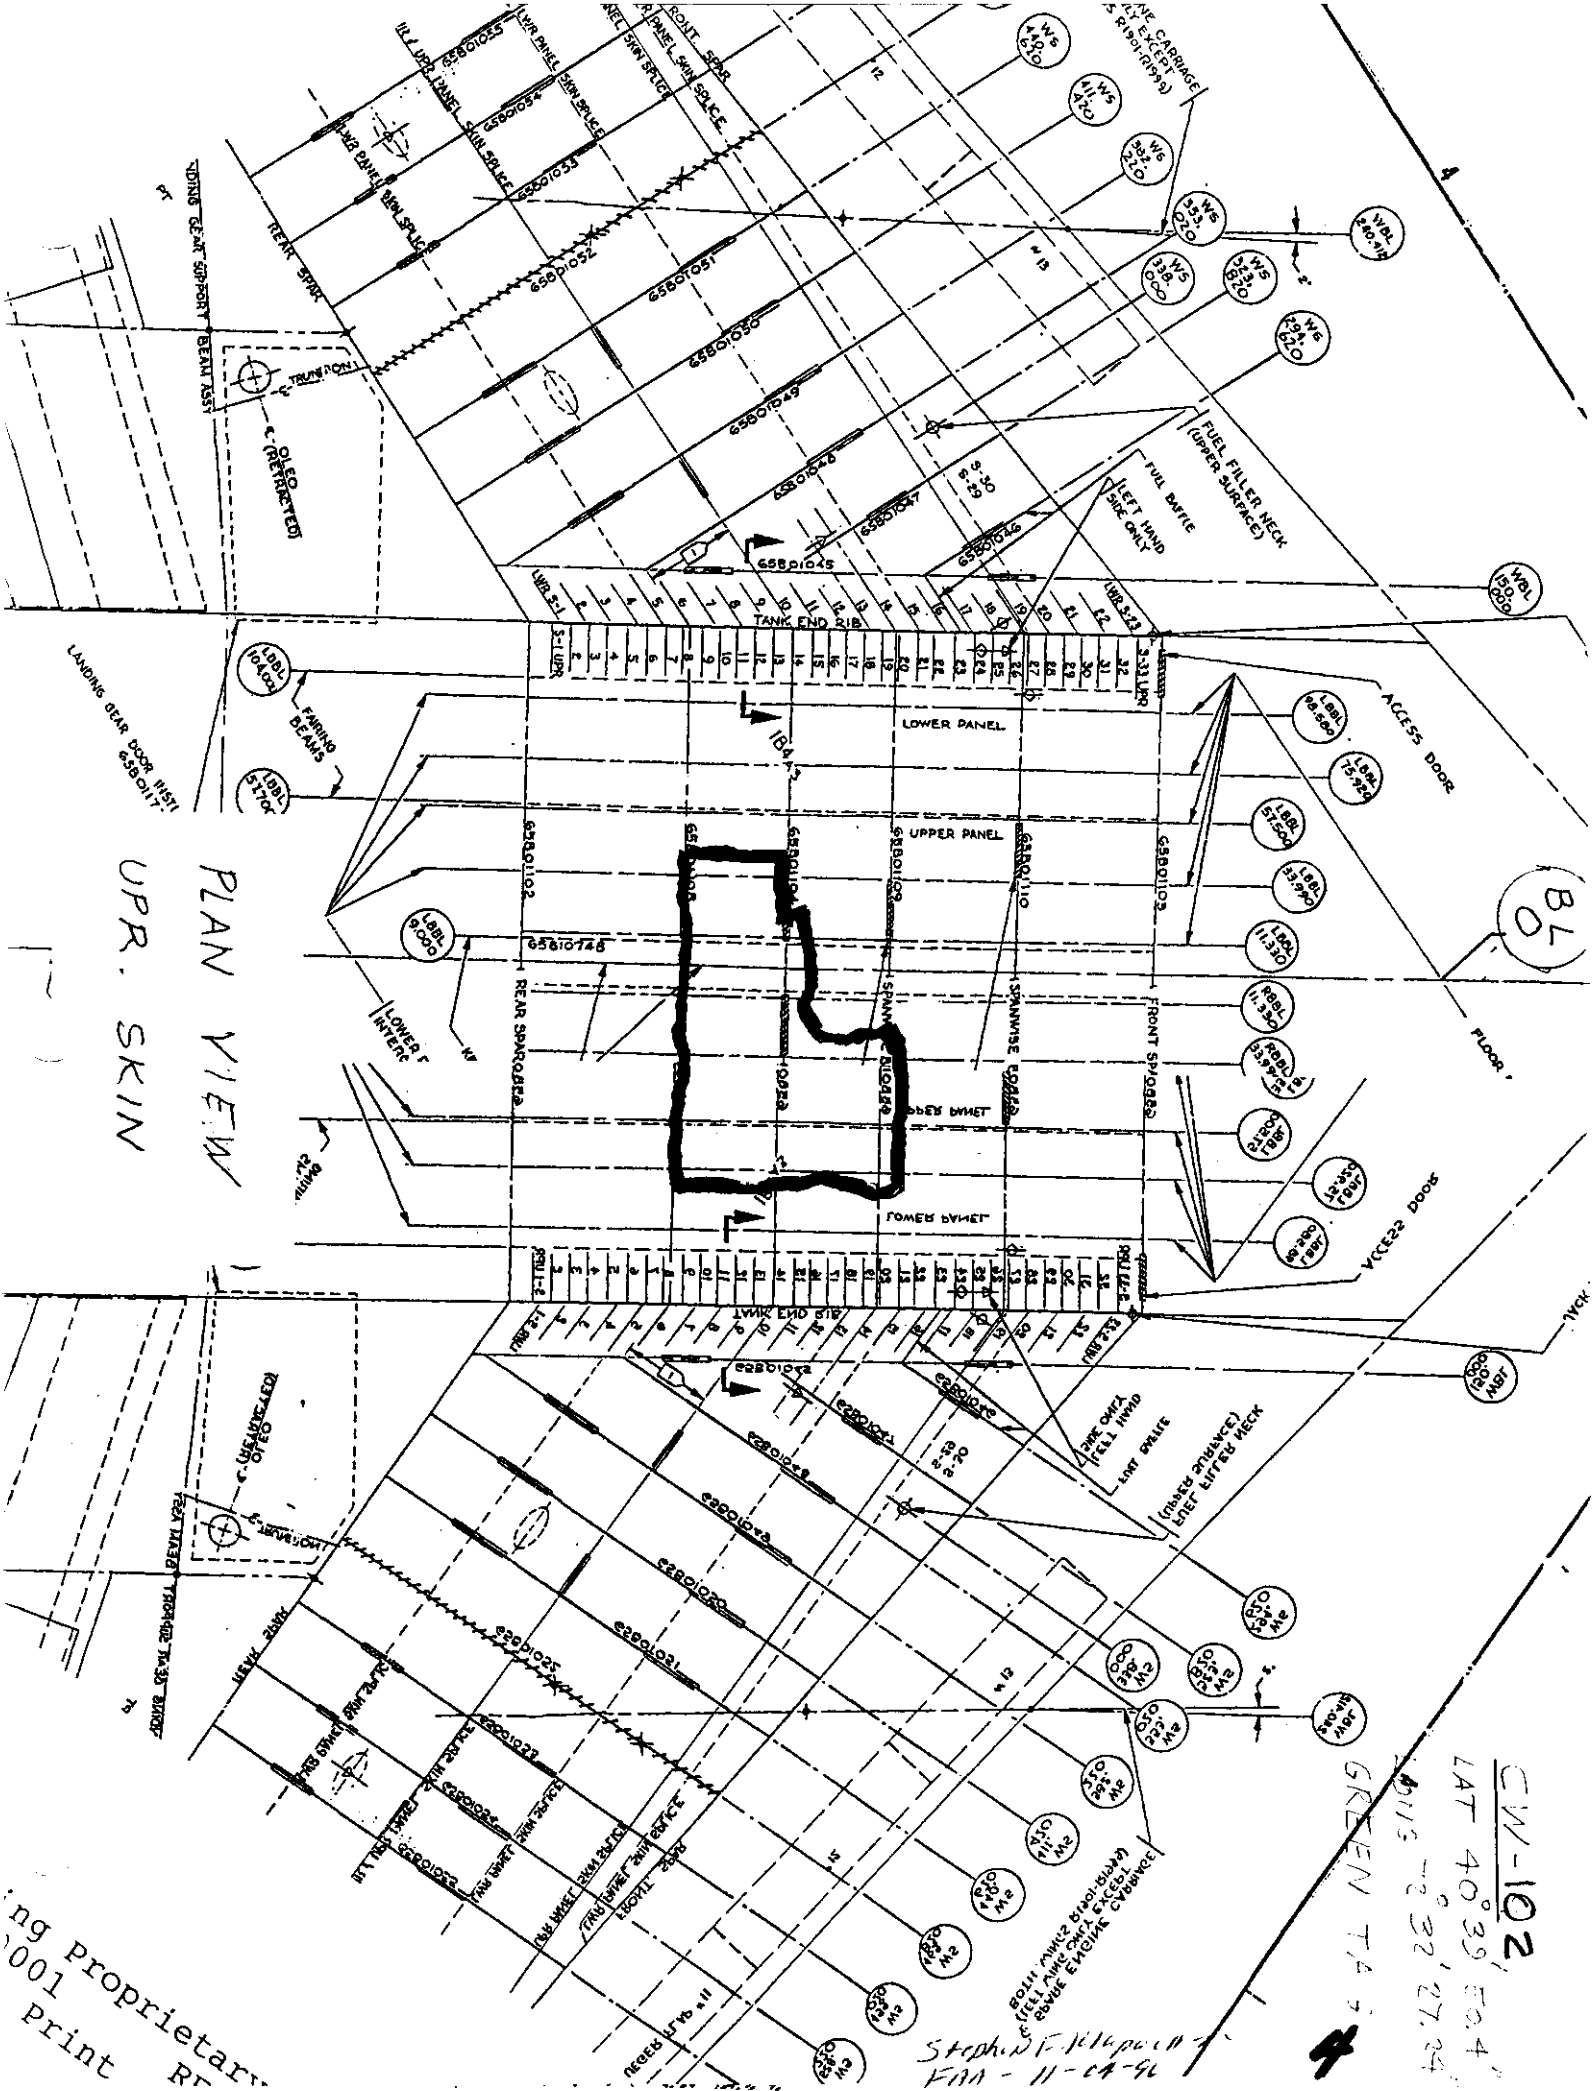
PLAN VIEW
UPR. SKIN

This is a portion of skin panel, with stringers, and floor beams that extends from RBL 78 to LBL 45 and from SWB1 to S-22. It also has large section of mid spar (CW-801) and a part of SWB2 (CW-702) still attached. The skin panel has multiple smaller fractures and has multiple bends of varying radii in several directions, but is generally bowed up at the inb'd and outb'd ends. The fracture edge at LBL45 has a local curl down. Only a portion of the floor beams at RBL 76, 57.5, 34, 11.3, LBL 11.3 and LBL 34 remain attached to the upper surface. Generally, the web of the floor beams has been burnt away. Some lower and upper chord and vertical stiffeners remain. The tension fitting common to SWB1, MS and SWB2 remained attached and intact. The skin splice at the MS is partially failed from RBL 11 to RBL 76. The fwd edge of the panel at SWB2 is bent upwards at a 35 degree angle and there is a fracture in the panel aft of SWB2. Just fwd of SWB2 there is a 3" X 1" vertical puncture in the skin.

At LBL 30 just aft of the MS there is a semi-circular 6" X 8" area of mid thickness spalling (delamination) on the skin on the lower side that is bent down approx 4" from the inner surface of the panel. It remains attached on the inb'd edge.

PARTIAL BEAMS STILL ATTACHED TO UPPER SKIN. FULLY BURNED

HEAT DAMAGE CABIN SIDE OF SKIN ONLY

UPPER SKIN EXTENSIVE HEAT DAMAGE

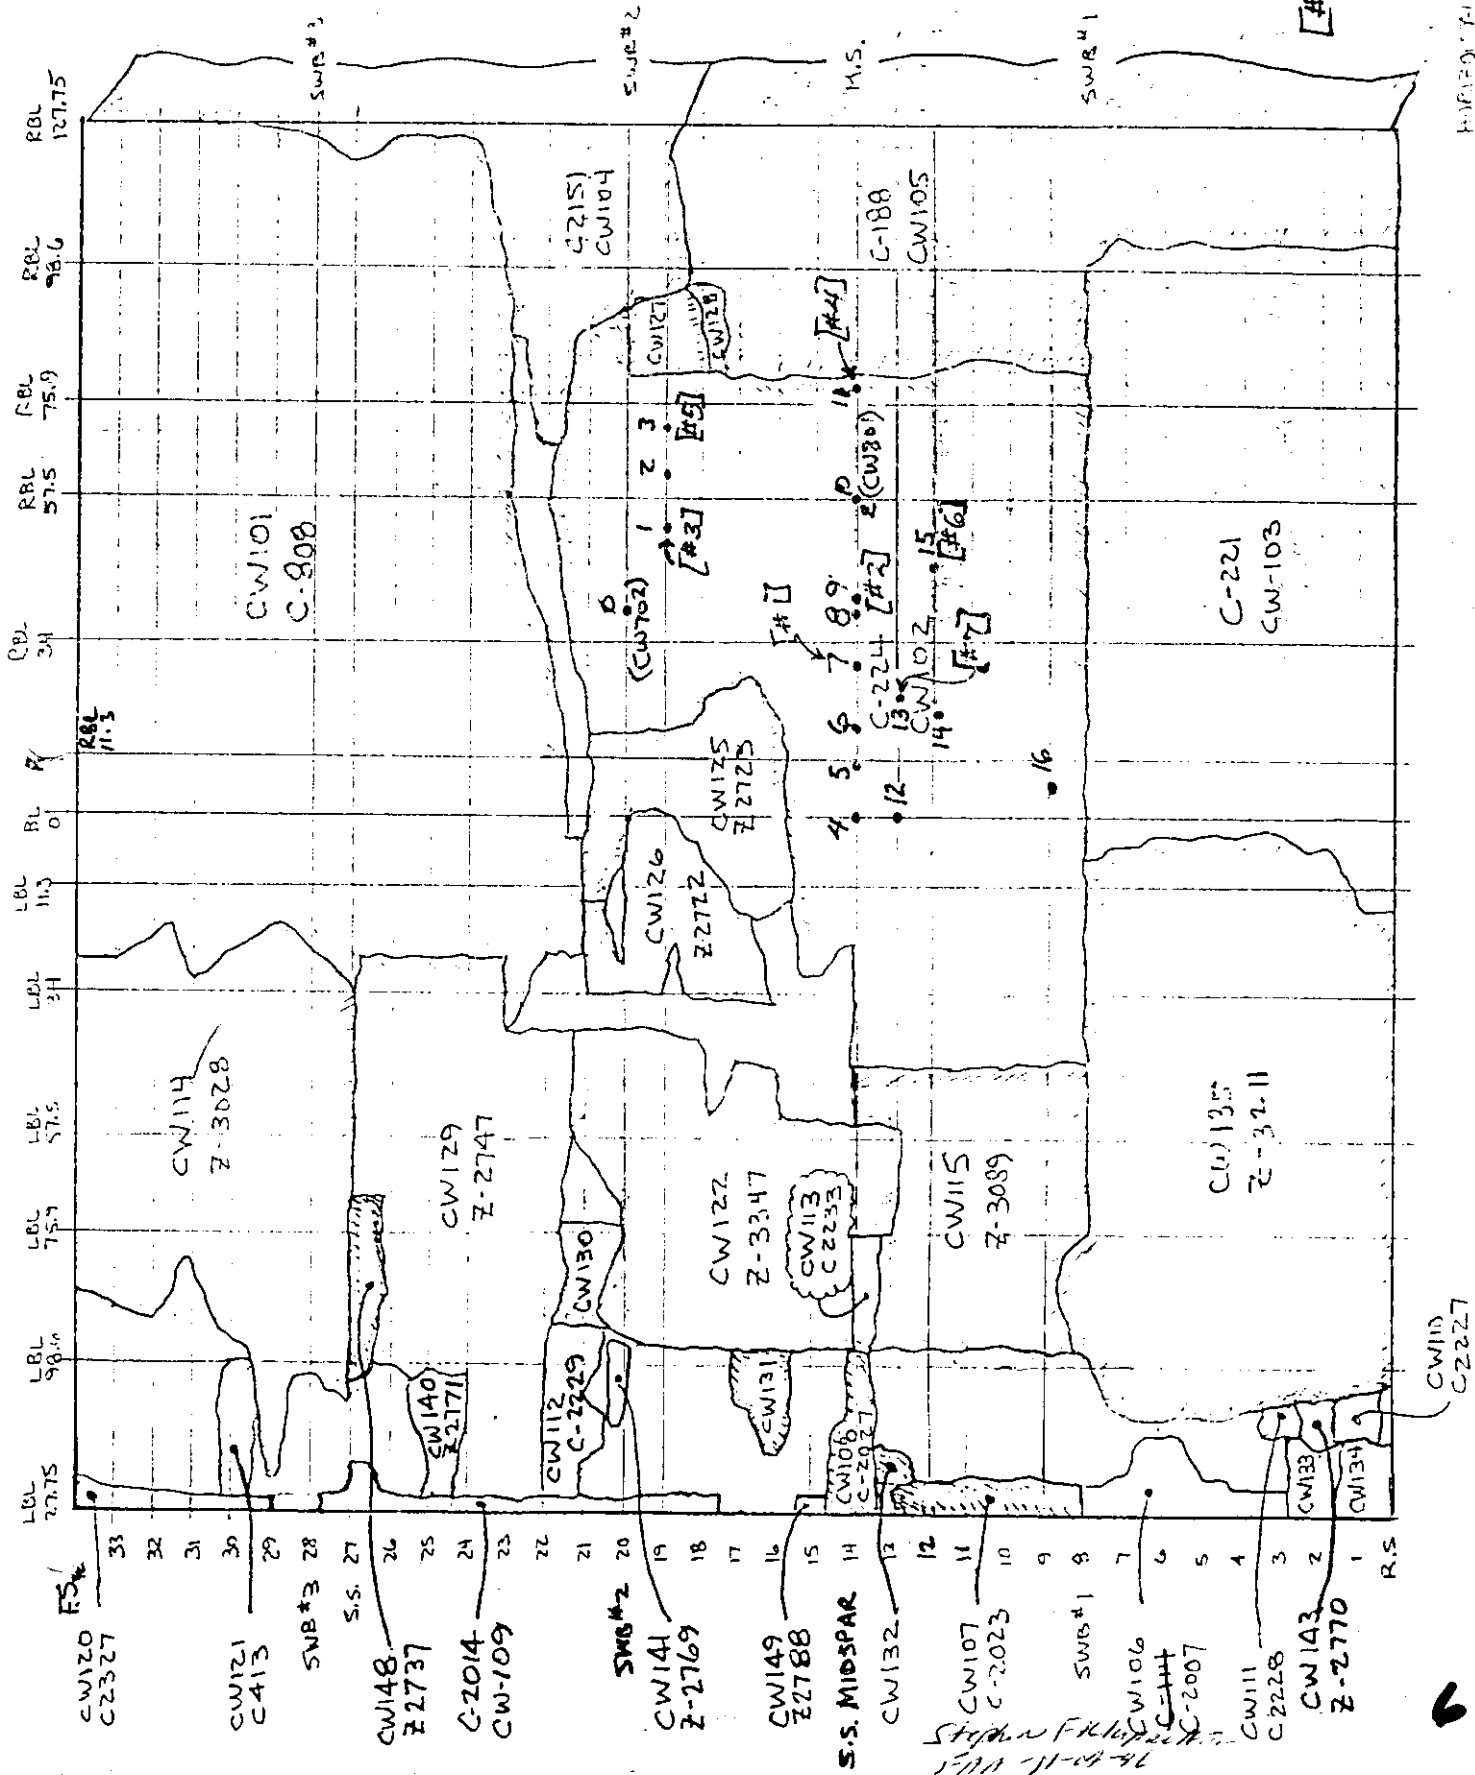
SUMMARY METAL PARTICLE LOCATIONS

METAL PARTICLE LOCATIONS
[PARTICLES ADHERING TO SEALANT
IN MOST CASES]

- 0 - SWB 2 @ RBL 38 FRAGMENT TRAPPED IN CRACK [CW-752]
- 1 - STGR 5-19 AFT OF SWB 2 @ RBL 55
[NTSB # 3]*
- 2 - STGR 5-19 @ RBL 60
3mm x 3mm
- 3 - STGR 5-19 @ RBL 70
[NTSB # 5]*
- 4 - MIDSPAR E ATTACH
- 5 - MIDSPAR @ RBL 8.94 SHEAR TIE
- 6 - MIDSPAR @ RBL 17.27 SHEAR TIE
- 7 - MIDSPAR @ RBL 31-32 [NTSB # 1]* UPPER CHORD
- 8 - MIDSPAR @ RBL 36 UPPER CHORD
- 9 - MIDSPAR @ RBL 37 UPPER CHORD [NTSB # 2]*
- 10 - MIDSPAR VERT. FLANGE @ RBL 58 TRAPPED FRAGMENT IN CRACK
[CW801]
- 11 - MIDSPAR @ RBL 79 UPPER CHORD [NTSB # 4]*
- 12 - STGR 13 @ RBL 1, 1.5, AND 3 SHEAR TIE
- 13 - STGR 13 @ RBL 22/23 [NTSB # 7]*
- 14 - CW102 @ RBL 18 AFT OF STGR 12 ABOUT 2.25 INCHES
- 15 - STGR 12 @ RBL 41/42 [NTSB # 6]*
- 16 - STGR 9 @ RBL 6/7

* [] REMOVED BY NTSB MB 10-16-96
FOR ANALYSIS

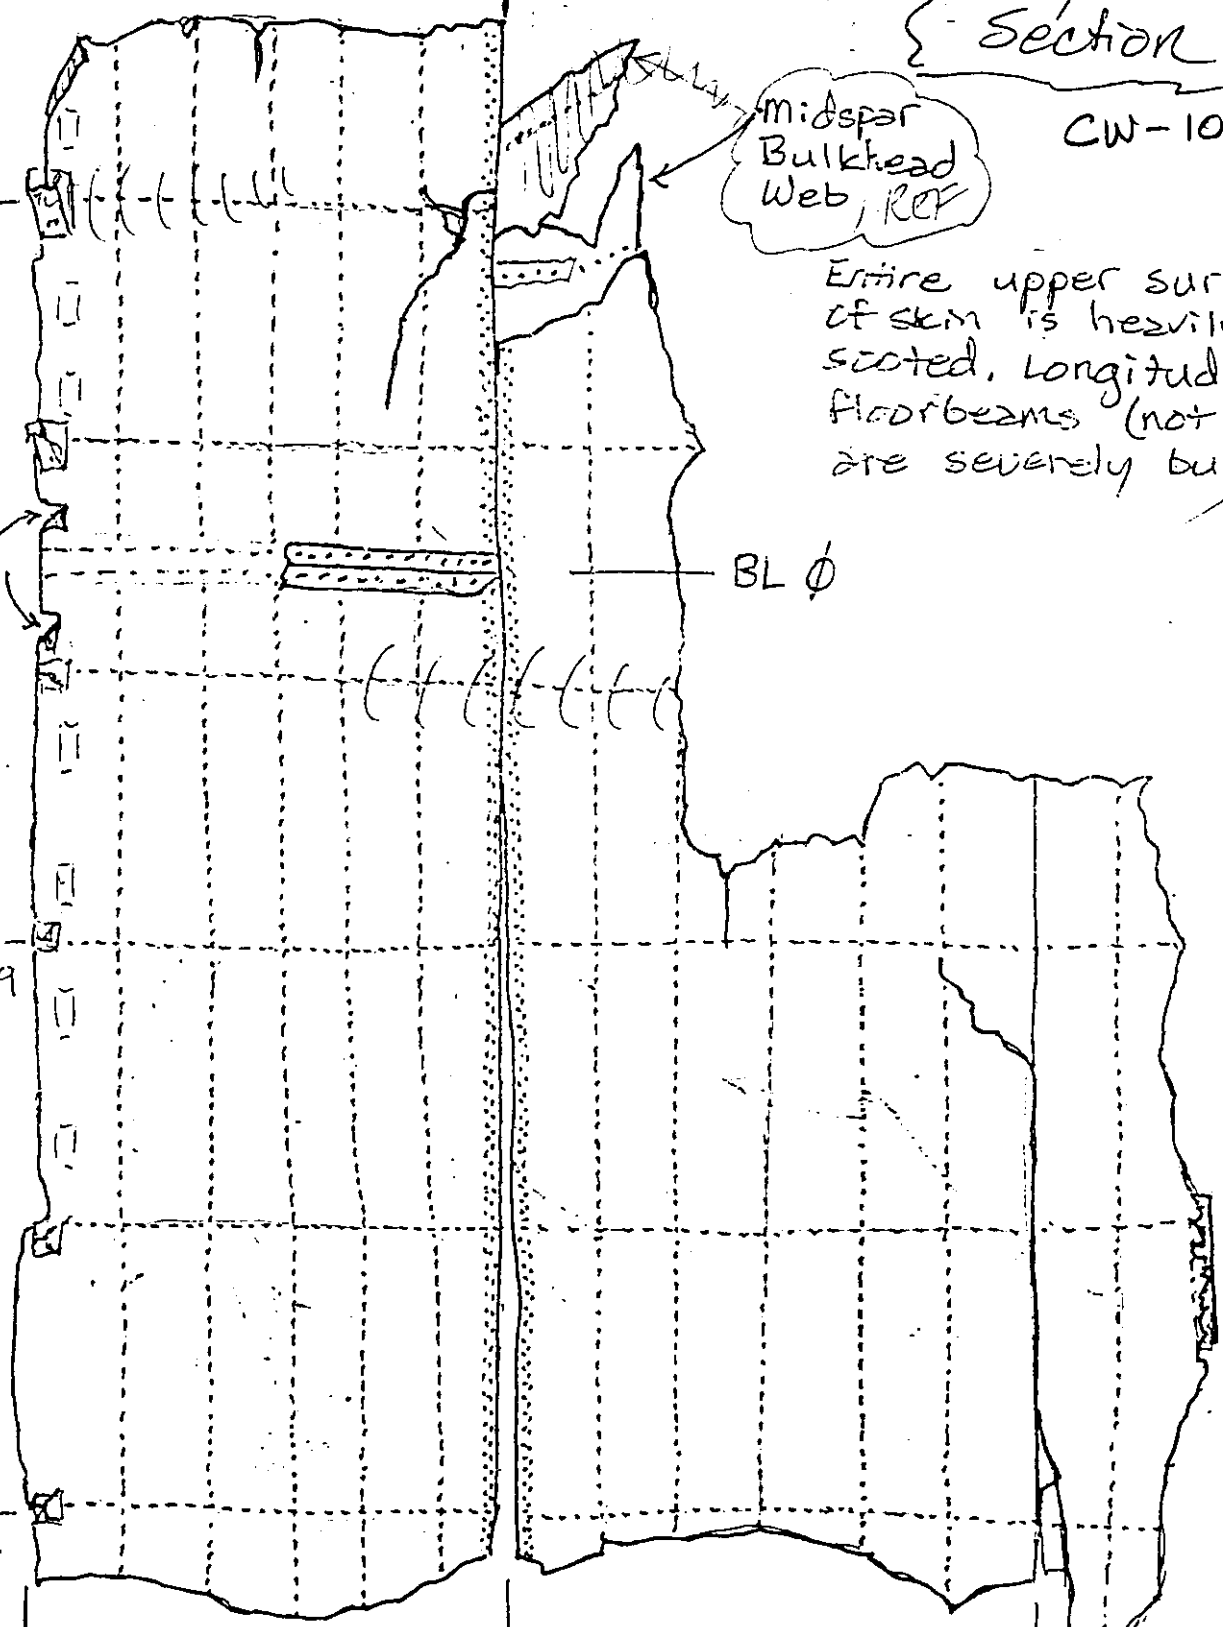
PLAN VIEW OF CENTER SECTION UPPER SKIN

Entire upper surface of skin is heavily scoted. Longitudinal floorbeams (not shown) are severely burned.

Curled Up

Spanwise Beam No. 1 loc'n (Beam not attached)
