UPPER SKIN PANEL - WING CENTER TANK

CW-103
C-221
GREEN

TOP SKIN CTR TANK

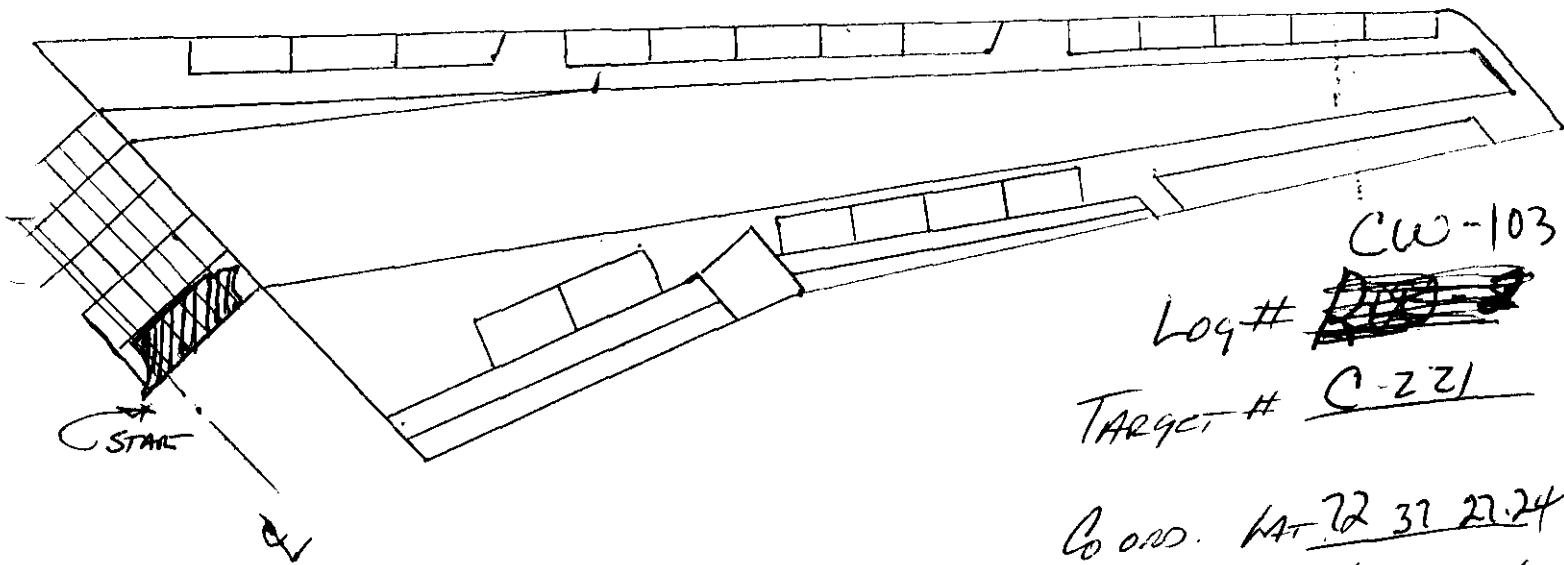
This is a portion of skin panel that extends from LBL 5 to RBL 100 and goes from RS to SWB1.

The only portions of the floor beams that remain are the lower chords at RBL 11.3, 34, 57.5, 75.9, and 98.6. The upper surface of this panel is burnt. No stringers remain attached to this panel. Only the skin flange of the upper rear spar chord remains attached. The fracture edge along the fwd edge of the panel goes thru the fastener line at SWB#1. The inb'd edge of the panel is bent upwards 10 degrees starting approx at RBL 8. The aft inb'd tab of the skin is further bent upwards approx 30 degrees.

There is evidence of heavy fire damage. See Fire and Explosion Group notes for further documentation.

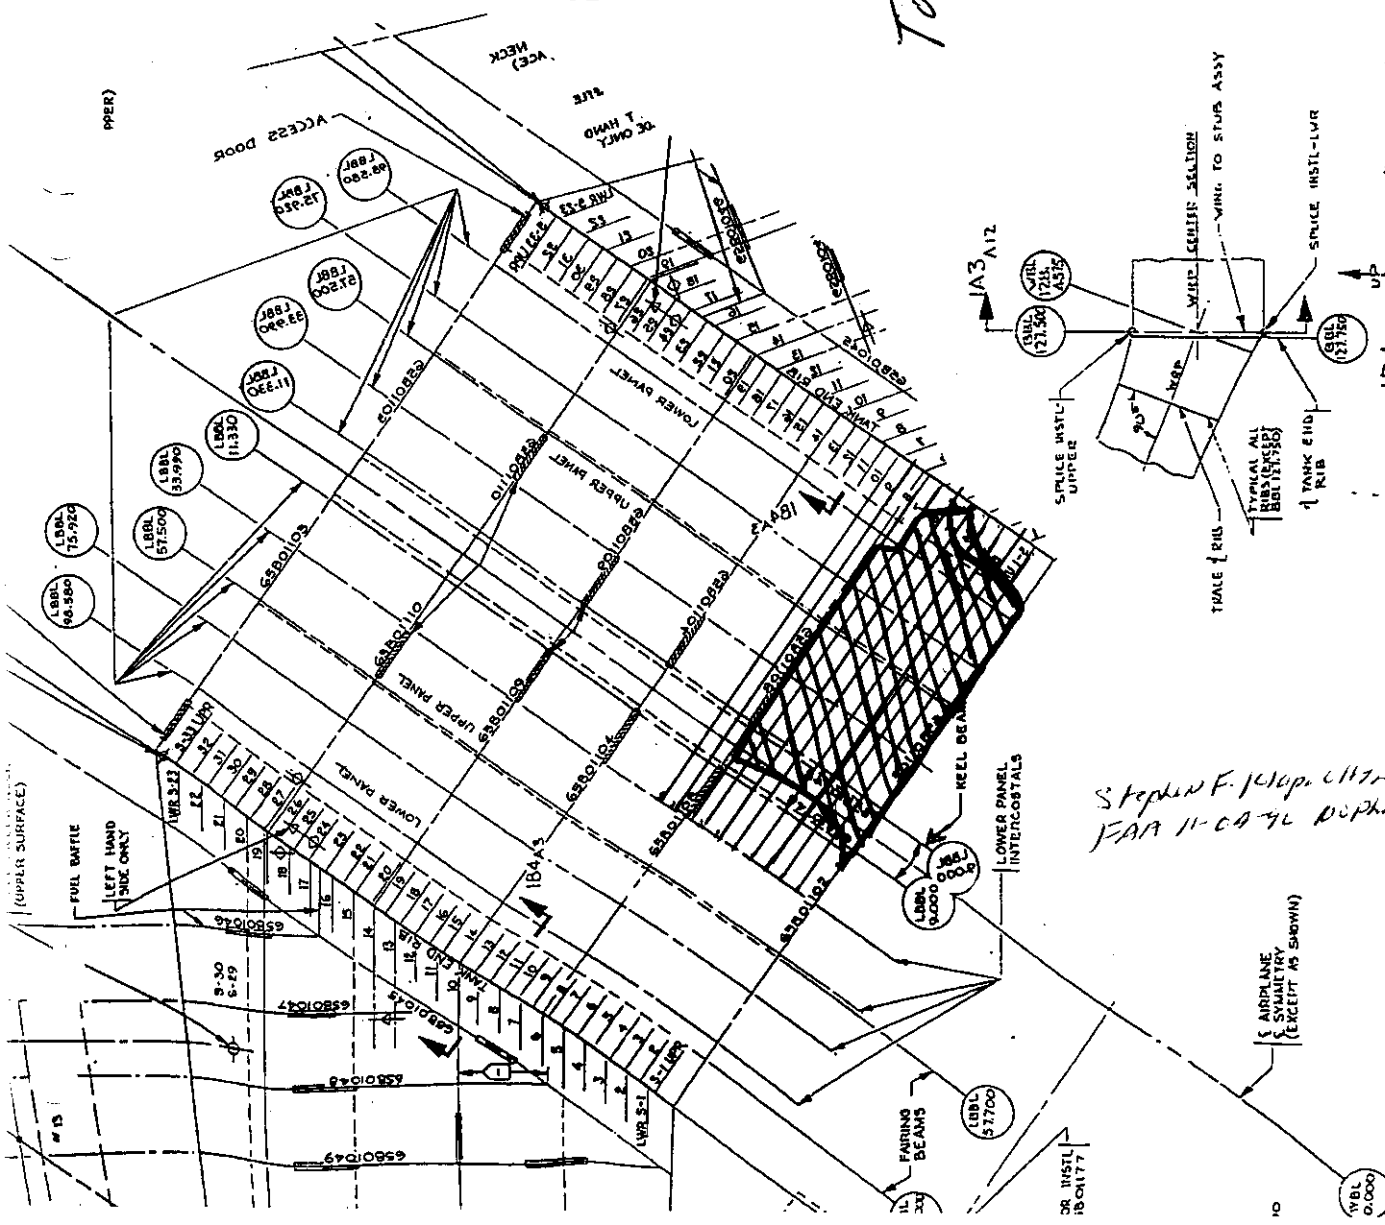
TOP VIEW
 CENTER TANK
 TOP WING SKIN
 CW-403

STARTING AT L0BL 15.0 AT REAR SPAR LEFT HAND SIDE OF CTR LINE.
 FRACTURE EXTENDS FWD 3.5° WITH SOOT IN FRACTURE, FROM THAT POINT
 THE FRACTURE CONTINUES TO UPPER S-1 AT L0BL 6.0. ~~AT THIS POINT~~ MINOR
 SOOTING IN FRACTURE LINE. FROM THAT POINT FRACTURE EXTENDS FORWARD
 IN A ~~SHARP~~ JAGGED LINE TO UPPER S-8. MINOR SOOTING ON FRACTURE.
 THE FRACTURE MOVES OUTBOARD ^{TOWARDS R.H. WING} ALONG ~~UPPER~~ UPPER S-8 TO STATION
 R0BL 94.0 THIS FRACTURE HAS MINOR SOOTING EXCEPT BETWEEN
 R0BL 76.0 + R0BL 57.0 WHERE IT IS MODERATE. FROM UPPER S-8 AND R0BL 94,
 THE FRACTURE CONTINUES OUTWARD AND REARWARD AT A 45 DEGREE ANGLE
 TO R0BL 98.58 AND UPPER S-7. THIS FRACTURE IS CLEAN OF VISIBLE SOOT.
 AT UPPER S-7 THE FRACTURE CONTINUES OUTBOARD 4 INCHES AND THEN
 PROCEEDS AGAIN AT A 45° ANGLE TO UPPER S-5 AND R0BL 100.6.
 THIS ~~FRACTURE~~ FRACTURE HAS VERY MINOR SOOTING, FROM THIS POINT THE FRACTURE
 CONTINUES IN A CIRCULAR PATH TO UPPER S-4 AND R0BL 103.6. THIS

~~IS A~~ FRACTURE LINE IS HEAVILY SOOTED. FROM THIS POINT, THE
 FRACTURE EXTENDS REARWARD TO THE REAR SPAR A R0BL 102.6.
 THIS FRACTURE LINE IS ALSO HEAVILY SOOTED. FROM THIS POINT
 THE FRACTURE TRANSFERS TO THE REAR SPAR AND RUNS ALONG
 THE TOP OF THE REAR SPAR FORWARD CAP STRIP AT THE INTERSECTION
 OF THE VERTICAL WEB BACK TO THE ~~ORIGINAL~~ ~~STARTING~~ STARTING
 POINT.

THE OUTER 4' FORWARD RIGHT CORNER
OF THE TOP OF THE SKIN IS HEAVILY
SOOTED WITH THE SOOTING DISSIPATING
TOWARDS THE LEFT REAR SECTION.

THE FORWARD R.H. SIDE IS NOT SOOTED. ~~THE~~ SOOTING BEGINS
ON THE R.H. SIDE AT UPPER S-5 AND CONTINUES AFT TO THE
REAR SPAR. SOOTING IS HEAVIEST FROM UPPER S-5 AFT.
THIS HEAVY SOOTING DIMINISHES TOWARDS THE CENTER OF
THE PIECE BUT BEGINS TO GET HEAVIER AGAIN AT
RBBL 57 TOWARDS THE LEFT SIDE OF AIRCRAFT
WHERE IT IS EXTREMELY SOOTED. THIS HEAVILY SOOTED
AREA IS AT RBBL 11.0 FROM 20" INCHES FORWARD
OF THE REAR SPAR TOWARDS AFT.
FRACTURES OF THE RBBL 11.33 INTERCOSTAL SUPPORTS
LEFT ON THE SKIN ARE ALSO SOOTED.
