UPPER SKIN PANEL - WING CENTER TANK

CW-104
C-2151
GREEN

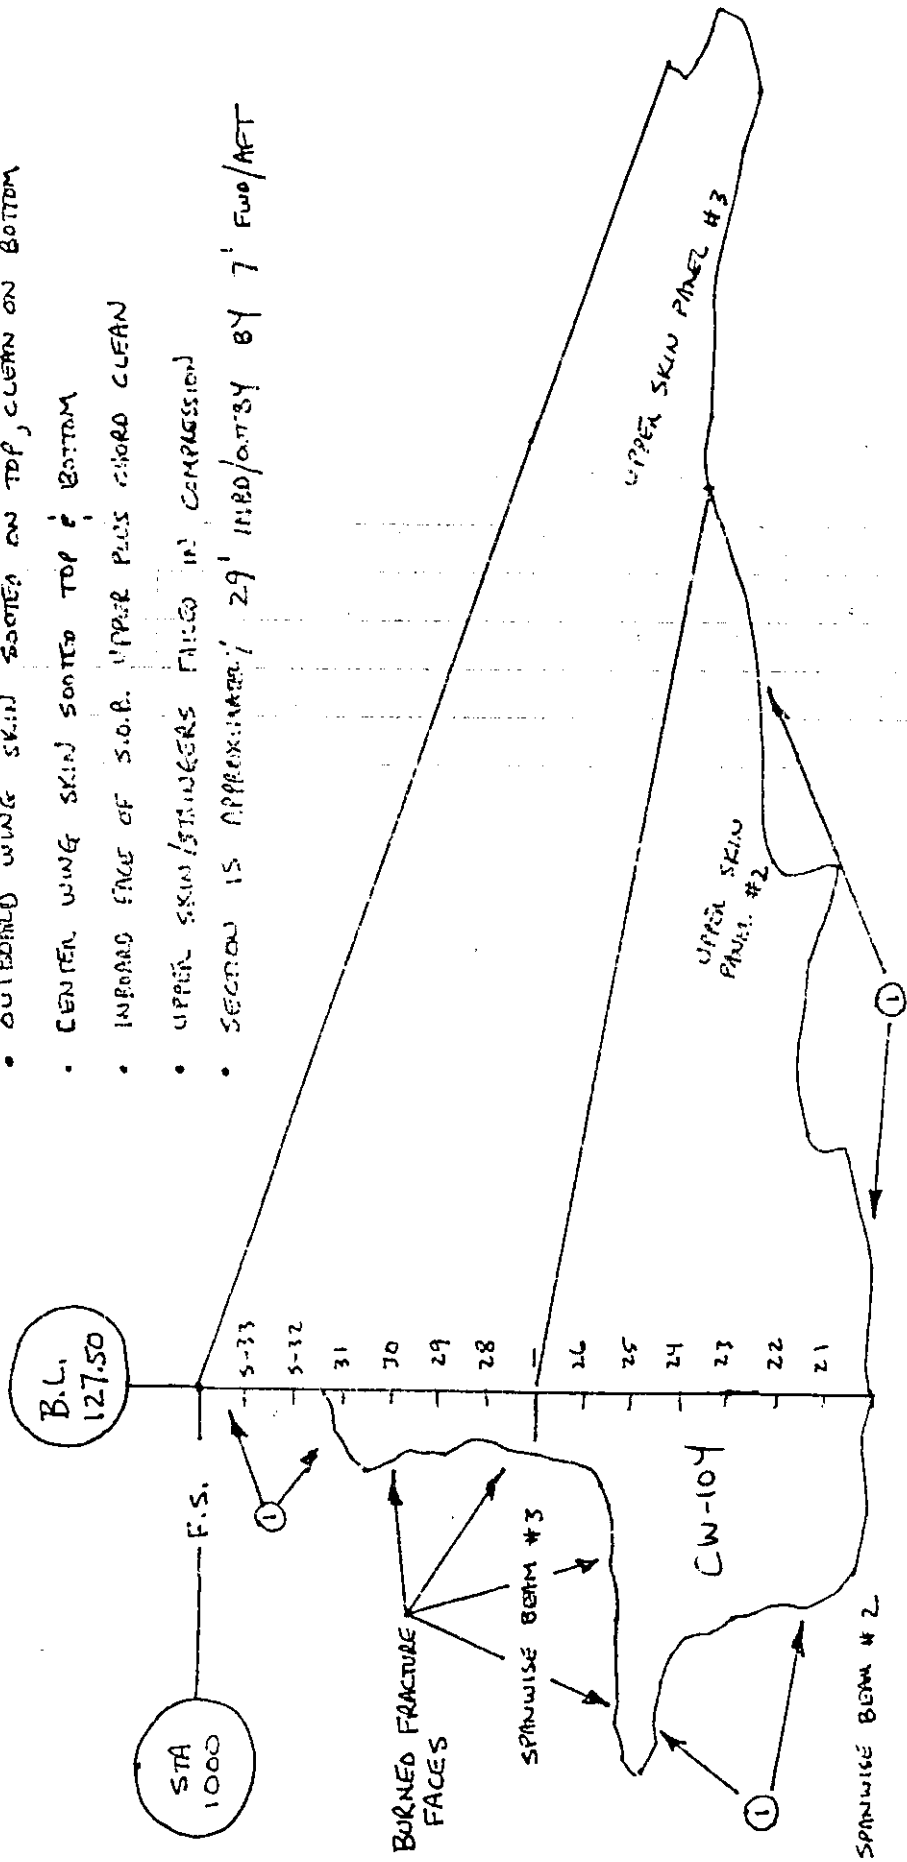
VIEW OF RH WING UPPER SURFACE

The skin has multiple jagged fractures and is generally flat. A small portion of the RBL 98.6 floor beam remains attached along with the tension fitting common to SWB2.

The stringer end fitting remains attached to both the stringer and the double plus chord from S-19 to SWB3. The stringers at S-24 thru S-26 have no skin panel above them and the approx 25" of each stringer is bent upwards on a 90 degree angle. Only a portion of the stringer S-23 to S-19 remains attached to the skin.

The fasteners remaining in the double plus chord free flange and the stringer end splice fitting at S-31 thru S-33 exhibit a shear failure in both inbd and upward direction. These fasteners are common to the splice fittings still attached to CW-101.

The panel exhibits sooting and fire damage. See the fire and explosion group notes for complete documentation.

- OUTBOARD WING SKIN SORTED ON TOP, CLEAN ON BOTTOM
- CENTER WING SKIN SORTED TOP & BOTTOM
- INBOARD FACE OF S.O.B. UPPER PLUS CHORD CLEAN
- UPPER SKIN/STRIKERS FILLED IN COMPRESSION
- SECTION IS APPROXIMATELY 29' INBOARD/OUTSIDE BY 7' FWD/AFT

① CLEAN FRACTURE FACES
