UPPER SKIN PANEL - WING CENTER TANK

CW-105
C-188
GREEN

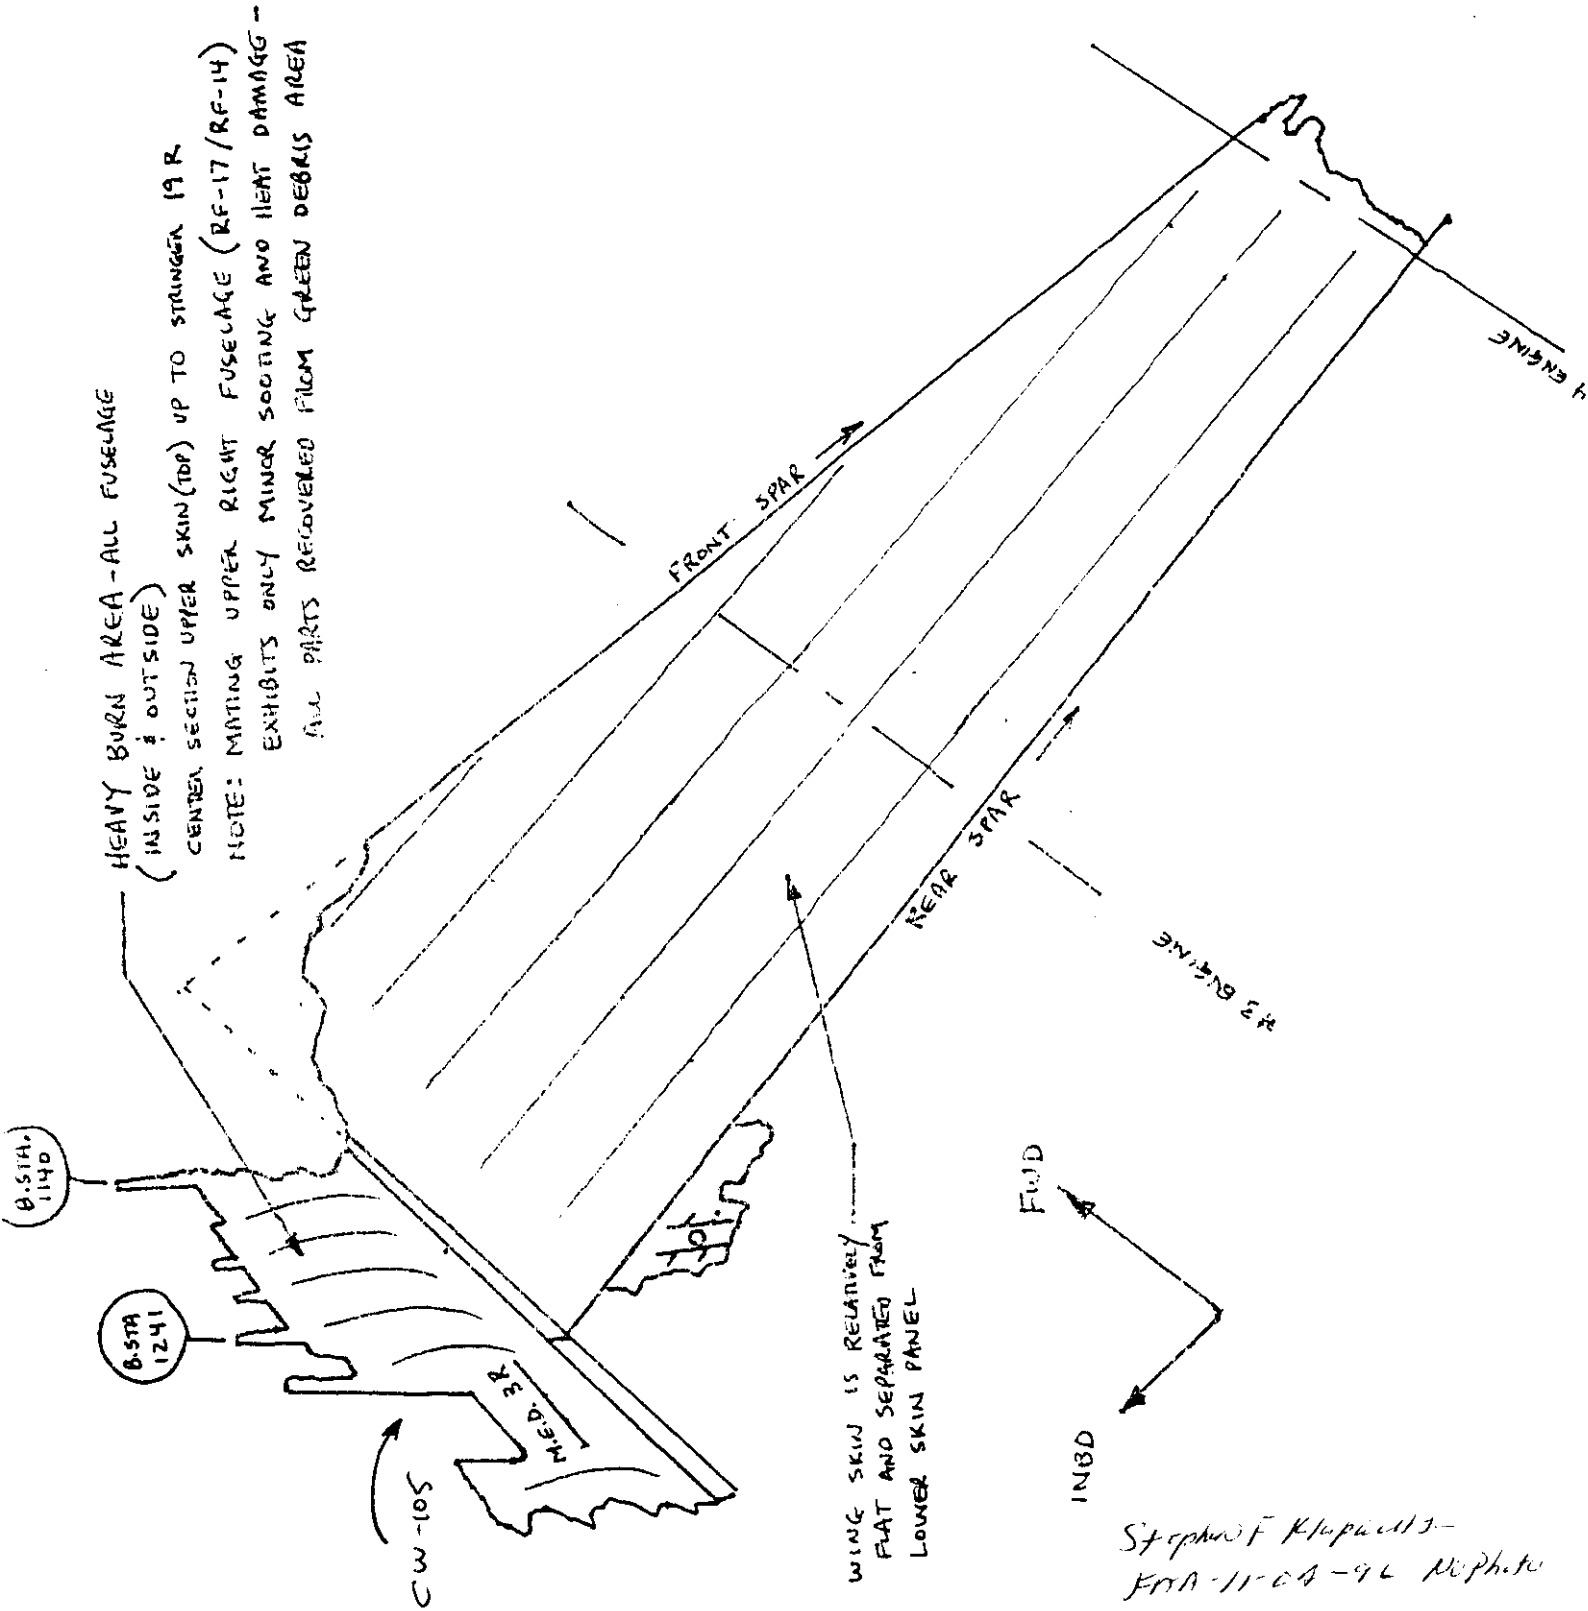
RW-8

RIGHT HAND WING UPPER SKIN

C-183 GREEN DEBRIS AREA

HEAVY BURN AREA - ALL FUSELAGE
(INSIDE & OUTSIDE)

CENTER SECTION UPPER SKIN (TOP) UP TO STRINGER 19 R.

NOTE: MOTTING UPPER RIGHT FUSELAGE (RF-17/RF-14)

EXHIBITS ONLY MINOR SOOTING AND HEAT DAMAGE -

ALL PARTS RECOVERED FROM GREEN DEBRIS AREA

WING SKIN IS RELATIVELY
FLAT AND SEPARATED FROM
LOWER SKIN PANEL

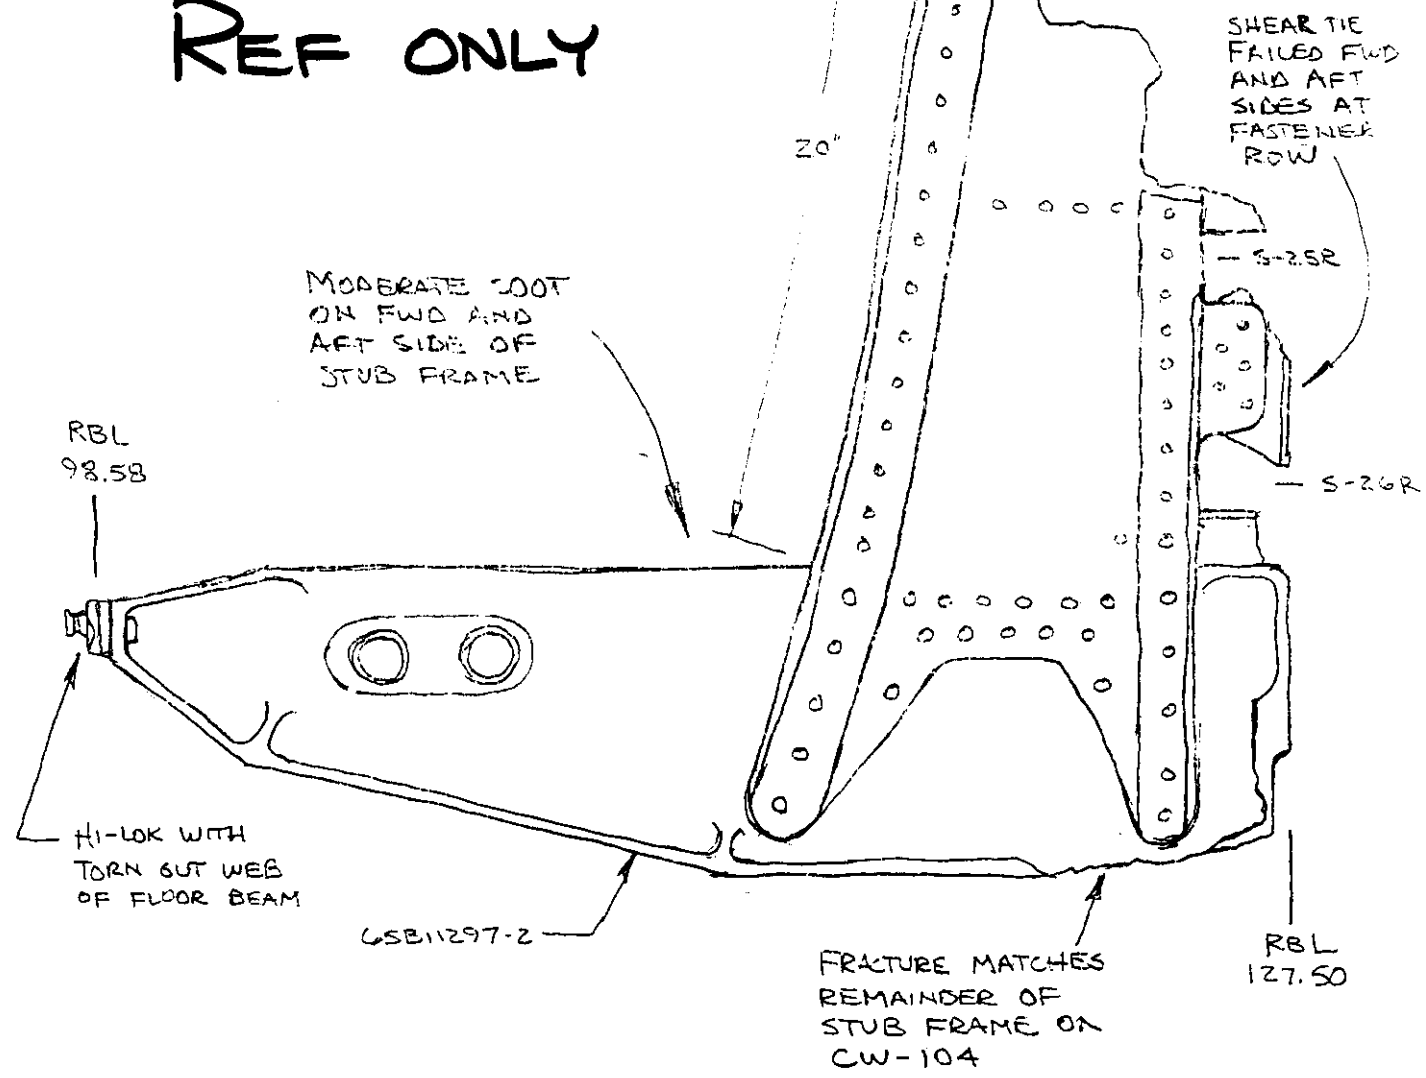
RIGHT STUB FRAME
STA 1060

RF-76
Z-2526
GREEN DEBRIS FIELD

NOTE: EVEN THOUGH PART IS MODERATELY SOOTED, IT IS CLEAN IN COMPARISON TO ADJACENT UPPER WING PANEL CW-104

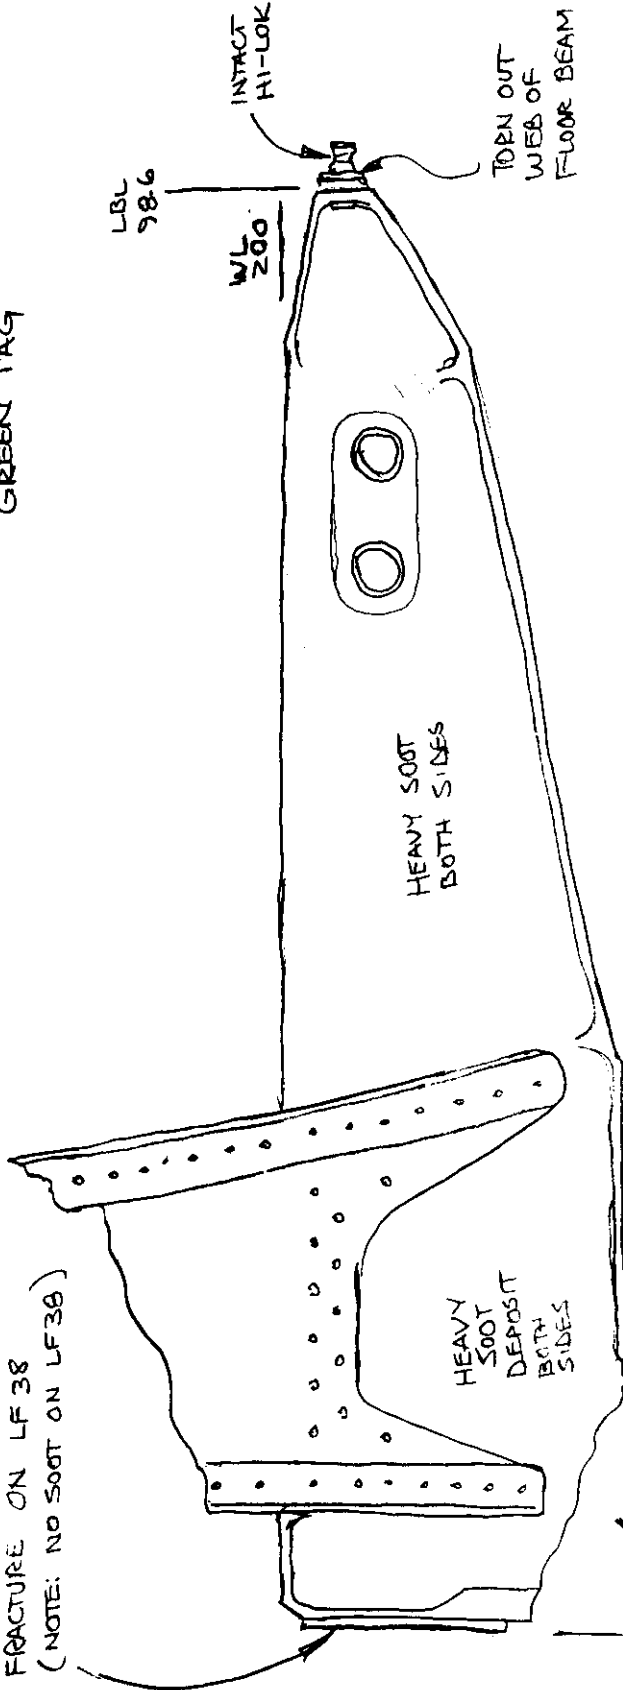
STA 1060 STUB FRAME

LF-68
Z-3100
GREEN TAG

REMAINING SKIN MATCHES
FRACTURE ON LF38
(NOTE: NO SOOT ON LF38)
