BODY BUTTLINE 0.00 RIB - WING CENTER TANK

CW-1103
Z-2749
GREEN

BLO RIB, WING CENTER SECTION - SWB #1 → R.S.

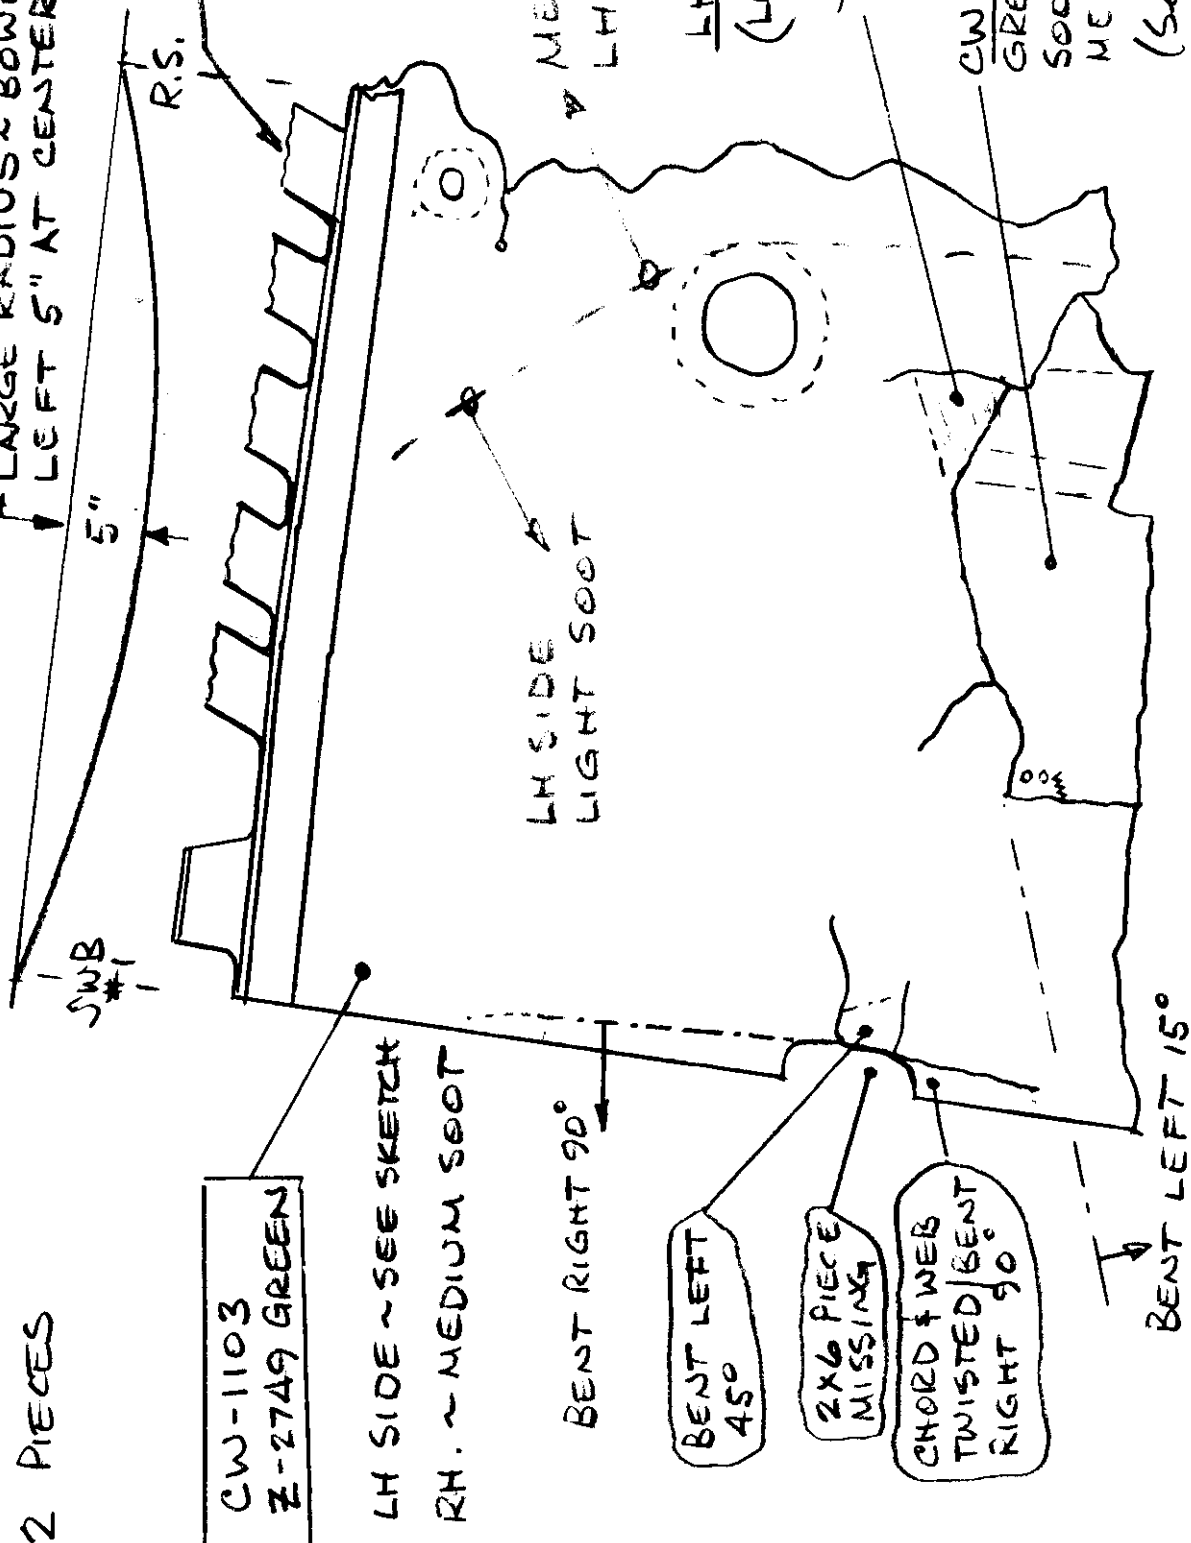
LH SIDE VIEW
(LOOKING RIGHT)

The upper shear tie chord is attached to the rib. All but the forward shear tie upper skin attach flange fractured in the root of the fillet. The part is bowed about 5 inches to the left at the center. The connection at the forward end where the rib attaches to the SWB#1 is generally bent over to the right. There is a 2 inch by 6 inch piece of the forward attachment missing about 8 inches up from the lower panel. All the vertical stiffeners remain attached to the panel.

There is soot on both sides of the part, see Fire and Explosion Group notes for details .

LARGE RADIUS ~ BOWED
LEFT 5" AT CENTER

2 PIECES

LH SIDE ~ SEE SKETCH
RH. ~ MEDIUM SOOT

BENT RIGHT 90°

BENT LEFT
45°

2X6 PIECE
MISSING

CHORD & WEB
TWISTED/BENT
RIGHT 90°

BENT LEFT 15°

SKIN PART OF
SHEAR TIE
FRACTURED -
EXCEPT FWD
ONE.

MEDIUM SOOT
LH SIDE

TAB BENT LEFT 30°

CW-1104 Z-2702
GREEN, MEDIUM
SOOT RH SIDE,
MEDIUM/LIGHT LH SIDE.
