BODY BUTTLINE 0.00 RIB - WING CENTER TANK

CW-1106
Z-2773
GREEN

CENTER WING
BL O RIB
CW-110 ~~B~~
Z-?
GREEN FIELD

BL Ø RIB FAILURE DIRECTION

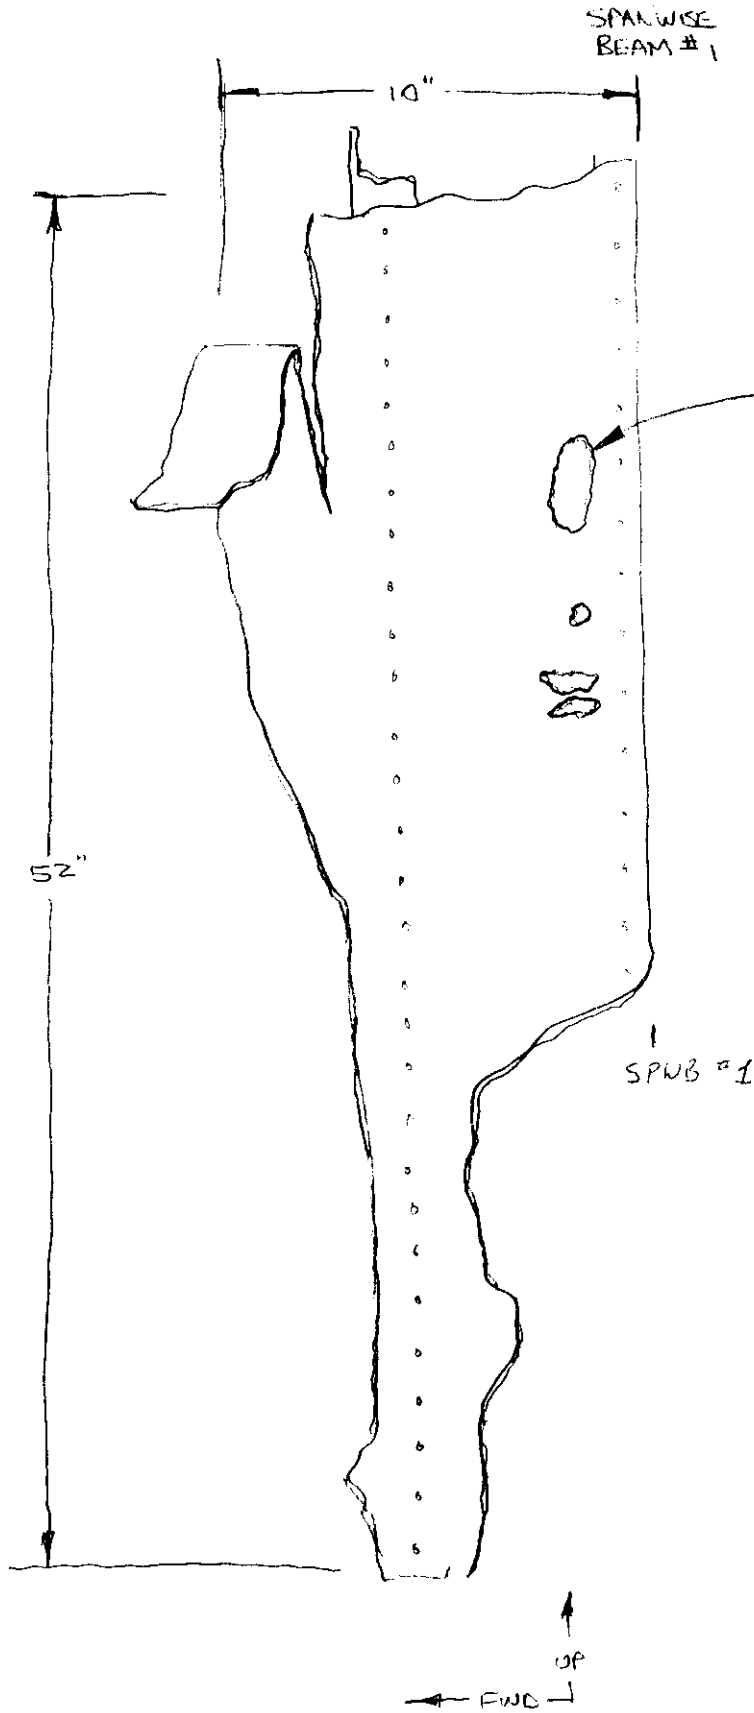
This part is a segment of the body buttlane 0 rib. It extends from the SWB#1 forward about 10 inches and from the upper chord down 52".

The part is generally a flat web with one vertical stiffener and the web flange of the aft rib post attached. There are three small holes in the web just forward of the SWB#1. At the top of the part, the top 6 inches of the forward edge is folded down to the left.

There is soot on right side of the part. See the Fire and Explosion Group notes for a more detailed description.

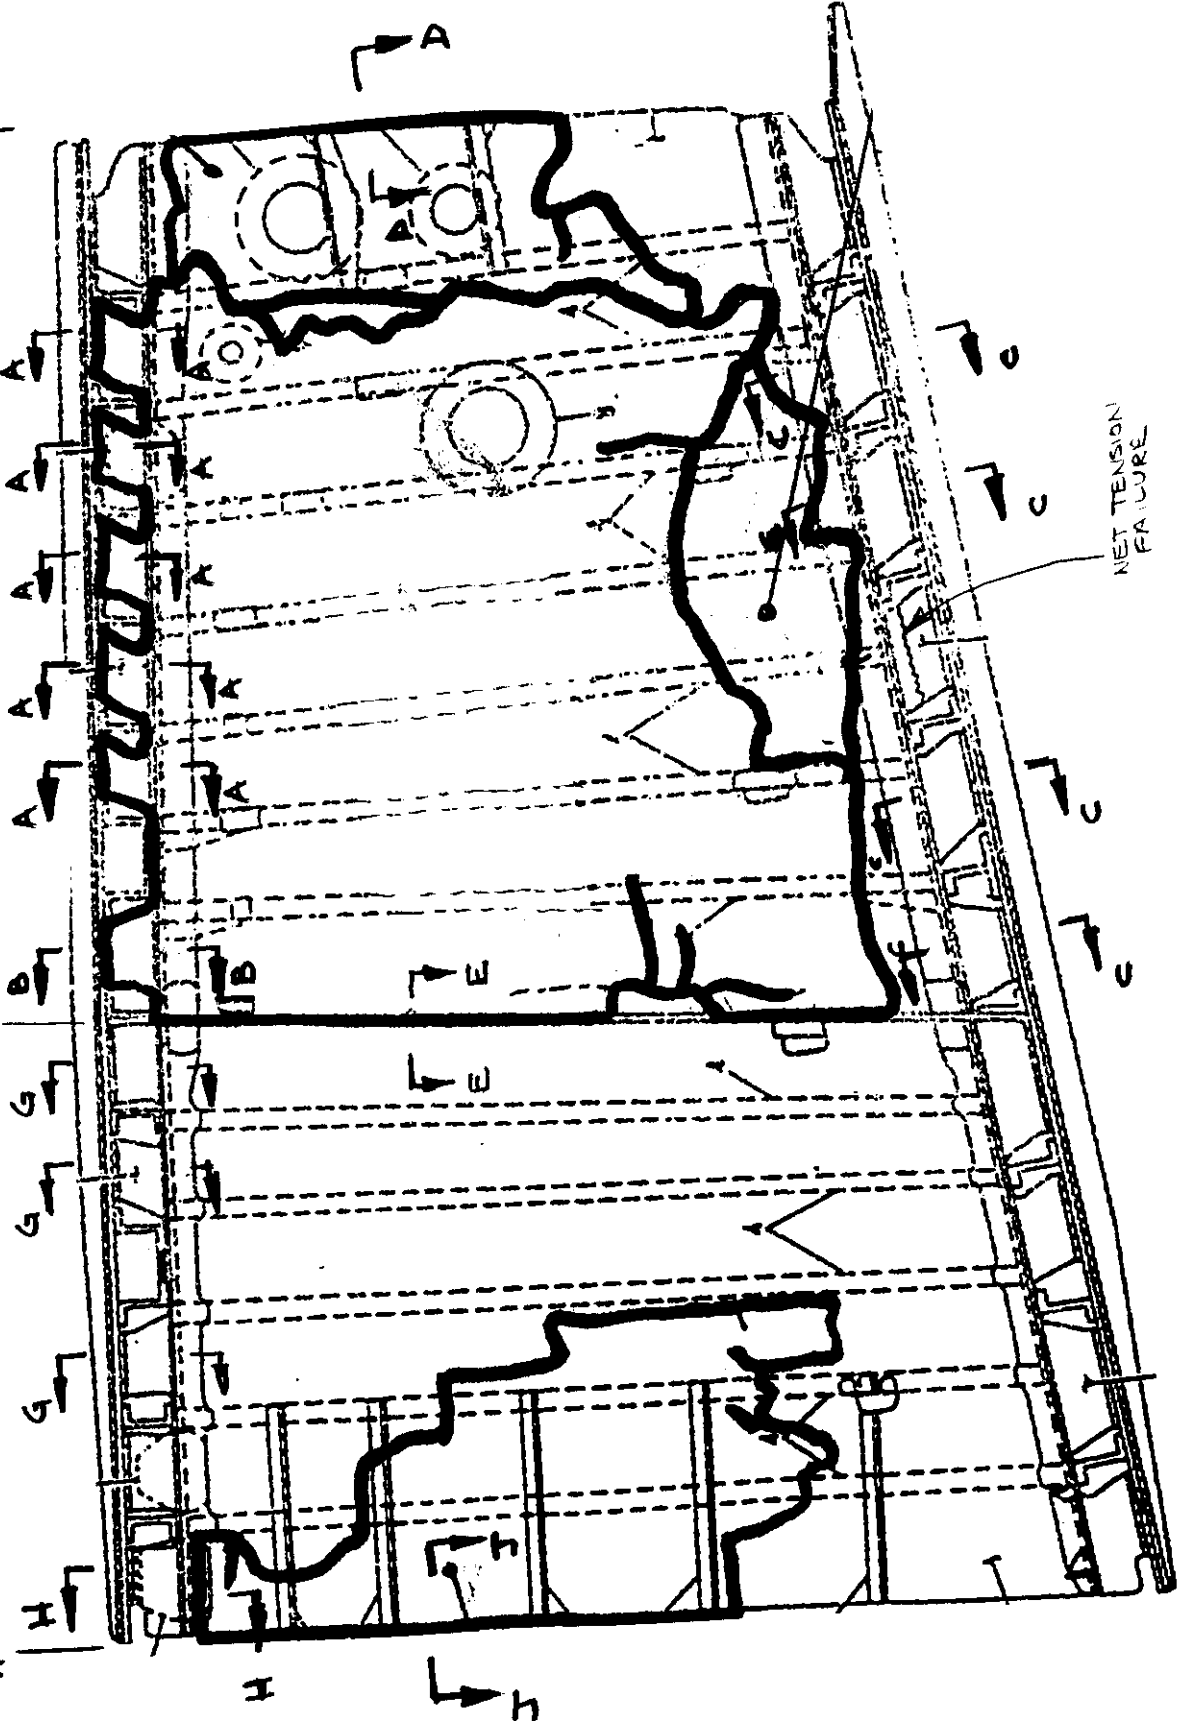
4 HOLES WITH NO
SIGNIFICANT DEFORMATION
AROUND HOLE.
SHOWS POSSIBLE INDICATION
OF BURN THRU PENETRATION?
SLIGHT OVERALL DEFORMATION
INDICATES RIGHT TO
LEFT PENETRATION DIRECTION.

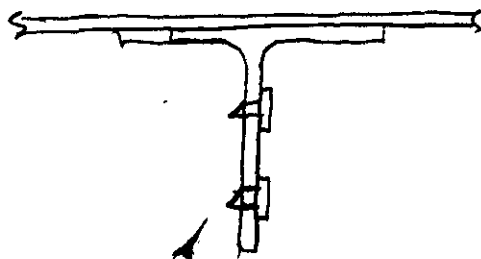
H-H

REMAINING RIVETS SHOW SHEAR
AND MOVEMENT TO THE LEFT.

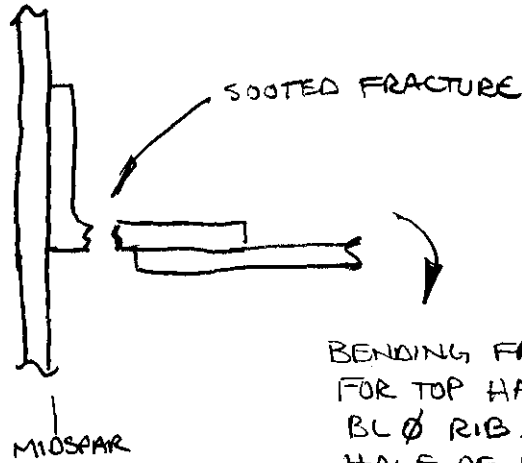
J-J

BENDING FAILURE
FOR TOP HALF OF
BL Ø RIB. BOTTOM
HALF OF RIB IS
INCONCLUSIVE.

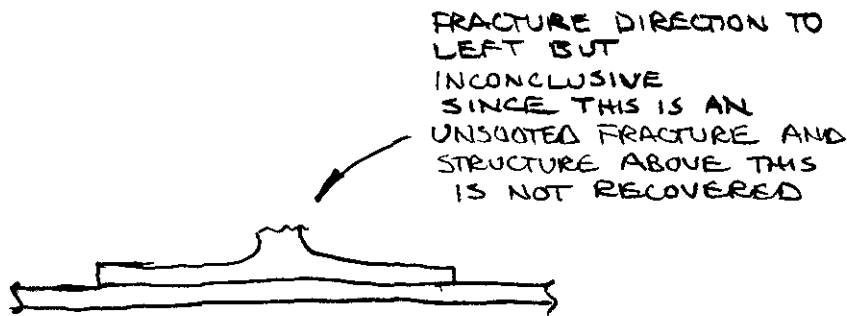
K-K

FRACTURE DIRECTION TO
LEFT BUT
INCONCLUSIVE
SINCE THIS IS AN
UNSOOTED FRACTURE AND
STRUCTURE ABOVE THIS
IS NOT RECOVERED
