CW-115
Z-3089

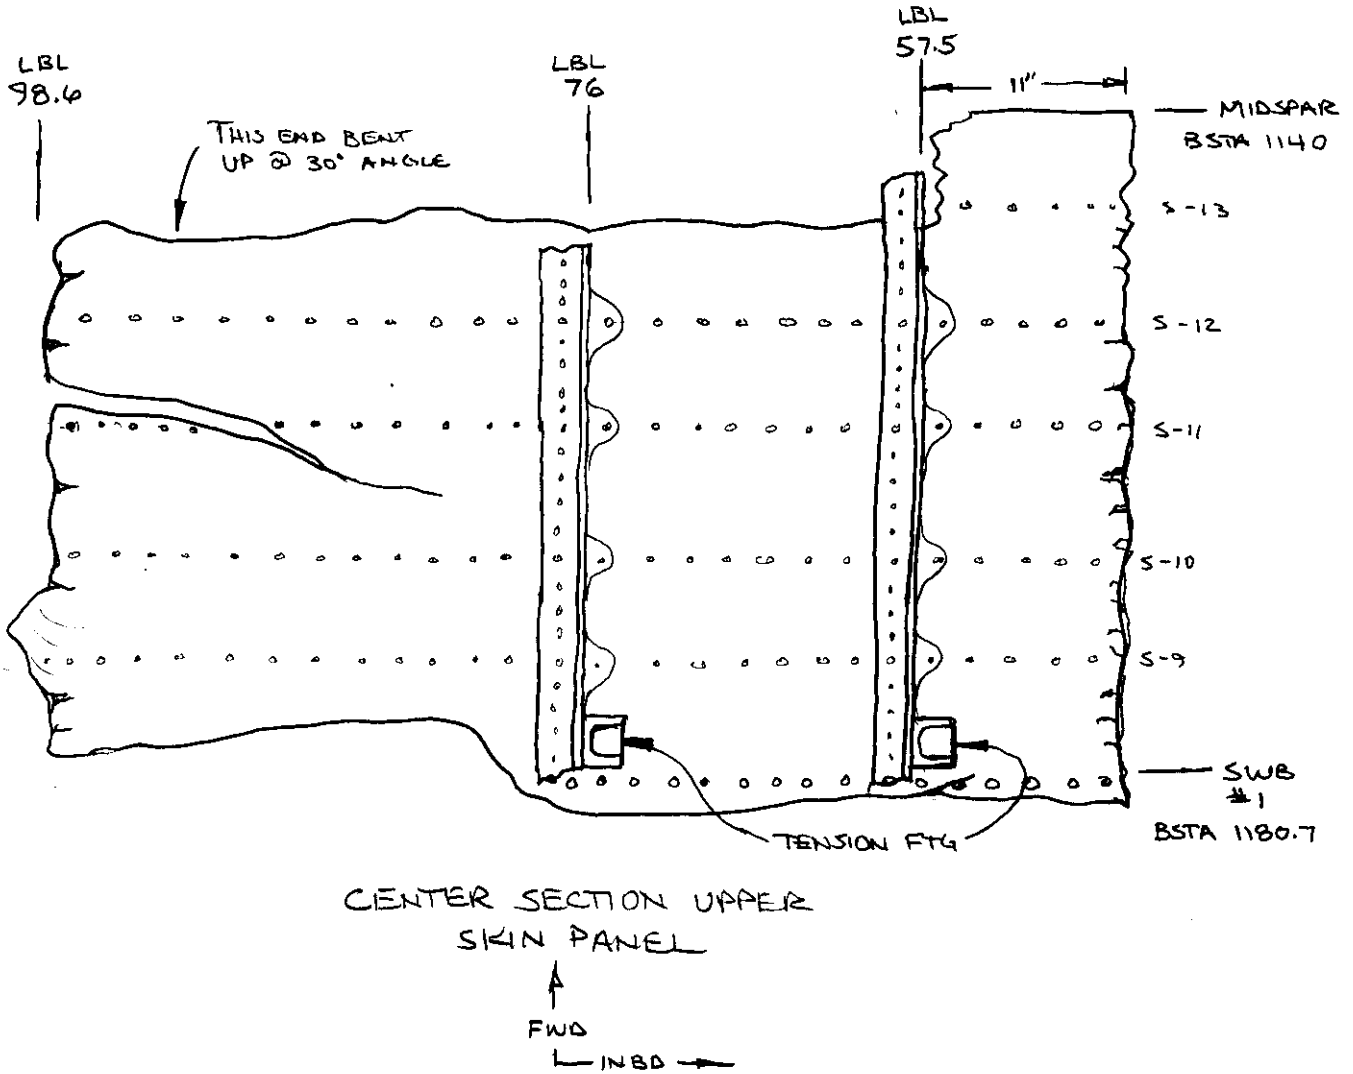
PART IS SLIGHTLY BENT WITH UPPER SURFACE BEING CONCAVE, INBD EDGE IS CURLED DOWN WITH APPROX 1" RADIUS AND EDGE SHOWS MULTIPLE DELAMINATIONS AND TEARS. FRACTURE EDGE SHOWS ONLY MINIMAL SOOT DEPOSITS (ESPECIALLY IN COMPARISON TO ADJACENT CW102 WHICH SHOWS CHARRING AND BURNING). ONLY SKIN FLANGE OF BL 57.5 CHORD REMAINS. BL 76 FLOOR BEAM LWR CHORD AND SMALL AMOUNT OF WEB SHOWS MODERATE SOOTING. BMSS-81 COATING (CAT-A-LAC) REMAINS INTACT WITH MODERATE SOOTING OVER ENTIRE UPPER SURFACE. NO STRINGERS REMAIN ON PANEL AND MODERATE SOOT IS ON ENTIRE SKIN IML INCLUDING SKIN TO STRINGER INTERFACE. SKIN/STRINGER RIVETS ARE SHEAR FAILURE. FLOOR BEAM/SWB #1 TENSION FTGS REMAIN ON BOTH UPR AND LWR SURFACE.
