UPPER SKIN PANEL - WING CENTER TANK

CW-125
 CW-126

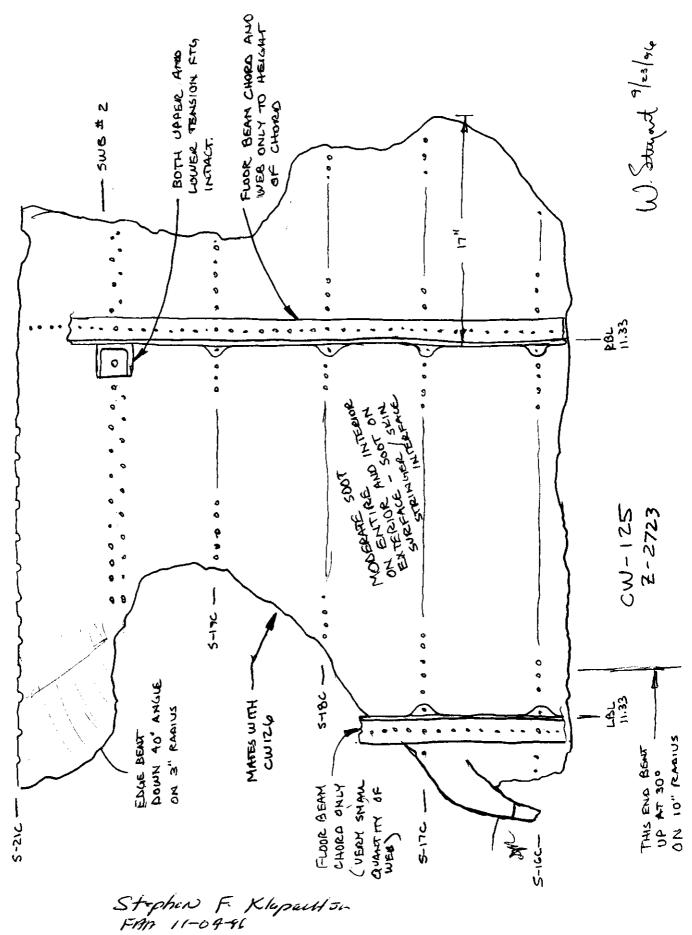
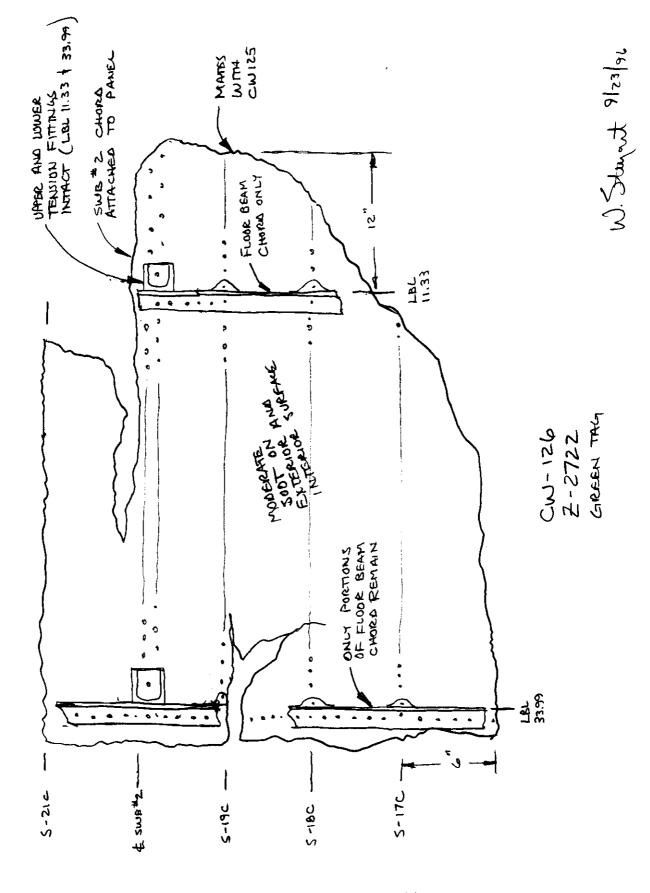
These two portions of skin are mating portions that are between RBL 25 and LBL 34 and S-15 to S-21. See the plan view diagram and detail sketches for complete description of periphery and location.

The forward fracture on both of the panels passes thru the fastener row at S-21. CW-126 has a fracture passing just fwd of SWB#2 and parallel to it and another fracture along the outbd edge just aft of S-19. The aft outbd edge of CW-126 is bent down 30 degrees and the portion of skin fwd of SWB#2 is also bent down approx 30 degrees. The fwd edge of CW-125 near LBL 15 is bent down and the aft edge near LBL 15 is bent up.

Only a portion of the stringers remain attached to the bottom of these panels and the skin/stringer interface where the stringers are missing is sooted. See the fire and explosion group notes for complete documentation.
