CW-135

Z3211 Green Tag (9-30-96-1)

Center Wing Section Upper Skin Panel

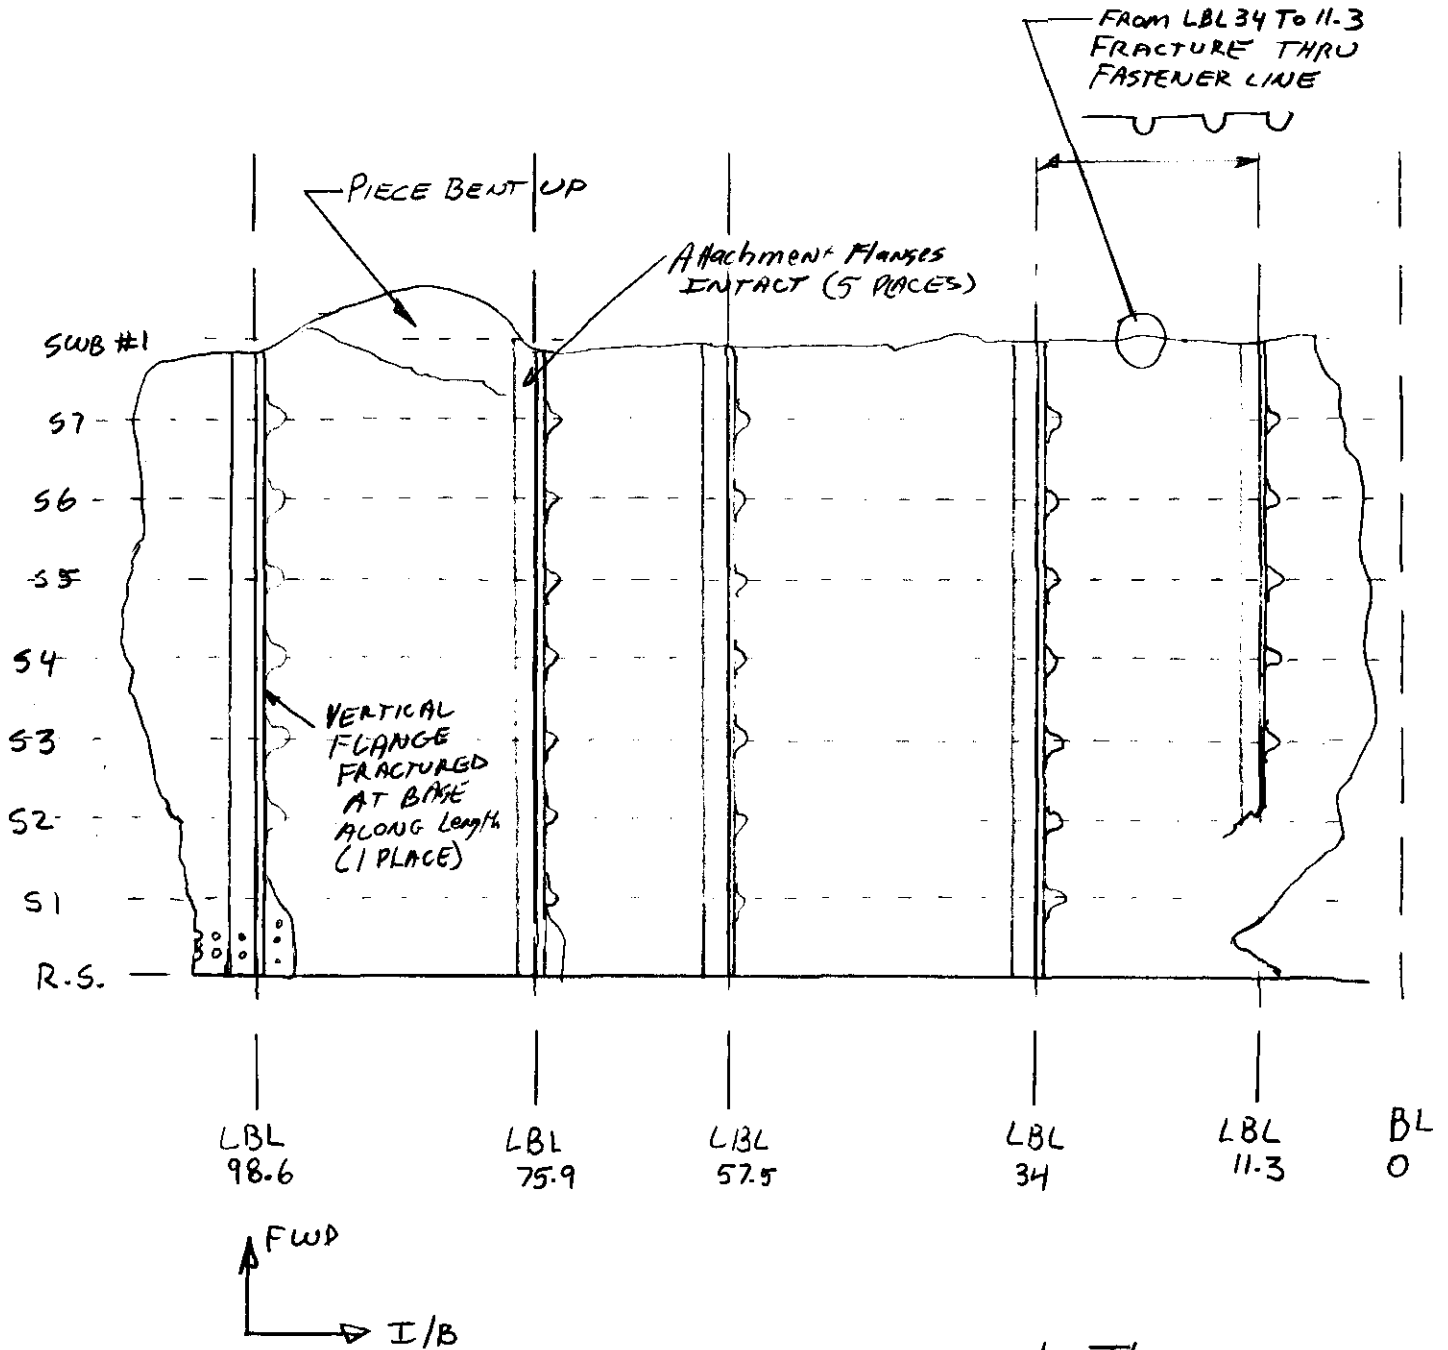
CW135 (Z3211, 9-30-96-1)

Panel extends forward from rear spar to span-wise beam #1, and from LBL 98.6 inboard to about LBL 5. The panel is curved about an axis that is parallel to LBL lines, with the upper surface of the panel on the convex side (upper surface tension/ stringer side in compression): When placed on a flat floor, with the interior side down and CAT-A-LAC coating on top, the middle bay between LBL 34 and 57.5 is approximately 12 inches above the floor.

The skin attachment flanges of the fore-aft chords at LBL 98.6, 75.9, 57.5, 34, and 11.3 on the upper surface of the panel remain. Segments of the vertical flange are missing, with fracture at the base flange radius (vertical flange on LBL 98.6 is mostly gone).

Wing stringers on the lower surface of the panel are entirely gone. Most of the stringer fastener holes located in the skin contain fastener shanks, fractured at the surface of the panel (shear failure). A small percentage of fasteners are missing entirely with no hole elongation. A few fasteners remain that have fractures that are at an angle to the fastener shank direction.

Fracture around the periphery of the part is jagged, and is free of pre-existing cracking. In one region, the fracture extends through the fastener line that is used to connect the span-wise beam, between LBL 34 to 11.3.

Interior surface of panel has varying intensities of sooting, including surfaces where stringers had previously been attached. The intensity is most severe along the 12-inch edge along the inboard edge of the panel. Exterior CAT-A-LAC coating is darkened / sooted over surface. Intensity of soot varies.

CENTER SECTION UPPER SKIN PANEL
