CW-164 (was CW-134)

GREEN DEBRIS FIELD

WING CENTER SECTION
UPPER SKIN PANEL

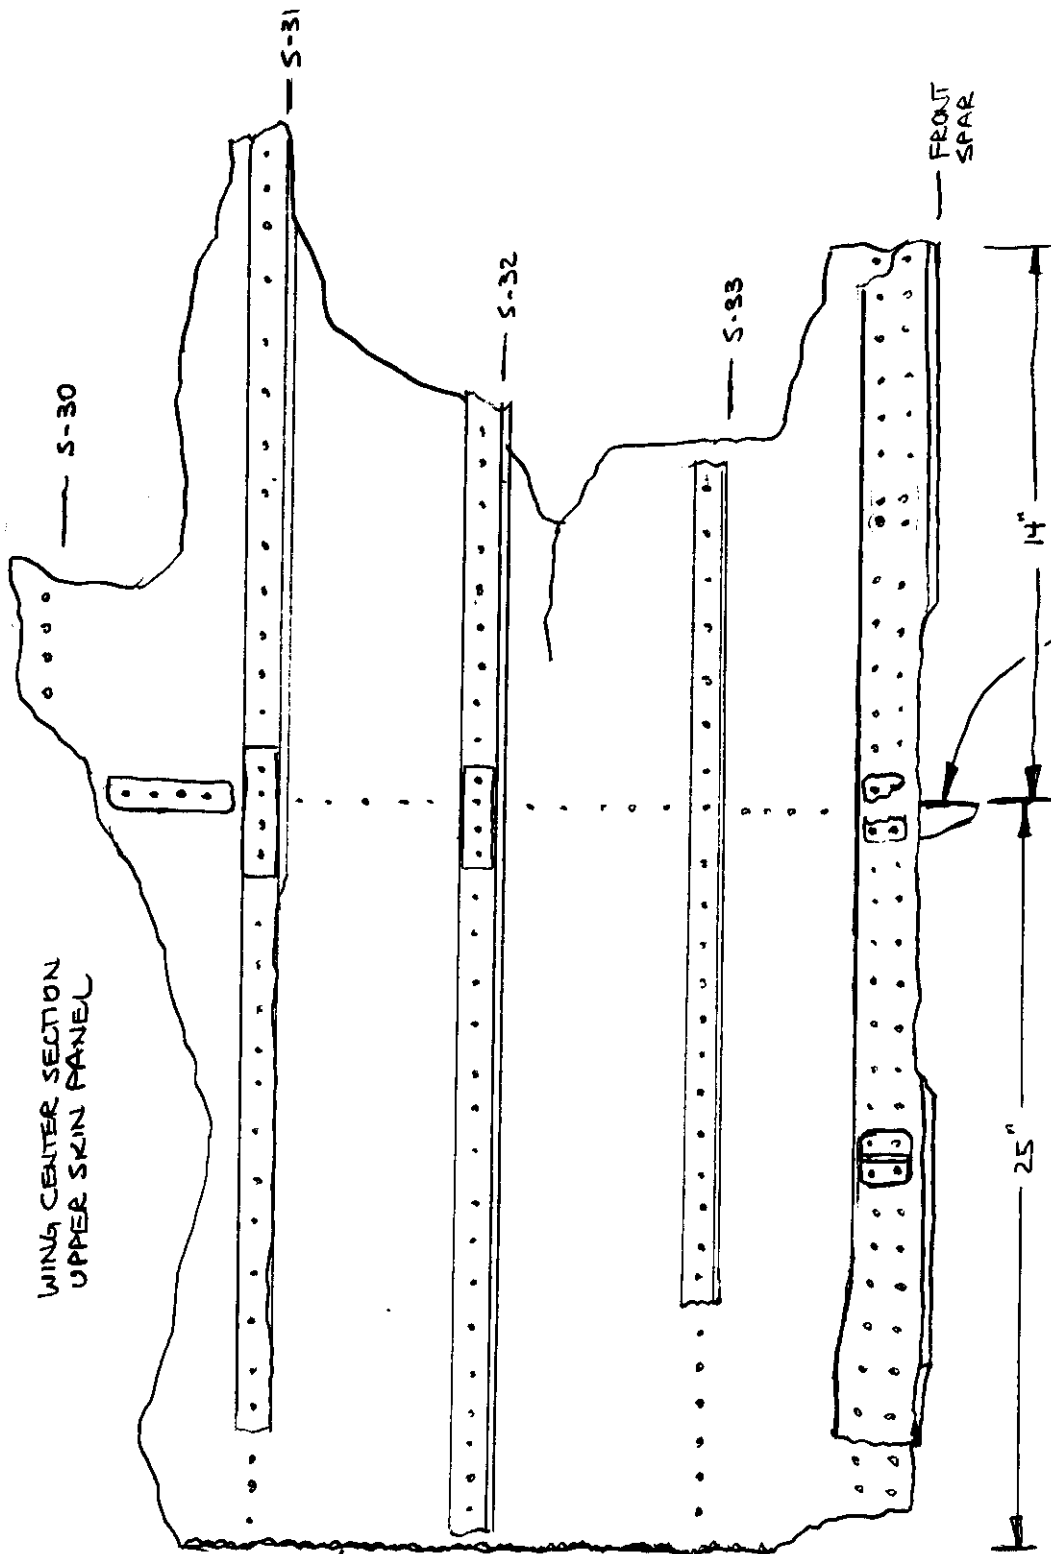
EW-16A (WAS CW-136)

THIS PORTION OF WING CENTER SECTION UPPER SKIN PANEL EXTENDS FROM THE FRONT SPAR TO A ZONE BETWEEN S-30 AND S-31 AND FROM ADJACENT TO THE LEFT DOUBLE PLUS CHORD TO LBL 84.

THE PANEL IS GENERALLY FLAT EXCEPT AT THE OUTBOARD EDGE WHICH IS CURLED UP 45° TO 60° ON A 2" RADIUS AND THE PORTION NEAR S-31 INBOARD OF LBL 98 HAS A SLIGHT DOWNWARD CURVATURE. THE OUTBOARD EDGE IS A VERY JAGGED FRACTURE.

PORTION OF THE SKIN FLANGE OF THE FRONT SPAR UPPER CHORD REMAINS ATTACHED ALONG WITH PORTIONS OF THE FRONT SPAR STIFFENER SHEAR TIES AT LBL 98 AND LBL 106. THE SHEAR TIE AT LBL 83 IS NOT ATTACHED AND THE REMAINING FASTENERS SHOW NO BENDING DEFORMATION.

THE SKIN FLANGE OF THE FLOOR BEAM CHORD AT LBL 98.48 REMAINS ATTACHED.

THERE IS NO SOOT ON THIS PART BUT THE INBOARD END OF THE UPPER SURFACE HAS A BROWN DEPOSIT ON THE PART AND THE AFT SIDE OF PROTRUDING FASTENER HEADS.

ALL FRACTURES ARE DUCTILE

SKIN FLANGE OF
FLOOR BEAM CHORD
STILL ATTACHED

EDGE CURLED
UP (AIRPLANE
ATTITUDE) 45°-60°
ON 2" RADIUS
