## LOWER SKIN PANEL - WING CENTER TANK

CW-201  
C-2147  
GREEN

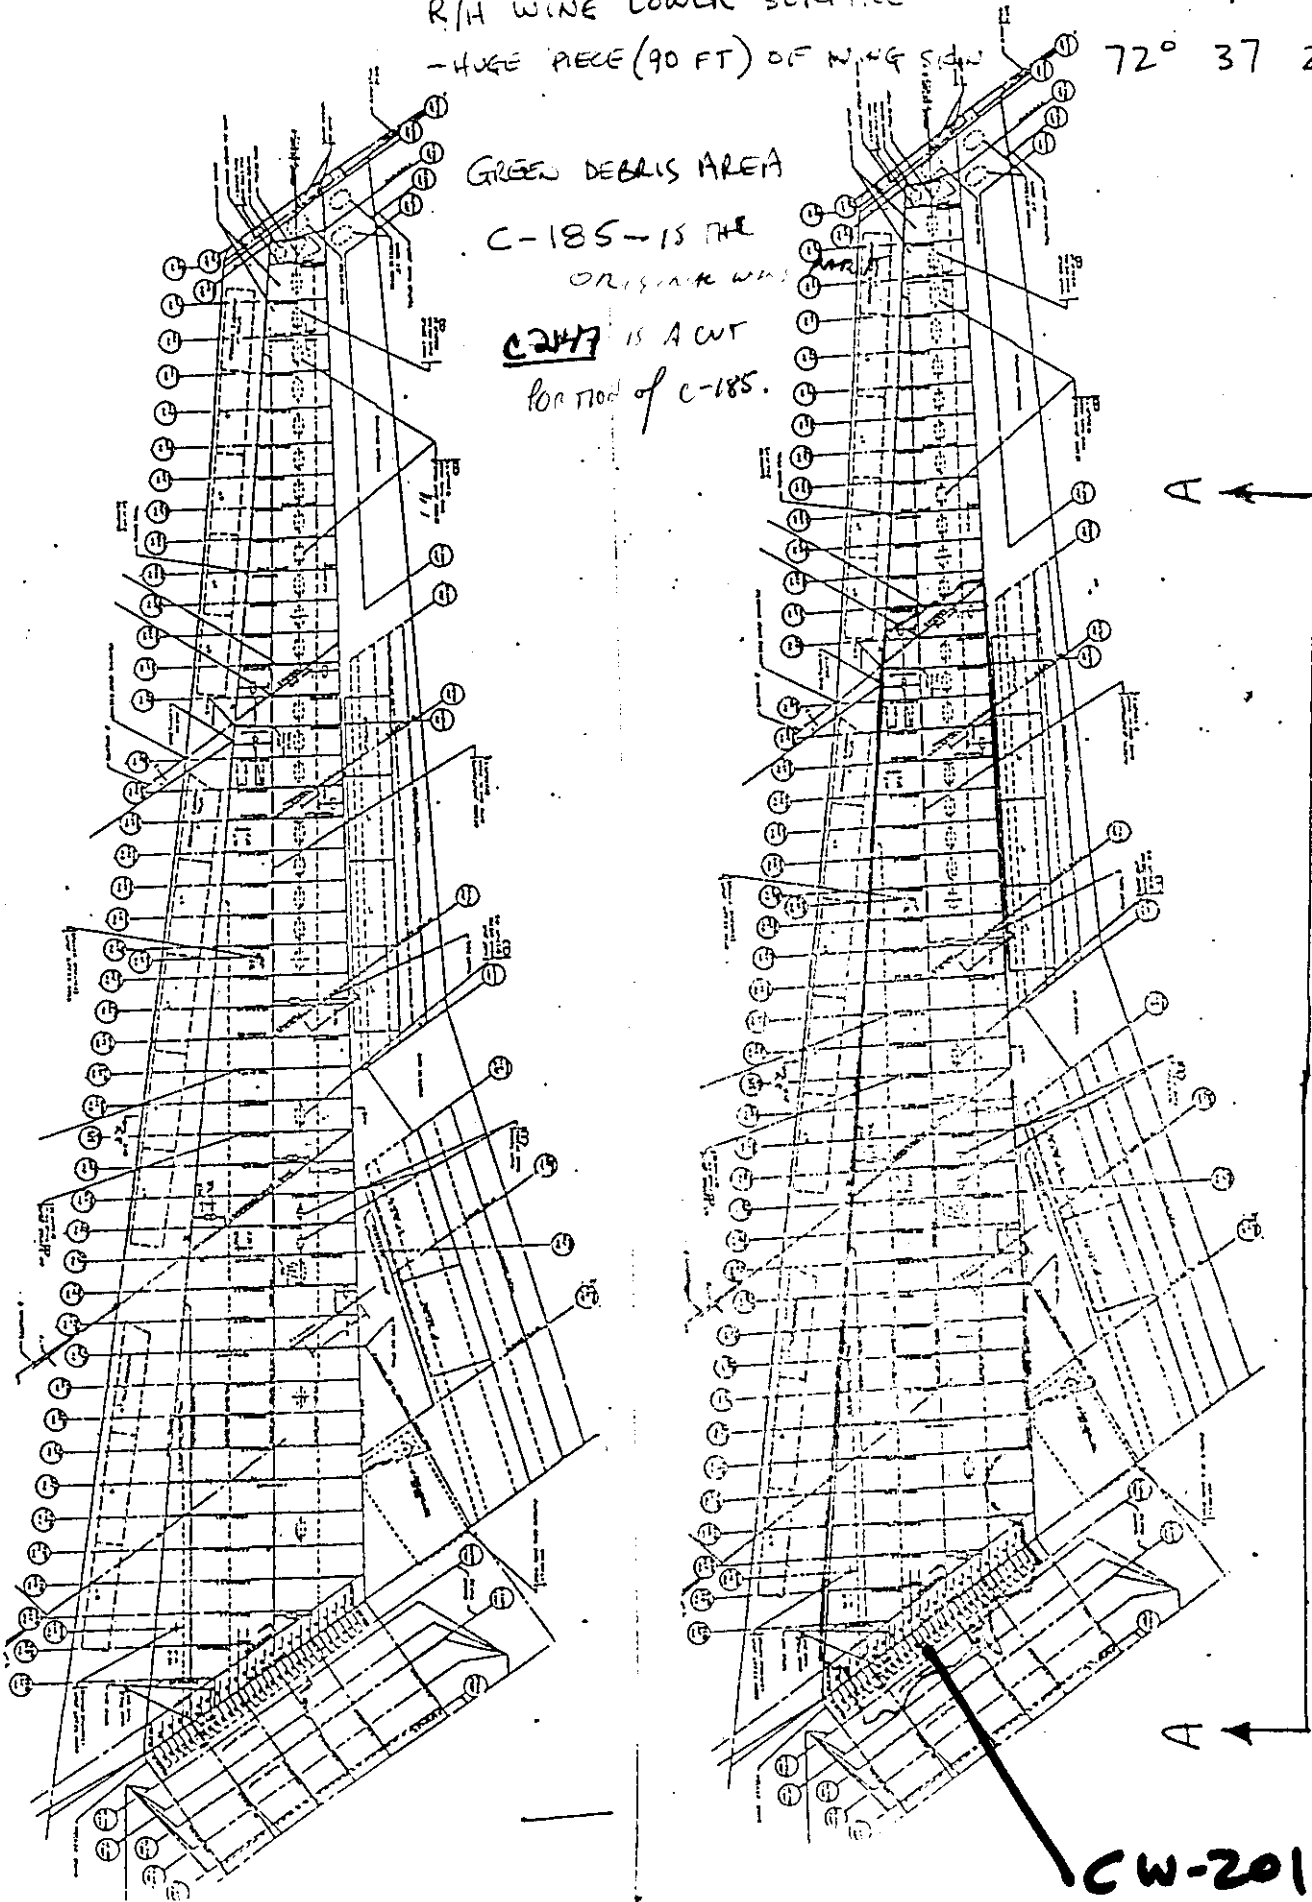
This section extends from S-1 to S-23. It was cut from the lower right hand wing skin (RW-3) to allow placement in the center tank reconstruction. The fracture line of the skin along the inboard edge is approx at RBL 98 from S-1 to S-5. The fracture edge from S-5 to Midspar (S-9) varies from RBL 120 to RBL 70 along its length. From the midspar to S-15 there is an extension of the skin that starts at RBL 98 and goes inb'd to RBL 30. Forward of S-15, the skin fracture extends diagonally from RBL 11 at S-15 to RBL 120 at S-23. Reference plan view diagram for complete details.

The inboard edge of the skin from rear spar to S-5 is curled down and the stringers are separated from the panel at S-1 to S-4. At S-5, the stringer matches the periphery of the panel and remained attached. At S-6 the majority of the stringer is missing except directly at the paddle fitting. The stringer at S-7 and S-8 are separated from the panel. Between S-6 and S-8 there is a portion of the panel that is fractured at RBL 110 and the outb'd edge is deflected downwards whereas the inb'd edge between S-7 and S-8 is bent upwards. The stringer at S-9 extends inb'd to RBL 45 and was separated from the skin segment (CW-205, CW-225, and CW-226). The midspar stringer and the skin is fractured at RBL 98. The skin between S-11 and S-13 extending inb'd has a very jagged fracture pattern and is bent both upwards and downwards at multiple locations. At S-14 (SWB2) the skin and stringer are both fractured at RBL 107. At the S-15 skin splice, the skin flange of the stringer remained attached to the skin. The skin portion between S-15 and S-23 exhibit general upward bending with multiple smaller curvature both upwards and downwards. There is also a fracture within the panel occurring from S-17 to SWB3 and from RBL 40 to RBL 65. There is a flap of skin broken out and bent upwards at S-20 and RBL 75. Just fwd of S-21, the skin is fractured from RBL 127 to RBL 100 and the outboard edge of the skin fwd of this fracture is bent down. There is evidence of impact marks and rub marks on the skin interior surface at various locations and the light yellow primer has been scraped off the skin at these location.

The lower splice paddle fittings both inb'd and outb'd of the side-of-body remain attached to both the stringers and the lower wing splice plate except at S-1 to S-4 on the outb'd wing side and the center section paddle fittings at S-22 and S-23 which are failed at the panel.

The vertical flange of the "T" chord at the right SOB rib is broken off. Refer to metallurgical notes for direction of failure.

All of the stringers that are not skin splice or SWB stringers are bent generally in the direction of the skin but their inboard end is twisted with free flange going forward. At the skin splice stringers, the skin flange remained attached to the skin panel. Of the fasteners that are remaining in the stringers, majority of these fasteners indicate tension type failures. Majority of the fastener holes on the skin exhibit no general elongation. There are locations on this panel (at SWB1, S-17, S-22) that exhibit slight elongation of the fastener holes in fore and aft direction. There is evidence of impact damage and rub marks on the upper surface nearly all of the paddle fitting and the free flange of the stringers. There is brown sealant applied to the paddle fitting and the stringer at S-1 to S-6 both inb'd and outb'd of the side-of body-rib.

The outb'd wing (Section 12) skin that is attached to this part was saw cut as mentioned earlier. At the end S-17, there is a skin penetration of a stiffener segment. The segment is approximately 2" X 1" and it remains embedded in the lower Section 12 wing skin. Other penetrations in the Section 12 lower skin are documented in the Section 12 wing notes.

There is evidence of upwards pillowing of the skin between the stringers for most of the entire CW-201 panel.

The exterior surface of the lower skin shows impact and rub marks at multiple location. There is evidence of fire damage and soot accumulation, but some areas show no soot accumulation. There is a distinct boundary between heavy and light soot directly at RBL 127.50. See Fire and Explosion Group notes for further documentation.
