LOWER SKIN PANEL - WING CENTER TANK

CW-202
C-186
GREEN

This section extends from RBL 98 to LBL ⁶⁹~~50~~ and goes from approx S-1 to S-5.

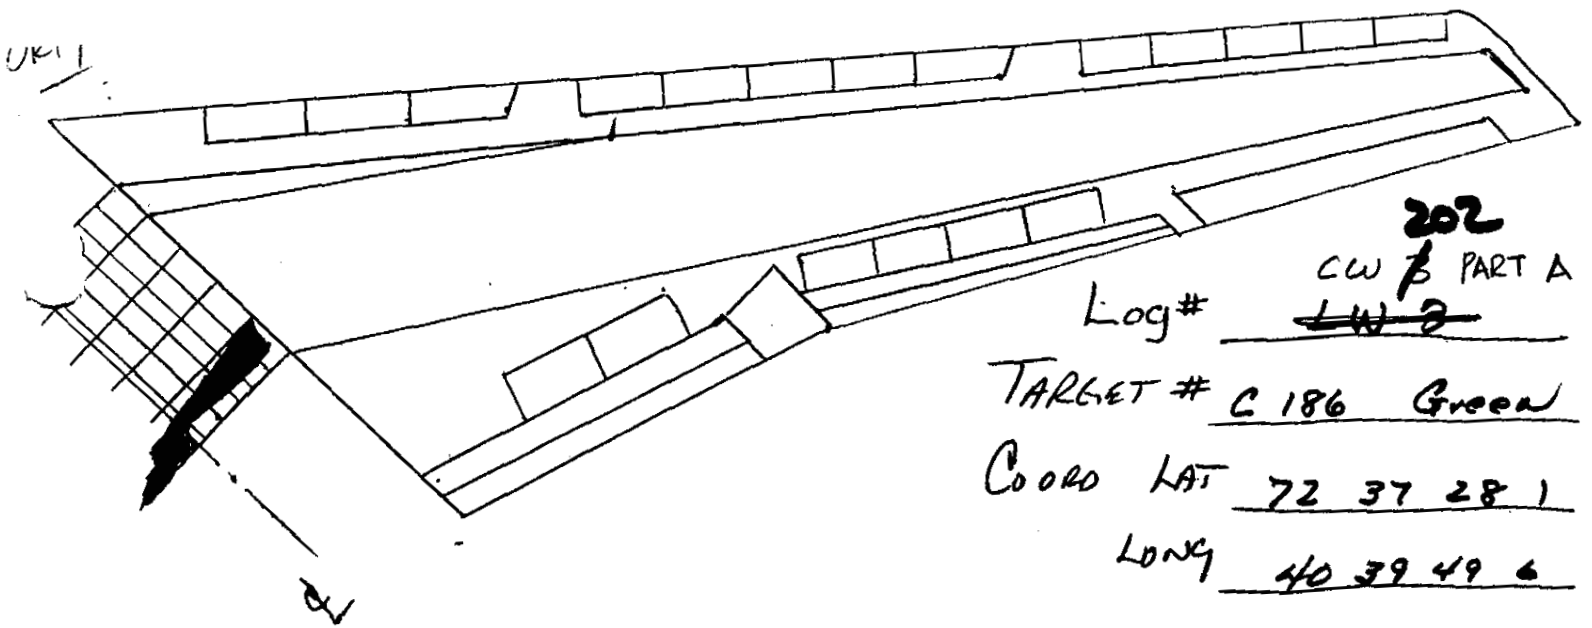
There is only a 15" long section of the S-5 skin flange remaining on the panel. No other stringer remained attached to this panel. The panel is bent inboard/outboard with the RHS and LHS both bent downward from BL0. The right side is bent down approx 10 degrees and the left side is bent starting at 10 degrees and gradually increasing to about 45 degrees. A portion of the BL0 rib shear tie remains attached. The few rivets remaining in the skin panel exhibit shear in the inboard and outboard direction, but the fasteners at RBL 57.5 at S-2,3 and 4 are bent aft ranging from 45 to 60 degrees.

There is generally no soot in the interface between the stringer and the skin. On the right outboard side of this section (30"), there is evidence of pillowing of the skin between the stringers in upwards direction. There is no evidence of pillowing to the remainder of the skin panel.

The keel beam attachment stiffener at right and left BL 9.0 have pulled away from the lower skin and the fasteners exhibit evidence of tensile failures. There is evidence of sooting on the lower surface of the skin and is heavier on the right side than on the left. There is evidence of some impact and rub marks on the lower surface of the skin panel.

At approximately RBL 77 there is a segment of chord attached to the lower skin from the aft edge of the panel to the forward edge of the panel.

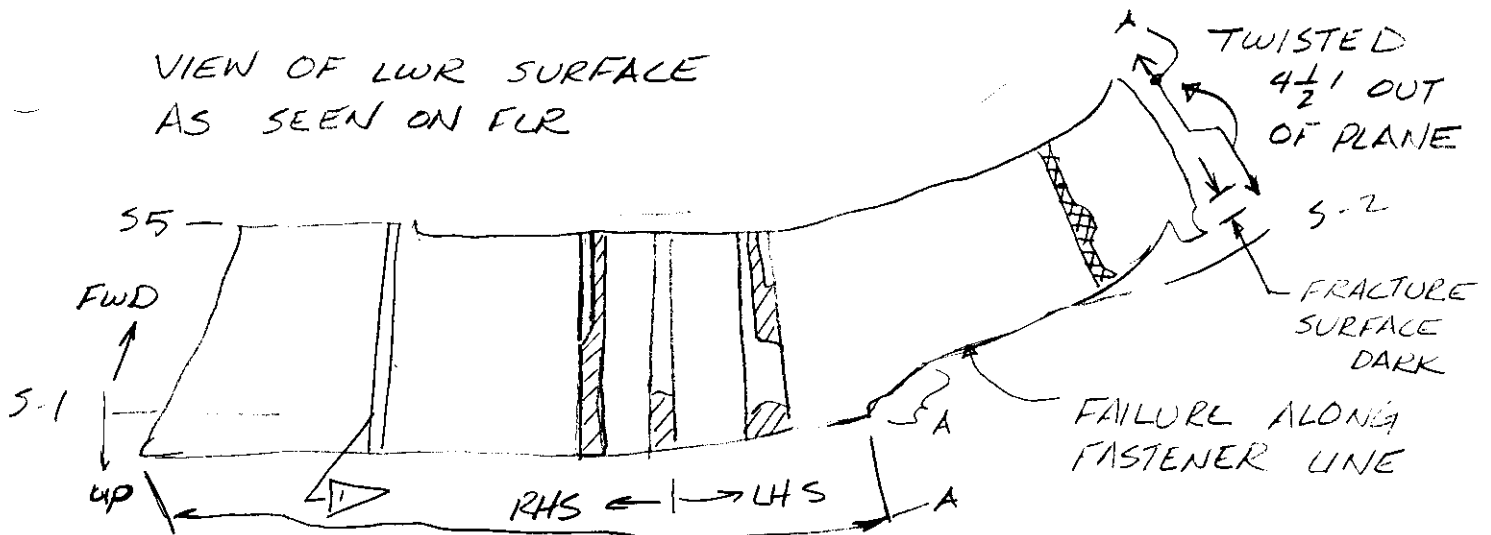
PART A BOTTOM SURFACE OF LWR SKIN 5-5

- ① SKIN is severed aft of ~~#8~~⁵ STR left of BBLO
 AND AT STR ~~85~~⁸⁵ OB of RBL 75.
 RAH
- ② Keel beam AT R & LBL 11 separated from skin.
- ③ Lower RH side OB of the keel beam shows indication
 of soot. on the external skin. Interior skin has indication
 of light soot residue.

WHITE ENAMEL NOT VISIBLE THRU HEAVY LAYER OF OILY/SOOT. WITH HARD RUBBING WITH PAPER TOWEL & MOISTURE, WHITE ENAMEL CAN BE FOUND ENAMEL MORE 'EGG SHELL' IN COLOR THAN PURE WHITE IN 5% OF AREA DOWN TO PRIMER w/o OILY SOOT.

WHITE ENAMEL VISIBLE WITH LIGHT BLACKENING WITH LIGHT PRESSURE & PAPER TOWEL BLACKENING IS REMOVED

A = ANGLED FRACTURE FACE SEE PART G

NO STRINGERS THRU-OUT PART, PRIMER FROM UNDER STRINGERS HAS VERY LITTLE BLACKENING, EXCEPT AT LHS END OF PART (LAST 3') SHOWS SOME BLACKENING

GREEN PRIMER WHERE UNDER WING BEAM TORE AWAY

GREEN PRIMER WHERE KELL BEAM BOX TORE AWAY FROM WING LOWER SURFACE - SEE LF-14 PART B

BETWEEN STR'S, FROM RBL 9 → RBL 101 AND THE MOST OUTB'D 3' ON LHS, HAVE OILY BLACKENING

ALL FRACTURE SURFACES ARE FREE OF BLACKENING

▷ CHORD FROM UNDER WING BEAM w/ 2 STIFF'S ATTACHED
SIGNS OF HEAT DAMAGE ON STIFF'S, PAINT ON CHORD
DOWN TO PRIMER

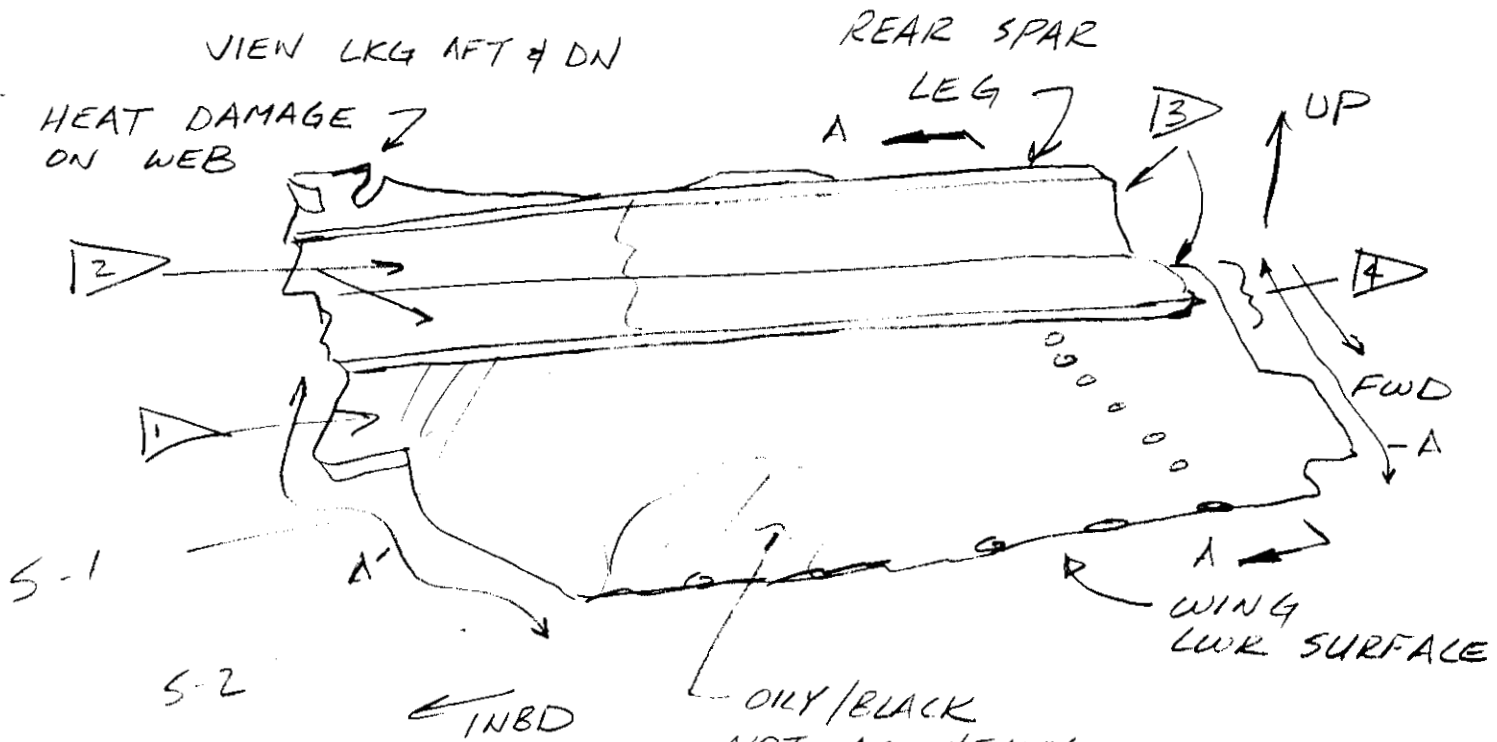
PART B - SEE NEXT PAGE FOR SKETCH

- BOTTOM SURFACE IS IDENTICAL TO PART A LHS
- THERE IS A DISTINCT DIFFERENCE BTWN AFT FACE OF VERTICAL LEG OF LWR R/S CHD & WING LWR SURFACE. R/S CHORD AFT VERT. FACE IS DARK WITH DRYISH SOOT. NOTE THE TWO SURFACES ARE SEPARATED BY VAPOR BARRIER PANEL IN DESIGNED CONDITION

1 HEAVY OILING
LIKE OIL PAN ON CAR

2 DRY BLACKENING, ALSO SAND MORE PREDOMINATE

3 DARK BLACKENING ON CHORD

4 MEDIUM AMOUNT OF BLACKENING ON WEB

- ALL OTHER SURFACES FREE OF BLACKENING
FRACTURE

A-A 3" OUT OF PLANE
NOTE INBD END IS STRAIGHT

A = ANGLED FRACTURE FACE - SEE PART G
