LOWER SKIN PANEL - WING CENTER TANK

CW-205
C-218
GREEN

CW # 205
 Log # ~~604~~ PART D

TARGET # C-218 Green

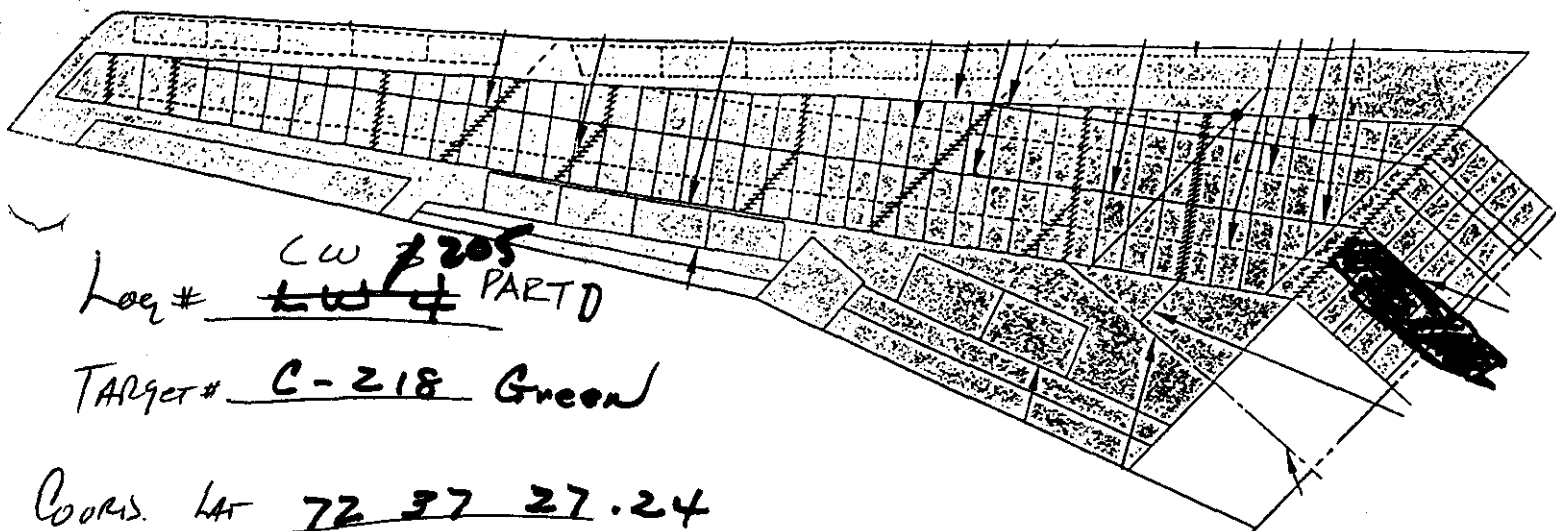
This is a section of skin panel and stringer that extends from S-4 to the midspar (S-10) and from the left SOB to approx RBL 70. There are portions of stringers S-5 through S-8 and mid spar which remain attached. 92.0

The stringer S-5 is intact and remains attached to the skin panel. The stringer at SWB1 is intact from the left SOB to RBL 11 and is separated from the panel from RBL 11 to RBL 23. The SWB1 stringer is fractured at LBL 107 and the stringer inbd and outbd at that point is separated from the skin panel. The S-7 and S-8 stringers are complete out to RBL 11 and RBL 33 respectively, but only remain attached to this section at the SOB paddle fittings. Both these stringers are bent and twisted in all directions. The S-9 stringer and paddle fitting at left SOB is not attached. Only the aft skin flange of the midspar stringer remained attached to this panel. The panel has a fracture running from LBL 16 at the mid spar to LBL 13 between S-7 and S-8. There is a fracture running down the fastener line at SWB#1 from RBL 58 to RBL 13. The panel is bent in "S" shape from left SOB to RBL 70. The skin attach flanges of the shear ties for the BL0 rib remained attached. There is a puncture in the skin panel 6" fwd of SWB1 at LBL 37 with the surrounding skin deflected down. The remaining rivets in the skin panel at S-8 and S-9 exhibit inboard/outboard shear. The Keel beam attachment tension fittings at SWB1 remained intact on the top side of the panel at both LBL 9 and RBL 9. The tension fitting on the lower side of the panel remained attached at LBL 9 only. The tension fittings of the keel beam at the midspar are not attached. The holes through the panel and mid spar chord exhibit no elongation. The keel beam "T" chord on the lower side of the panel has fractured off with vertical flange being torn away. There are fairing support rods partially attached to the lower surface of the skin .

The right end of this panel is highly deformed. The general shape of this portion is an upward deflected dome that is as much as 14" high in relation to the adjacent structure. The dome is centered about RBL 57.5 at S-8. The sections around this area including CW-232, CW-231, and CW-201 exhibit this same general shape.

There is a spike-tooth fracture occurring at RBL 39 just fwd of S-9. See the metalurgical report for complete details.

There is soot on the interior and exterior surfaces of the panel. This is documented in Fire and Explosion Group notes.

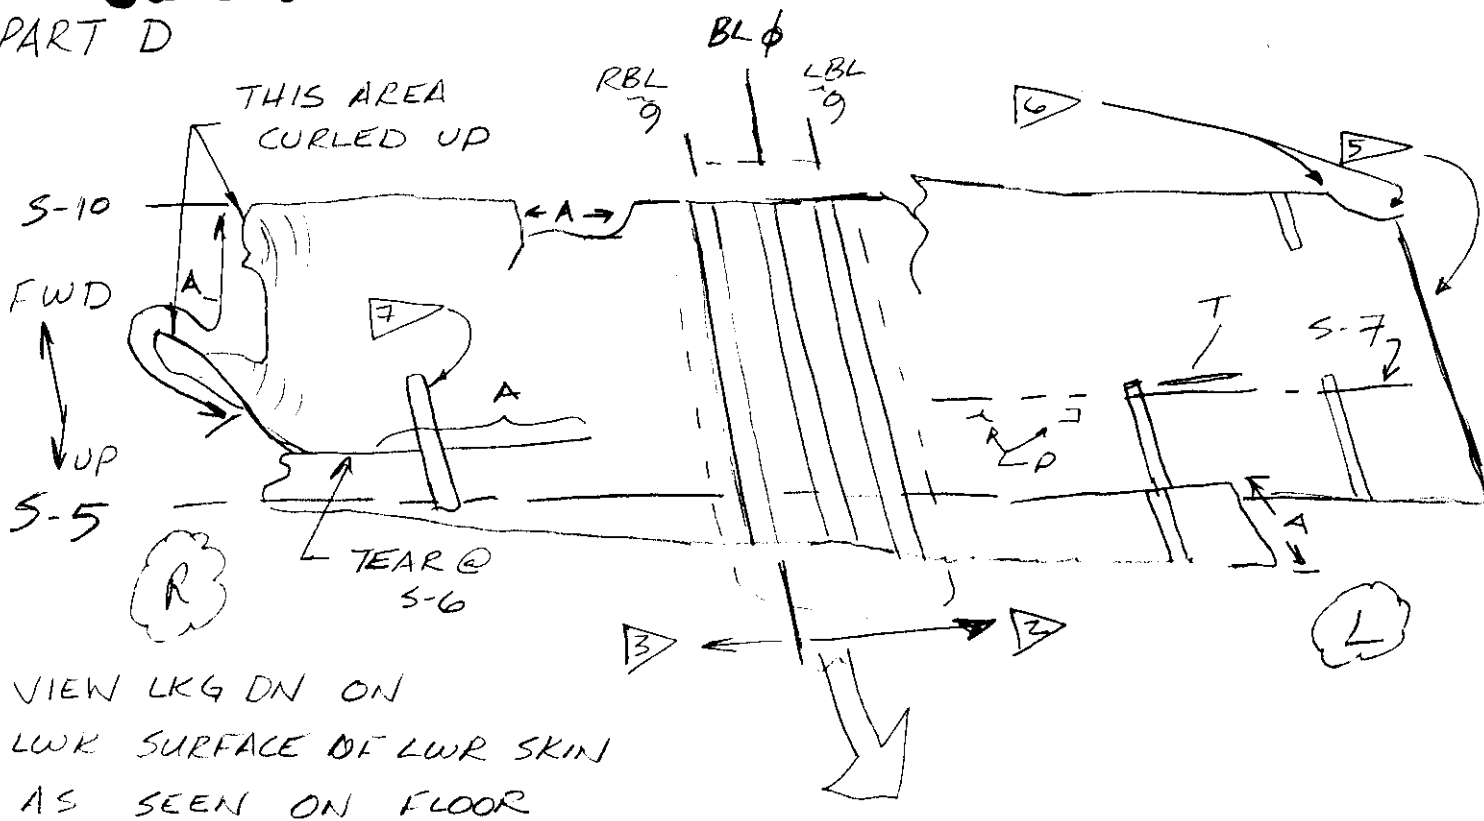
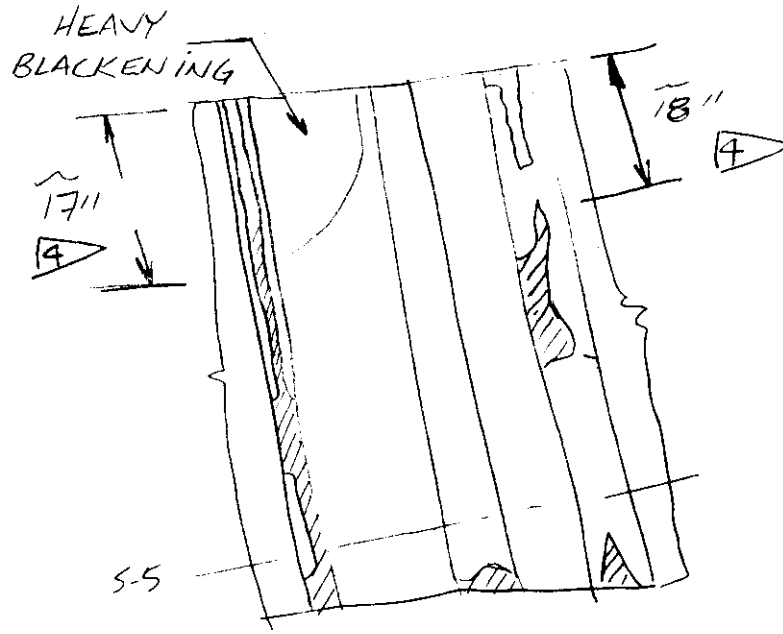
CW-205

P = PUNCTURE'S
 BOTH ~2" DIA
 FROM INSIDE OUT

T = TEAR, 10" LONG
 PUSHED INSIDE-OUT

A = ANGLED FRACTURE
 FACE - SEE PART G

GREEN PRIMER
 WHERE CHORDS
 TORN OFF

- 2 BOTTOM SURFACE IS IDENTICAL TO LHS PART A
- 3 " " " " RHS PART A
- 4 WHERE CHORDS TORE OFF & EXPOSED PRIMER, IS BLACKENED
- 5 FRACTURED THRU SPLICE PLATE, NO SIGN OF BLACKENING - NOTE ON UPPER SURFACE OF LWR WING SKIN IS HEAVY BLACKENING (PART UPSIDE DN ON FLOOR - LOOKING UNDER EDGE) MATES W/ LW-7
- 6 TWO VERY LOCALIZED AREAS OF BLACKENING ON FRACTURE SURFACES, OTHER WISE BLACK FREE
- 7 UNDER WING CHORD & STIFFENER, SHOWS SIGN OF HEAT DAMAGE PRIMARILY LOSS OF PROTECTIVE FINISH

- LHS OF UPPER SURFACE APPEARS TO HAVE DARKER BLACKENING THAN RHS
- 3 STRINGER SEGMENTS ATTACHED
