LOWER SKIN PANEL - WING CENTER TANK

CW-206
C-2160
GREEN

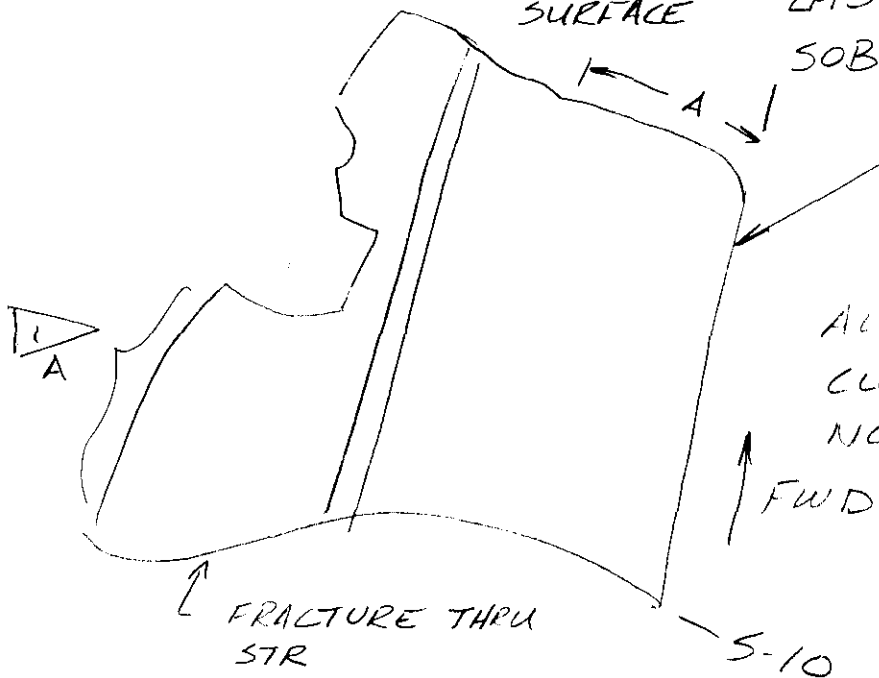
GREEN TAG # C2160

The remaining rivets in the skin panel have a shear failure and two holes have elongation in the inbd/outbd direction. The outbd fracture line passes thru the inbd bolt row common to the side of body splice. The panel is s-shaped with the outbd end bowed up and the inbd end bowed down. There is a partial fracture through the panel at S-11 at approx LBL 103. Portions of the angle mounted on the exterior surface of the panel at LBL 104 remain attached.

FAILURE THRU FASTNR
LINE - COMBINATION ANGLED &
V SHAPED FRACTURE FACE

ALL FRACTURE SURFACES
CLEAN EXCEPT AS
NOTED

WHITE ENAMEL STILL INTACT W/ SMEARED HEAVY
SOOT { PART LOOKS LIKE IT'S BEEN IN BACK OF CAR
GARAGE FOR YEARS)

THIS PART LOOKS DISTINCTLY DIFFERENT THAN PART D
IN TERMS OF SOOTING

UPPER SURFACE OF LWR WING SKIN HAS FILM OF
BLACKENING (LIGHT) THRU OUT INCLUDING AREAS
WHERE STR FOOT PRINTS WERE

▷ SLIGHT BLACKENING ON FRACTURE SURFACE

A = ANGLED FRACTURE FACE - SEE PART G
