LOWER SKIN PANEL - WING CENTER TANK

LOWER SKIN ~ SUPPLEMENT FOR CW-236

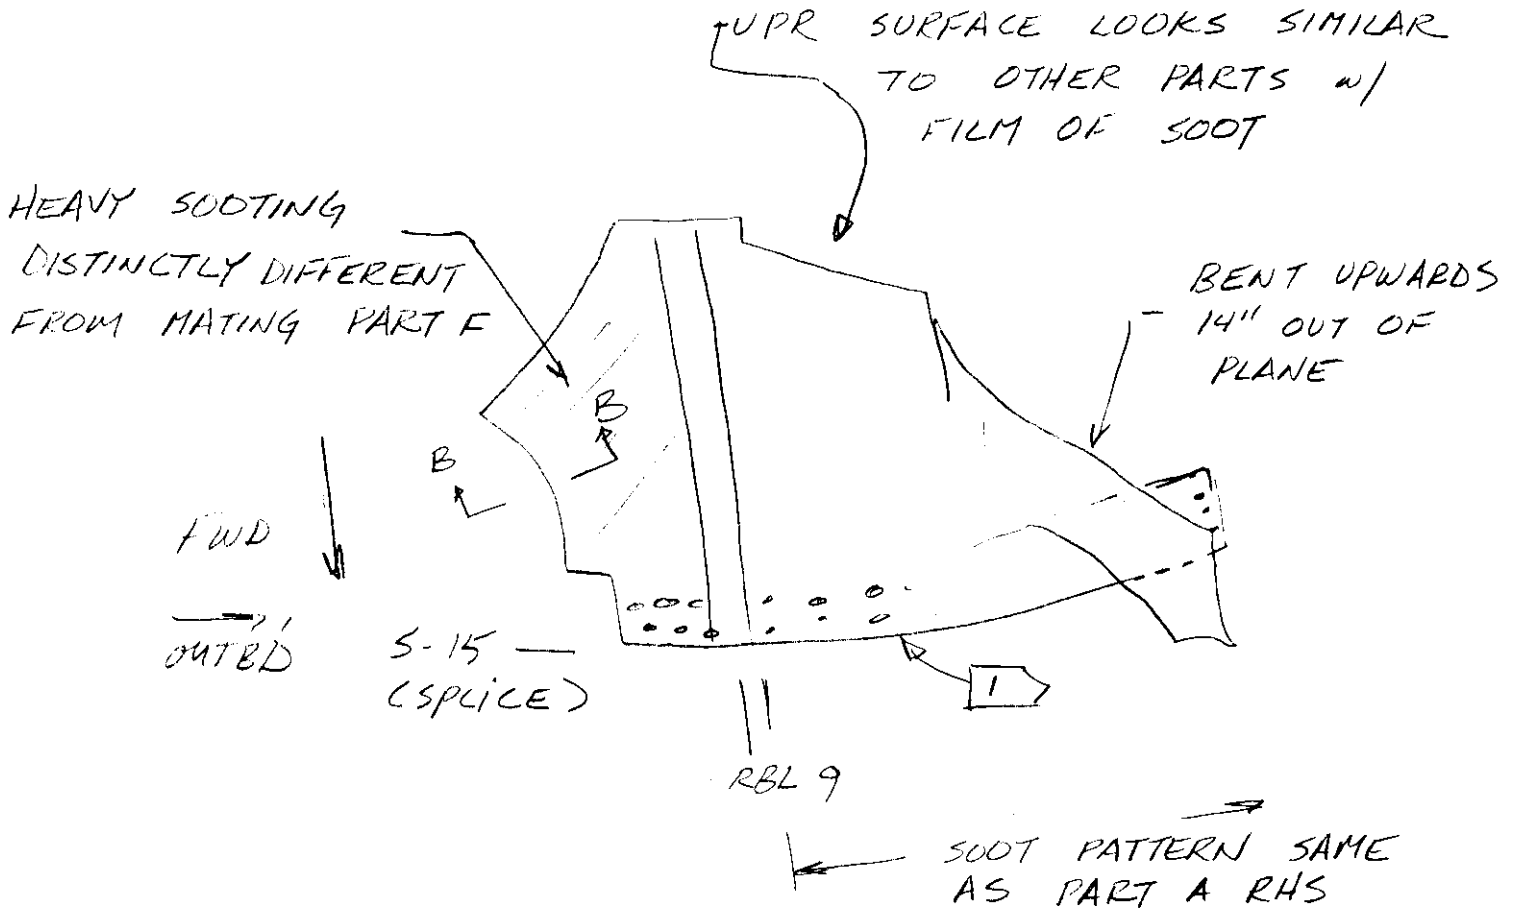
PART G

1) FAILURE BY STR SEVERING

ALL FRACTURE SURFACES FREE OF BLACKENING

VIRTUALLY ALL FRACTURE FACES ARE 'ANGLED'

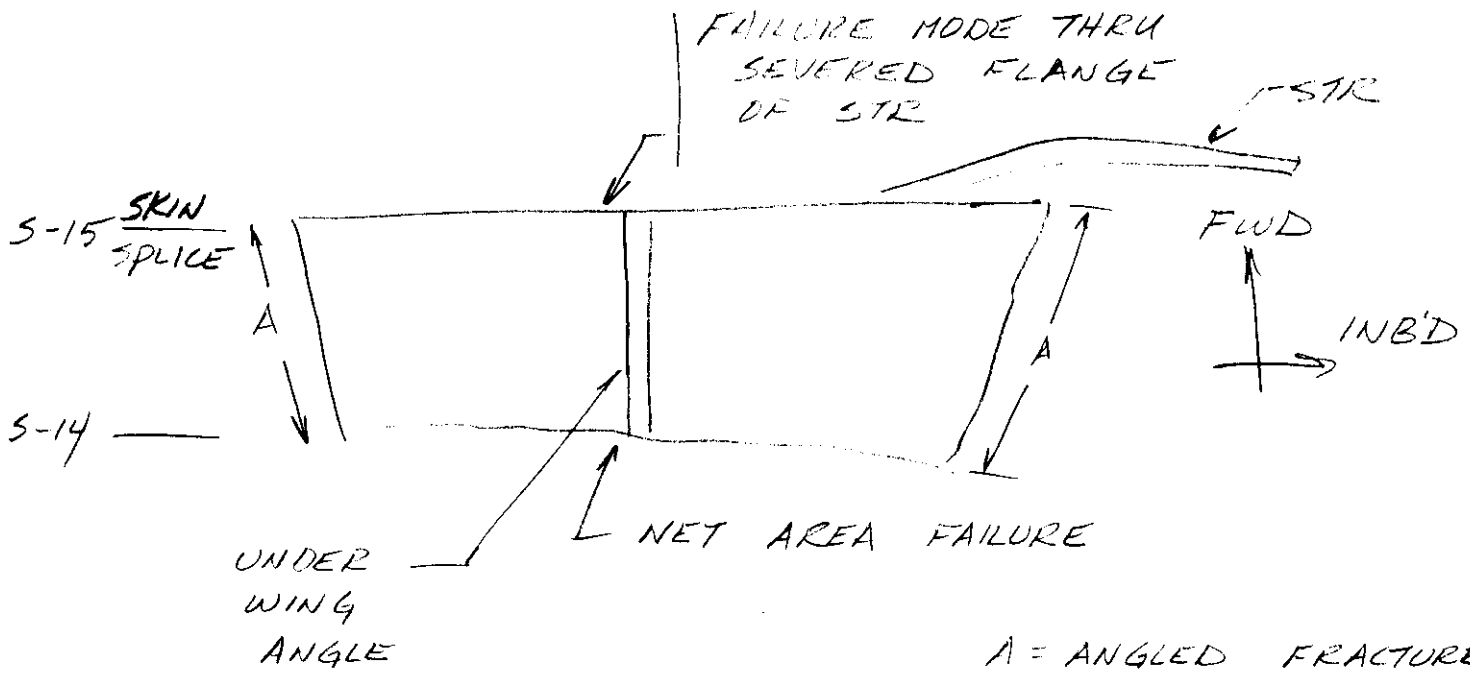
CW-1209  
PART H

A = ANGLED FRACTURE  
FACE - SEE PART  
G

ALL FRACTURE FACES FREE OF BLACKENING

CONDITION OF LWR SURFACE SAME AS PART A RHS  
BUT SLIGHTLY DARKER

UPR SURFACE SIMILAR TO ADJACENT PARTS WITH  
FILM OF SOOT
