LOWER SKIN PANEL - WING CENTER TANK

CW-221
C-3492
GREEN

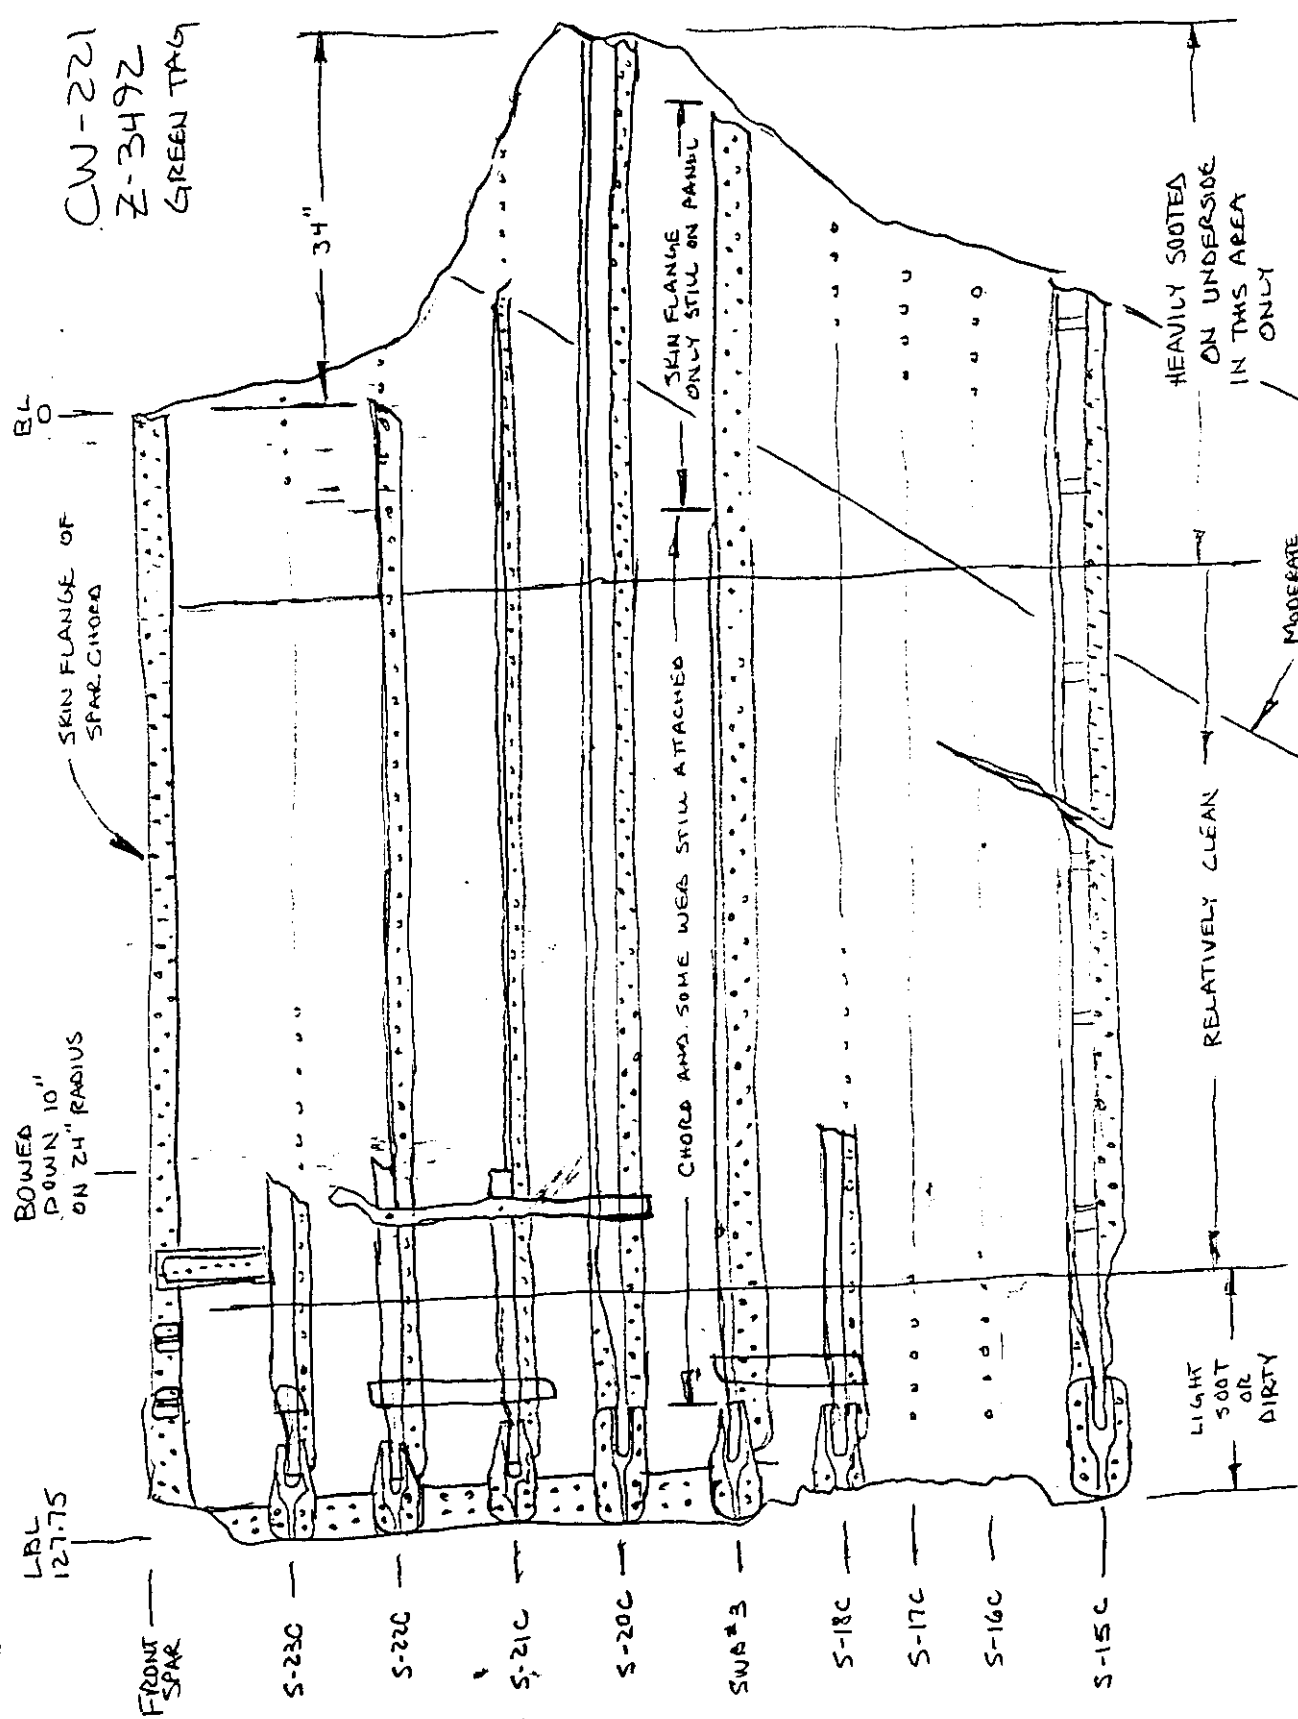
CENTER SECTION LOWER SKIN

This is a large section of skin panel and stringers that extends from the left S.O.B. to ^{RBL} RBL 33 and from S-15 to the front spar. It contains partial stringers at all locations except at S-16 and S-17. It also contains the skin flange of the front spar chord and the inbd portion of the S.O.B. lower splice plate. A portion of the lower web of SWB #3 remains attached from LBL 26 to SOB.

Using the area at BL 0 as a reference, the panel bends down at a 15 degree angle at LBL 43 going outbd and bends back up at a 10 degree angle at LBL 72. The depth of the bend is 7" at the front spar and about 12" at SWB #3. The forward edge of the skin and spar chord is bent down from BL 0 to LBL 75. The remaining stringers are attached to the S.O.B. paddle fittings and only a portion of the remaining stringers are attached to the skin panel and conform to the general shape of the skin panel. See the sketch of this section for description and the quantity of remaining stringer on the panel.

Only the skin flange of the front spar shear ties remain except at LBL 26 which has failed at the attachment to the front spar stiffener. There are small fatigue cracks on the aft side of the shear ties at LBL 84 and LBL 92. There is also a small fatigue crack at the fillet radius of the front spar chord near the longeron splice at LBL 80. The fatigue cracks are fully documented in the metallurgical report. The upper tension bathtub fitting on the inside of the skin panel at the longeron splice is fractured vertically thru the tension bolt hole and is deformed at the fwd end. The lower tension fitting attached to the lower surface of the panel is intact and the tension bolt hole is elongated vertically. The forward facing lug on the longeron splice fitting exhibits a tension failure at the aft bolt hole with some bending to the left. The keel beam chord is missing from the panel and the fasteners remaining in the holes exhibit tension failures. There are several fairing support rods attached to the lower surface at LBL 110.

There is some soot on the inner and outer surfaces of the skin panel. See the Fire and Explosion Group notes for further documentation.

BOWED DOWN 10" ON 24" RADIUS

LIGHT SOOT OR DIRTY

RELATIVELY CLEAN

MODERATE SOOT ON SKIN INTERIOR INCLUDING SKIN/STGR INTERFACE

HEAVILY SOOTED ON UNDERSIDE IN THIS AREA ONLY

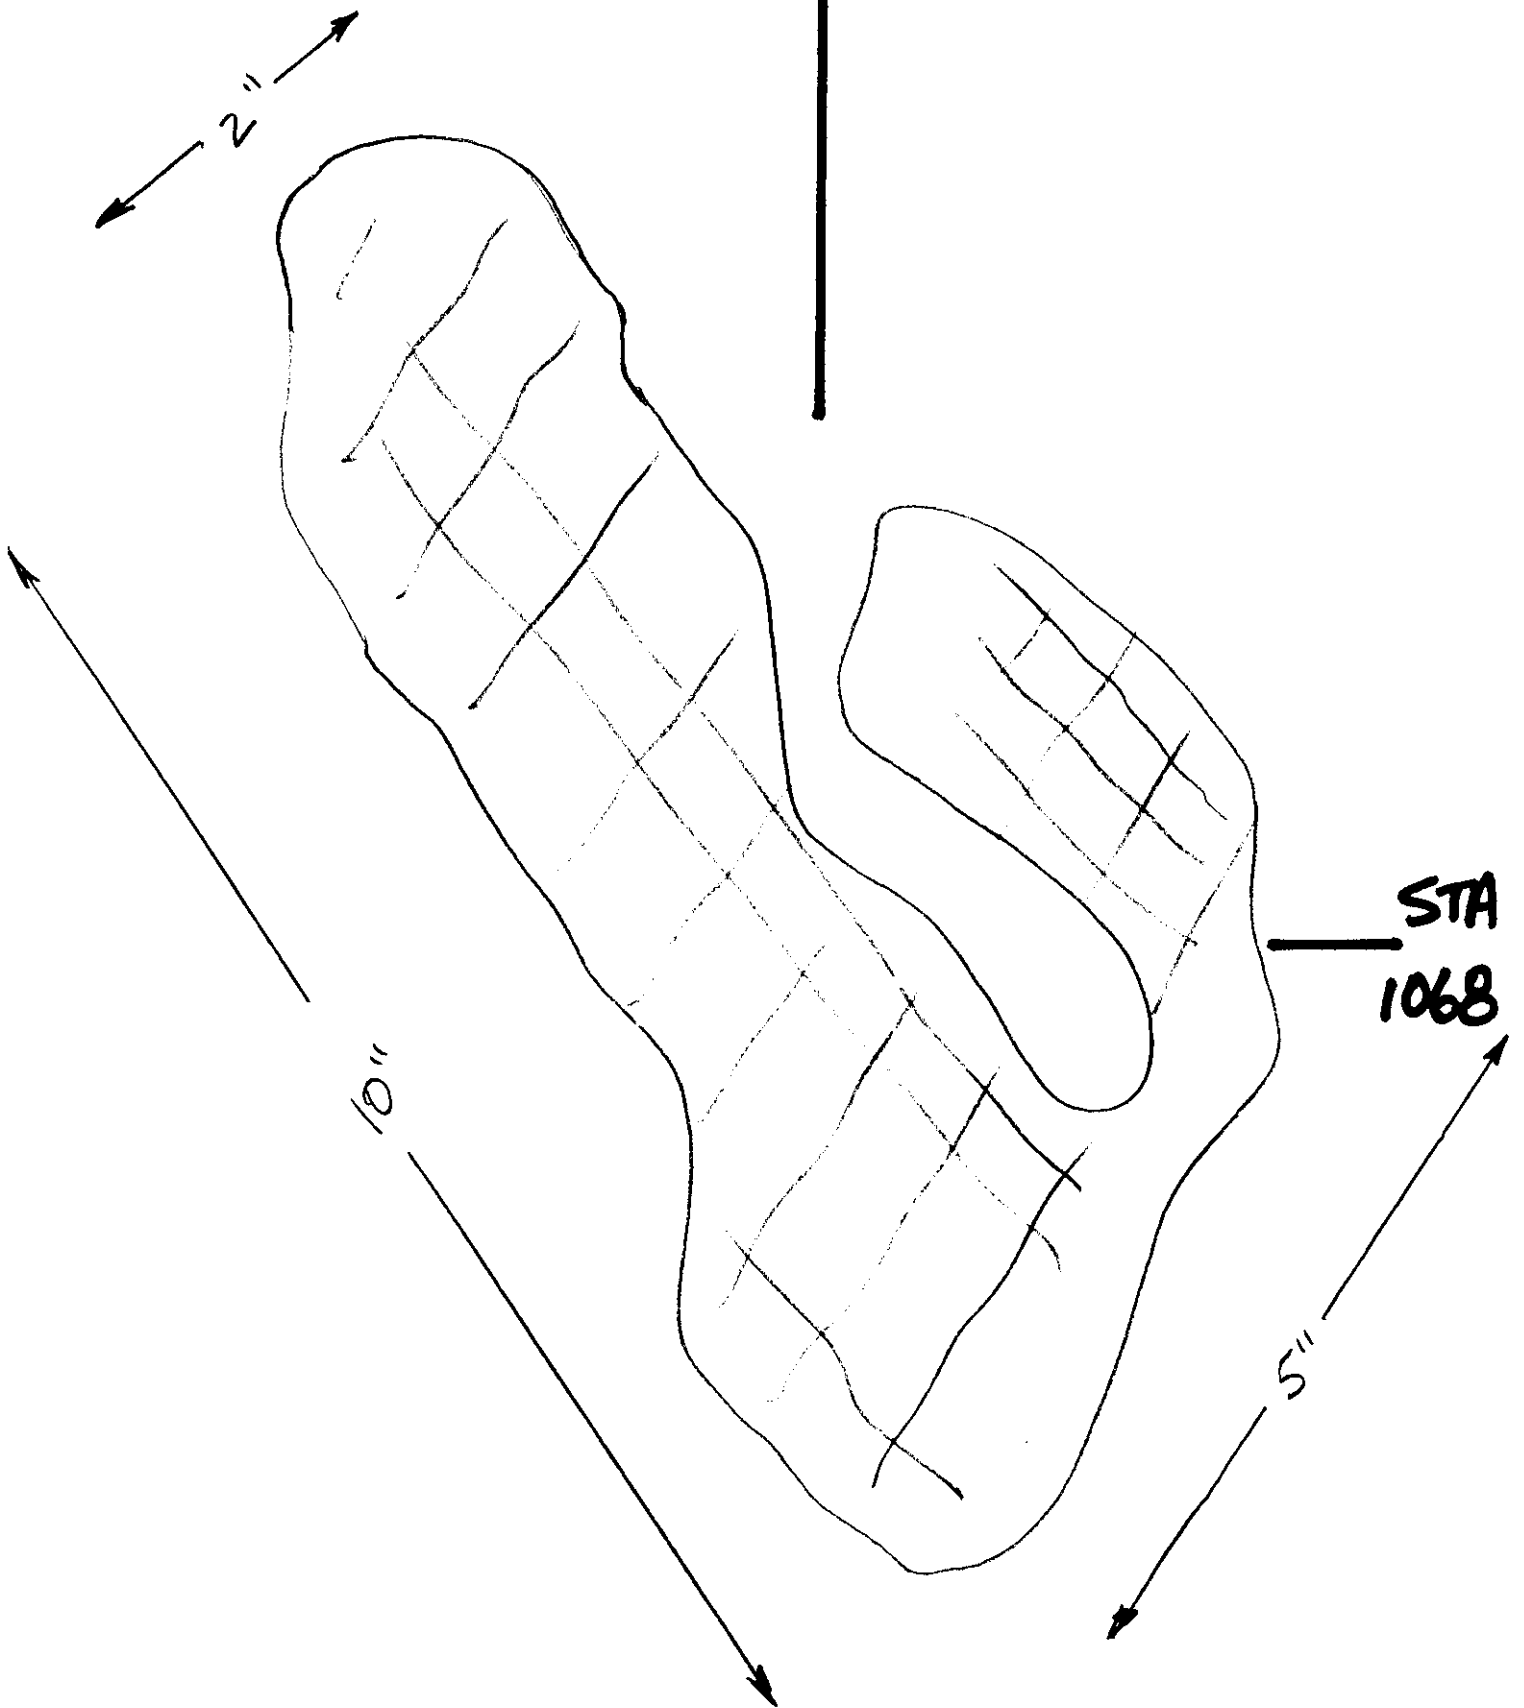
SUBJECT: LWR SURFACE RUB MARKS

THE SUBJECT MARK APPEARS TO POSSIBLY HAVE BEEN MADE BY CONTACT BETWEEN A FIBREGLASS FACE SHEET AND THE LOWER SURFACE OF THE LOWER CENTER SECTION SKIN PANEL (PANEL CW221 Z-3492). THE SURFACE IS NOT SOOTED. THE SOOTING ON THE ENTIRE LOWER PANEL IS PROGRESSIVELY MORE PRONOUNCED ON THE LOWER SURFACE AS YOU MOVE TOWARD THE RIGHT HAND SIDE OF BODY RIB. SOOTING ON THE UPPER SIDE IS LESS PRONOUNCED AND IS OBSERVED OVER ITS ENTIRE SURFACE.

THE SUBJECT MARK IS ABOUT 1/4 FT² IN SIZE. NO OTHER SIMILAR MARKS ARE FOUND ON THE BALANCE OF THE 400 FT² SURFACE (APPROX.). THERE ARE DUCTS ABOVE THE AIR CYCLE MACHINE WHICH CHANNEL AIR INTO/OUT OF THE ACM. THESE APPEAR TO BE OF A SIMILAR PATTERN TO THE MARK OBSERVED. THESE DUCTS HAVE BEEN CRUSHED AND BROKEN IN VARIOUS WAYS. THERE ARE BLADE "STAY OUT" ANGLES ON THE TOP OF ALL 3 ACMS WHICH APPEAR TO PREVENT FOD INTO THE ACM RADIATORS. THE BLADES ON ACM NO. 1 ARE PUSHED FWD WHILE THOSE ON ACM'S 2 & 3 ARE UNTOUCHED. [IF THE LOWER
